# Medium-Scale Fire Resistance Testing of Timber Structures with Composite Cement Fibre Materials

**Abstract:** The combustibility of natural wood presents a negative impact for using this material in buildings. Timber elements can be clad with boards made of non-combustible materials. This study represents a group of options for increasing the resistance of timber against the effects of fire and the possibility of slowing down the effect of thermal degradation of wood. The aim of this study is focused on an experimental testing of structures with timber elements protected by cement fibre boards as a non-combustible fire retardant. Cement fibre boards are fibre-reinforced composite materials used for systems of dry constructions. These boards present the highest degree of fire reaction class (A1). The behaviour of the structure, loaded by the effects of fire, was monitored during the experiment. The specimen was tested with reduced dimensions. The temperature loading corresponded to the procedure according to the standards. The final fire resistant (FR) results were evaluated in accordance with the requirements for the selected limit states of FR. This was assessed based on the me

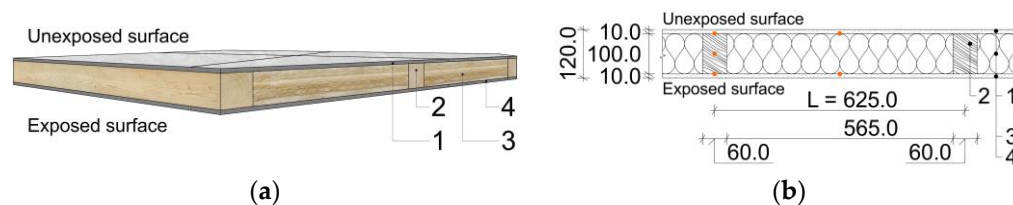
The specimen presents a typical structure of the inner wall of timber buildings. The schematic 3D section (a) and cross-section (b) with the dimensions of the materials and elements of the tested structure can be seen in Figure 1.

**Figure 1.** Composition of the tested structure: (a) Schematic 3D section; (b) Cross-section.

The dimensions of the structure were adapted to the dimensions of the experimental testing equipment. The height and width of the wall were reduced from the original dimensions of 3 m × 3 m to the reduced dimensions of 1.3 m × 2.3 m. The sample height ratio was 1:0.76, and the sample width ratio was 1:0.43, compared to the procedure according to the standards. The cross-sectional dimensions of the wooden elements were maintained at the original values, as well as the sample thickness of 0.12 m.

The frame was built from spruce timber (average density 450 kg·m<sup>-3</sup>) studs with cross-sectional dimensions of 60 mm × 100 mm (layer no. 2). The fire reaction class of the timber studs is classified as D-s2, d0 [23]. The insulation was from glass-based mineral wool (A1) between the wooden frame with the same thickness as the studs (layer no. 3). The structure was covered by the cement fibre board cladding (layers no. 1 and 4). The total dimensions of the tested specimen were 1.3 m × 2.3 m × 0.12 m (width × length × thickness). The structure can be classified as the DP2 structural part, according to Czech standards [24]. This classification is analogous to the European system with K classes for the fire protection ability of coverings. The K classes are divided into two types, according to the properties of the substrate behind the protective material. A K<sub>2</sub> class is usually assessed for the protection of wood. The K classes allow the classification of claddings from combustible materials, which can also protect the structure from the effects of fire [25]. The DP2 classification can also be compared to the principle of fully encapsulated structures. The structure can be classified as a DP3 structural part after the failure of the lower exposed layer of the cement fibre boards. This complies with the principle of partial encapsulation, where the wood surfaces are protected from rapid flame spread, but it will not prevent the charring or ignition of the underlying timber in the later fire stage [14].

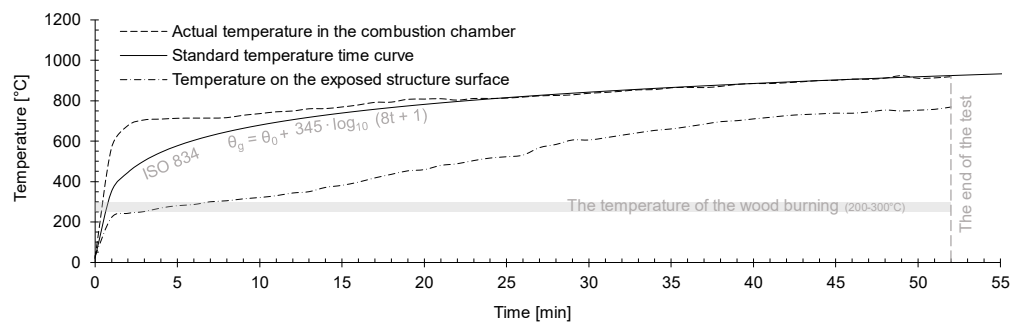
The temperature courses in the combustion chamber are shown in the chart in Figure 2.

**Figure 2.** Chart of the furnace control temperature.

The temperature was a bit higher in the first few minutes of the test because of the higher burner performance. Previous research points to the fact that a thermal exposure slightly higher than the standard time–temperature curve has less effect on the fire resistance than a lower thermal exposure [27]. The lower thermal exposure than the standard curve provides better fire resistance values, which can significantly affect the final evalu-

ation of the medium-scale test. Based on these facts, the temperature loading took place according to the standard time–temperature curve during the experimental medium-scale FR test. The sample with the original thickness (1:1) was, therefore, tested under the standard thermal loading.

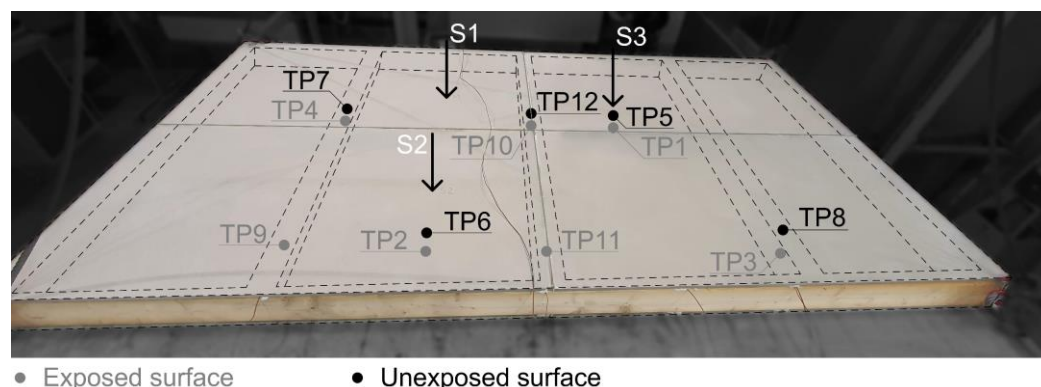
**Figure 3.** Structure before the test—positions of the measured temperature profiles.

The temperature courses inside the structure were measured by thermocouples at the positions of the studs and between them. The thermocouples were connected to a pair of measurement modules, and the data were continuously recorded. The positions of the thermocouples inside the specimen are shown in Figure 3. The temperature profiles are described in Table 1. The thermocouples were built into the structure during sample preparation.

The temperature courses from the data in Table 2 are shown in Figure 8. The highest values were measured at the position of surface point S1 (see Figure 3). The limit value (average increase of  $\Delta t = 140^\circ\text{C}$ ) was exceeded after the 47th minute. The limit value of the maximum increase of  $\Delta t = 180^\circ\text{C}$  was exceeded in point S1 also around the 48th minute. Exceeding the limit values can be seen in the figure below.

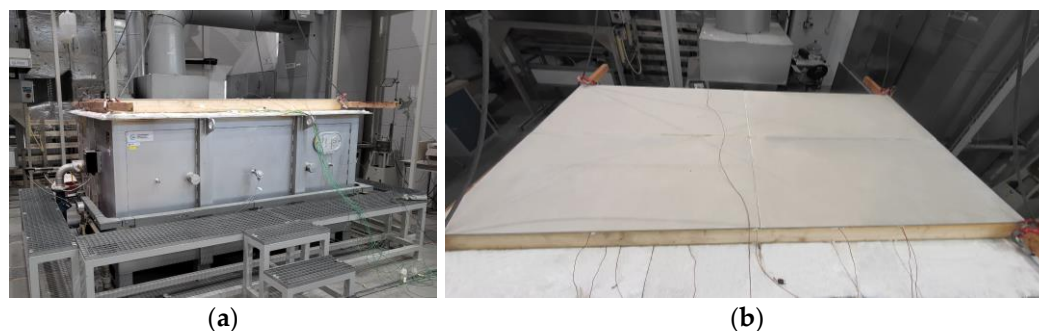
The specimen before the start of the test and the test equipment can be seen in Figure 4.

**Figure 4.** (a) Test equipment; (b) The specimen before the start of the test.

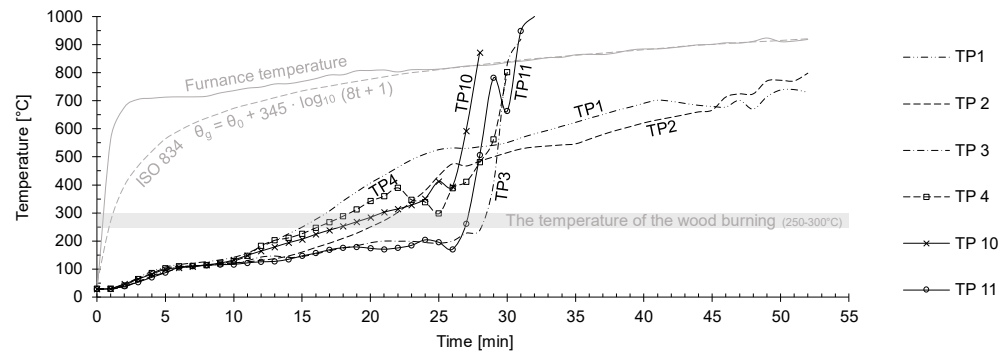
The thermal loading of the tested structure was performed for the test duration of 52 min. The temperatures measured on both surfaces inside of the structure can be seen in the figures below (Figures 5 and 6). The temperatures between the exposed cement fibre board and the thermal insulation (glass-based mineral wool) are shown by the courses TP1 and TP2 in the chart in Figure 5. These temperature profiles show gradual increases in temperature throughout the test. The limit of 300 °C was exceeded after the 15th minute (TP1) and 22nd minute (TP2). The smooth rising course of the temperature curves may indicate the integrity of the boards.

**Figure 5.** Temperature profiles (TPs) of the exposed surface structure.

Data from the thermocouples placed at the positions under the timber elements are shown by the temperature profiles TP3, TP4, TP10, and TP11. TP10 and TP11 show higher temperatures at the position of the glued board joints. The chart shows an obvious failure of the cement fibre boards between the 25th–30th minute (rapid rise in temperatures). The evaluation of the structure type can be based on these values.

The lower layers of the non-flammable cladding were broken around the 20th–25th minute. This was based on the sharp temperature rise at this time, as can be seen in Figure 5. The specimen can be evaluated as a DP2 structural part (the combustible timber elements covered by the non-combustible cement fibre board layer) for 15 min [24], and after this time, as a DP3 (unprotected combustible material) because of the crack failure of the lower boards.

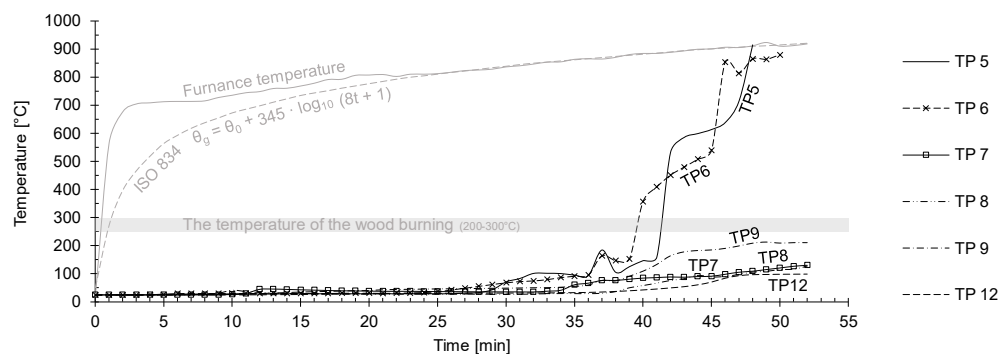
**Figure 6.** Temperature profiles (TPs) of the unexposed surface structure.

The specimen's temperature profiles in the upper part (unexposed surface) can be seen in Figure 6. The low values indicate the thermal insulating properties of the structure.

The temperature rises of TP5 and TP6 show a failure of the thermal insulation layers between the timber elements of the frame. TP7, TP8, and TP12 point to the thermal insulation properties of wood. These temperature profiles were measured on the unexposed surfaces of the timber elements. The measured values reached temperatures around 130 °C at the end of the test. This shows that the wood mass on this side of the structure was not damaged by the fire. The last thermocouple was placed in the centre of the timber stud at half the height. The TP9 from this thermocouple shows an approximate temperature distribution along the height of the timber element.

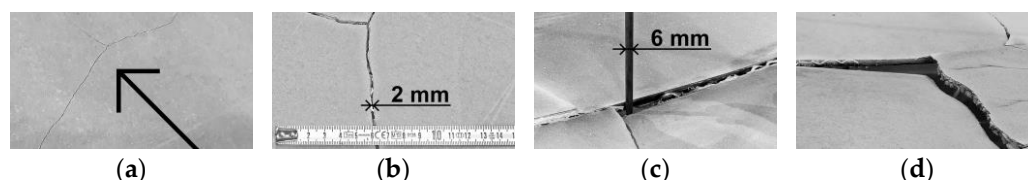
The unexposed boards (upper surface) were broken by cracks. The progress of the defect of the upper cement fibre boards can be seen in Figure 7. The first crack formed at the position between the timber studs around the 42nd minute of the test—Figure 7a. The size of this crack was about 2 mm in the 47th minute after the start—Figure 7b. The other

measuring of the crack was according to the gap gauges based on the EN standards. The 6 mm diameter gap gauge can penetrate a through gap, such that the end of the gauge projects into the furnace—Figure 7c. The gauge cannot be moved in the gap for a distance of at least 150 mm, so this requirement for the LS (E) violation was not exceeded. This LS (E) was exceeded in the 52nd minute because of the penetration of a 25 mm gauge through the specimen—Figure 7d. This over-limit crack formed at the position of the thermocouple with TP5.

**Figure 7.** Integrity failure of the specimen—cracks in the: (a) 42nd minute; (b) 47th minute; (c) 50th minute; (d) 52nd minute.

The LS of integrity (E) can be assessed according to the condition of the unexposed surface. This LS was exceeded in the 52nd minute because of the excessive crack damage. This LS can be also classified for 45 min [24].

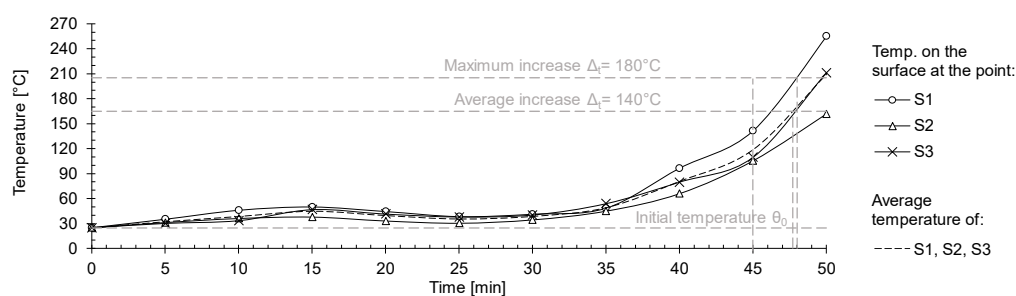
**Figure 8.** Temperature profiles (TPs) of the unexposed specimen surface.

The maximum temperature was  $141.3^\circ\text{C}$  at point S1 at the 45th minute. The maximum increase of the temperature was  $\Delta t = 116.5^\circ\text{C}$ , according to the value of the initial surface temperature. The average temperature was  $118.6^\circ\text{C}$  at the 45th minute, so the average increase of the temperature was  $\Delta t = 93.8^\circ\text{C}$ .

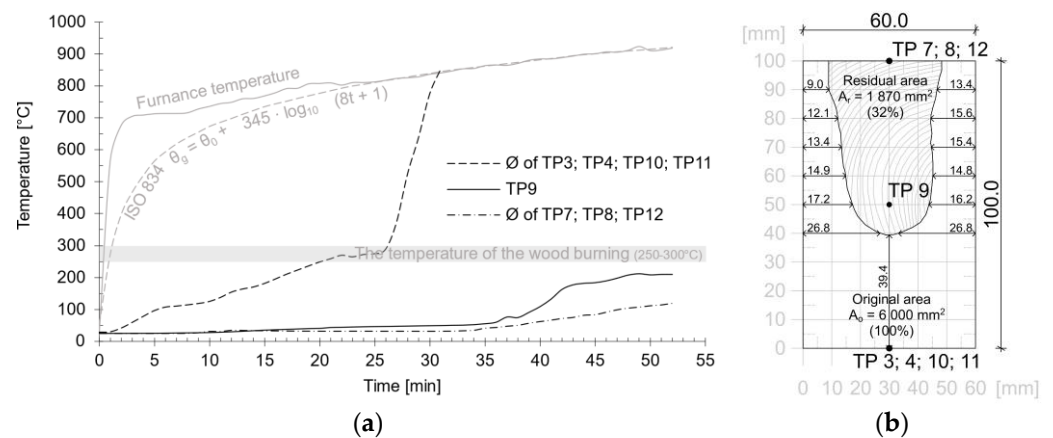
**Figure 9.** (a) Average temperature profiles (TPs) of the studs; (b) Cross-sectional area of the timber element after the test.

Figure 9a presents the average temperatures from the thermocouples placed at the positions of the exposed and unexposed timber surface. TP9 shows the temperature course in the centre of the timber stud at half the height. It can be assumed that the wood mass in the middle of the element was only minimally affected by the temperature. The maximum temperature rise was  $\Delta t = 185 \text{ }^\circ\text{C}$  at this position at the end of the test (52nd minute) and  $\Delta t = 159 \text{ }^\circ\text{C}$  in the 45th minute, so the wood burning limit was not exceeded.

properties of the equipment. The load-bearing capacity requirements were, therefore, not monitored. The condition of the timber elements was analysed after the end of the test. The studs were cut in the most damaged positions, and all samples were measured and registered. The data were then processed in the CAD software for further analysis. The timber studs were exposed to fire from one side in the first half of the experiment. This is given by the encapsulation in the non-combustible cement fibre boards. Charring of the timber occurred only on the edges in contact with the fire-exposed boards, so there was a less rapid reduction in the wooden mass and strength [33,34]. After the exposed boards were completely damaged, the insulation between the timber studs loosened and fell off. The timber elements were exposed from three sides from this time, and the reduction in the stud's dimensions was faster. The cross-sectional area after the 52 min test can be seen in Figures 9b and 10.

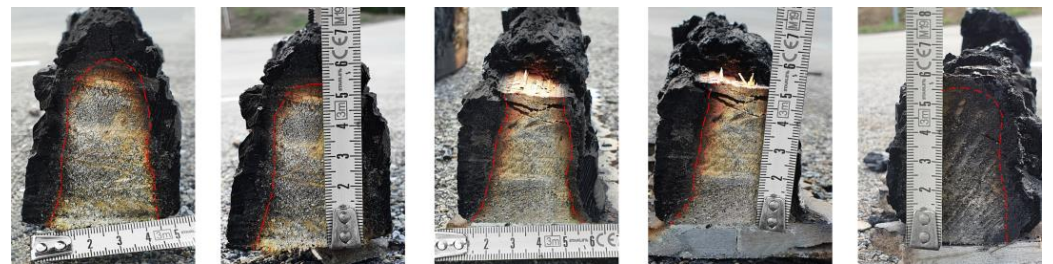
**Figure 10.** Residual cross-sectional areas of the timber elements after the test.

The carbon charred layer can be seen in the cross-sections of the timber studs at the end of the test—Figure 10.

The specimen was not loaded by forces during the test due to the limits of the testing equipment. The residual undamaged area of the wood mass was about 32% of the original value of the cross-sectional area.

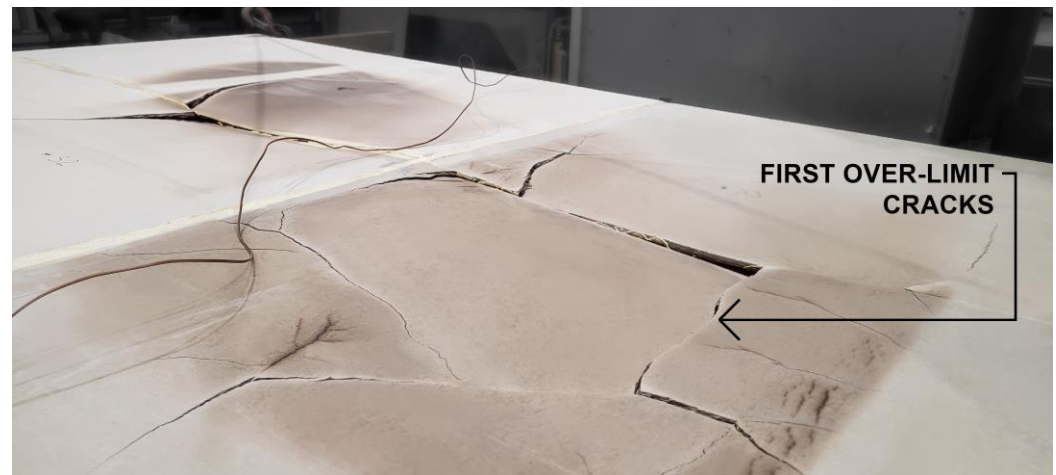
The conditions of the specimen after the test can be seen in Figures 11 and 12. Figure 11 shows the structural damage and the first oversized cracks of the unexposed cement fibre board surface.

**Figure 11.** The condition of the structure at the end of the test.

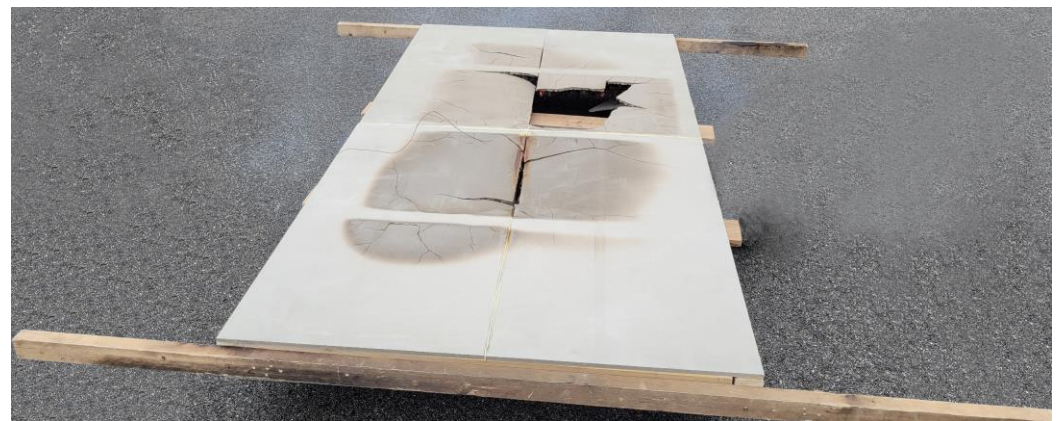
**Figure 12.** The condition of the structure after the test.
