# Detection and Damage Evaluation of Hinge Joints in Hollow Slab Bridges Based on a Light-Load Field Test

**Abstract:** The hollow slab bridge is a widely used bridge type for urban bridges. The slabs are prefabricated in a factory and are assembled on site, and then the hinge joints are poured on site. Shallow hinge joints have been used in most existing hollow slab bridges, which commonly bring inadequate connection to the adjacent slabs and probably result in bridge damage. Traditional detection and test methods for hinge joints interrupt traffic, which is inconvenient for local commuters. In the present study, a light-load field test method for hinge joints was proposed. The principles and procedures of the light-load test were concluded and provided based on the test results of 96 spans. The theoretical and measured lateral load distribution ratios were calculated and compared based on hinge joint plate theory. The damage evaluation method and damage classification for hinge joints were defined based on the test results of 1100 hinge joints. Furthermore, the accuracy of the proposed method was verified by a destructive experiment. The research results indicate that the light-

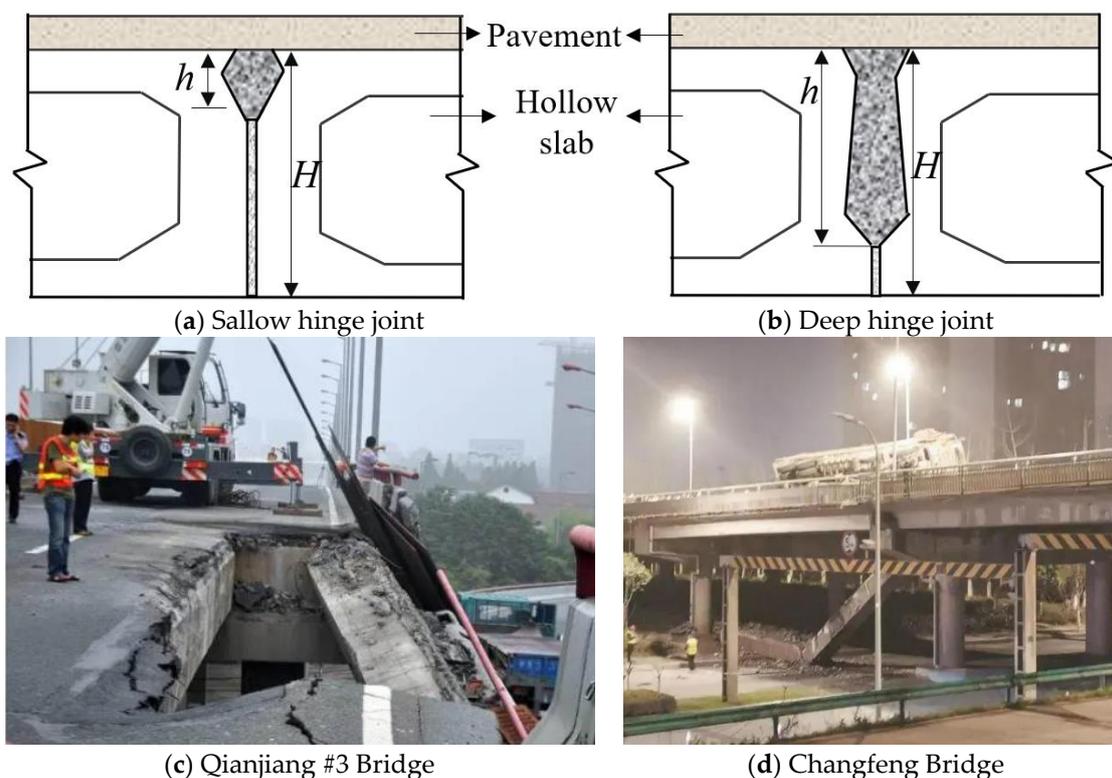
**Figure 1.** Pictures of slab failure.

Two examples of slab failure are shown in Figure 1c,d (taken from [image.baidu.com](https://image.baidu.com) accessed on 15 January 2023), both of which are commonly seen hollow slab bridges, using shallow hinge joints, located in urban roads, with a span of approximately 20 m. The immediate cause of slab failure was an overloaded truck moving on the bridge. The difference was that a limbic slab of the Qianjiang #3 Bridge fell off from the bridge on 15 July 2011, and a middle slab of the Changfeng Bridge fell off from the bridge on 16 March 2021.

difficult to use visual detection methods to detect the damage of the hinge joints. Because the pavement is above the hinge joints, the slabs surround the hinge joints, and even some waterproof cloth covers the bottom of the hinge joint. In other words, the hinge joints are enclosed by structural members. If the hinge joint loses its bonding ability to a large extent, a single slab will bear more load than it should, which may result in slab failure and greatly threaten human lives and properties [7,13].

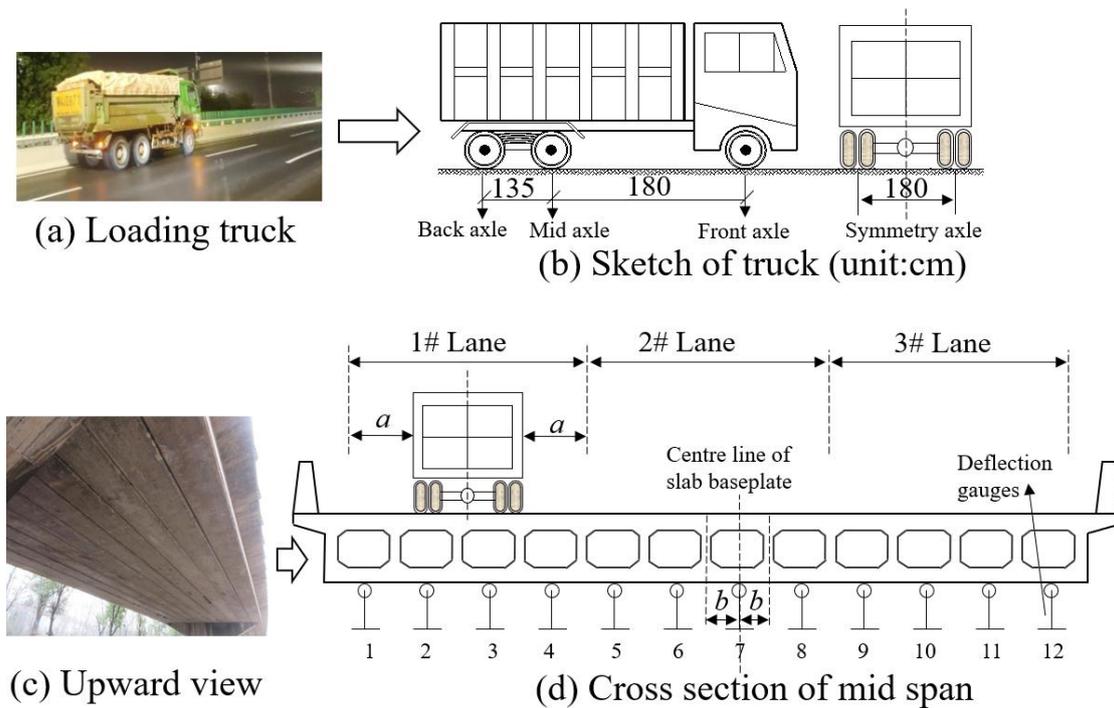
**Figure 2.** Schematic diagram of the test conditions for the light-load field test.

The lanes of Qingling #5 Bridge are shown in Figure 2, which works as a schematic template to exhibit the test principles and test conditions. The truck will move forward on the lanes in sequence. The symmetry axle of the truck will coincide with the center line of the lane, as shown in Figure 2d. The testing points are situated at the intersection points of the midspan line and the center line of the slabs' baseplate. In the latest light-load field test conducted by our research team, a truck's picture is shown in Figure 2a,b. It weighs 400.9 kN and the weights of the front axle, mid axle, and back axle were 60.4 kN, 170.2 kN, and 170.2 kN, respectively.

- (3) In each test condition, a lane should be ground by the truck in a single test condition, and the data of the mid 7 slabs (or mid 6 hinge joints) below the testing lane deserve analysis. For example, in test Condition 1, the truck is moving in the 1# Lane, the deflections of the #1~#7 slabs are needed for calculating the lateral load distribution ratio. In test Condition 2, the truck is moving in the 2# Lane, the deflections of the #3~#9 or #4~#10 or even #3~#10 slabs are studied. Similarly, in test Condition 3, the truck is moving in the 3# Lane, the deflections of #6~#12 slabs are studied.

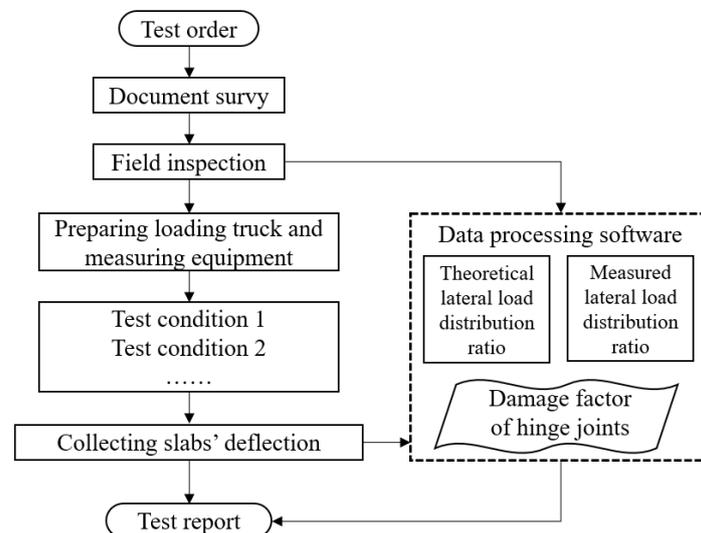
**Figure 3.** Flow chart of the light-load field test.

The purpose of the light-load field test is to evaluate the damage status of the hinge joints based on the lateral load distribution ratio, and then to help to make reasonable decisions for bridge maintenance. Data processing software based on hinge-joint plate theory has been developed according to a great deal of test experience. It has been applied in lots of bridge tests. The software can calculate and predict the lateral load distribution ratio of bridges and evaluate the damage status of the hinge joints after the criteria have been set up. The test procedures are shown in Figure 3. One of the most significant advantages of light-load field tests is avoiding interrupted traffic; another advantage is

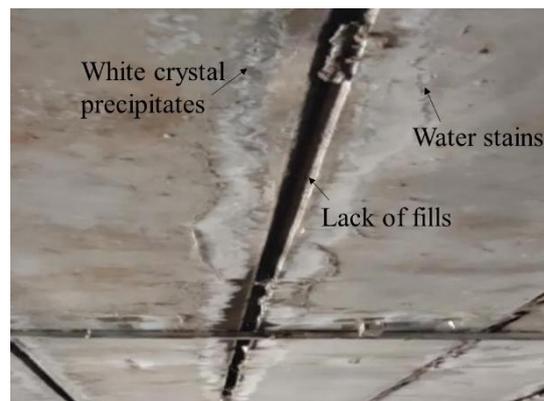
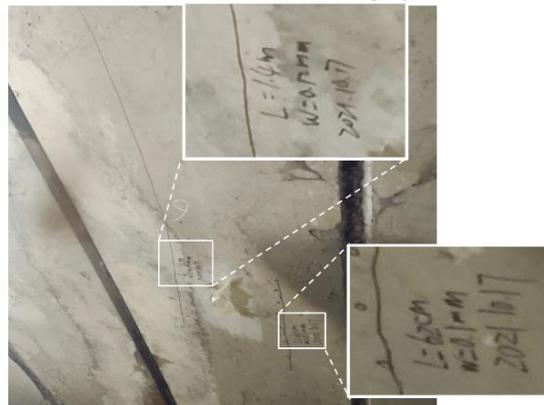
Figure 4. Damage status of the hollow slab bridge.

(a) Defects of the hinge joint

(b) Cracking on the slab

Generally, hollow slab bridges bearing urban traffic did not appear to have serious bridge damage. Almost all of the tested samples worked well based on their conventional maintenance record. Actually, they looked like newly built bridges when observed from the deck, even if there was some damage to the slab when observed below the bridge. One of the most commonly observed types of damage was the defect of the hinge joint, as shown in Figure 4a. Some fills had fallen off the joint, water leaked from the joint, and even some white crystal precipitates appeared near the joint. Another form of damage was cracking on the slab, as shown in Figure 4b. Two longitudinal cracks appeared on the bottom of the slab, the length of the crack was marked as “L”, the width of the crack was marked as “W”, and the day the cracks were found was also marked on the slab. It should be noted that cracking on the bottom of the slab is not a commonly seen defect, and only 4 out of 96 spans appeared with longitudinal cracks during the latest detection. Furthermore, no transverse crack was found on the bottom of the slab.

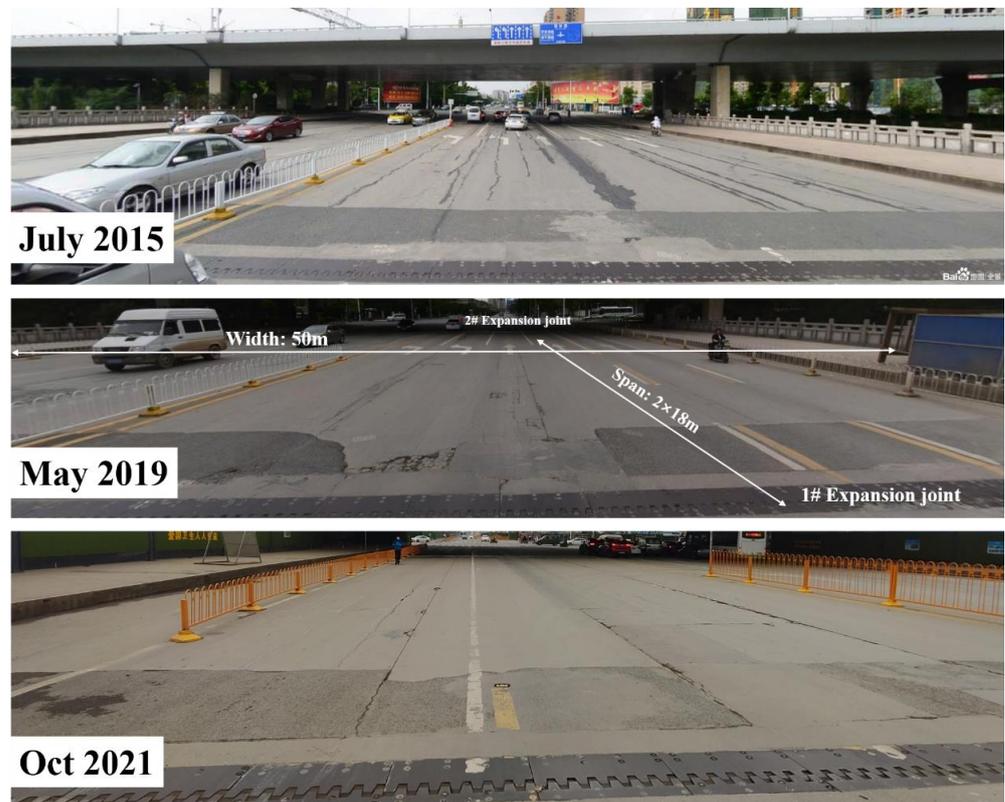
Figure 5. Appearance of Luojiagang Bridge.

Among the latest detections, obvious damage such as cracking of the deck pavement appeared on only one bridge, called Luojiagang Bridge, as shown in Figure 5 (the upper two pictures were quoted from [map.baidu.com/](http://map.baidu.com/) accessed on 15 January 2023, and the third picture was taken by the research team). It is located on a busy traffic road and has two spans and 47 slabs. It was built and opened to traffic in 2003. The profiles of Luojiagang Bridge are listed in Table 1 and are marked in Figure 5. The longitudinal cracks on the deck pavement, as well as the stains of repairing measures were clear. Compared with its status in July 2015, May 2019, and October 2021, despite conventional maintenance, the pavement had been damaged again and again by busy traffic. This indicates that there may be some structural damage to the load-carrying members, and repairing the pavement in order to avoid further damage may make no sense. However, the longitudinal cracks expanding along with the hinge joints indicate that the slabs were no longer working together. This means that some hinge joints lost their function to some extent, making the slabs deform asynchronously.

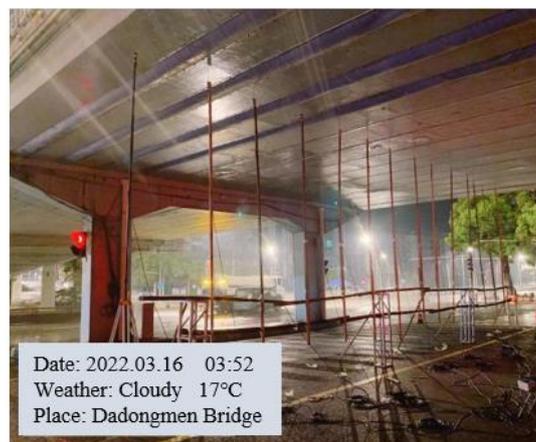
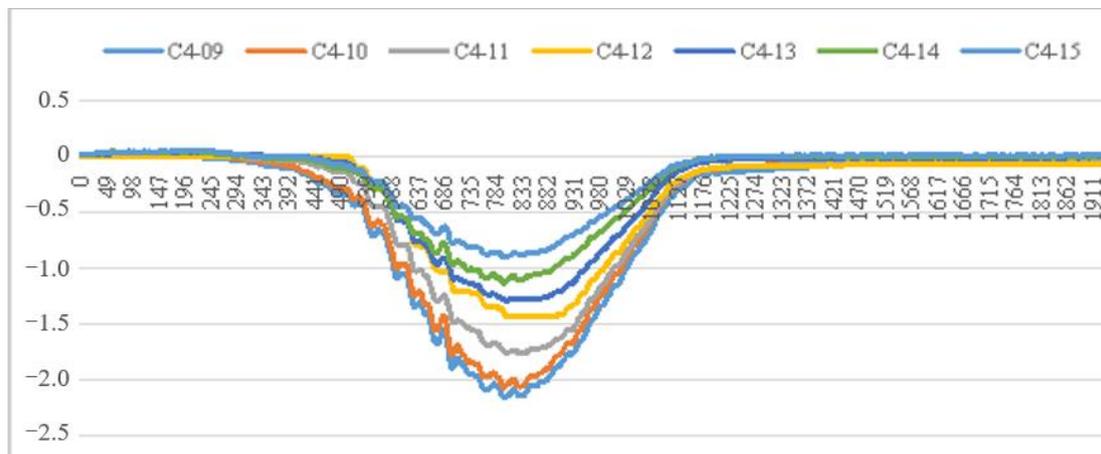
**Figure 6.** Deflection measurement.

One of the most noteworthy advantages of the light-load field test is that the test will be implemented without interrupting traffic. Hence, the dynamic deflection of the slab needs to be recorded. In the latest detection, a system for recording and reading dynamic deflection gauges was used to measure the deflection, as shown in Figure 6. A deflection sensor (called a dial indicator) was installed at each testing point, as shown in Figure 6a. The deflection history of each slab was recorded and is shown in Figure 6b. The horizontal axis represents the time intervals, the record frequency is 50 Hz, and the vertical axis represents the deflection, the unit is millimeter. The peak value of the curve is the need data, which is treated as the deflection obtained from the static load test.

(a) Picture

(b) History curves of deflection

According to the measured deflections from the 287 slabs, the maximum value of dynamic deflection was 2.96 mm, and most values ranged from 1.00 mm to 2.00 mm. As an example, the measured deflections of the Qingling #5 Bridge are listed in Table 2. Qingling #5 Bridge opened to traffic in 2006, and no obvious visible damage to structural members was found. The theoretical deflections were calculated using the data processing software, and the measured deflections came from the peak values of the dynamic deflection curve.

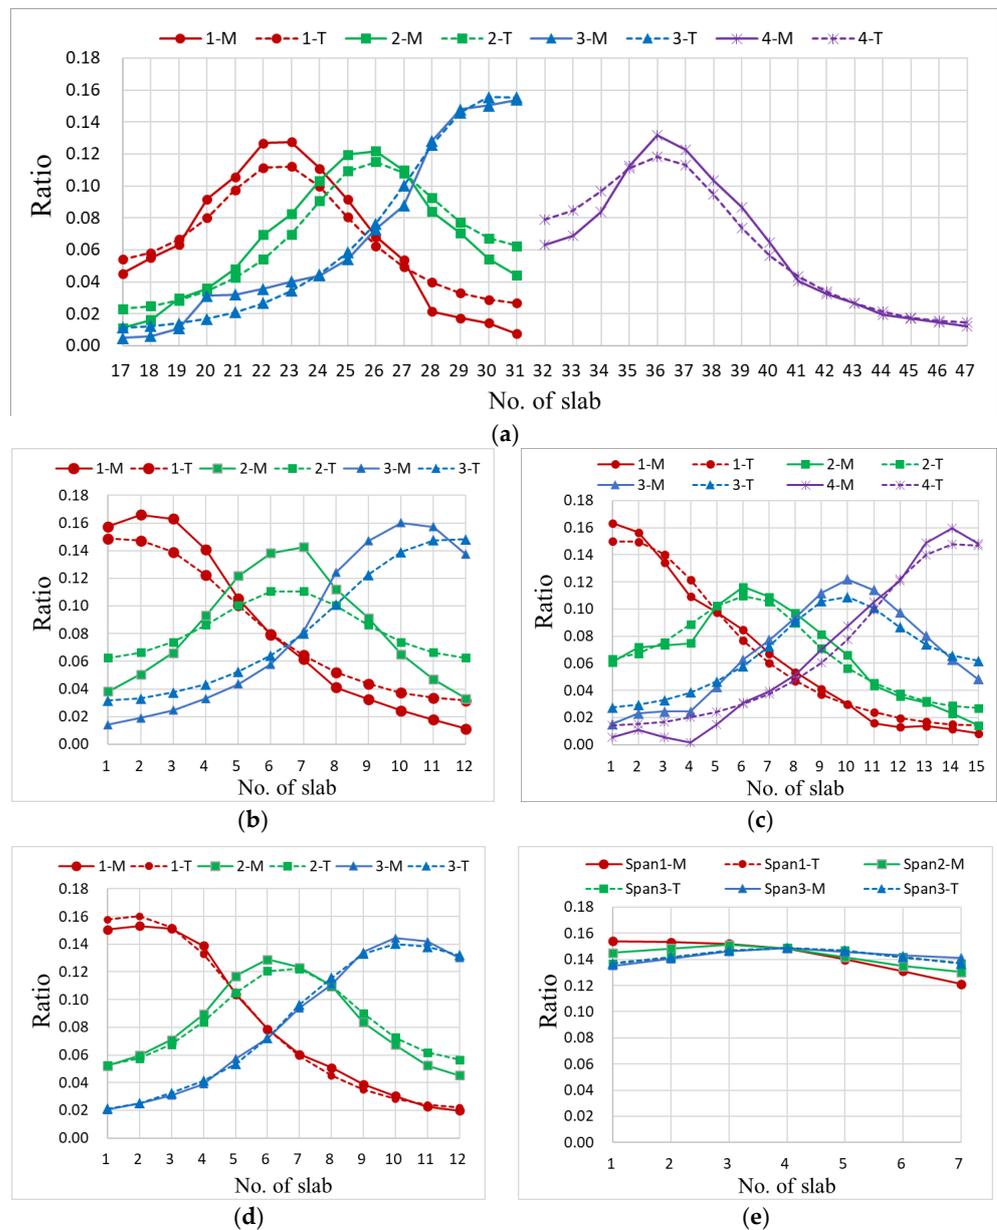
**Figure 7.** Lateral load distribution ratio of different spans. (a) First span of Luojiagang Bridge. (b) First span of Qingling 5# Bridge. (c) First span of Dadongmen Bridge. (d) First span of Yezhi Bridge. (e) First, Second, and Third span of 8# Ramp Bridge.

The values of the lateral load distribution ratio were calculated and are presented in Figure 7. In the legend, the number means the test condition; the solid line means the measured value and the dashed line means the theoretical value. In general, the bulge of the curve reflects the position of the lane that is ground by the loading truck. If the solid line is in accordance with the dashed line, it indicates that the tested slabs work cooperatively, as shown in Figure 7d,e. Otherwise, if some mutational slopes between two points occur to the solid line, this indicates that the slab near the mutational slope may bear more load than it was designed to, shown as segment 19#–20# in Figure 7a, segment 3#–4# and segment 7#–8# in Figure 7b, as well as segment 4#–5# in Figure 7c.

The hinge joint between two slabs plays the role of a force delivery device. Taking Figure 7a as an example, in test Condition 1, the central line of the lane was above the 23rd slab, and the truck's weight was first loaded to the 23rd slab, second delivered to the 22nd slab and 24th slab simultaneously, and then delivered to the 21st slab and 25th slab, respectively. In each step, the hinge joint did not deliver 100% of the load it obtained, and the delivery efficiency obeyed the lateral load distribution ratio. Hence, the attenuation factor of the hinge joint can be calculated by Equations (1)–(3).

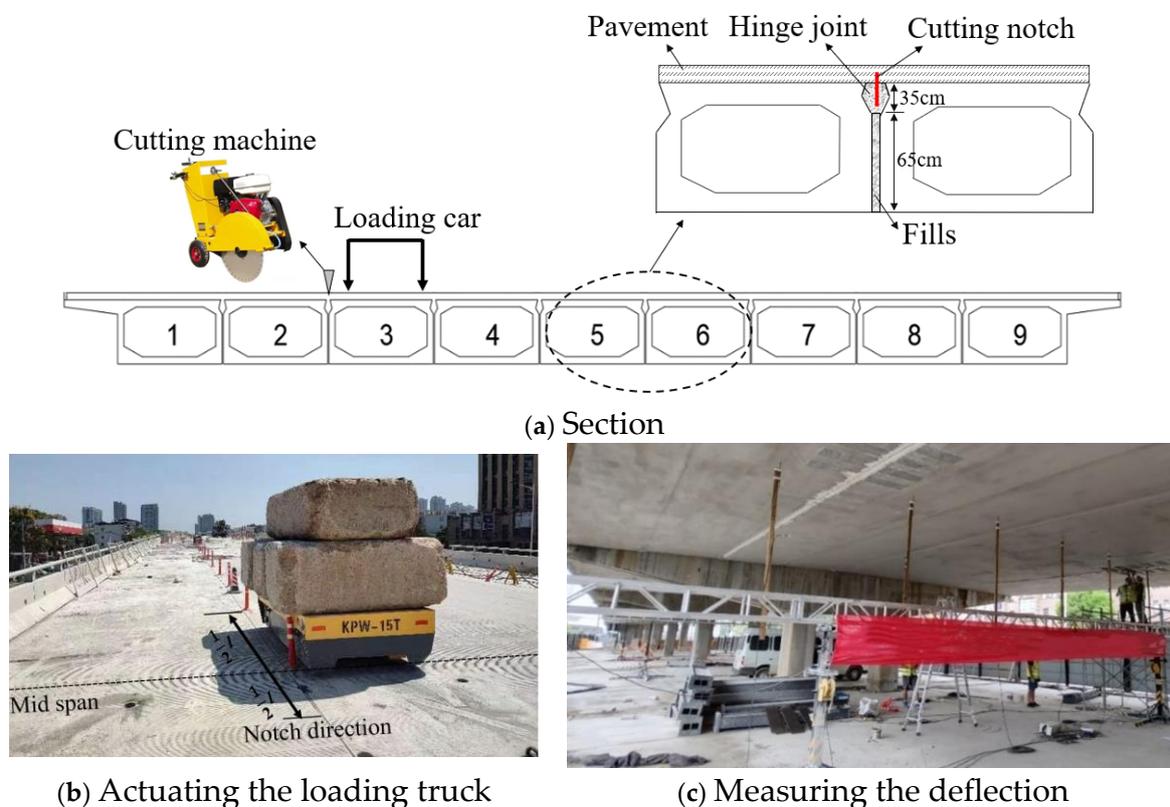
**Figure 8.** The destructive experiment.

A destructive experiment was implemented on a bridge to verify the accuracy of the proposed method. This hollow slab bridge will be demolished in 2023, which provides us with a chance for this destructive experiment. The length of the span was 20 m, and the width of the span was 10 m. First, the pavement was wiped off. Second, the slabs were unclenched by cutting at the central line of the hinge joints. The second hinge joint was chosen to be destroyed, and its location and a detailed sketch are shown in Figure 8a. Third, the loading car, which weighed 15 tons, was actuated to the third slab, and its back axle was placed on the midspan, as shown in Figure 8b. Then, the deflections were collected, as shown in Figure 8c.

After the cutting machine was used, there was a notch left in the hinge joint, as shown in Figure 8b. The blade of the cutting machine was 0.2 cm; therefore, the thickness of the notch was 0.2 cm. The length of the notch was marked as “*l*”, and the depth of the notch

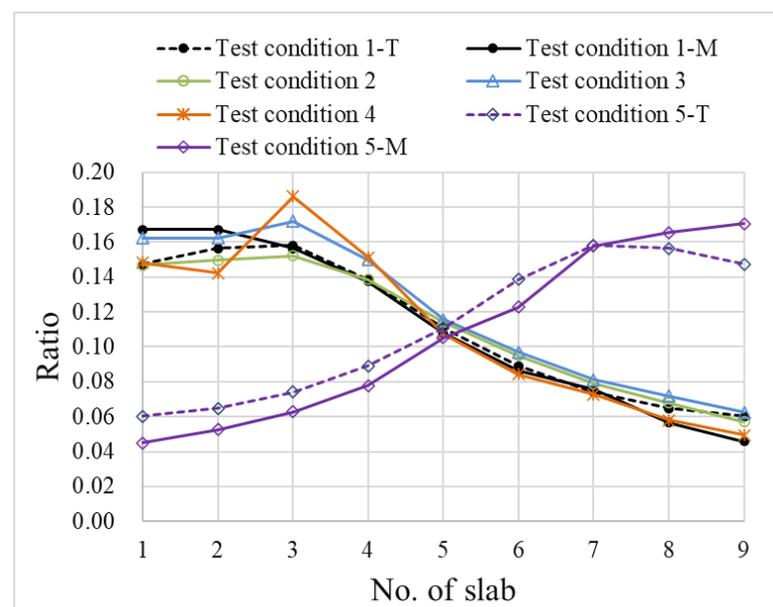
Figure 9. Load distribution ratio of different test conditions.

The lateral load distribution ratio of each condition was calculated and is shown in Figure 9. It is clear that the ratio of the third slab had the largest value, which indicates the location of the loading lane. In test Conditions 1 and 5, the test curves of the “no notch” showed good agreement with the theoretical curves. However, cutting a short shallow notch (test Condition 2) may not attenuate the bonding ability of the hinge joint. In test Condition 3, the ratio of the third slab was slightly larger than that in the theoretical curve, which means that cutting a longer notch, with a length that reached almost half of the total span, may have attenuated the bonding ability of the hinge joint by a small extent. In test Condition 4, the ratio of the third slab was obviously larger than that in the theoretical curve, which means that cutting a long deep notch indeed attenuated the bonding ability of the hinge joint.

Test Condition 5 was a control test of Condition 1. From Figure 9 and Table 3, the theoretical values of the lateral load distribution ratio of test Condition 1 and test Condition 5 were in the mirror phase. For example, the value of  $\frac{T_7}{\sum T_i}$  was the largest ratio in test Condition 5, and it was equal to the value of  $\frac{T_3}{\sum T_i}$  in test Condition 1. The results of test Condition 5 also show the good original state of the bridge because the measured curve was in good agreement with the theoretical curve and the damage factors of the hinge joint were smaller than 10%.
