Article

Test on Shear Behavior of Double-Sided Thin Steel Plate Shear Wall Filled with Rigid Polyurethane Foam

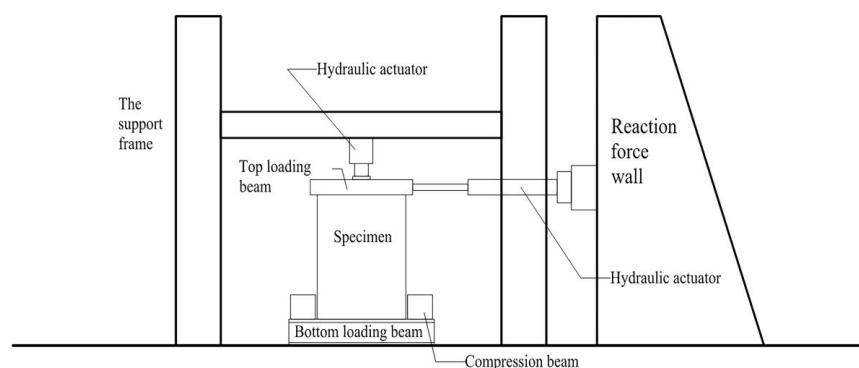
Figure 2. The loading system.

The MTS electro-hydraulic servo program-controlled structural testing machine system was used for the loading. The maximum loading force of the vertical actuator was 100 kN, and the maximum loading force of the horizontal actuator was 500 kN. The brake stroke of the horizontal actuator was ± 200 mm in acting distance. To ensure the safety of the test, two compression beams were used for fixing the bottom loading beam on the ground, as shown in Figure 2.

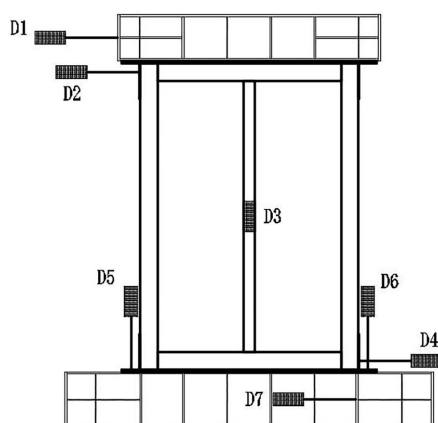
Figure 3. Displacement measuring points.

Following JGJ 227-2011 [21], seven displacement instruments were arranged for both the monotonous horizontal loading and the low cycle reciprocating test, as shown in Figure 3. The displacement recorded by the following displacement meters is based on the ground as a reference. D1 is the horizontal displacement of the left side of the middle of the top loading beam. D2 is the horizontal displacement of the top of the wall. D3 is the lateral displacement in the middle of the wall. D4 is the horizontal displacement at the bottom of the wall. D5 and D6 are the vertical displacement on both sides of the wall. D7 is the horizontal displacement of the bottom loading beam.

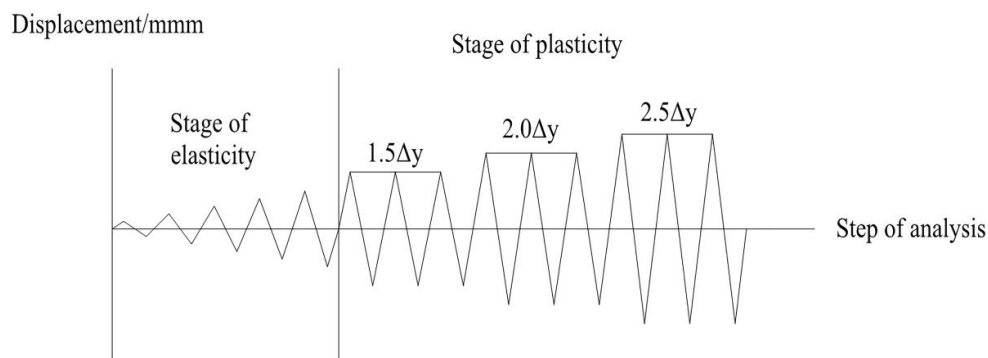
Figure 4. Plan of the quasi-static cycling loading.

The vertical load was treated in the same way as the monotonic loading. The horizontal loading plan for the quasi-static cycling loading is displayed in Figure 4. First, the specimens

were subjected to five stages of single cyclic loading to the approximate yield displacement Δy was estimated by the horizontal monotonic loading test results. Then, the displacement control mode was continued for the following stages, and incremented at $0.5 \Delta y$ for each loading grade until the specimens were damaged. There were three cycles repeated in each stage. During cyclic loading, test data were collected continuously in real time.

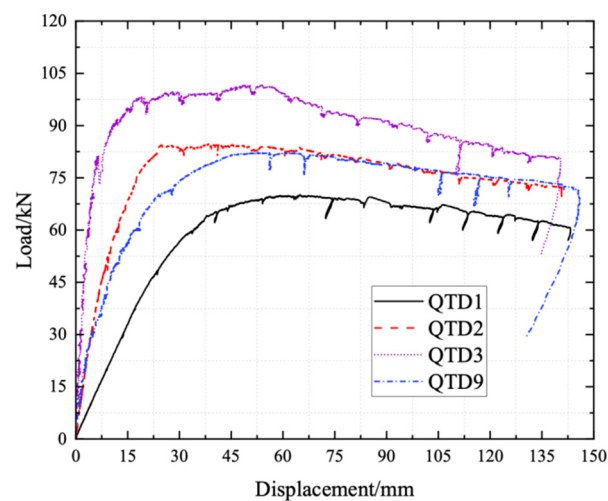
Figure 5. Load-displacement curves under the horizontal monotonic loading.

Throughout the loading process on QT-D1, there was no other phenomenon except steel frame deformation. Figure 5 shows that when the horizontal relative displacement of the top loading beam was 64 mm, the horizontal force reached the peak value of 70.1 kN and then very slowly decreased. This indicates that QT-D1 had good ductility. Figure 6 shows that when the horizontal displacement of the loading beam reached 144 mm, the side column depressed obviously beside the edges of the pull-out connecting plates; then, the loading stopped.

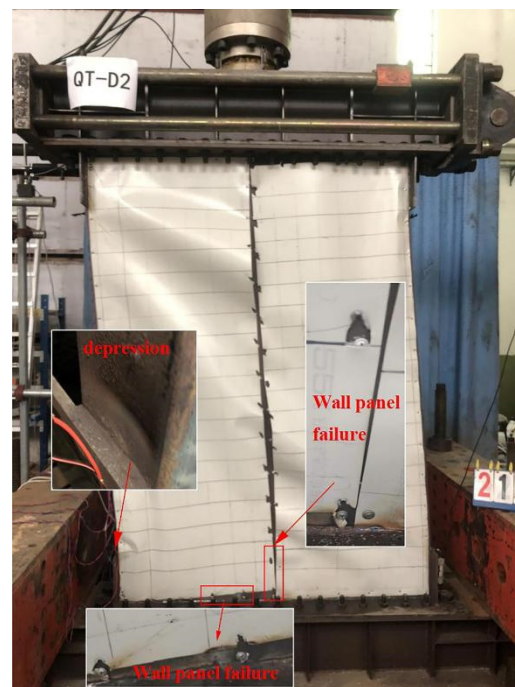
Figure 7. Failure image of QT-D2.

During the first stage loading on QT-D2, the specimen made a clear sound and the thin steel plates appeared slightly wrinkled. The sound was due to the out-of-plane buckling of the thin steel plates. Because the cavity between the double-sided thin steel plates was empty, the thin steel plates lacked out-of-plane support. The thin steel plates kept making sounds during loading and the wrinkled region on the thin steel plates kept growing. When the loading reached 78 kN, an apparent sound appeared and the load-displacement curve showed obvious twist and downturn, as shown in Figure 5. This was due to the out-of-plane buckling developing seriously and suddenly of the thin steel plates. When the horizontal displacement of the top loading beam was 36 mm, the thin steel plates began tearing from the regions near the screws on the middle column. After that, the load value remained basically unchanged, but the thin steel plates kept tearing. When the horizontal displacement was 51 mm, the shear bearing capacity was no longer increased and reached the peak value of 84.9 kN. When the horizontal relative displacement reached 71 mm, the bottom part of the left thin steel plates and the top part of the right thin steel plates were completely torn and destroyed by screws, as shown in Figure 7. When the horizontal displacement of the loading beam reached 141 mm, the loading stopped. Compared with QT-D1, the shear strength and the initial shear stiffness of QT-D2 increased by up to 21% and 142%, respectively.

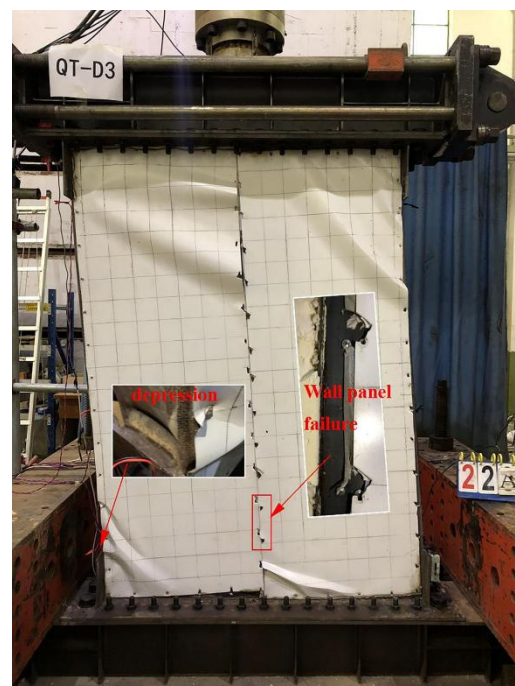
Figure 8. Failure image of QT-D3.

During the first stage loading on QT-D3, the wall specimen deformed linearly. A slight muffled sound occurred and kept going until the load reached 30 kN, but no wrinkle was observed. The slight muffled sound indicated that the thin steel plates were partially detached from the RPUF. When the force reached 40 kN, a small bulge appeared at the corners of the thin steel plates. This bulge kept growing as the sound continued. When the loading force reached 60 kN at the sixth stage, a large noise was heard, indicating a significant turning point on the load-displacement curve, as shown in Figure 5. When the loading force was 90 kN, at the top part of the right thin steel plates appeared a large oblique bulge; the load-displacement curve suddenly dropped, and then the displacement

control began. When the horizontal displacement was 31 mm, the sound became constant, and the bulge kept increasing. The thin steel plates kept detaching from the RPUF. When the displacement reached 41 mm, the thin steel plates started tearing from the screws near the middle column. The tearing of the thin steel plates in QT-D1 was significantly later than in QT-D2. When the displacement reached 51 mm, the bulge in the bottom left corner of the left panel and the bottom left corner of the right panel suddenly worsened, and the force reached its peak value of 101.6 kN. When the displacement was 101 mm, the bottom right corner of the right thin steel plates was seriously torn, and the thin steel plates tore at the middle column. When the horizontal displacement reached 131 mm, a large area of the top part of the left panel suddenly broke away from the RPUF, as shown in Figure 8. When the horizontal displacement reached 141 mm, a crisp sound was heard and the loading process ended. The sound was due to the fracture of the ends of the middle column in the steel frame.

Compared with QT-D1, the shear bearing capacity and the initial shear stiffness of QT-D3 increased by up to 45% and 233%, respectively. Compared with QT-D2, those of QT-D3 increased by up to 20% and 38%, respectively. It turns out that the RPUF significantly increases the shear bearing capacity and the initial shear stiffness of the SWR. However, the RPUF was seriously damaged, as shown in Figure 8. This indicates that the strength of the RPUF was low. The main reason for this is that the RPUF bonds components together, prevents the out-of-plane buckling of thin steel plates, and enhances the integrity of the SWR.

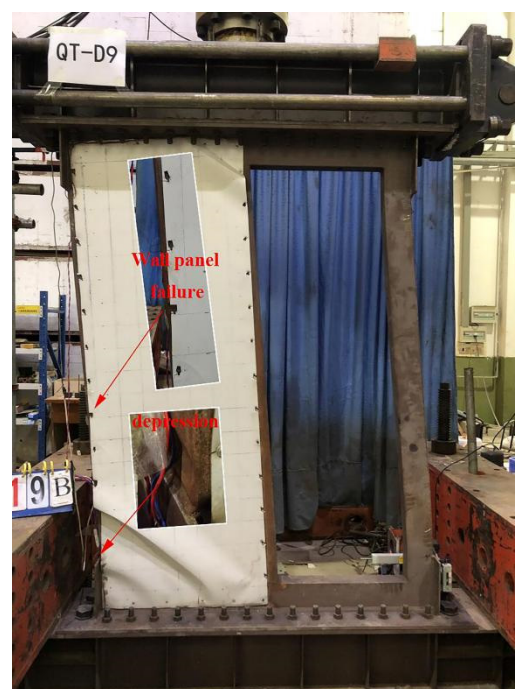
Figure 9. Failure image of QT-D9.

During the first loading stage on QT-D9, the specimen deformed linearly. A slight muffled sound occurred and kept going until the load reached 30 kN. In the third stage, the bottom right corner of the right thin steel plates made a sound and a slight fold appeared. Similar to QT-D3, the slight muffled sounds continued during loading. When the horizontal displacement reached 55 mm, it was observed that the horizontal force reached its peak value of 82.1 kN, as shown in Figure 5. In the tenth loading stage, when the displacement control reached 65 mm, the thin steel plates tore near the screws on both sides of the wall, as shown in Figure 9. Compared with QT-D1, the shear bearing capacity and the initial shear stiffness of QT-D9 increased by up to 19% and 141%, respectively. This also showed that the shear bearing capacity and the initial stiffness of QT-D2 and QT-D9 were almost the same, and load-displacement curves of the two specimens were very close, as shown in Figure 5. This indicates that the contribution of the RPUF on the shear bearing capacity and the initial stiffness could be approximately equal to that of two 0.5 mm steel plates.

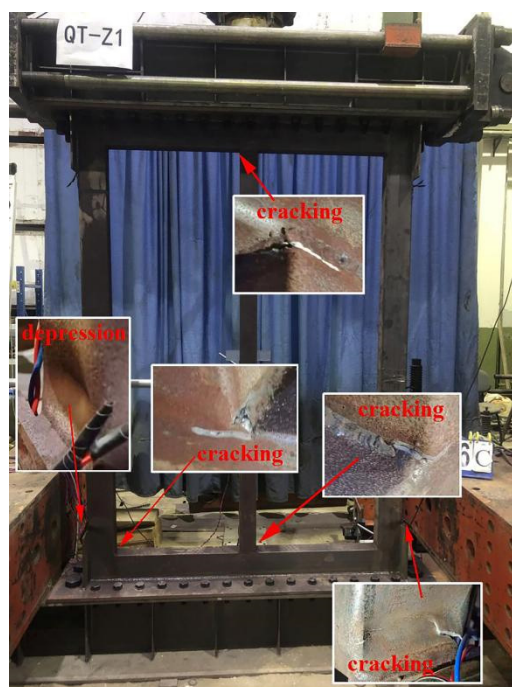
Figure 10. Failure image of QT-Z1.

When the horizontal displacement was 60 mm in QT-Z1, sound from the steel frame could be heard, and cracks were observed at the top and the bottom roots of the column in the steel frame, as shown in Figure 10. When the horizontal displacement was 75 mm, the edge area of the lateral pull-out connecting plates of the bottom side columns sagged. With the increase of horizontal displacement, the concave and the convex ranges of both sides of the side columns near the edge of the pull-out connecting plates gradually expanded. When the horizontal displacement was pushed to 90 mm for the second time, a slight sound appeared again, the root of the middle column was seriously fractured, and the frame of the pull-out connecting plates of the side column completely cracked, as shown in Figure 10. This was regarded as the eventual damage and the loading was terminated. In QT-Z1, the serious cracks on the steel frame led to the eventual failure.

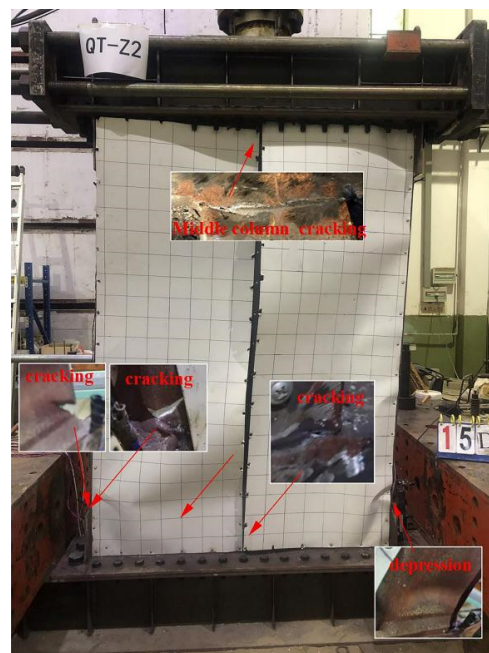
Figure 11. Failure image of QT-Z2.

Sound from the thin steel plates appeared at the first stage of loading on QT-Z2 and increased as the horizontal displacement increased. At the sixth stage of the loading process, the seam of the thin steel plates was torn by screws, the left and right sides of the thin steel plates damaged by screws, and the thin steel plates bulged considerably. When the horizontal displacement reached 40 mm at the seventh stage, a depression appeared at the edge of the pull-out connecting plate in the bottom right corner of the steel frame; the

thin steel plates were seriously damaged and lost shear bearing capacity. At the 12th stage, when the horizontal displacement was pushed to 70 mm, the left column was seriously dented and the top part of the thin steel plates fell off, as shown in Figure 11. The loading was then ended. This shows that the failure mode of QT-Z2 was that the thin steel plates lost shear capacity at an early stage due to tearing near the screws and the serious cracks on the steel frame led to the eventual failure.

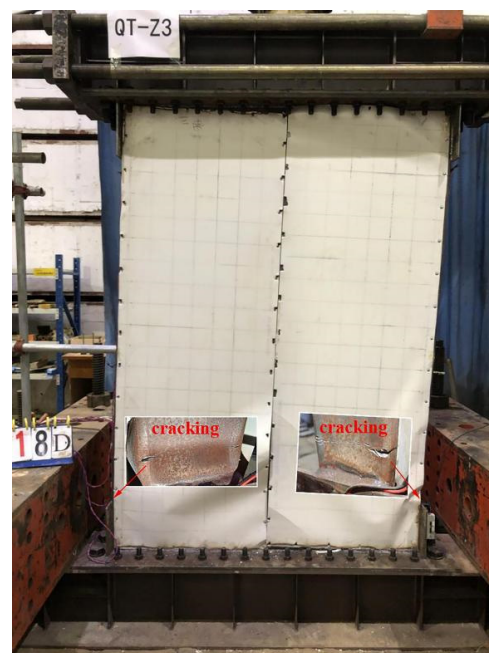
Figure 12. Failure image of QT-Z3.

During the first stage of the loading process on QT-Z3 there appeared both an oblique bulge whose length increased and a muffled noise. When the displacement was 2 mm, a slight bulge was observed on the right wall panel. In the second stage, a drum song occurred in the upper right corner of the left wall panel. During the third stage, the bulge area of the left wall panel became larger, and appeared in the bottom left corner of the right wall panel. During the fourth stage, the left wall panel bulge was run through diagonally, and the sound was louder. When the displacement was pulled to 8 mm, the bulge of the right wall panel was run through diagonally as well. In the sixth state, a bulge occurred in the upper right corner of the left wall panel, and a large bulge in the bottom right corner of the right wall panel appeared with continuous sound. The wall panel continued to detach from the RPUF, and the thin steel plates near the middle of the wall were torn by screws. In the tenth stage, the thin steel plates were indented near most screws in the middle column, and most of the edge of the wall panel slipped. At the 19th stage, when the horizontal displacement reached 85 mm, a large crack appeared in the bottom right column of the steel frame, as shown in Figure 12, which was regarded as the failure of the wall. Compared with the failure image of QT-Z2, most of the area of the thin steel plates in QT-Z3 maintained a neat and flat appearance, with only a small region on the top and bottom parts bulged. This difference was due to the contribution of the RPUF by the bond and the support function, so that thin steel plates possessed better shear resistance.

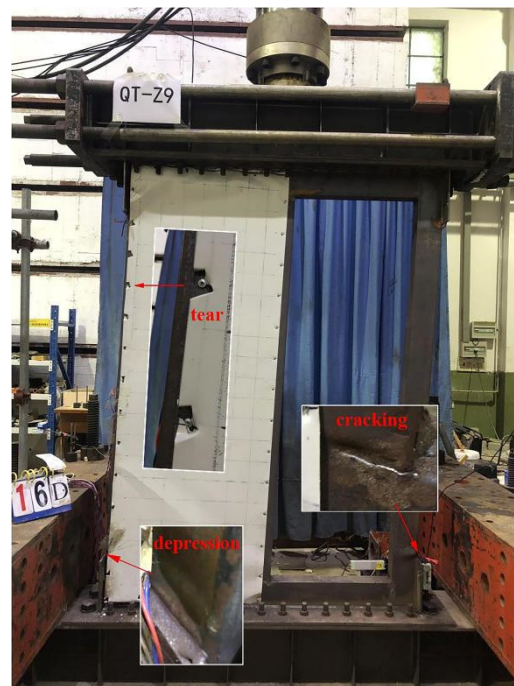
Figure 13. Failure image of QT-Z9.

When the displacement of QT-Z9 reached 10 mm, a slight bulge and fold were observed at the bottom left corner of the left wall panel. During the third stage, the middle part of the wall panel bulged and the sound continued. When the displacement reached 40 mm, the thin steel plates were torn near the screws. In the ninth stage, the back wall panel buckled and the folds increased. Most of the screws were indented, and most of the edge of the wall panel slipped. In 16th stage, when the displacement reached 85 mm, large cracks appeared at the bottom of the middle column, as shown in Figure 13, and loading stopped. The damage mode was the same as QT-Z3.

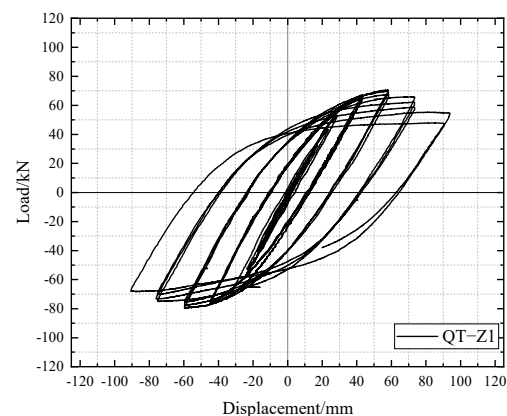
Figure 14. Load-lateral hysteresis curve of QT-Z1.

Figure 14 shows that the hysteresis loops of QT-Z1 was full and spindle. This shows that the ductility and energy dissipation capacity was good. As shown in Figures 15–17, QT-Z2, QT-Z3, and QT-Z9 show a pinch phenomenon in the first five cycles, but full and spindle cycles during the later stages. This is because the thin steel plates and the RPUF work together with the steel frame in the early stages. After however, the thin steel plates and the RPUF fail and the steel frame bears most of the load. We conclude that the mechanism works as follows. At the early loading stage, the steel frame, thin steel plates, and the RPUF work together. Then, due to the buckling of the steel plates, the stiffness of the specimen decreases gradually. When the direction of loading turns, thin steel plates enter in the recovery process, and the steel frame bears most of the horizontal load. When the thin steel plates are in the deformation state, the three work together again. In the late stages, the thin steel plates are damaged, and the steel frame and the RPUF work together. In the end, the steel frame gradually yields, the RPUF is damaged, and the stiffness decreases.

QT-Z1 and QT-Z2 show that, with the use of steel plates, a pinch effect appears in the hysteresis curve of the specimen, the peak load is larger, the initial loading stiffness is higher, and the hysteresis curve is fuller. This is because the thin steel plates and the steel frame are connected by screws. Thus, they share the horizontal load at the early stage. For QT-Z2 and QT-Z3, the pinching effect in the early stage of both specimens gradually increases and the peak value of load increases. This is because the RPUF can effectively cooperate with the thin steel plates to bear the horizontal load, constrain the bulging deformation of the thin steel plates, and improve the bearing capacity and stiffness of the specimens. Compared with QT-Z2 and QT-Z9, QT-Z3 has the highest peak load and the fullest hysteretic curve. There is a small difference between QT-Z9 and QT-Z2 in the load peak, and the pinching effect of QT-Z9 is more obvious than that of QT-Z2. This

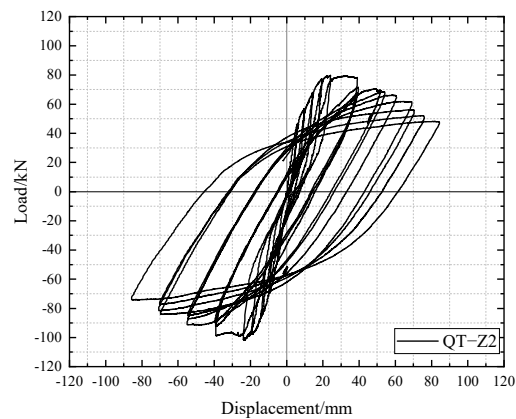
Figure 15. Load-lateral hysteresis curve of QT-Z2.

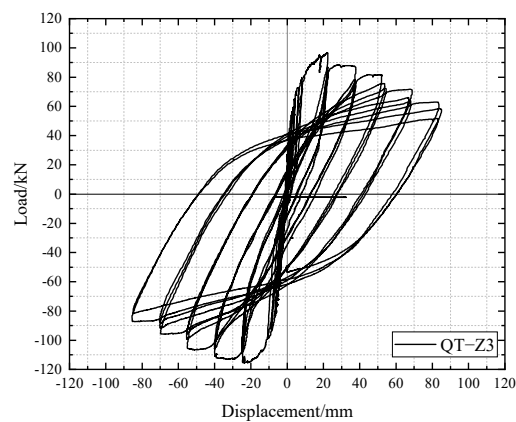
Figure 16. Load-lateral hysteresis curve of QT-Z3.

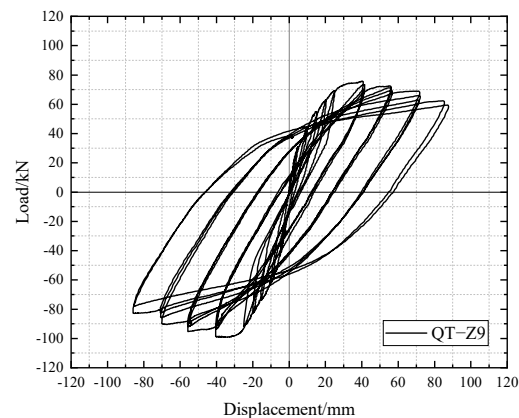
Figure 17. Load-lateral hysteresis curve of QT-Z9.

is because, as the RPUF fills in the space between the thin plates, the stiffness of the plates increases.

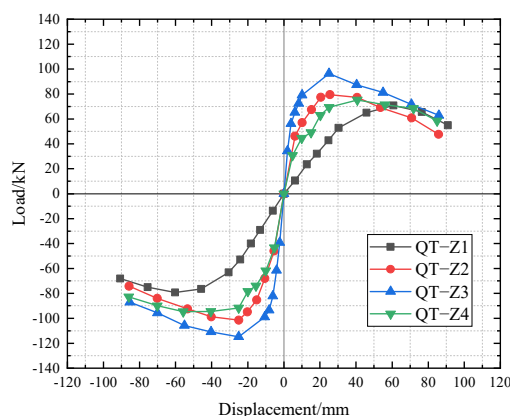
Figure 18. Skeleton curves.

Figure 18 shows the skeleton curves of the four specimens. Compared with the other specimens, QT-Z1 reached the peak value with the largest displacement. This indicates that the stiffness was lower. This is because it had no thin steel plate or RPUF. Compared with QT-Z1, the shear bearing capacity of QT-Z2, QT-Z3, and QT-Z9 increased by 27.79%, 44.74%, and 19.21%, respectively. We concluded that thin steel plates and RPUF can effectively improve the shear bearing capacity of the specimens. QT-Z2 and QT-Z3 had the same decline rate and yield severity after the load reached the maximum value. These were greater than the decline rate and yield severity of QT-Z1 and QT-Z9. This shows that the stiffness and shear bearing capacity is significantly reduced after the thin steel plates and the RPUF fail. The shear bearing capacity of the steel frame does not significantly decrease after reaching the peak, and the yield only appears locally. The steel frame still bears the horizontal load, and the bearing capacity decreases sharply until the connection between the frame columns and the frame beams is damaged. When all the specimens reached their ultimate failure states, the lateral displacement was within 90 mm, and the inter-story displacement angle did not reach 1/50, which is up to code [23].

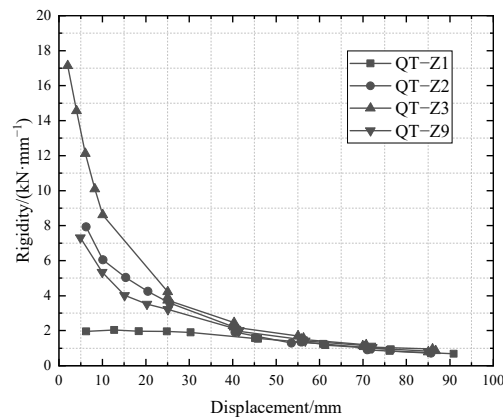
Figure 19. Stiffness degradation curves.

The stiffness of the specimen decreases with the increase of the number of load cycles and displacement. Following regulation [21], stiffness degradation curves are used to represent the stiffness at different times. Figure 19 shows that the stiffness degradation curves of all the samples were smooth. Since QT-Z1 had no thin steel plates or RPUF, stiffness in the early stages is low, and the stiffness degradation rate is slow. The initial stiffness of QT-Z3 is the largest, eight times that of QT-Z1. However, the stiffness degradation rate of QT-Z1 is the fastest in the early stages, due to the failure of the thin steel plates and RPUF. The stiffness degradation curves of QT-Z2 and QT-Z9 are not much different, and the initial stiffness is four times that of QT-Z1. The stiffness degradation rate of QT-Z2 and QT-Z9 is very fast at the early stages, but as the loading displacement increases, the stiffness degradation rate decreases significantly, remaining basically unchanged at the late stages. At the end of loading, all the curves tended to horizontality. This is because only the steel frame works at the end of the loading stages.

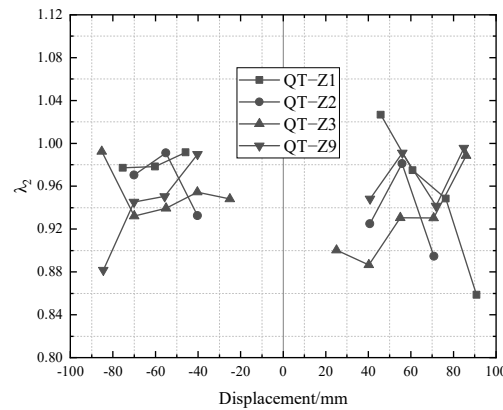
Figure 20. Degradation coefficient λ_2 .

The bearing capacity degradation coefficient is a measure of the degree to which the bearing capacity of the specimen decreases with the number of loading cycles. Figures 20 and 21 show the degradation coefficients λ_2 and λ_3 of all the specimens, respectively. λ_2 and λ_3 respectively represent the peak load of the second and third cycles and the previous peak load in the same displacement loading stage. In addition to λ_2 of QT-Z1 being 1.026 times greater than 1, the degradation coefficients of the other specimens are less than 1. Most of the distribution being in 0.90~1.0, the curve basically shows a decreasing trend with the increase of displacement. The bearing capacity degradation coefficients λ_3 of all the specimens show similar trends as those of λ_2 . As the shear bearing capacity was stable, the specimens demonstrated good plasticity and ductility.

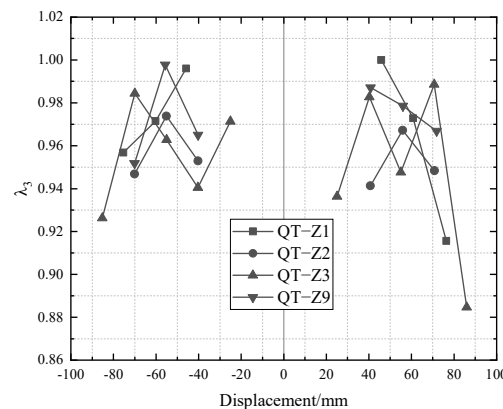
Figure 21. Degradation coefficient λ_3 .

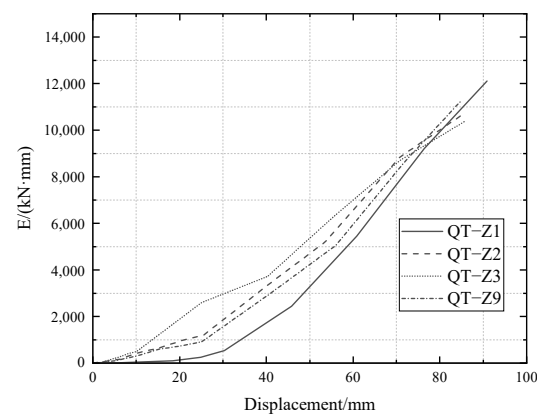
Figure 22. Energy consumption curves.

The area of the graph surrounded by the load-displacement hysteresis curve represents the energy consumption capacity of the sample. The fuller the hysteresis curve is, the higher the equivalent viscous damping coefficient is; the larger the area is, the greater the energy dissipation energy is. The energy consumption curves and the equivalent viscous damping coefficient curves are shown in Figures 22 and 23, respectively. Figure 22 shows that in early loading stages, the energy consumption values of QT-Z1 are the lowest, those of QT-Z3 the highest, and those of QT-Z2 and QT-Z9, in between the previous two, are almost the same. The main reason for this is that, in the early stages, the steel frame is in an elastic stage, but the thin steel plates and the RPUF yield and contribute to energy consumption. As the displacement increased, the energy consumption capacity of QT-Z1 rose the fastest, those of QT-Z2 and QT-Z9 second-fastest, and the curve of QT-Z3 the slowest, remaining basically linear. This is because the steel frame starts yielding and contributes to energy consumption. In the late stages, the energy consumption capacity of all the samples was almost the same. The reason for this is that the thin steel plates and RPUF were badly damaged and the steel frame plays the main role in energy consumption. Figure 23 shows that the changing trend of the equivalent viscous damping coefficient of QT-Z1 is consistent with the energy consumption capacity. The basic changing trend of the equivalent viscous damping coefficients of QT-Z2, QT-Z3, and QT-Z4 is in agreement with the energy consumption capacity, but more complicated in the early stages.

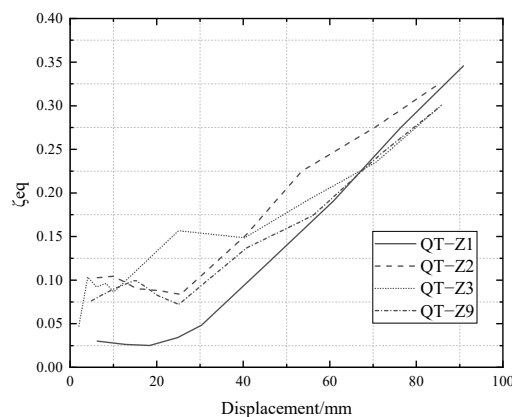
Figure 23. Equivalent viscous damping coefficient curves.
