Study on Arching Mechanism of Bridge Pile Foundation: Taking the Shiyangtai No.1 Bridge as an Example

Abstract: The structure of a bridge has certain peculiarities, and its pile foundations are susceptible to uplift or settlement deformation due to various factors. This can result in bridge deck cracking, structural instability, tilting, and even irreversible damage, which significantly impacts the bridge's stability and driving safety. This study focuses on the Shiyangtai No.1 Bridge and aims to investigate the factors that cause abnormal rise and fall deformations of bridge pile foundations. The study combines macro and micro analysis, physical characteristic testing of the overlying soil under the bridge pile foundation, and numerical simulation of the bridge pile foundation in the goaf. The study discusses in-depth the formation mechanism of the abnormal uplift of some pile foundations of the Shiyangtai No.1 Bridge based on the analysis of the factors influencing the abnormal rise and fall deformation of the bridge pile foundations at home and abroad. The expansive soil beneath the pile foundation is weak, and the force generated by the water expansion is insufficient to cause

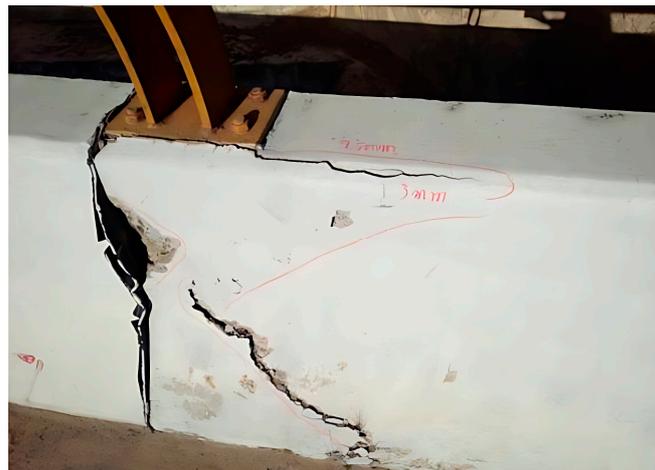
Figure 2. Bridge disease diagram of Shiyangtai No.1 Bridge.

Due to the uplift of the bridge pile foundation, the bridge pier is cracked and deformed, the bridge railing is damaged and destroyed, the bridge subgrade is cracked and linearly changed (Figure 2). The structural stability of the bridge and the safety of traffic are seriously affected. This not only hinders the development of social economy in the region, but also poses a great threat to people's personal safety and to property safety to a certain extent.

(a) Bridge guardrail cracking

(b) Squeezed expansion joints

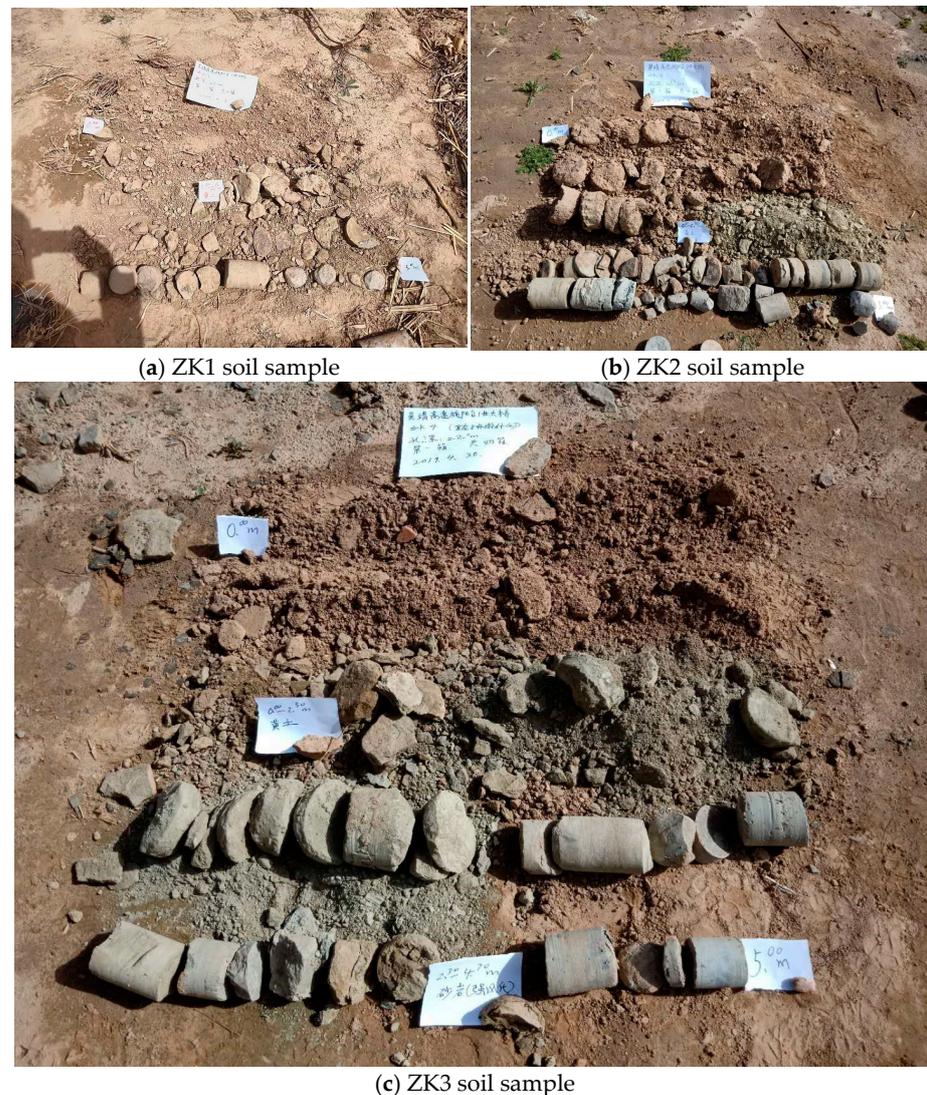
Figure 3. Drilling core soil samples. The Chinese characters in the figure only indicate the depth and type of rock samples, which has little influence on the research content of this paper.

The soil samples (as shown in Figure 3) were sent to the Xi'an Mineral Resources Supervision and Inspection Centre of the Ministry of Land and Resources for component analysis. It is found that the core soil samples in three boreholes near pier No. 8 of the Shiyangtai No.1 Bridge contain different proportions of montmorillonite. At the location of the ZK1 borehole, the content of montmorillonite is the largest, between 2% and 8%, and the maximum reaches 7.24%. The montmorillonite content of the other two core samples is around 3%, with a maximum of 4.71%. It can be judged that there are different proportions of clay minerals with strong hydrophilicity in the core soil samples of the overlying soil layer under the pile foundation of the Shiyangtai No.1 Bridge.

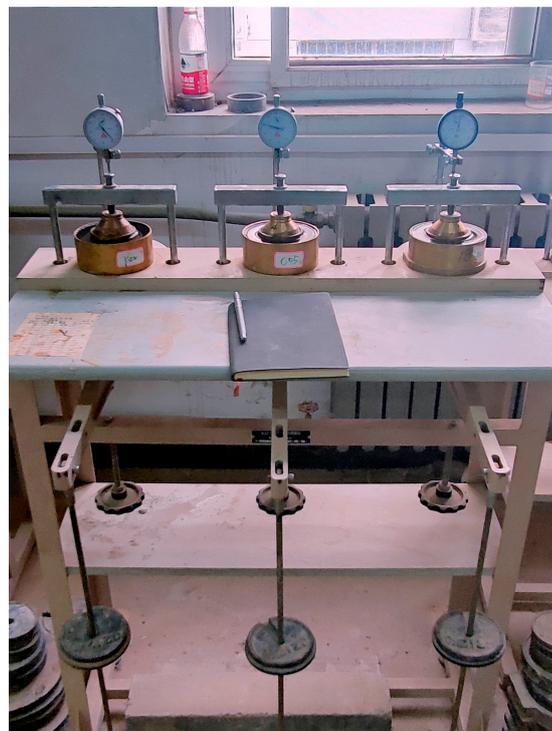
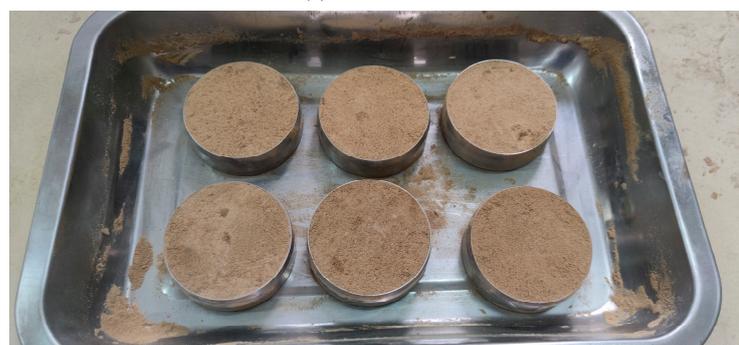
Figure 7. Load expansion rate test.

The top layer of rock and soil with expansion characteristics will experience additional stress in its current state. When it expands in water, external stress will hinder its expansion potential. Therefore, the uniaxial consolidation instrument was used to determine the expansion potential of the expansive soil beneath pier No. 8 of the Shiyangtai No.1 Bridge under the conditions of self-weight load of the upper bridge and pile end load. The load expansion rate test instrument and samples are shown in Figure 7.

(a) Consolidator

(b) Expanded soil specimen

The load expansion rate test of 10 kPa constant axial pressure was applied to the core soil sample in the overlying soil layer near pier No. 8 of the selected Shiyangtai No.1 Bridge using the consolidation instrument. The deformation of the soil sample after soaking expansion was measured to obtain the expansion rate of the expansive soil in the overlying soil layer under constant load conditions. The specific test data is presented in Table 3.

Table 3 shows that the test soil samples exhibited varying degrees of deformation after full immersion. The six groups of soil samples in this test experienced deformation ranging from 0.06 mm to 0.23 mm under a constant load of 10 kPa axial compression, with the maximum deformation being 0.23 mm. The load expansion rate was calculated based on the maximum deformation of the sample under the most unfavorable conditions. Specifically, the sample's expansion deformation under 10 kPa axial compression reached 0.23 mm, resulting in an expansion rate of 1.09%. It is assumed that the 2 m stratum under pier No. 8 of Shiyangtai No.1 Bridge consists entirely of expansive rock and soil mass. Based on the ratio, the underground expansive soil only expands 23 mm when encountering water, which is significantly less than the expected 309 mm. Therefore, it can be concluded that the impact of expansive soil on the uplift deformation of certain piers of Shiyangtai No.1 Bridge is minimal.

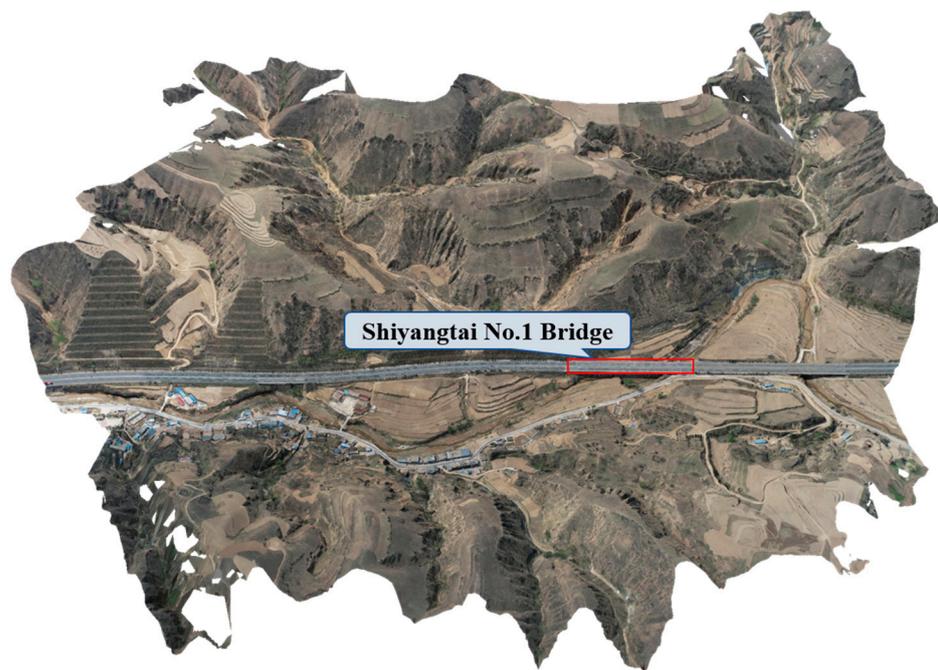
Figure 8. UAV aerial photography three-dimensional map.

Prior to modelling, an on-site investigation was conducted to plan the route scanning area of the Shiyangtai No.1 Bridge. Aerial photography of the bridge research area was then carried out using the DJI Jingling UAV to obtain multi-directional photos of the bridge area with centimeter-level accuracy. The software Photoscan was used to import the pictures and create an aerial three-dimensional geomorphological model of the Shiyangtai No.1 Bridge area, as shown in Figure 8.
