Article

Quality Evaluation of Sizeable Surveying-Industry-Produced Terrestrial Laser Scanning Point Clouds That Facilitate Building Information Modeling—A Case Study of Seven Point Clouds

Department of Civil Engineering and Architecture, Tallinn University of Technology, Ehitajate Road 5, 19086 Tallinn, Estonia; raido.puust@taltech.ee (R.P.); artu.ellmann@taltech.ee (A.E.)

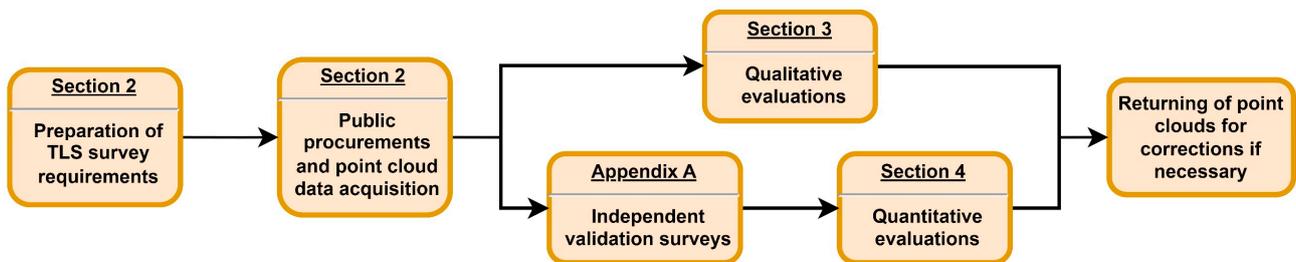
Figure 1. Overview of the experimental process. The headings refer to sections where further details on a specific aspect can be found.

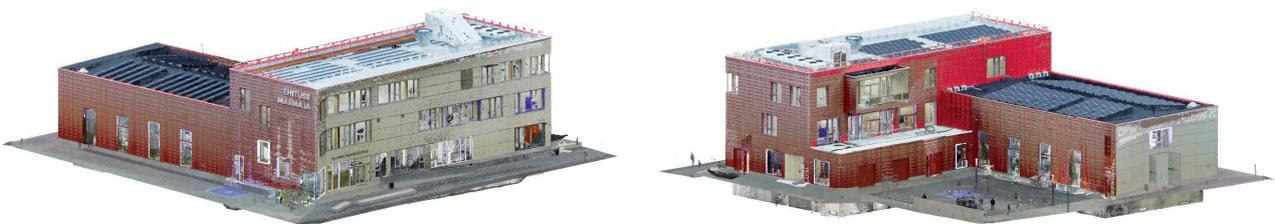
Figure 2. The CON point cloud (also refer to Table 1); the views depict opposite facades.

A total of 490 scanning stations were required to obtain full point cloud coverage (except the roof) of the CON building. Because the rooms were yet to be furnished, occlusions could be easily avoided. During surveys, the scanning resolution was always set to 12 mm at 10 m (i.e., the sparsest user-selectable scanning resolution; cf. Table 2). Since distances between scanner locations and measured surfaces were generally just a few meters, rarely exceeding 10 m, even the sparsest option was sufficient for a dense and detailed point cloud (all the more, as most surfaces were measured from multiple scanning stations). Images were also captured during the TLS surveys to RGB color the point cloud, which also contains intensity information. Leica Cyclone Core point cloud processing software was used to register surveyed point clouds into a compound point cloud of the building. The point clouds of stations were first aligned visually and then optimized using the software's cloud-to-cloud registration functionality. The cloud-to-cloud registration of Leica Cyclone Core is based on the piecewise (i.e., the registration quality between two point clouds is not affected by the registration of the following point clouds) iterative closest point method [37]. After all TLS surveyed point clouds of stations were registered together, the drone-derived point cloud of the roof was also registered with the rest using Leica Cyclone Core. Figure 2 shows the complete point cloud of the CON building.

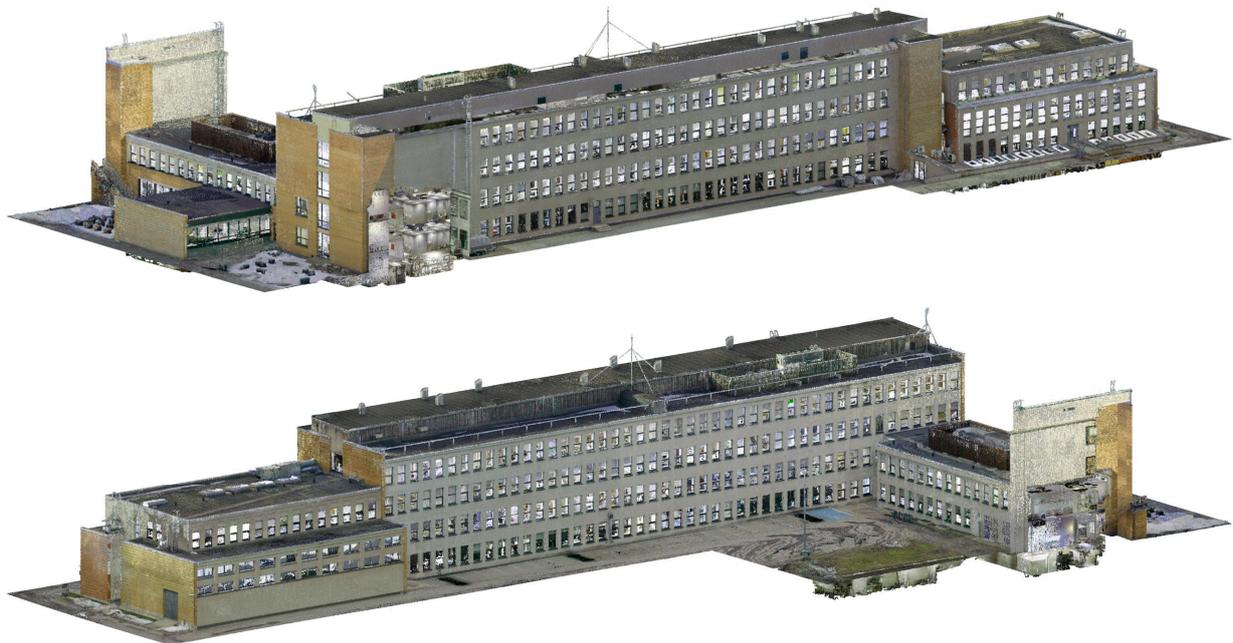
Figure 4. The U03 + U03B C1 point cloud (also refer to Figure 3 and Table 1); the views depict opposite facades.

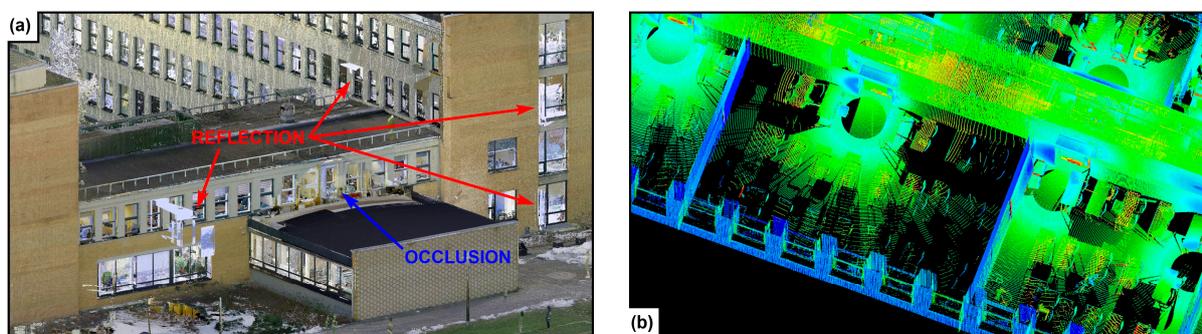
Figure 5. Reflections (red arrows) and an occlusion (blue arrow) in the U04 (refer to Figure 3) point cloud (a), and occlusions in the U03 + U03B C3 (refer to Figure 3) point cloud ((b); the point cloud is colored according to intensity information—blue denotes high intensity and reddish low).

Regarding noise, all surveyed point clouds contain some reflections (see the example in Figure 5a) and artifacts of passing people to varying levels. Admittedly, it was not specified in the requirements provided to the surveying companies that point clouds must be cleaned (this requirement should be included when updating survey requirements in the future). During the assessments of point clouds surveyed by Companies 1 and 2, it was determined that BIM quality should generally not suffer due to noise as the point cloud details (e.g., in corridors where bypassing people moved) were distinguishable. Most surveys were also conducted when few people were around. The U03 + U03B C3 point cloud is similar to those of Companies 1 and 2 in terms of noise. In contrast, the CON point cloud was cleaned from the most significant reflections. During the survey, only surveyors were present at the CON building; hence, people moving around was not a problem.

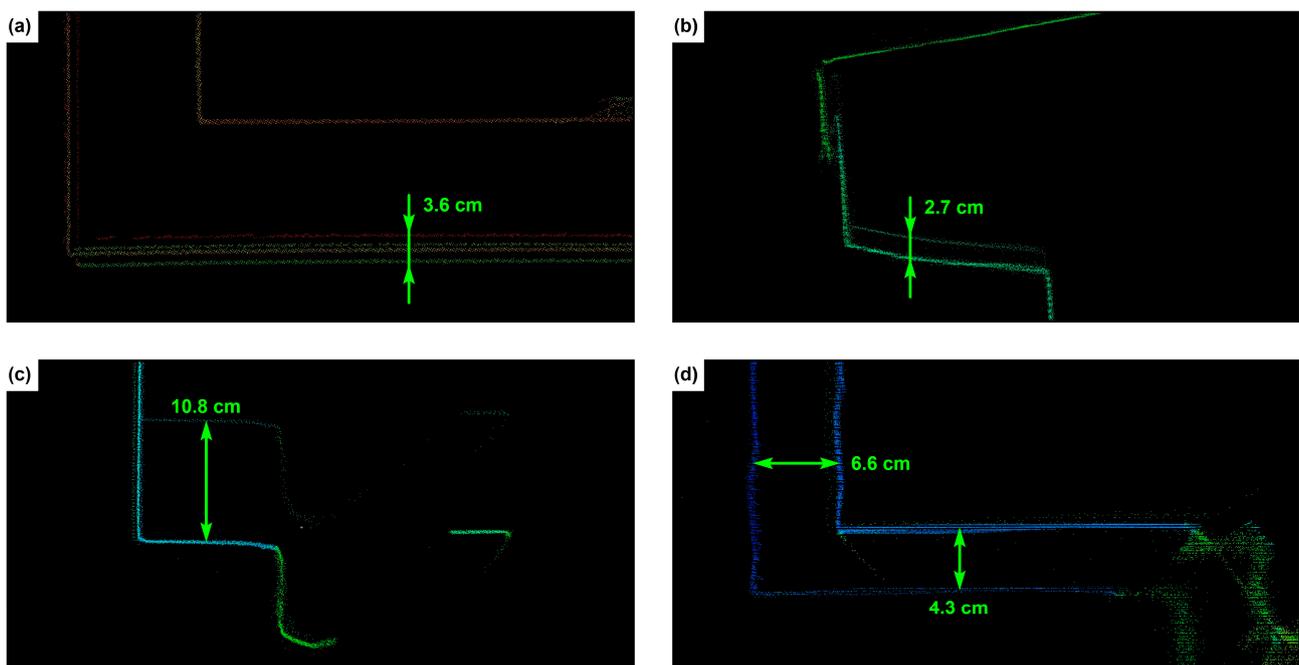
Figure 6. A selection of more significant registration errors in different point clouds: basement floor corridor wall discrepancies (horizontal plane) in the CON point cloud (a), vertical discrepancies in the eaves overhang of the U05 (refer to Figure 3) point cloud (b), vertical outer wall discrepancies in the U06A (refer to Figure 3) point cloud at a window (c), and vertical (4.3 cm) and horizontal (6.6 cm) discrepancies in the U03 + U03B C3 (refer to Figure 3) point cloud at an exterior doorway (d). Point clouds are colored according to intensity information—blue denotes high intensity, and the reddish color low.

The examinations of Company 1 and Company 2's results yielded similar conclusions—most discrepancies that could be visually detected were within a centimeter. A few more significant discrepancies, as shown in Figure 6b, were in the 2–3 cm range. One excep-

tional height-wise discrepancy of around a decimeter was found in the U06A point cloud (Figure 6c). However, this discrepancy appeared outside the BIM target area and was thus not considered detrimental to the modeling. Regarding more recent surveys (not included in the assessments of this study), an occasion was found where several rooms of a point cloud had height-wise registration discrepancies exceeding a decimeter. The affected point cloud was requested to be corrected. More significant problems were also found with the U03 + U03B C3 point cloud. Several discrepancies up to 10–15 cm were discovered. An example of a discrepancy in both horizontal and vertical directions is shown in Figure 6d (i.e., a significant misalignment of point cloud portions). Such an erroneous point cloud demonstrates that there must be some inspection arranged from the client's side to determine the quality of the provided point clouds. It should be noted (based on visual inspections) that a common tendency observed between the point clouds surveyed by Companies 1 to 3 was that more significant registration errors were more likely to appear outdoors than inside the buildings. The likely reason is that indoor point cloud registration is more constrained (i.e., point clouds of scanning stations generally contain multiple walls, a floor, and a ceiling) compared to outdoors (i.e., surveyed point clouds generally contain one or two walls and the ground, which may be irregular due to, e.g., vegetation).

Examinations of surveying-industry-produced point clouds have revealed commonly occurring significant registration errors (see Figure 6 for a visualization). For instance, on the third floor of the CON building point cloud, an error of around 7–8 cm was determined (discussed in Section 4.1). If these errors can be found visually, they can be (in principle) corrected while compiling the compound point cloud. However, a rather alarming outcome of the study is that significant registration errors may remain hidden during visual inspection. Only with a validation survey was it possible to determine that the CON (cf. Figure 10c) and U03 C1 (cf. Figure 14c) point clouds contain around 4 cm height errors. In addition, an unrealistic bend with an angle of around $6.9'$ was found in the U03 C3 point cloud (cf. Figure 14e; also, a trend in height is visible from Figure 14f). A common characteristic for these hidden errors seems to be that these appear in the vicinity of complex element combinations, such as stairways (the 7–8 cm error in the CON point cloud is also associated with a nearby stairway). One potential cause for such errors could be that incorrect local optimal point cloud registration solutions (i.e., point cloud portions match in a smaller local region, but there may still exist shifts or tilts between them) have been assumed true [51]—a drawback of the iterative closest point method (i.e., the basis for point cloud registration implemented in Leica Cyclone Core and FARO Scene). Thus, it appears that the registration of point cloud portions of individual stories via stairways requires meticulous attention. The initial proper alignment of point cloud portions prior to registration is crucial [52].

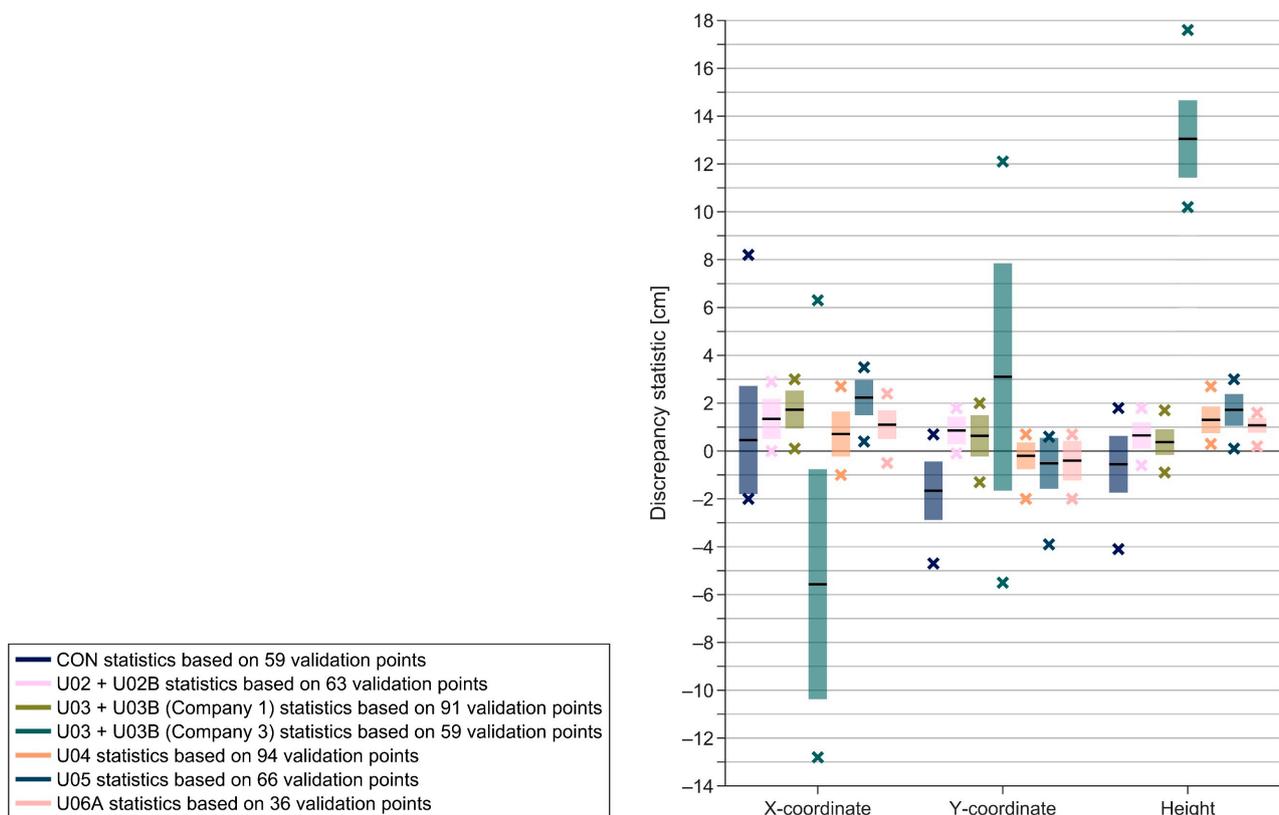
Figure 7. Descriptive statistics of discrepancies between validation points' coordinates and those extracted from point clouds. Black lines denote mean values, colored bars standard deviation estimates, and colored crosses minimum and maximum discrepancies. Note that the CON-associated statistics represent an indoor survey, whereas all others describe outdoor surveys' results.

Descriptive statistics regarding discrepancies between validation points' coordinates and those extracted from the CON point cloud are summarized in Figure 7 (considering all 59 validation points). It can be noticed that the mean discrepancies are 0.5 cm for the X-coordinate, -1.7 cm for the Y-coordinate, and -0.5 cm for the height. Considering total station survey accuracy (cf. Figure A1), these results suggest proper georeferencing of the point cloud. It should be noted that significant point cloud registration errors also contribute to these mean discrepancies, which will be discussed subsequently.

The standard deviation estimates of 1.2 cm for the Y-coordinate and height seem to indicate good consistency between the point cloud and validation survey (cf. Figure 7). In contrast, a standard deviation of 2.3 cm for the X-coordinate is more concerning, where the increased value is due to plus-signed discrepancies up to 8.2 cm. Although the baseline discrepancies' (Figure 8) standard deviation estimate of 1.6 cm suggests relatively good consistency, discrepancies up to 7.3 cm also appear. A more detailed comparison of discrepancies based on individual floors (Figure 9) demonstrates that problems occur on the basement (height component) and third (X- and Y-coordinate components) floors. Consistency between the validation survey and the point cloud is good on the first and second floors, where standard deviation estimates remain within 0.7 cm. Note that significant discrepancies in the ventilation system details, up to around 2 dm between the as-designed digital model and point cloud (interested readers can find these comparisons in [33]), as mentioned in Section 2, were examined on the first floor.

The point clouds surveyed by Companies 1 and 2 have good consistency according to Figure 7—the largest standard deviation estimate of 1.1 cm is associated with the U05 point cloud's Y -coordinates. Good consistency is also evident from baseline discrepancies, which yield standard deviation estimates around a centimeter for all point clouds surveyed by Companies 1 and 2 (Figure 8). Contributing factors to these estimates are point cloud registration errors, noise generated by atmospheric and environmental conditions, performance characteristics of laser scanners, beam incidence angle, and materials of surveyed surfaces [49,50], errors in the total station validation survey, and possible mismatches between validation points and the point cloud. The good quality of point clouds can be acknowledged despite all these error sources and the sheer size of point clouds, whereby the 1 cm point cloud accuracy requirement can be considered fulfilled (at least based on the outdoor validation; recall the notion at the end of Section 3 that more significant visually detectable registration errors were more likely to appear outdoors than inside the buildings).

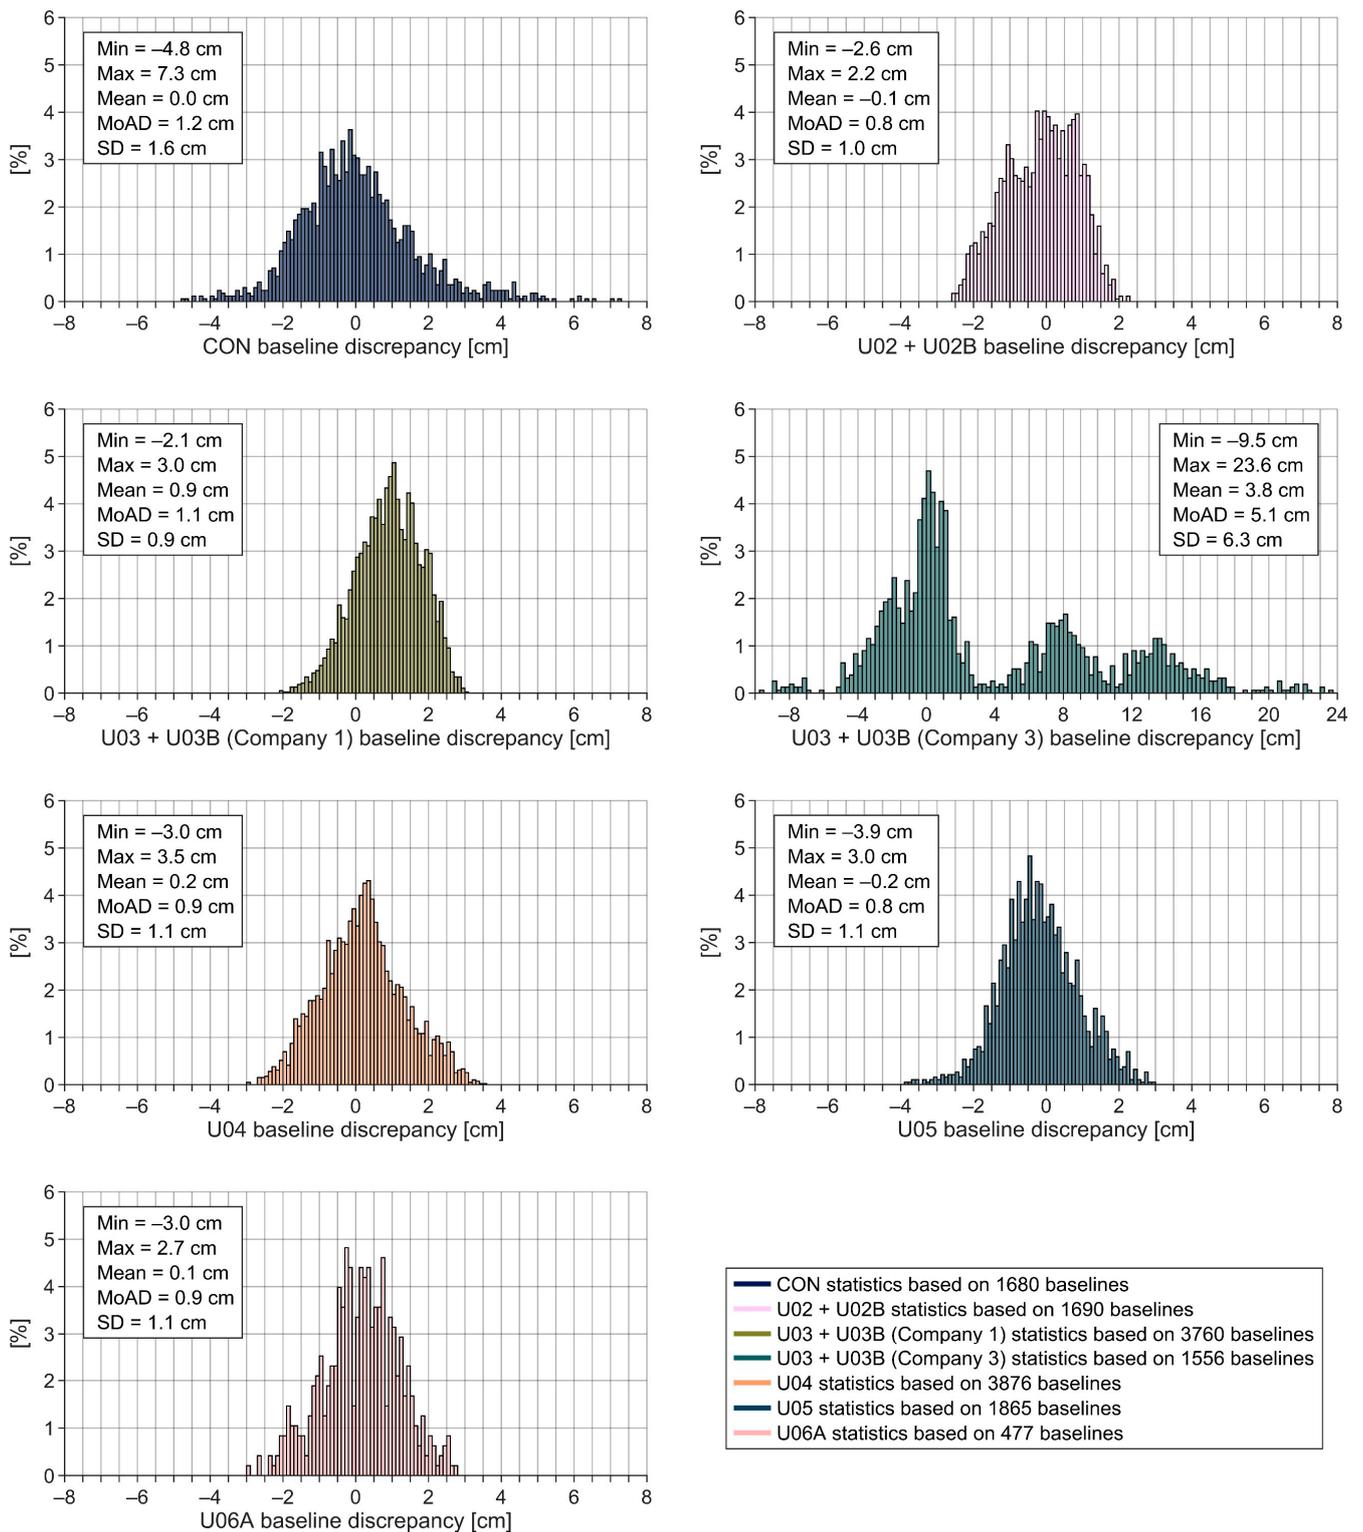
Figure 8. Histograms and descriptive statistics (MoAD—mean of absolute discrepancies; SD—standard deviation) of baseline discrepancies (cf. Equation (1)). Note that the CON-associated statistics represent an indoor survey, whereas all others describe outdoor surveys' results.

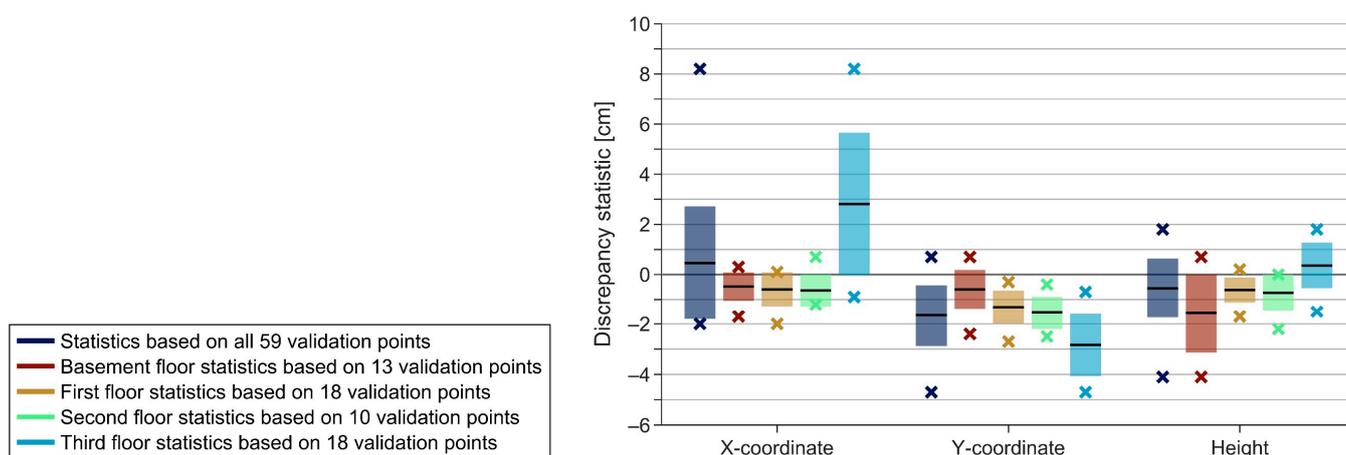
Figure 9. Descriptive statistics of discrepancies between validation points' coordinates and those extracted from each CON point cloud floor; the statistics of all 59 validation points are the same as in Figure 7. Black lines denote mean values, colored bars standard deviation estimates, and colored crosses minimum and maximum discrepancies. Notice that more significant discrepancies are associated with the basement floor (height) and third floor (X- and Y-coordinates).

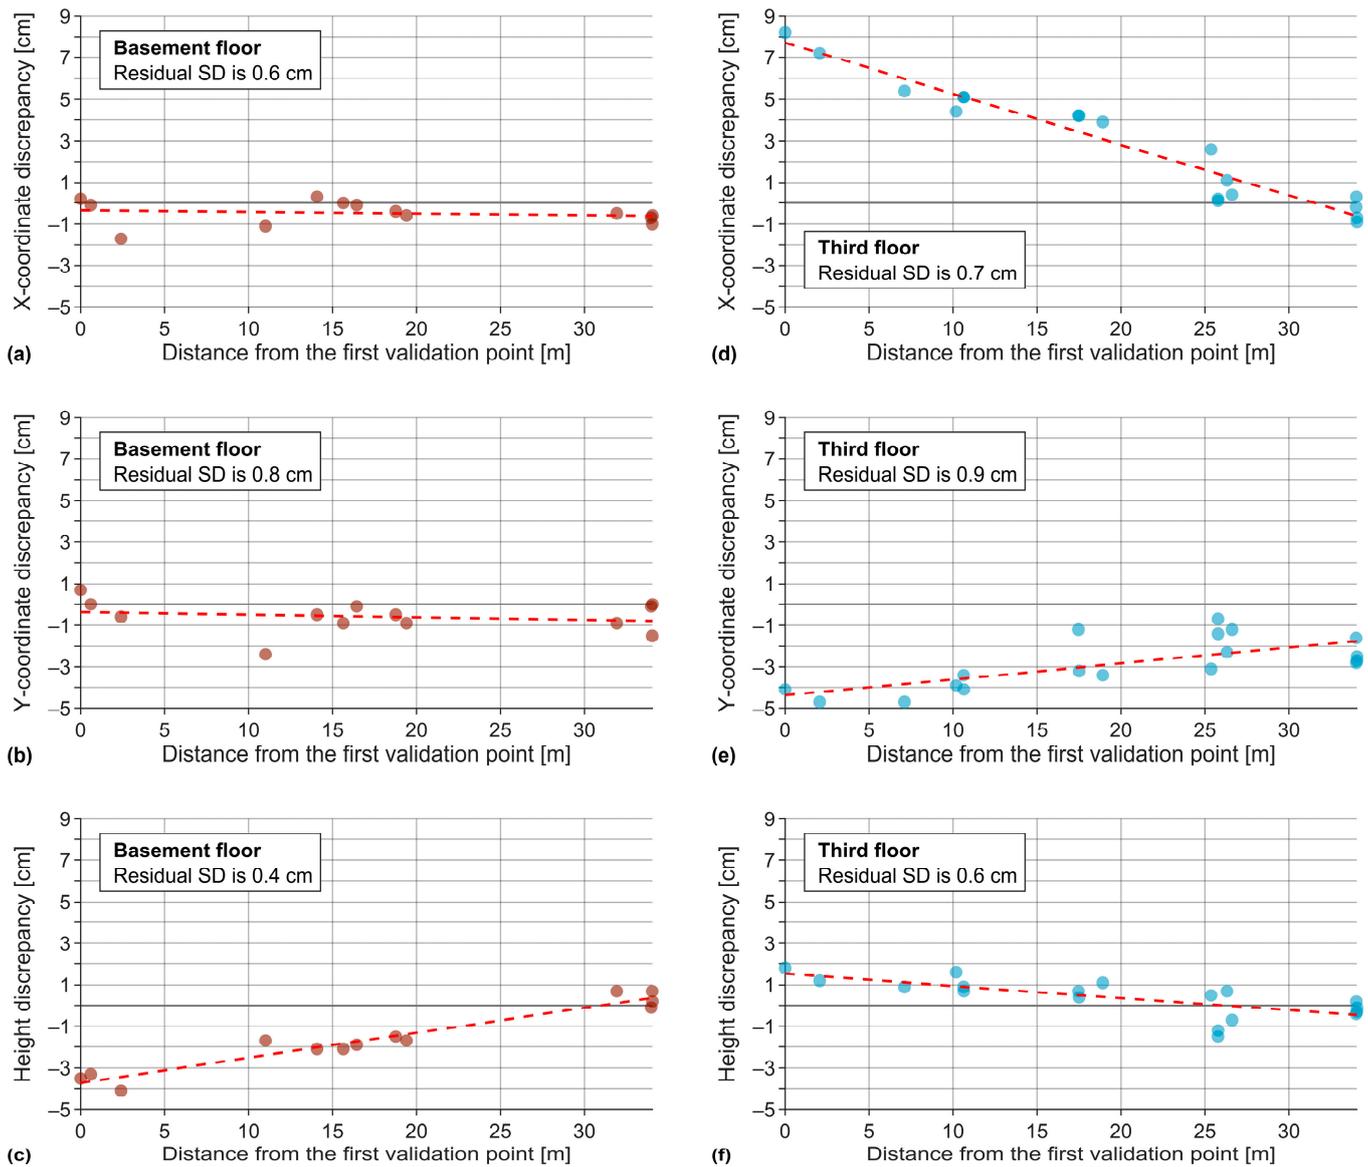
Figure 10. Discrepancies between validation points' coordinates and those extracted from the CON point cloud portion of the basement floor (sub-plots (a–c)) and the third floor (sub-plots (d–f)). The dashed red lines show the corresponding discrepancy trends. Note that discrepancies have been projected along a baseline aligned with the corridor connecting the secondary stairway (left) to the main stairway (right; refer to Figure A1). Residual standard deviation (SD) describes discrepancy residuals relative to the trend.

The discrepancies were further examined by projecting these along a baseline aligned with the corridor connecting the secondary stairway to the main stairway (rough locations of stairways are shown in Figure A1). Figure 10 sub-plots a to c show the basement floor discrepancies and corresponding trend lines fitted in the least-squares sense. While the X- and Y-coordinate discrepancy trends reveal nothing unusual, there is a clear linear trend in height discrepancies from one stairway to the other. According to the results, a height bias of around 4 cm can be found near the secondary stairway, which evens out near the main stairway. Total station survey controls near the secondary stairway (a resection traverse loop) and main stairway (determined from outside through an open door) both provide a height error of 0.2 cm. Hence, it can be safely assumed that the discovered error of around 4 cm is due to a mistake in point cloud registration. Most alarmingly, this error could not be detected during careful visual inspection of the point cloud discussed in Section 3.

Similar discrepancy plots for the third floor are presented in Figure 10 sub-plots d to f. Again, clear discrepancy trends can be noticed from one stairway to the other, where biases appear near the secondary stairway. The most significant is a bias of around 8 cm in the X-coordinate, which corresponds to the roughly 7 cm registration error found during visual inspection, also mentioned in Section 3. It should be noted that a total station control measurement on survey network point D21U (cf. Figure A1) from the third-floor balcony (near the secondary stairway) provided a 0.9 cm discrepancy for the X-coordinate, 1.6 cm for the Y-coordinate, and 0.2 cm for the height, confirming that errors in the total station survey can be ruled out for the appearance of this significant bias. The 1.6 cm control discrepancy of the Y-coordinate (i.e., the validation survey is positively biased on the third floor, as the initial coordinates were subtracted from control measurements) explains why point cloud Y-coordinate discrepancies in Figure 10e have a persistent negative bias (recall that validation survey results were subtracted from the point cloud coordinates). According to the trend, the bias near the main stairway is -1.7 cm.

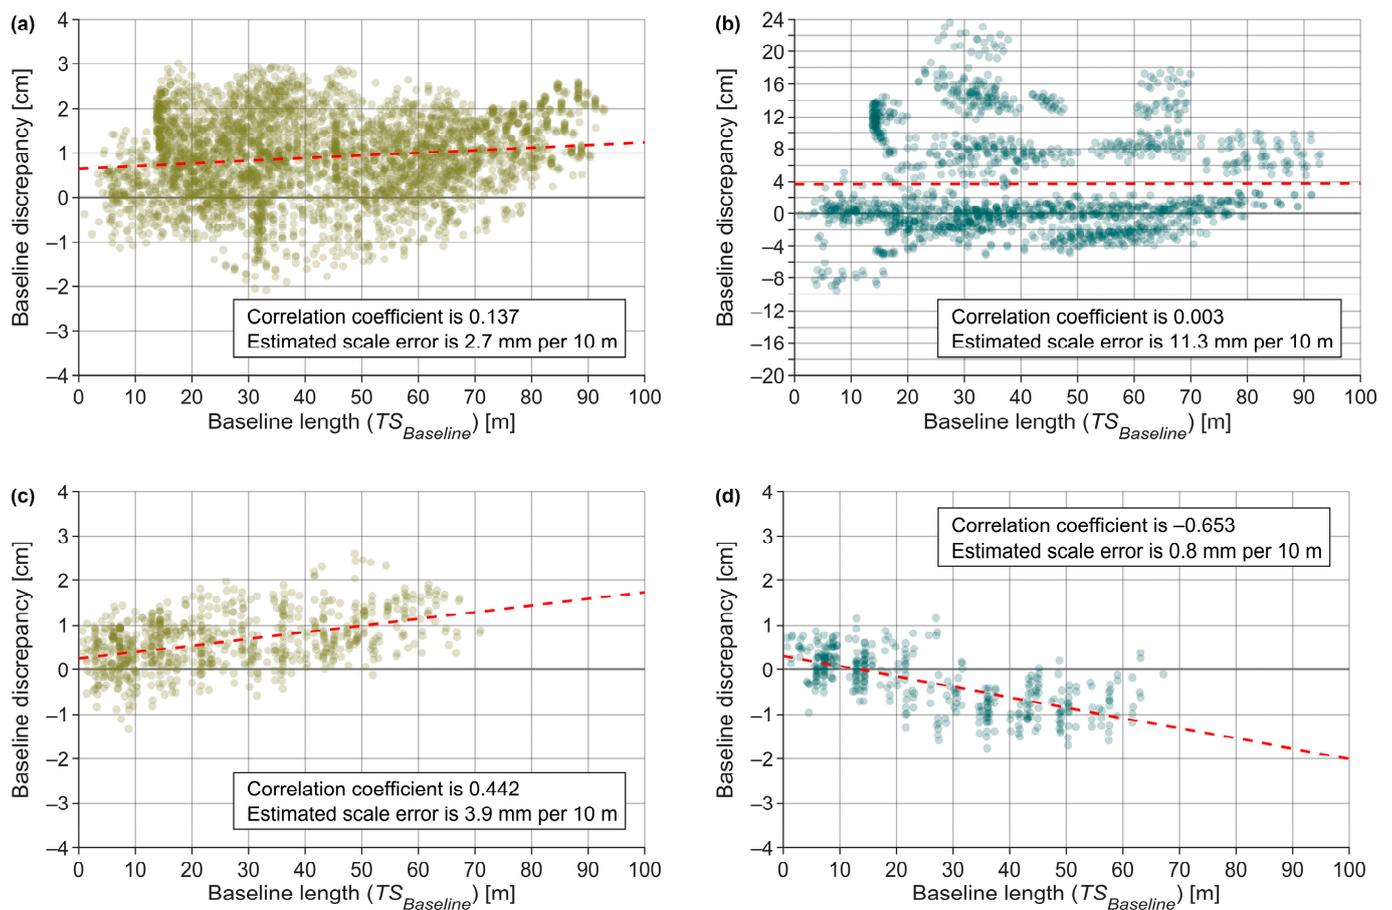
Figure 11. Baseline discrepancies (the same as in Figure 8) plotted relative to the total station estimated baseline lengths for U03 C1 (a) and U03 C3 (b) outdoor and U03 C1 (c) and U03 C3 (d) third-floor surveys. The dashed red lines show the corresponding trends, and the scale error values are estimated according to Equation (2).

where N is the total number (3760 in this case) of determined baselines (also refer to Equation (1)). The baseline discrepancies were also plotted relative to the estimated baseline lengths from total station surveys for further analysis (cf. Figure 11a). A trend line was then fitted in the least-squares sense to the plotted discrepancies, and a Pearson correlation coefficient was calculated. Based on the U03 + U03B outdoor total station validation survey, the scale error suggests an artificial lengthening of 2.7 mm per 10 m for the Company 1 surveyed point cloud. On the other hand, although there appears to be a mild trend in the data (the trend-based scale error is 0.6 mm per 10 m), the baseline discrepancies are only weakly correlated with the baseline lengths. Based on these results, conclusive evidence for erroneous scaling cannot be drawn. Because the Company 3 point cloud is validated using the same total station measurements, a similar analysis was conducted for comparison (cf. Figure 11b). Unfortunately, significant point cloud errors dominate these results.

Regarding the investigation of baseline discrepancies, both point clouds appear to show excellent consistency with the validation survey—the standard deviation estimates are 0.6 cm (cf. Figure 13). It can also be noticed that, similarly to the outdoor validation results, the baseline discrepancies of Company 1's point cloud are positively skewed, again suggesting point cloud scale error. Using Equation (2), the estimated artificial lengthening of the point cloud is 3.9 mm per 10 m, which is somewhat larger than the previous estimate of 2.7 mm per 10 m. The baseline discrepancies are now moderately correlated with the baseline lengths, and the trend in data is more evident (cf. Figure 11c); the trend-based

scale error is smaller, being 1.5 mm per 10 m. Note that the indoor and outdoor total station validation surveys are entirely independent (see Appendix A.4).

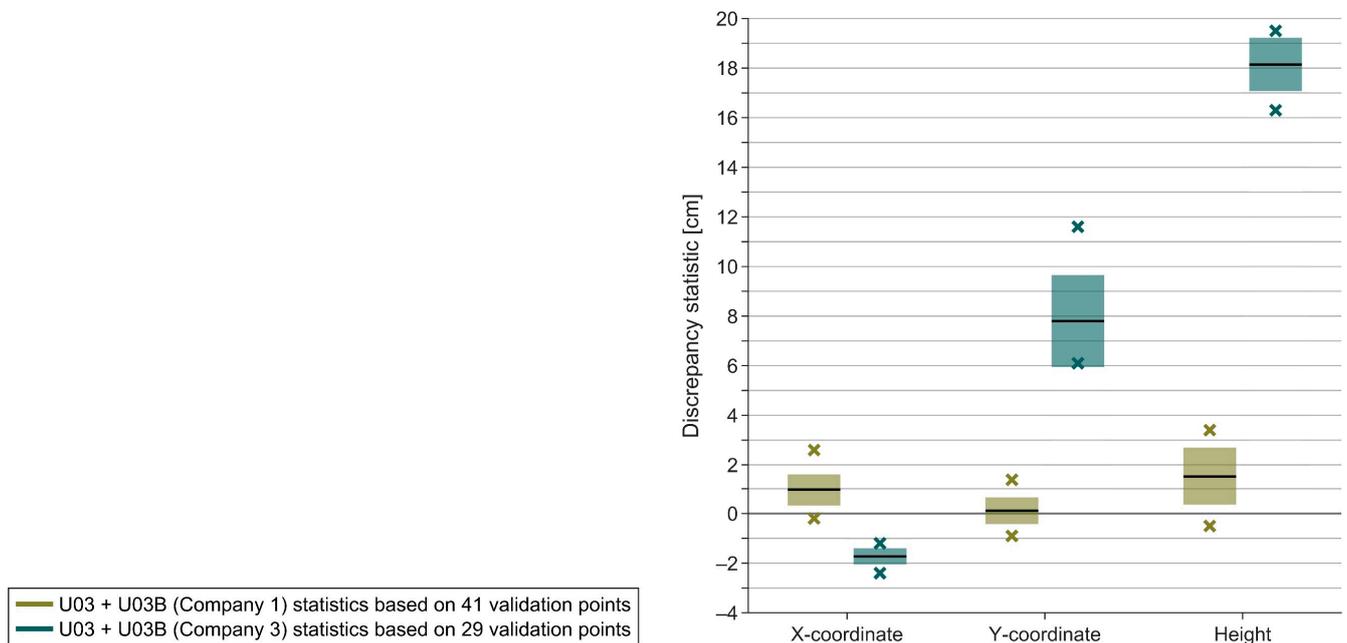
Figure 12. Descriptive statistics of discrepancies between validation points' coordinates and those extracted from the point clouds of the U03 building's third floor. Black lines denote mean values, colored bars standard deviation estimates, and colored crosses minimum and maximum discrepancies.

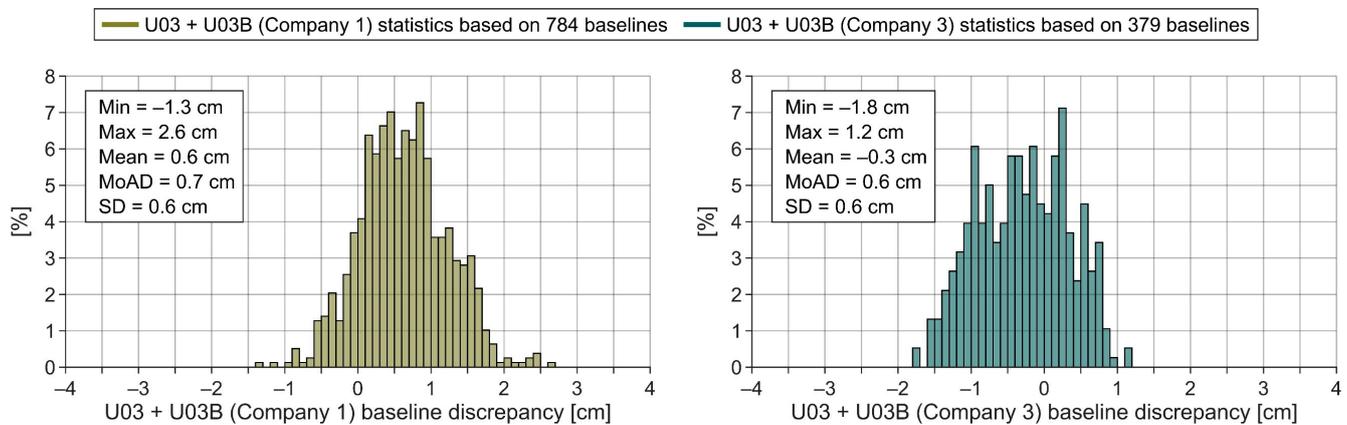
Figure 13. Histograms and descriptive statistics (MoAD—mean of absolute discrepancies; SD—standard deviation) of baseline discrepancies (cf. Equation (1)) representing the U03 building's third floor.

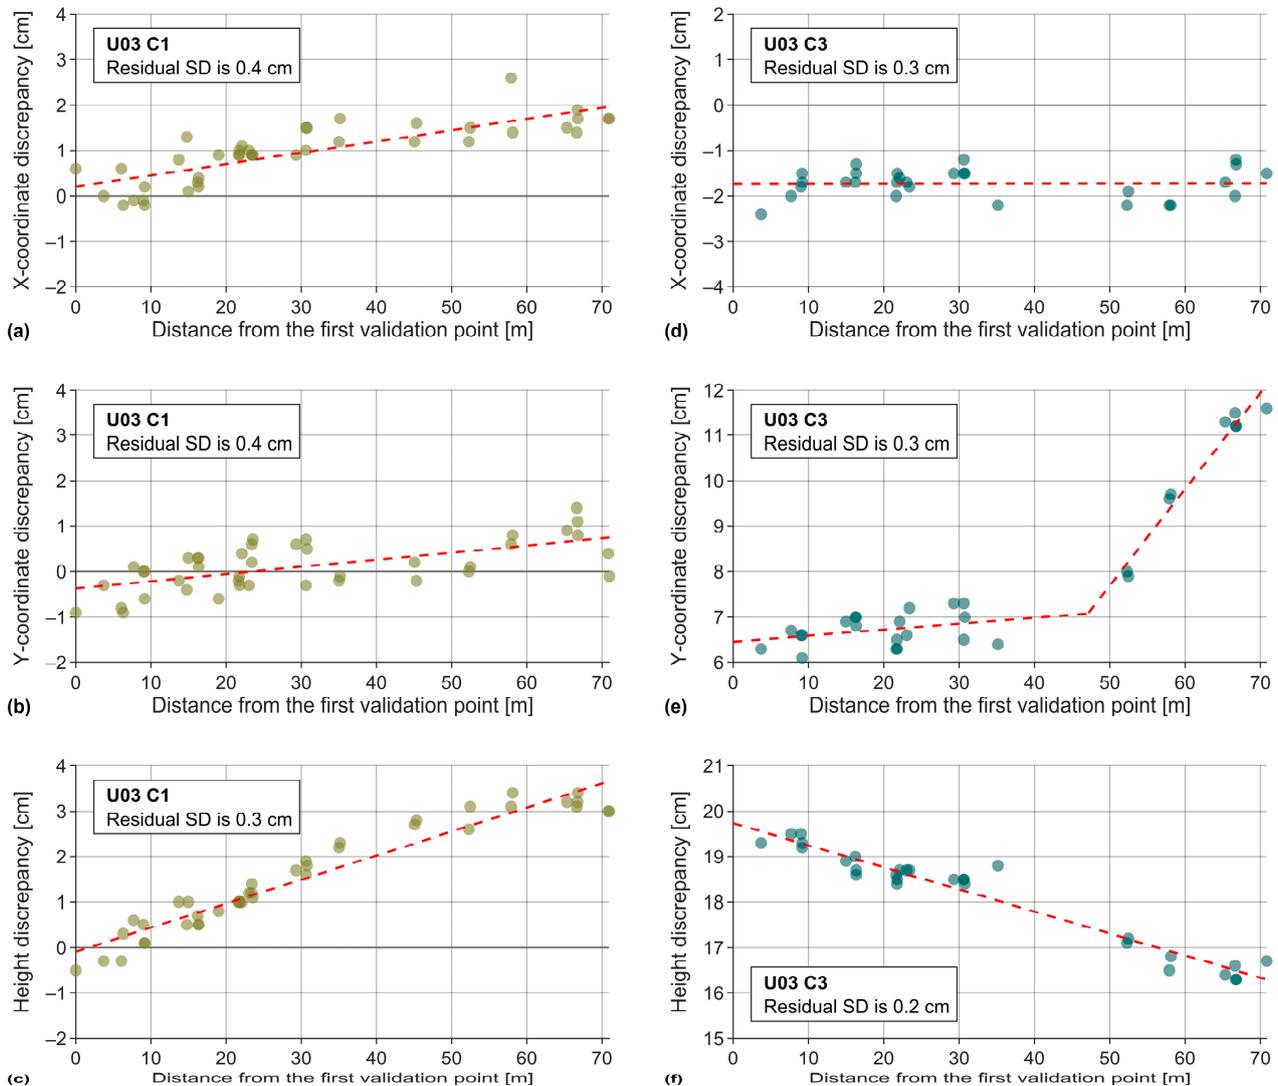
Figure 14. Discrepancies between validation points' coordinates and those extracted from the U03 C1 (sub-plots (a–c)) and U03 C3 (sub-plots (d–f)) point clouds. The dashed red lines show the corresponding discrepancy trends. Note that discrepancies have been projected along a baseline aligned with the corridor connecting the secondary stairway (left) to the main stairway (right; refer to Figure A3). Residual standard deviation (SD) describes discrepancy residuals relative to the trend. Notice vertical scale offsets in the C3-associated sub-plots.

A curious observation in Figure 14a is that the trend associated with the X-coordinate discrepancies is larger than that of the Y-coordinate. Because the corridor connecting stairways is roughly aligned with the X-coordinate axis (cf. Figure A3), such a result makes little sense unless it is due to a scale error. Hence, Figure 14a appears to support the speculation that the scaling of the U03 + U03B C1 point cloud is erroneous. In this case, the trend-based (Figure 14a) scale error is estimated at 2.5 mm per 10 m. Accumulating registration errors are unlikely, considering the point cloud's high consistency (residual standard deviation estimates are from 0.3 cm to 0.4 cm).

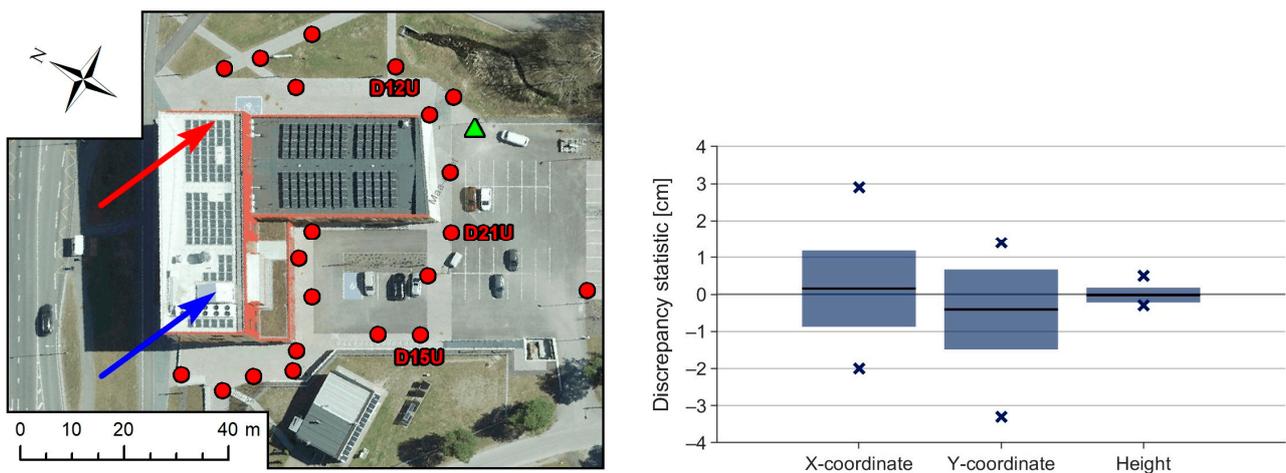
Figure A1. Outdoor survey network points (red dots) of the CON building (**left**) and descriptive statistics (based on 24 comparisons) of discrepancies between initial coordinates and control measurements (initial coordinates were subtracted from the latter) describing the CON building total station survey (**right**). On the **left** sub-plot: the green triangle shows the location of base station for the total station survey; the red arrow points roughly to the location of the main stairway, and the blue arrow points to the secondary stairway; background orthophoto originates from the Estonian Land Board. On the **right** sub-plot: black lines denote mean values, colored bars standard deviation estimates, and colored crosses minimum and maximum discrepancies.

A total of 24 control points could be measured to assess the accuracy of the total station validation survey: 3 on the basement floor, 10 on the first floor, 4 on the second floor, and 7 on the third floor. The results in Figure A1 suggest no significant systematic effects in the survey, and errors appear random (i.e., at most, the Y-coordinate mean discrepancy is −0.4 cm). An accuracy of around 1–2 cm should be expected for the X- and Y-coordinates. On the other hand, the height component should have an accuracy of a few millimeters. Therefore, the conducted total station survey should be sufficient for detecting point cloud errors of a few centimeters, especially considering the height component.

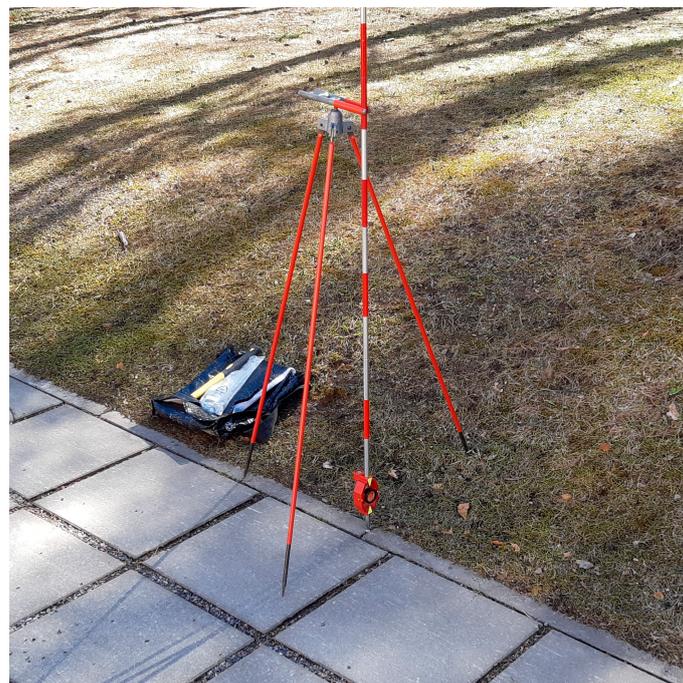
Figure A2. Mini prism and tripod used during total station surveys.

3. All survey network points were coordinated using a mini prism in combination with a tripod to maintain the levelness and stability of the prism (see Figure A2).

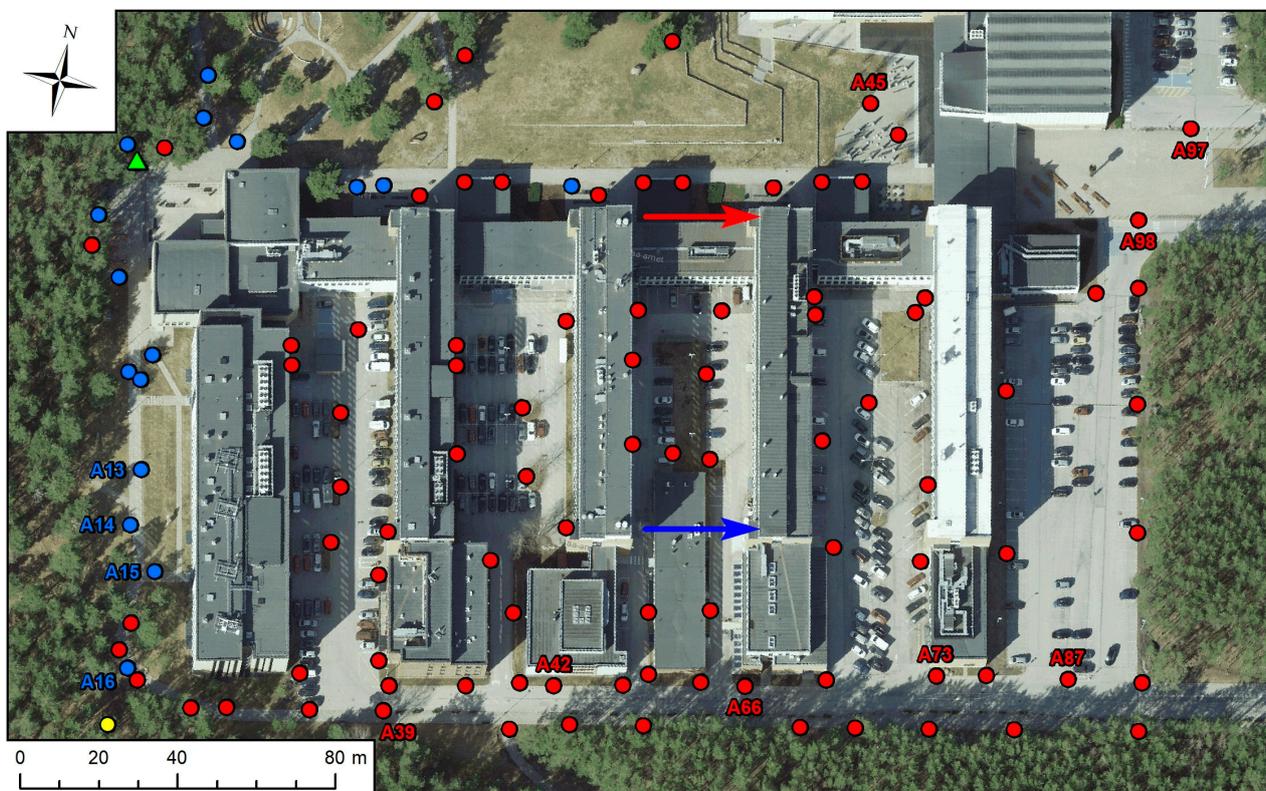
Figure A3. Outdoor survey network points (blue and red dots) for the main campus. Blue dots denote points that were initially measured using RTK-GNSS. The yellow dot denotes a temporary point established with a wooden stake, and the green triangle shows the location of the total station survey's base station. The red arrow points to the location of the main stairway, and the blue arrow points to the secondary stairway of the U03 building. Background orthophoto originates from the Estonian Land Board.

Initially, 16 survey nails were installed (notice blue dots in Figure A3), the coordinates of which were RTK-GNSS-measured relative to the Estonian national network of continuously operating GNSS reference stations [63] using a Trimble R12 GNSS receiver [64]. Ellipsoidal heights were reduced to normal heights (corresponding to the EH2000 system) using the EST-GEOID2017 [45] quasigeoid model. Each point was measured 10 times, whereby measurement cycles (point 1 to point 16) were conducted at different times (minimum time between each measurement on the same point was 30 min) on different days

of 0.1 cm for point A13, -0.5 cm for A14, and 0.0 cm for A15 and A16 (refer to Figure A3 for points' locations). A slightly larger discrepancy for point A14 could be considered an outlier (e.g., it could be that a slight pebble was under the leveling staff), as there was no indication of such an error during the total station surveys. Additionally, trigonometric leveling observations (using three full measuring rounds) were made during total station surveys on benchmarks of the U01 and U02 buildings (cf. Figure A4). The U01 benchmark height was measured once, and the U02 benchmark four times from different survey stations. Comparisons between the official height of the U02 benchmark and trigonometric leveling observations always yielded a discrepancy of 0.0 cm. For the U01 benchmark, a discrepancy of 0.3 cm was determined (official height was subtracted from the trigonometric leveling result). This more considerable discrepancy appears to be confirmed by the resection traverse loop 3 height discrepancy of 0.2 cm (cf. Figure A4).

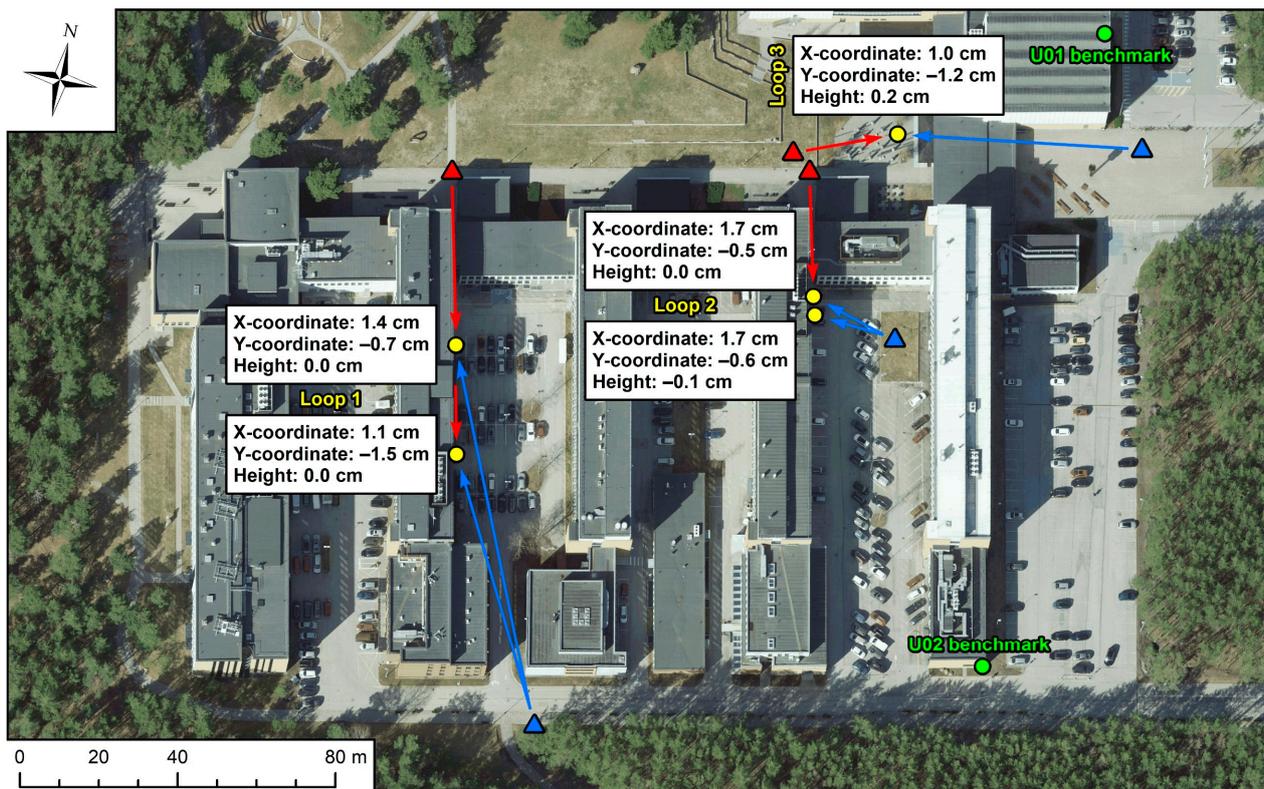
Figure A4. Scheme of resection traverse loops' closings. Yellow dots denote survey network points used for closing the loops. Red triangles and arrows show survey stations' locations and prism sights for determining the initial coordinates of survey network points, whereas blue triangles and arrows denote survey stations' locations and prism sights of control measurements. Numbers associated with X- and Y-coordinates and heights show discrepancies between initial coordinates and control measurements (initial coordinates were subtracted from the latter). Background orthophoto originates from the Estonian Land Board.

Precise leveling results between two benchmarks (the U02 benchmark, cf. Figure A4, and another located to the west) could be used to validate the height accuracy. A Trimble DiNi 0.3 mm digital level [66] was employed with invar leveling staffs; survey network points were leveled using intermediate sights. Note that one millimeter was subtracted from leveled heights because survey nails have a slight depression for the prism's tip. After adjustment computations, the comparison between leveled heights and survey network heights (leveled heights were subtracted from the network heights) yielded discrepancies
