# Rising Damp Treatment in Historical Buildings by Electro-Osmosis: A Case Study

**Citation:** Koca, A.; Uğural, M.N.; Yaman, E. Rising Damp Treatment in Historical Buildings by Electro-Osmosis: A Case Study. *Buildings* **2024**, *14*, 1460. <https://doi.org/10.3390/buildings14051460>

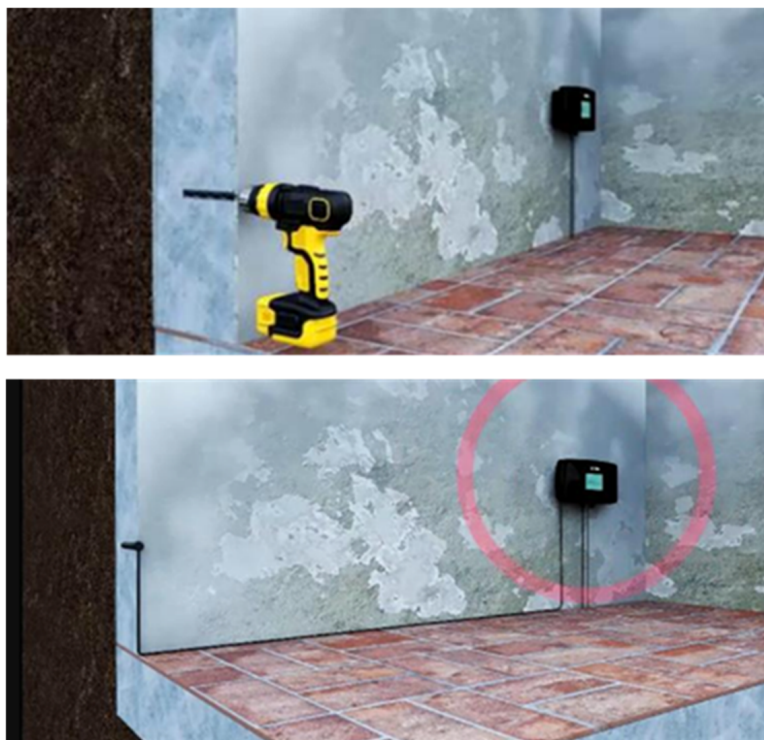
**Figure 3.** First stage of installation of the capillary moisture treatment device [41].

beyond the foundation, in a manner consistent with their initial entry point, without the need for any construction activities such as plastering and painting. Capillary moisture repulsion devices facilitate the alignment of the load exerted by the building walls with the mineral water present in the soil. The graphic representations in Figure 3 depict the device and the electrodes that are strategically placed on the walls.

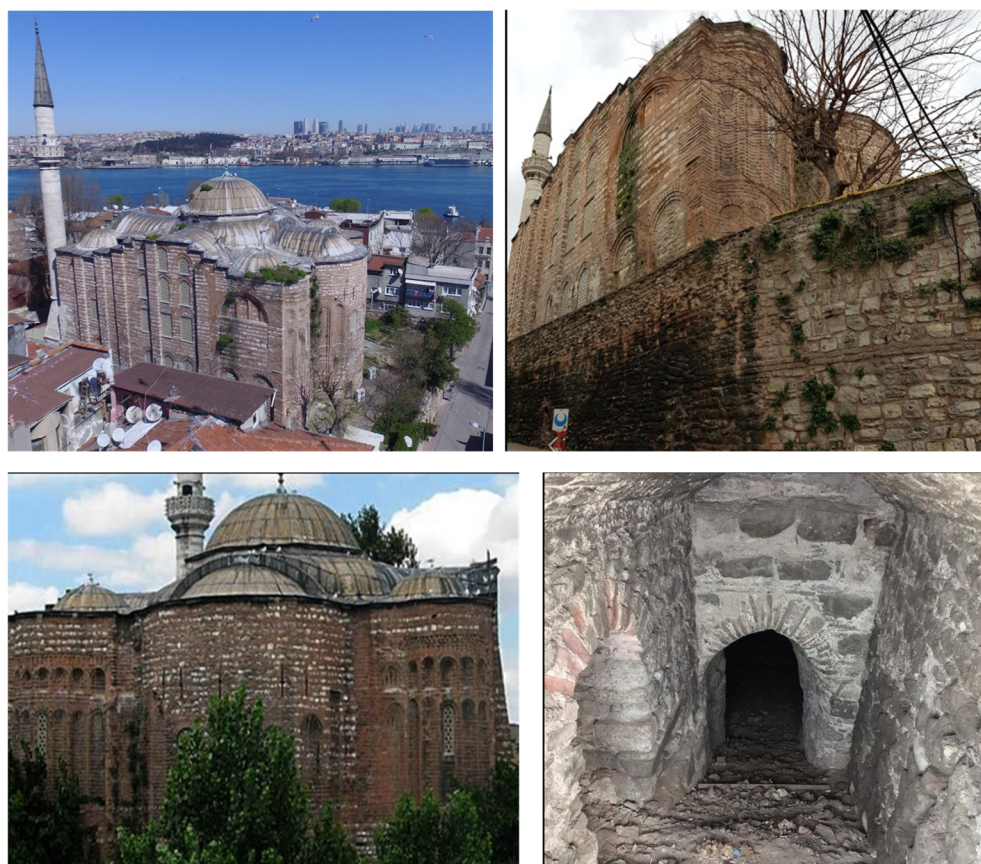
**Figure 5.** Gül mosque.

The Gül mosque was built on a brick vaulted basement. The mosque is situated on an elevated site. The building sits on gravel, sand, clay, and silt soil (sedimentary soil). The building content of the mosque shows an alternating style comprising faceted stone and classical brickwork, with Khorasan joints. Stone and brick have been mixed into the masonry (Figure 5). The mosque has a total exterior wall area of 1560 m<sup>2</sup>. It has a total external wall volume of 312 m<sup>3</sup>. Due to its proximity to the sea, the mosque has long been plagued by moisture and dampness issues caused by the ground (Figures 6 and 7).

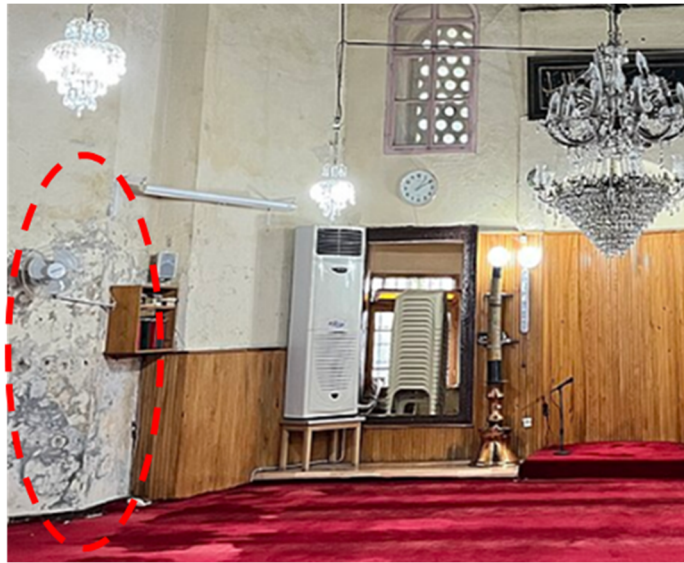
Figure 7. Persistent issue of dampness and humidity within the mosque.

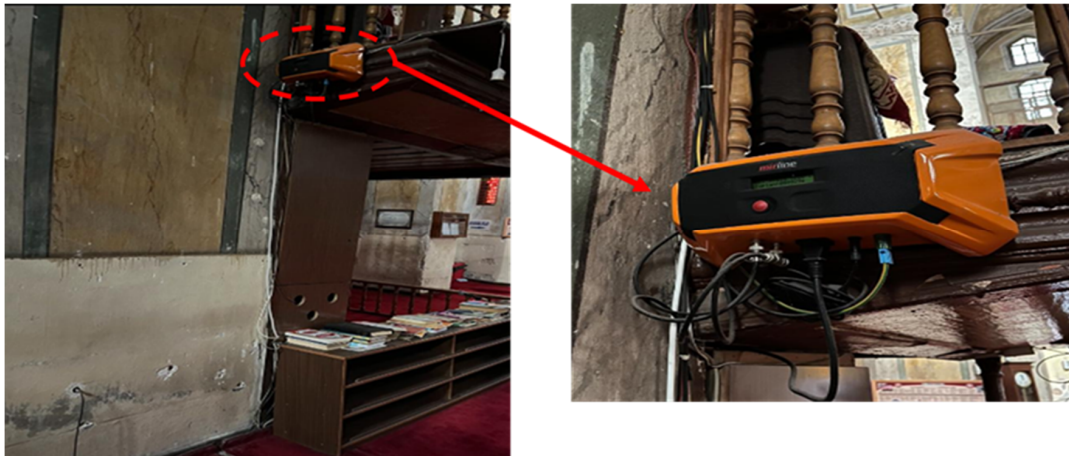
Figure 9. Installation of the capillary rising damp treatment device.

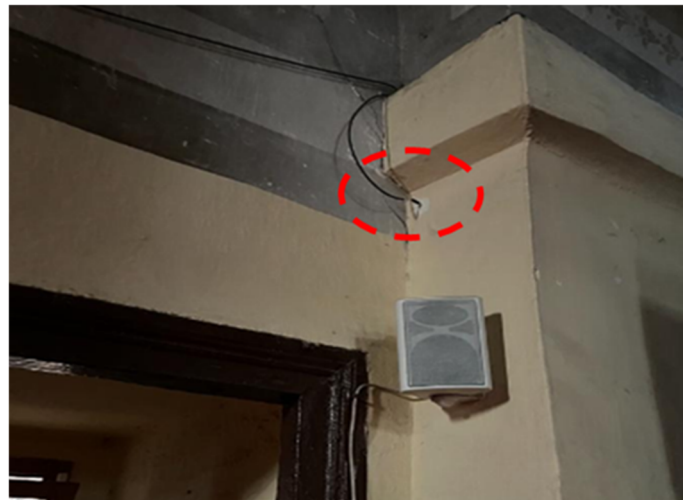
**Figure 10.** Electrode mounted on the vertical axis (shown in a red circle).
