# Four-Dimensional Digital Monitoring and Registering of Historical Architecture for the Preservation of Cultural Heritage

**Citation:** Sedek, M.S.; Touahmia, M.; Albaqawy, G.A.; Latifee, E.; Mahioub, T.; Sallam, A. Four-Dimensional Digital Monitoring and Registering of Historical Architecture for the Preservation of Cultural Heritage. *Buildings* **2024**, *14*, 2101. <https://doi.org/10.3390/buildings14072101>

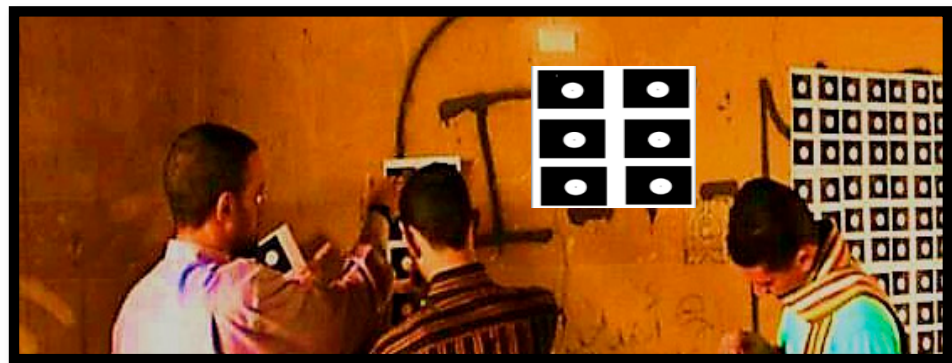
**Figure 3.** Artificial targets placed on the control field wall. White circles with black background were placed inside the hall of Baron Palace (*the first author appears in the left*).

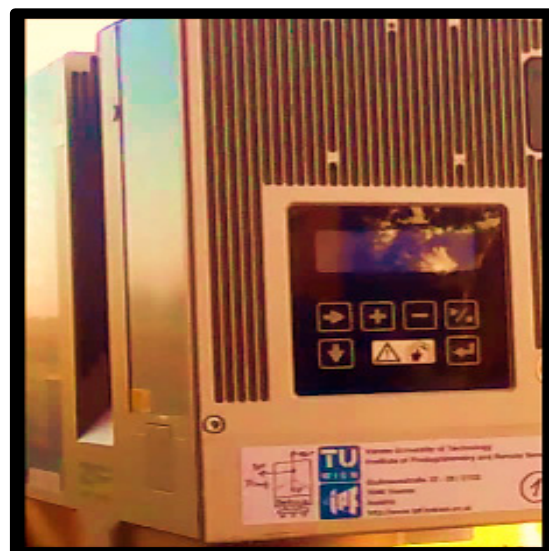
**Figure 4.** (Z + F) image laser scanner used in the scans of Baron Palace and statues in fieldwork.

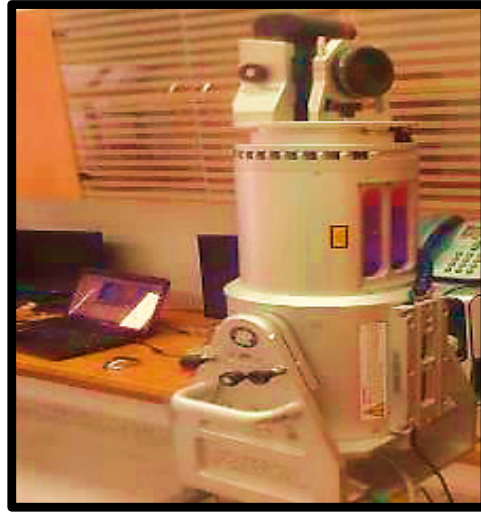
- The captured digital images by Nikon (Tokyo, Japan) D300 digital camera were used in the calibration task of the RiSCAN. Nikon digital camera was mounted on the top of Riegl LMS-Z620 laser scanner (in the laboratory test), as shown in Figure 5.

**Figure 5.** Nikon digital camera mounted on Riegl laser scanner and laptop used in laboratory test.

In the laboratory test work results, a Nikon D300 digital camera was mounted on top of a Riegl LMS-Z620 scanner as shown in Figure 5, and the lab area was scanned through a Riegl scanner by operation of tie point images on robotically identified reflectors. After the image acquisition had finished, the camera was calibrated. The main benefits are that the calibration field was built easily and no total station was required. The calibration results were the following: The Nikon D300 camera's internal calibrations (as interior orientation parameters, IOPs and distortion parameters) are as shown in Figure 7, and the mounting calibration matrix (as exterior orientation parameters, EOPs) were calculated in RiSCAN.

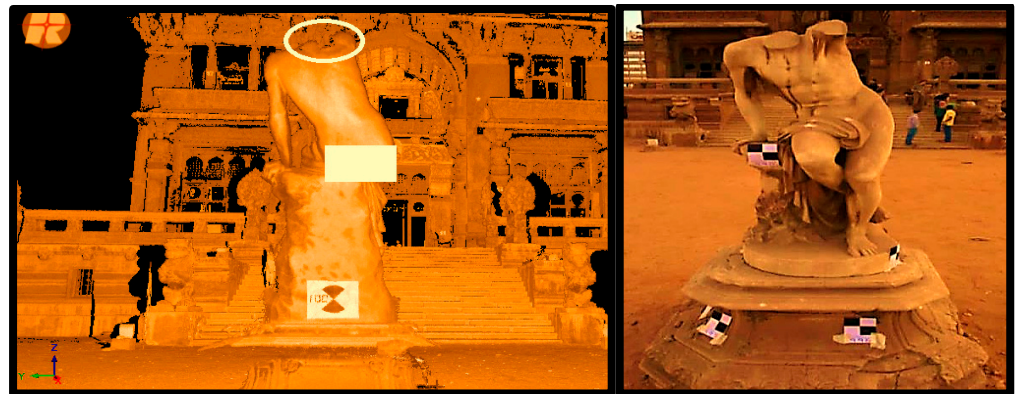
**Figure 6.** Four-dimensional laser scan of the defective statue in RiSCAN (left) and digital image of it in the same date (right), without its head and arm, with some artificial paper targets.

As mentioned in the first step of the methodology, the 3D models of the defective Baron statue (without its head and its arm) were scanned at a specified date and prepared in RiSCAN, as shown at the left of Figure 6, and the digital images of the statue were captured on the same date, as shown at the right of Figure 6, with some artificial paper targets that were observed and detected.

The 4D analysis of the two statue models was matched and compared to identify geometric defects in the head, arm, and other body parts, as well as to determine the extent of these defects. From the left of Figure 6, it is observed that the 3D point cloud gave very detailed resolution and a more like-like image of the palace and the defective statue in RiSCAN than in other modeling programs, because RiSCAN has a high detection of the point's intensity values of the laser scans. However, the point cloud navigation and handling in RiSCAN were hard because of the high number of point clouds (tens of millions of points).

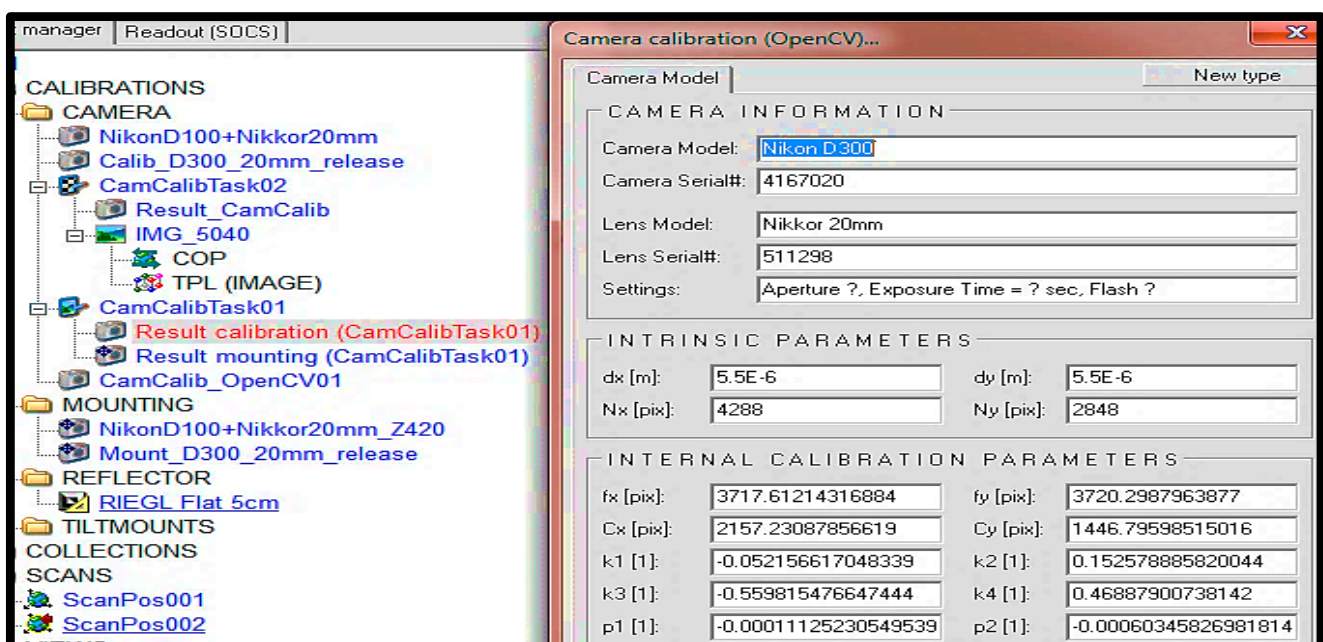
**Figure 7.** Nikon D300 camera's internal calibration parameters (as interior orientation parameters, IOPs and distortion parameters) were calculated in the RiSCAN.

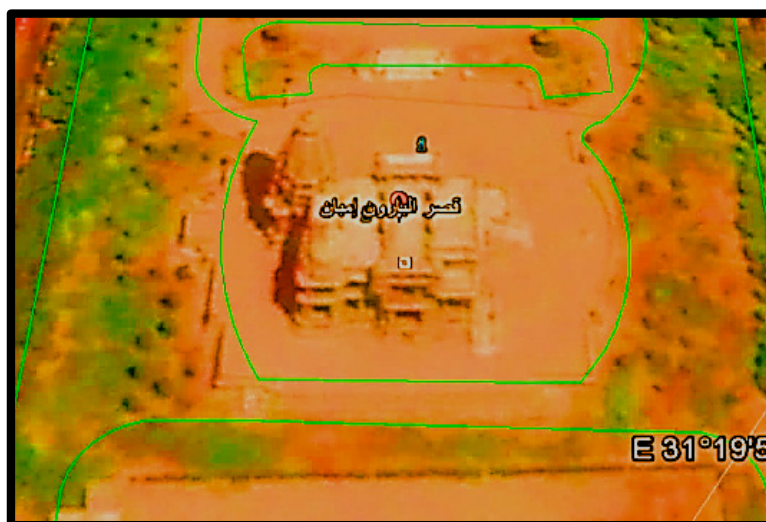
**Figure 8.** Baron Palace detected during the time with its 3D coordinates (30°05'11" N, 31°19'43" E and 61 m Z elevation) in Google Earth maps, in 2017 before restoration [25].

The observed components of the defective model of Baron Palace were identified on the map during the time and recognized on the 4D models of the point clouds. So, the observed model of Baron Palace was detected during the time with its 3D coordinates (30°05'11" N, 31°19'43" E and 61 m Z elevation) and identified in Google Earth maps, in 2017 before restoration, as shown in Figure 8.

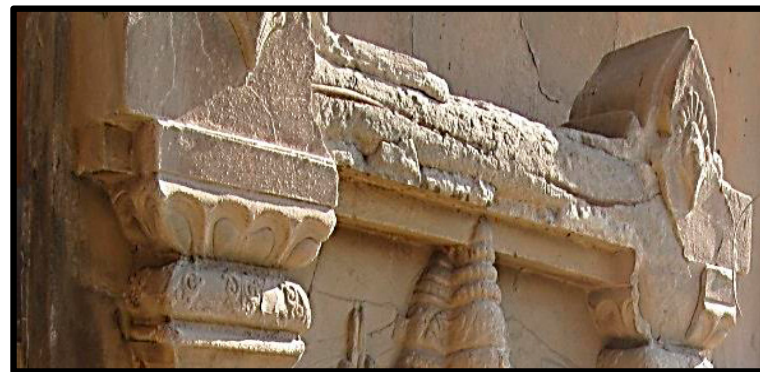
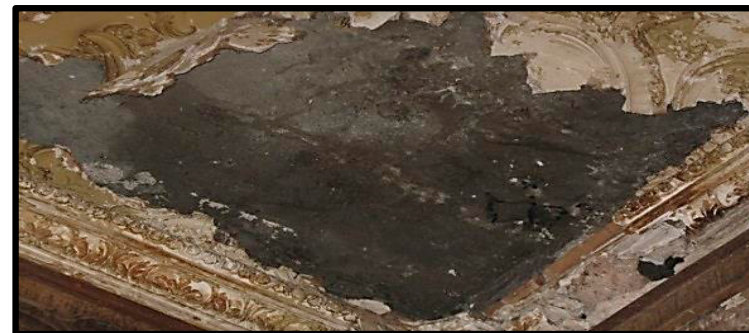
Some defect types in Baron Palace were investigated, as spalling damage and cracks in the inner walls, which were constructed of sandstone. The crack measurements were measured by tapes. The defective historical models were imported into the modeling software; then, the defect properties were identified and determined; e.g., in a crack defect, the width of the crack defined its severity. The defect characteristics were determined and compared with the other data sources such as the defect digital images, as shown in Figures 9 and 10. Figure 9 shows

- A. Damage in the upper beam cover and appearance and corrosion of inner reinforcement bar.
- B. Erosion in the column cover and in the roof cover.
- C. Water seepage defect and some cracks and flaking of the slab paints.

**Figure 9.** Some defect characteristics in Baron Palace: (A)—Damage in upper beam cover and appearance and corrosion; (B)—Erosion in the column and roof covers; and (C)—Water seepage defects.

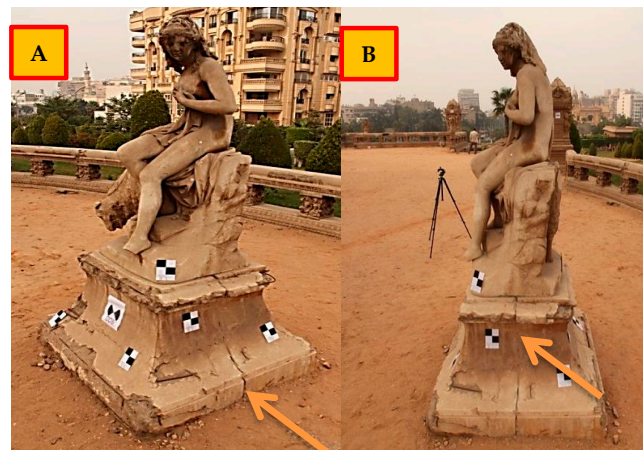
**Figure 10.** Images (A,B) illustrating vertical cracks in the defective side of the statue attributed to harsh weather conditions, as well as micro cracks and cracks in the statue due to deterioration.

It is noted that the quality of the marble in Baron Palace and the defective side of the statue is medium and that it has suffered from different weathering forms and conditions, like cracks, micro cracks, and loss of strength as a result of the harsh climate in Cairo. The statues are exposed to different high-value temperatures (38–45 °C) in summer and low temperatures (8–10 °C) in winter. Based on the visual observations of the statue, many vertical cracks were observed, as well as micro cracks and cracks in the statue due to deterioration factors, as shown in the results in Figure 10.

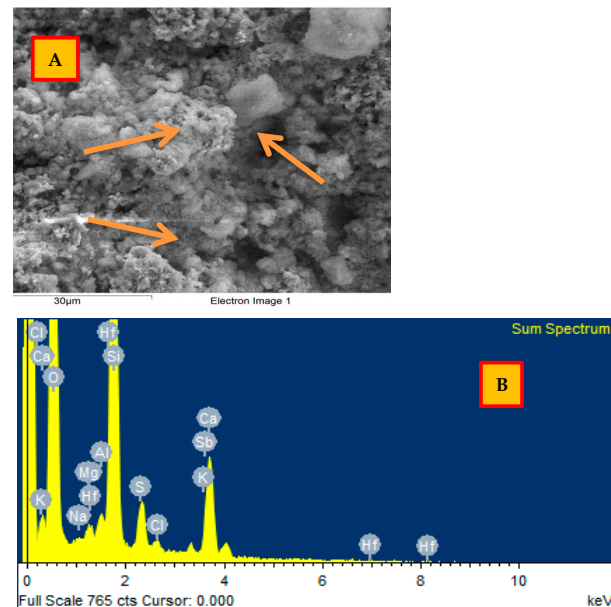
**Figure 11.** (A) SEM photomicrographs demonstrating the surface of marble and gaps attributed to harsh weather conditions. (B) EDX analysis of the same sample indicating the presence of Si and Ca as the major components.

The characterization of the marble samples was performed using SEM. The SEM-EDX images shows that the samples are rich in quartz and calcite as the major components, as shown in the results in Figures 11 and 12.

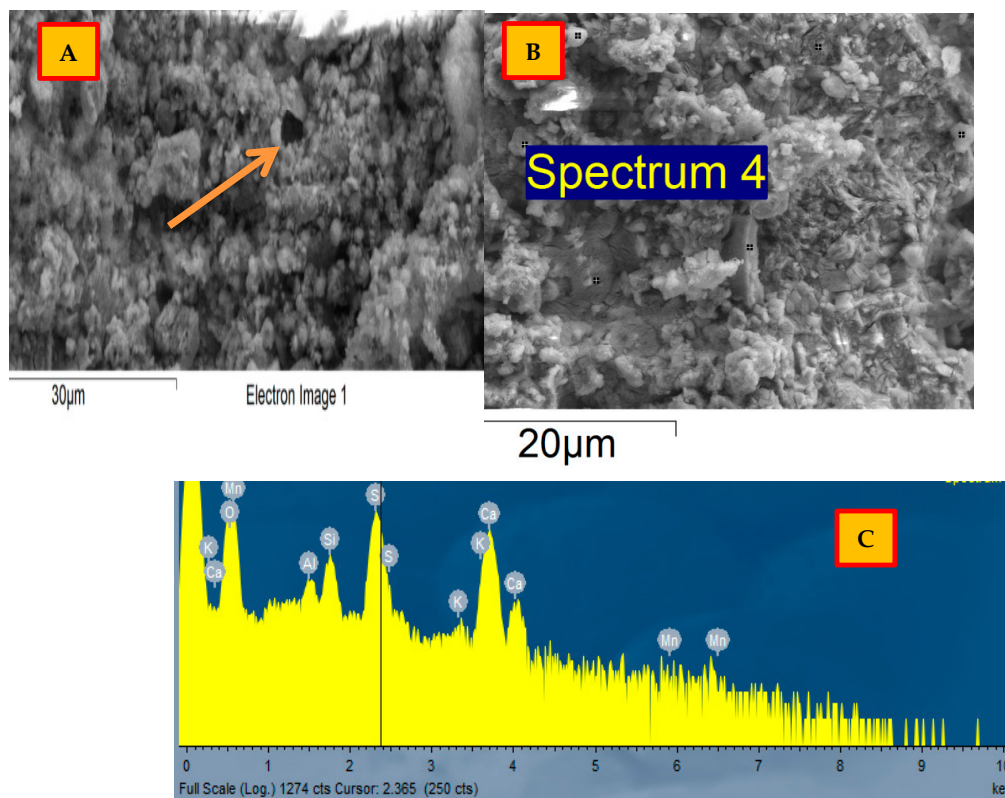
**Figure 12.** (A,B) SEM photomicrographs demonstrating the surface of marble and (C) EDX analysis of the sample indicating the presence of Si and Ca.

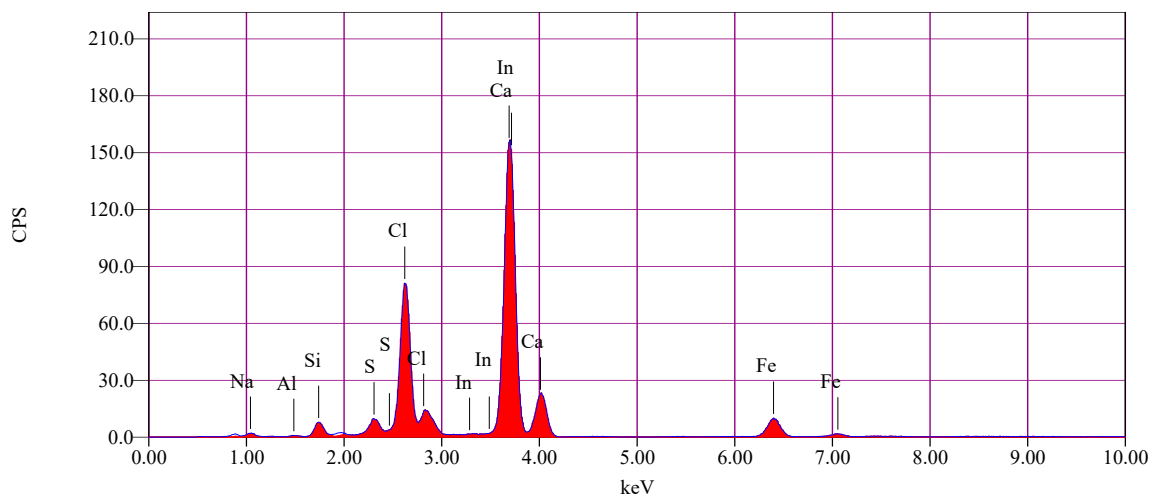
**Figure 13.** XRF spectrum of the sample taken from the defective side of the statue.

The sample of the defective side of the statue consists of calcite (Ca) calcium carbonate  $\text{CaCO}_3$ , as the major component, chloride (Cl), sodium (Na), sodium chloride (NaCl), sulfate (S) sulfate dehydrate  $\text{CaSO}_4 \cdot 2\text{H}_2\text{O}$  (gypsum), and quartz (Si) as shown in the results in Figure 13 and Table 1.

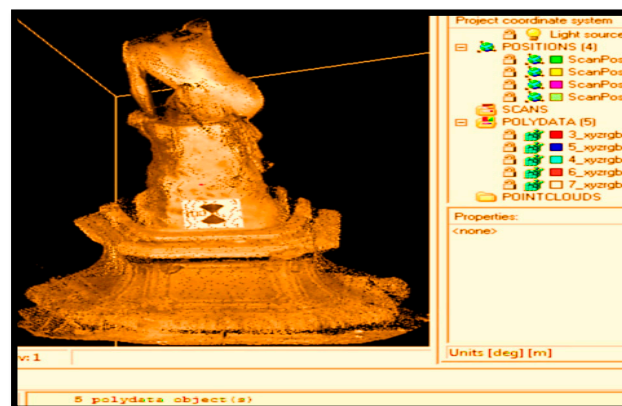
**Figure 16.** The filtration and the registration of 5 polydata laser scans of 605,066 points as high-resolution real images of the defective front statue in RiSCAN.

The filtration and the registration of five polydata laser scans of 605,066 points as high-resolution real images of the defective front statue in RiSCAN resulted and are shown in Figure 16.

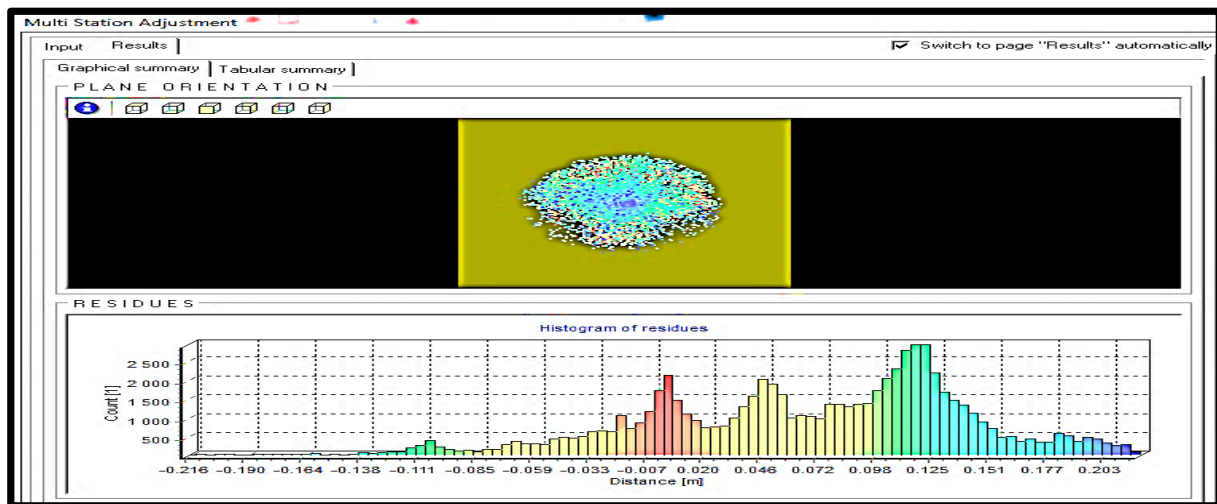
**Figure 17.** The count up to 2500 polydata points (in green) are at distance = 0.125 m between two registered planes (red = small error in middle and blue = big error on the side).

The first author displayed some of the registration parameter results about the used polydata in the charts as illustrated in Figures 17–21. The paint of the points is visualized based on the total distance between the two surfaces of the observation (red = minor errors and blue = huge errors). In these diagrams, the histogram of the remaining errors (residues) displays how several observations had a convinced space between the two planes (surfaces) of the observations.

Once the analysis was performed (it's meaning that the search for the corresponding point pairs and the analysis of the errors, without any modifications to the positions and the orientations of the scans images). That in order to study the relation between the input of the numbers of the observations as polydata numbers and the output of the standard deviation values of the spaces (the distances) among the sets of the polydata scans. For example, Figure 17, shows that the polydata point number count is up to 2500 at

a distance = 0.125 m between the two registered planes (the surfaces) of the observations (the registered point clouds of the two scans images of the Baron Palace façade).

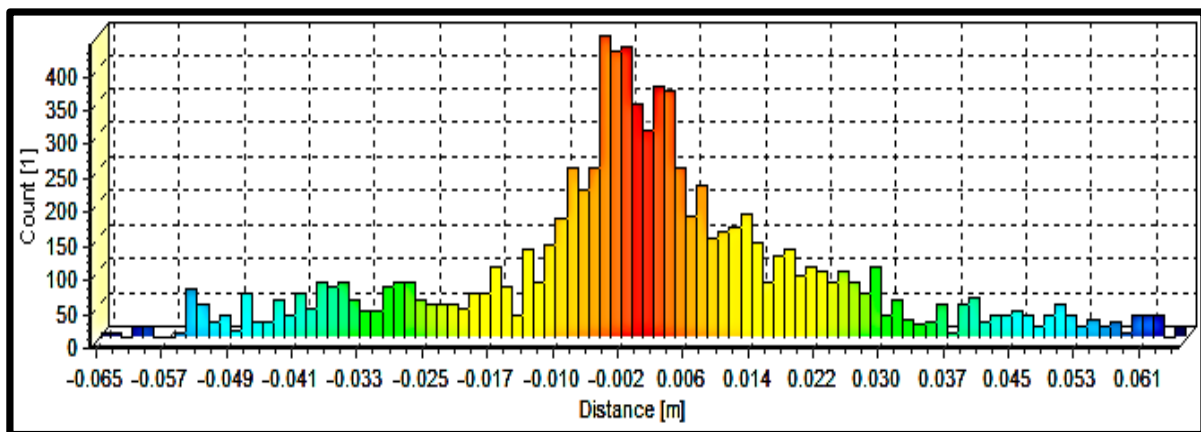
**Figure 18.** The search radius = 0.1 m, polydata point number = 8950, standard deviation = 0.023, by least square fitting method.

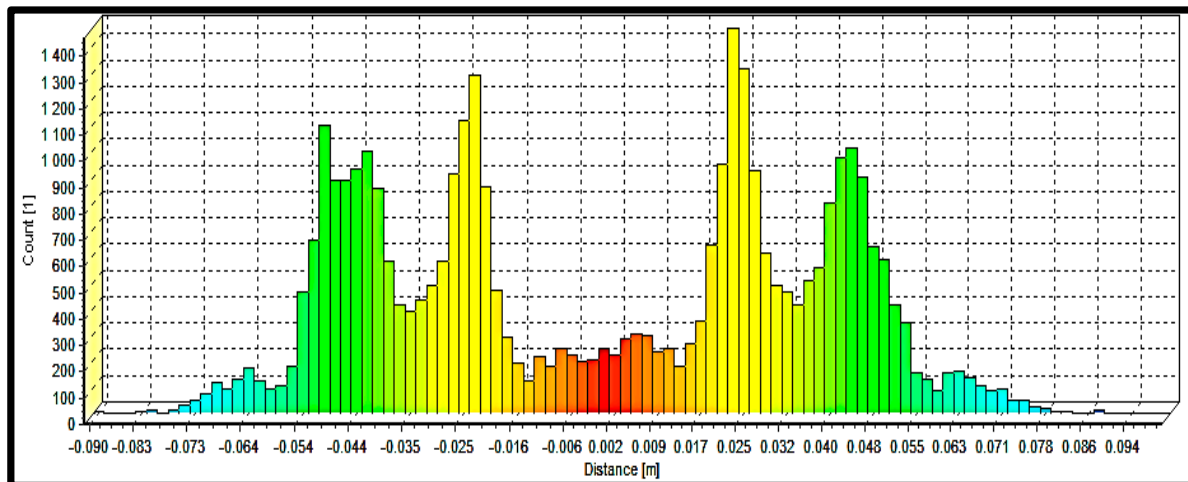
**Figure 19.** The polydata point number = 35187; standard deviation = 0.0376;  $m$ , by the robust fitting method.

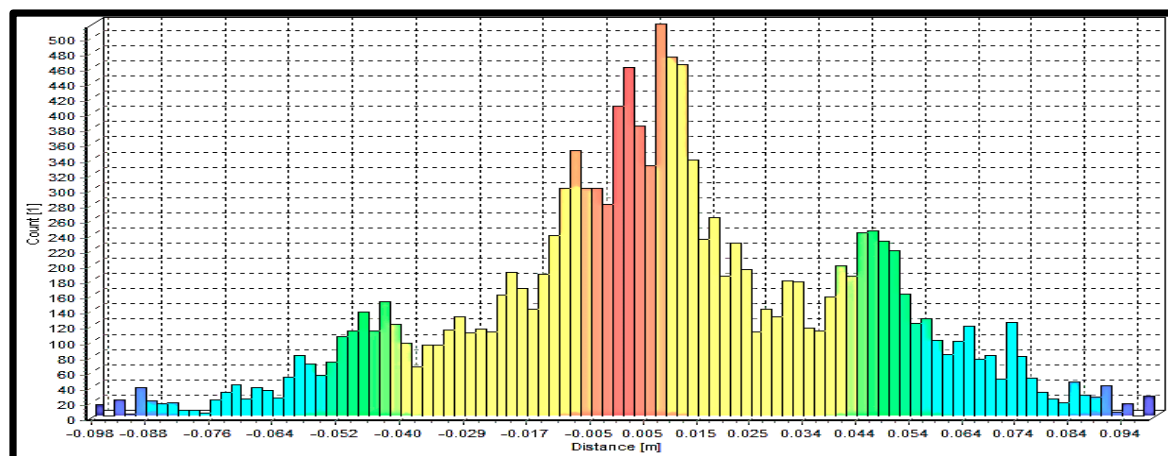
**Figure 20.** The polydata point number = 13,372; standard deviation = 0.0364;  $m$ , by least square fitting method.

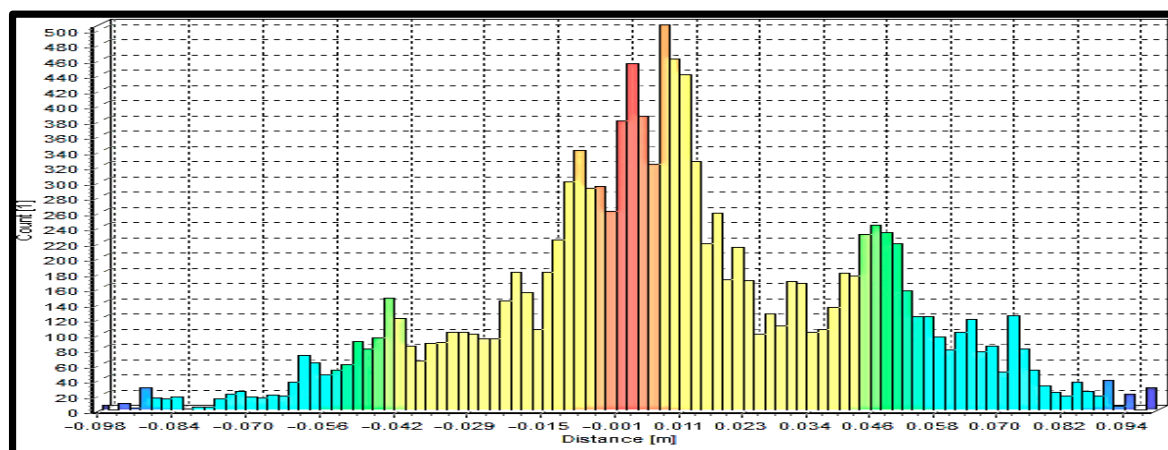
**Figure 21.** The polydata point number = 12,488; standard deviation = 0.0358;  $m$ , by least square fitting method.
