Unique Aspects of Scaffolding Design for the Urgent Seismic Retrofitting of Zagreb Cathedral

Keywords: Zagreb Cathedral; cultural heritage; modular scaffolding; steel; nonlinear analysis; restoration; seismic strengthening

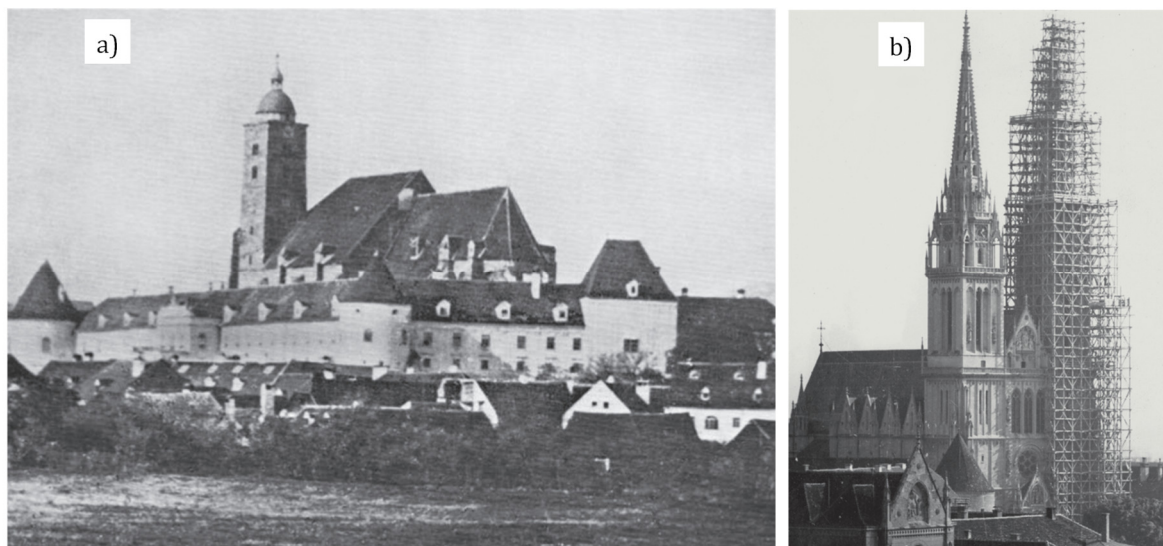
Figure 1. Zagreb Cathedral: (a) before the earthquake of 1880 [1], (b) restoration of the southern bell tower, 1938–1940 [2].

The progressive deterioration of the limestone used in the renovation after the earthquake of 1880 led to new damage and thus to a new renovation, which began in 1938 and in which the entire south tower was renovated; see Figure 1b [2]. The last renovation of the cathedral began in December 1990 and lasted until the last earthquake measuring 5.5 on the Richter scale shook Zagreb on 22 March 2020. At the time of the earthquake, the south

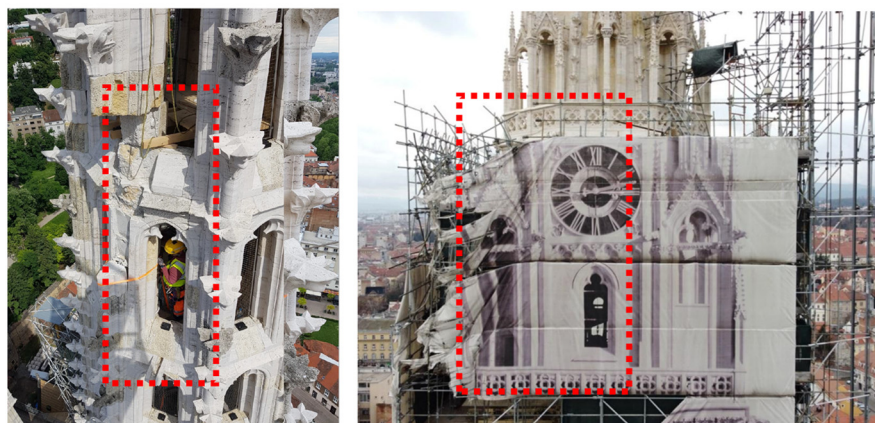
Figure 2. Damage to the south tower and the old tubular scaffolding after the 2020 earthquake.

The old scaffolding on the south tower was also damaged; see Figure 2. The broken stone elements of the towers fell onto the scaffolding and damaged part of its structure. Due to the jeopardised stability and deterioration of the existing scaffolding, as well as the complexity of the future retrofitting work, it had to be removed and replaced with new scaffolding. A mobile crane with a maximum capacity of 120 tonnes and a maximum reach of 120 m was used to dismantle the old scaffolding. The old scaffolding was dismantled by removing it piece by piece and transporting the dismantled parts to the ground using a mobile crane with a construction basket. The removal was completed at the end of 2022 before the new scaffolding was erected in 2023.

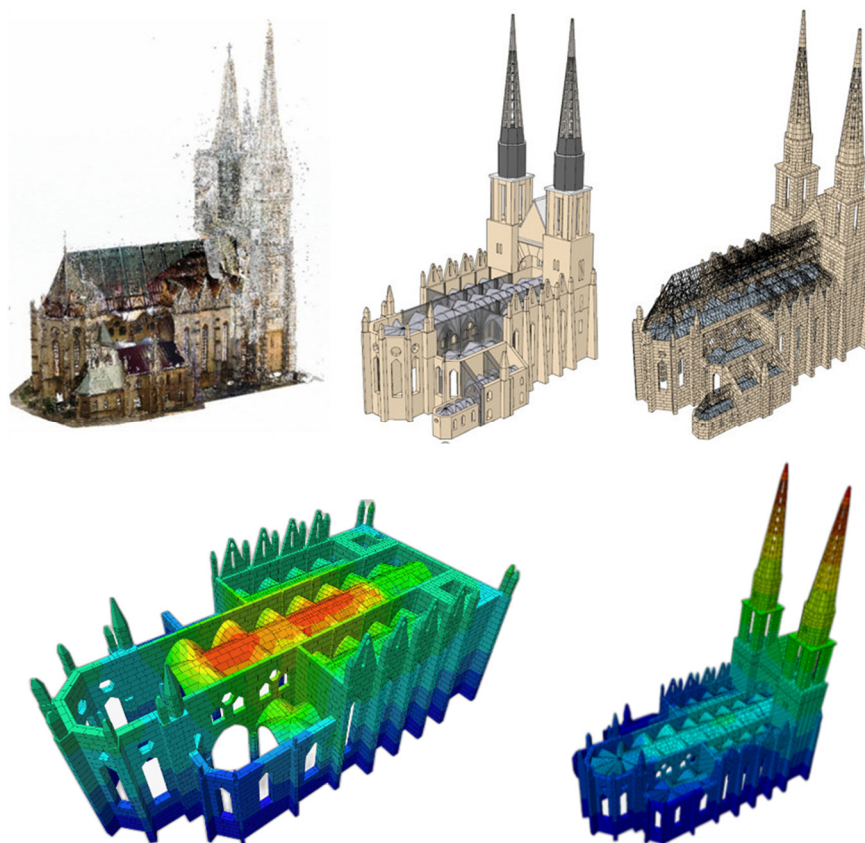
Figure 3. Point cloud model and preliminary numerical models of the Zagreb Cathedral [6].

Due to the damage to the towers and numerous cracks in the vaults and walls, the cathedral was categorised as unsafe for use after the earthquake. The original aim was to stabilise the cathedral with urgent measures so that the subsequently planned reconstruction work could be carried out. These activities were to be led by the Faculty of Civil Engineering at the University of Zagreb in cooperation with several design offices (Toding, Studio Arhing, Foretić and Sons) and numerous experts, including monument conservators. The design and implementation of the urgent stabilisation and reinforcement work was co-funded by the European Union Solidarity Fund. The photogrammetric survey of the cathedral and the extensive investigation work (dynamic properties of the structure, properties of the materials used, condition assessment of the structural components) provided essential data for the urgent restoration projects of Zagreb Cathedral. Figure 3 shows the point cloud model and the preliminary numerical models created by the author of the retrofit concept, Prof Dr Damir Lazarević, together with a close team of collaborators from the Faculty of Civil Engineering at the University of Zagreb. The basis for the creation of the numerical model was a point cloud model, on the basis of which first a spatial model and then a numerical model of the deformable blocks was created [6]. In developing the urgent measures, these numerical models were calibrated using small-scale models [7–9] based on the latest scientific, especially experimental, research on the behaviour of stone masonry worldwide. This approach highlighted the highly complex behaviour of the cathedral and underlined the need for a complete seismic retrofit of the structure.

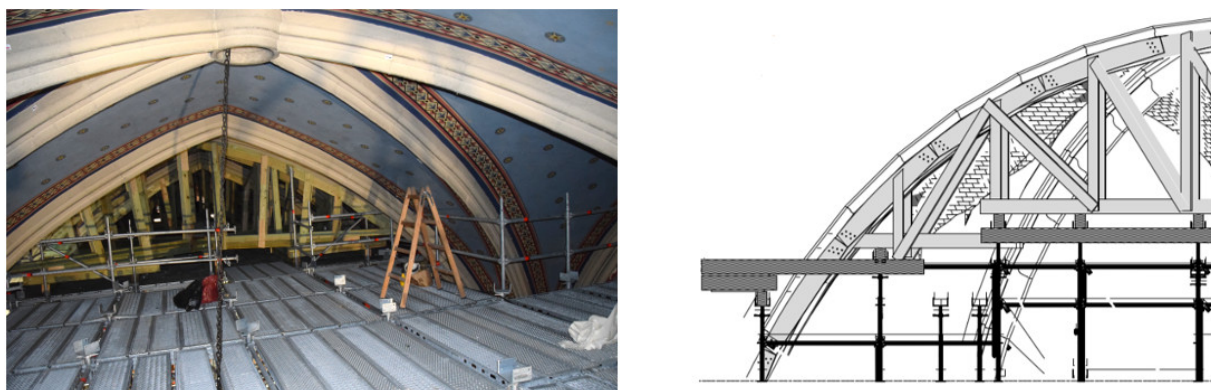
Figure 7. Working area under the vaults and timber structure (centring) to support the masonry vaults.

Load-bearing timber structures were erected on the working areas to support the masonry vaults (centring); see Figure 7. Therefore, the scaffolding was designed to bear the load of the masonry vaults and the timber structures supporting them. The timber structure rests directly on the columns of the scaffolding. The evaluation of the geometrically irregular vaults was based on the analysis of the point cloud model, where it was found that the thickness of the vaults varies between 20 and 30 cm.

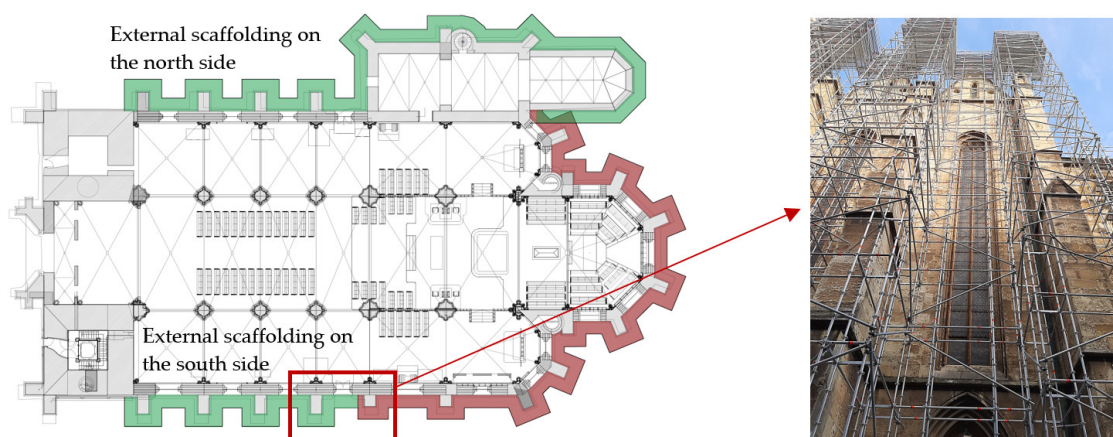
Figure 8. Structure and position of the external scaffolding (the position of the scaffolding erected after the earthquake in Zagreb is marked in red; the position of the new scaffolding is marked in green).

Although the eastern part of the outer walls of the cathedral was scaffolded immediately after the earthquake of 22 March 2020, the need for new scaffolding became apparent due to the inspection, retrofitting and strengthening (prestressing) work on the buttresses; see Figure 8.

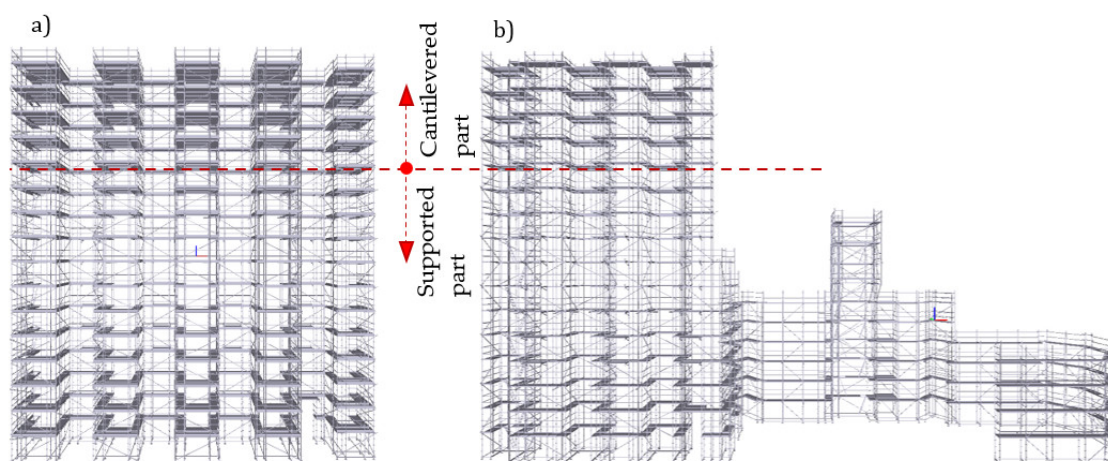
Figure 9. External scaffolding: (a) south side of the cathedral, (b) north side of the cathedral.

The façade scaffolding structure on the south side consists of 16 levels, each 2.0 m high; see Figure 9a. The scaffolding was erected around the perimeter of the south façade of the cathedral and includes five buttresses that were damaged during the earthquake [34]. The total length of the scaffolding is 29.5 m, the total width is 3.5 m, and the height is 32.0 m. The scaffolding structure on the north side consists of 16 levels, each 2.0 m high; see Figure 9b. The north façade of the cathedral is scaffolded around five buttresses that were damaged in the earthquake, as well as the outer walls of the sacristy. The total length of the scaffolding is 52.9 m, the total width is 11.6 m, and the height is 32.0 m.

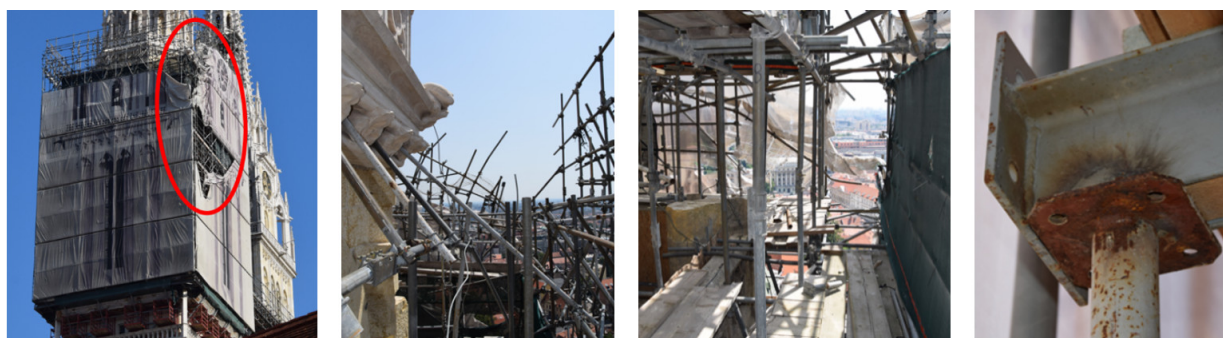
Figure 11. Damage on the old scaffolding structure on the south tower of Zagreb Cathedral [36].

An inspection of the old tubular scaffolding structure on the south tower [36] revealed numerous deficiencies in terms of the durability of the scaffolding elements and the steel platform, mainly in the form of corrosion, local mechanical damage and global damage caused by the 2020 earthquake, as shown in Figure 11. There was also the problem of connecting the old scaffolding on the south tower with the new scaffolding intended for the restoration of the cathedral's towers (urgent removal of the damaged parts of the tower and construction of new ones). The interaction between the two systems, the old tubular scaffolding and the new modular scaffolding, which differ in geometry and construction technology, led to a series of additional problems (adequate connection of the different geometries of the two scaffoldings, load-bearing capacity issues of the old tubular scaffolding after the upgrade, etc.), which are analysed in detail in [36].

With the assumptions made in the numerical model, which mainly concern the old tubular scaffolding geometry, the bracing on the cathedral tower, the connection between the two scaffolding systems and the effects of wind and earthquakes, it was found that about 25% of the tubular scaffolding members and platform does not have sufficient load-bearing capacity. Based on the issues related to the connection of the two scaffolding systems, which are described in detail in [36], it could be concluded that both the old tubular scaffolding and the old platform were not reliable for a possible extension to the top of the tower.

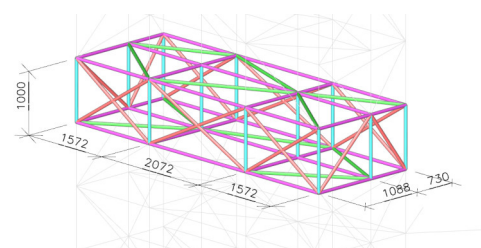
Figure 13. Characteristic module of the scaffolding structure for elevator support (dimensions in mm).

The supporting structure of the elevator measures 5.2 m in depth, 1.8 m in width and 39.2 m in height. The main elements are tubes with a diameter of 48.3 mm from the manufacturer's catalogue. Horizontal bracing is provided on each level and vertical bracing on all outer planes, as illustrated in the characteristic module; see Figure 13. This part of the scaffolding is not intended for the personnel movement or elevator stations, so no platform units have been installed. At heights +3.2 m, +9.2 m, +16.2 m, +25.2 m and +34.2 m, horizontal anchoring to the cathedral is achieved using four scaffold tubes (CHS 48.3 \times 4, S 235 JR) with end plates and bolts. Anchoring to the cathedral wall was carried out using chemically injected threaded rods (4 \times M16, grade 10.9).

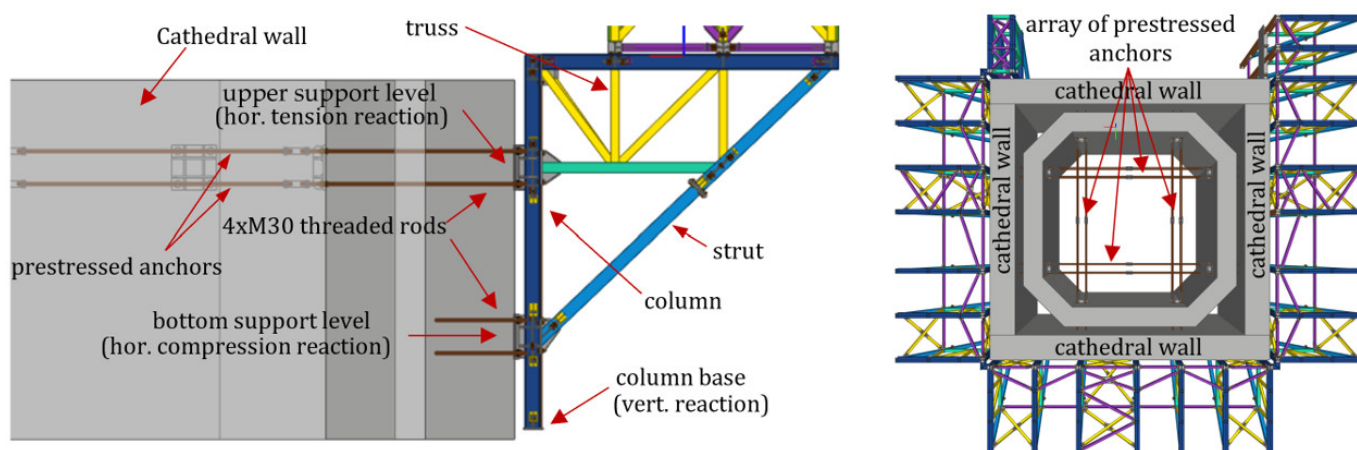
Figure 15. Anchoring of steel frames into/through the cathedral wall.

array of prestressed anchors; see Figure 15. It is important to note that only the anchors embedded in the two opposite walls transfer the tensile force. This solution was chosen because the anchoring forces in the design were almost 300 kN, which is a considerable value given the condition of old masonry walls. In this way, even if the transfer of anchoring forces into the masonry walls fails, the steel platform can anchor itself through a series of prestressed anchors.

The columns of the cantilever frames are made of HEA 160 and HEA 180 profiles. The cantilever trusses consist of various hot-finished tubular profiles. The top chord of the trusses is fabricated from HEA 160 profiles, while the bottom chord is formed from SHS 100 × 100 × 5. The truss diagonals are made of SHS 80 × 80 × 5 tubular members, and the strut of the frame is made of SHS 120 × 120 × 6 profiles. Between the cantilever frames, there are also bracings made of SHS 80 × 80 × 5 tubular profiles; see Figure 15.

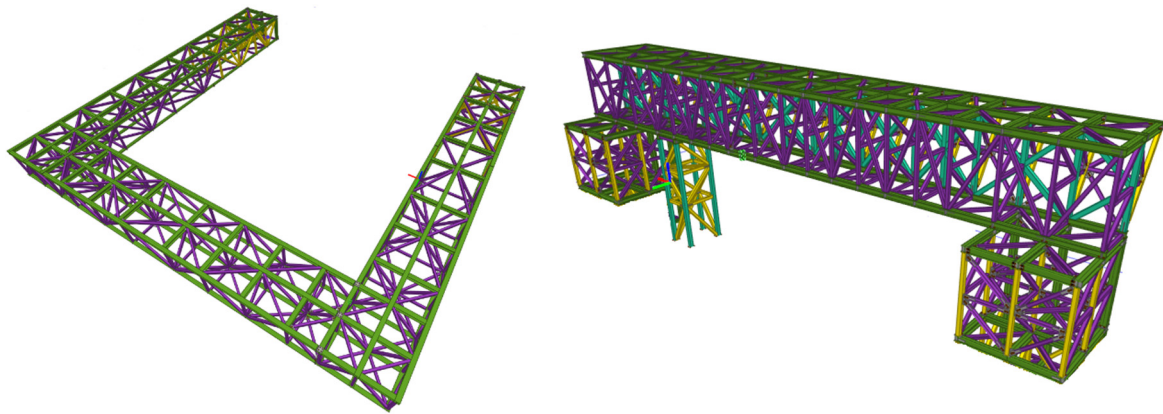
Figure 16. The bottom truss of the platform structure and the truss columns with the spatial bridge truss structure.

The third and fourth levels of the platform P1 consist of spatial truss columns (level three) and a spatial truss bridge (level four), which support the side of the scaffolding facing the adjacent tower; see Figure 16. The truss columns are made of vertical members fabricated from SHS 80 × 80 × 5 or SHS 100 × 100 × 5 profiles. At the edges of the columns facing the roof of the cathedral, the vertical members of the spatial truss columns are made of stronger HEA 140 cross-sections, as these vertical members take the majority of the vertical reactions of the truss bridge structure. The diagonals of the columns are made exclusively from hot-finished SHS 70 × 70 × 4 or SHS 80 × 80 × 5 tubular profiles. The top spatial truss bridge rests on these truss columns. The chords of the truss are made of HEA 140 profiles and the diagonals of SHS 100 × 100 × 5 and SHS 70 × 70 × 4 tubular profiles. The struts that support the top chord of the truss facing the adjacent tower are made of hot-finished SHS 80 × 80 × 5 tubular sections. The truss bridge is divided into two assembly units, which are bolted to the top chord with 6 × M16 bolts and to the bottom chord with 8 × M16 bolts.

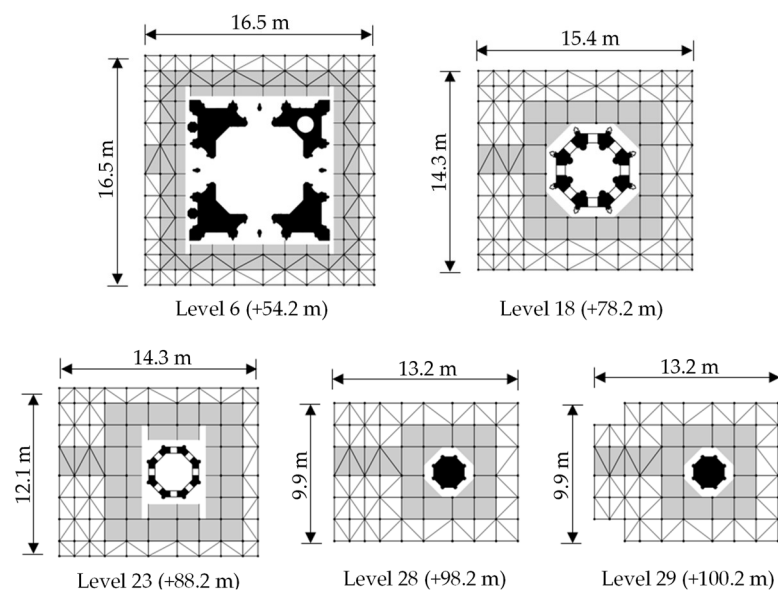
Figure 17. Characteristic ground plans of the tower scaffolding.

In the first section, from the top of the base jacks on platform P1 (+42.2 m) to a height of +74.2 m (levels 0 to 16), the width of the levels is 16.460 m in both directions. In the second section, from +74.2 m to +86.2 m (levels 17 to 22), the ground plan dimensions of the scaffolding are 15.372×14.284 m. In the third section, from +86.2 m to +96.2 m (levels 23 to 27), the plan dimensions are 14.284×12.108 m. In the fourth section, from +96.2 m to +98.2 m (level 28), the ground plan dimensions are 13.196×9.932 m. In the highest section, from +98.2 m to +106.2 m (levels 29 to 32), the ground plan dimensions are 13.196×6.788 m. Figure 17 shows the plan view of the characteristic levels with their dimensions at the points where the scaffolding tapers. The shaded areas represent the working areas with platform units.

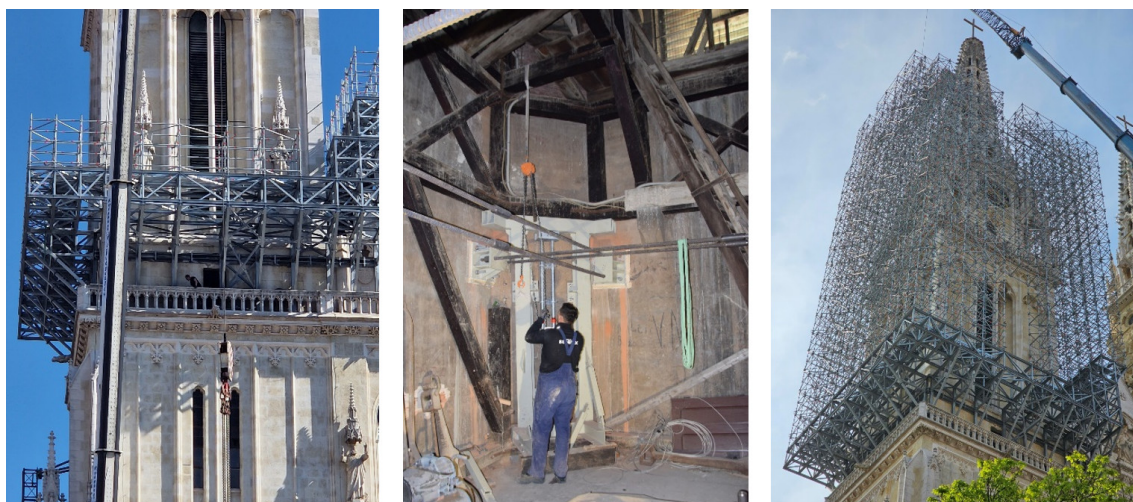
Figure 19. Assembly of the tower modular scaffolding on the north tower of the cathedral.

Some specific phases of the assembly of the tower scaffolding on the north tower are shown in Figure 19. The photo on the left shows the steel platform P1 and the first level of the scaffolding that was erected on the north tower. The photo in the centre shows the interior of the tower during the assembly of the anchorages after the mounting of the corner steel structures supporting the wooden bell structure in the north tower. The photo on the right shows the scaffolding on the north tower during the assembly phase. Further levels were added later, as were the aluminium platform units and the elevator for vertical communication.
