Monitoring Environmental and Structural Parameters in Historical Masonry Buildings Using IoT LoRaWAN-Based Wireless Sensors

The subject of this study is a four-story tenement house located in a city center of southern Poland, built at the end of the 19th century. This building, part of a row of tenement houses, is a masonry structure without insulation. Sensors placed in this building monitored various parameters, analyzing displacements and humidity–temperature conditions using a system based on LoRaWAN wireless IoT technology. Some sensors measured a single parameter (e.g., displacement), while others measured multiple parameters simultaneously, such as both temperature and humidity. The building exhibits damages that, if further developed, could potentially compromise its safety. Additionally, there are signs of moisture in the structural elements and cracks that show irregularities in the structural system.

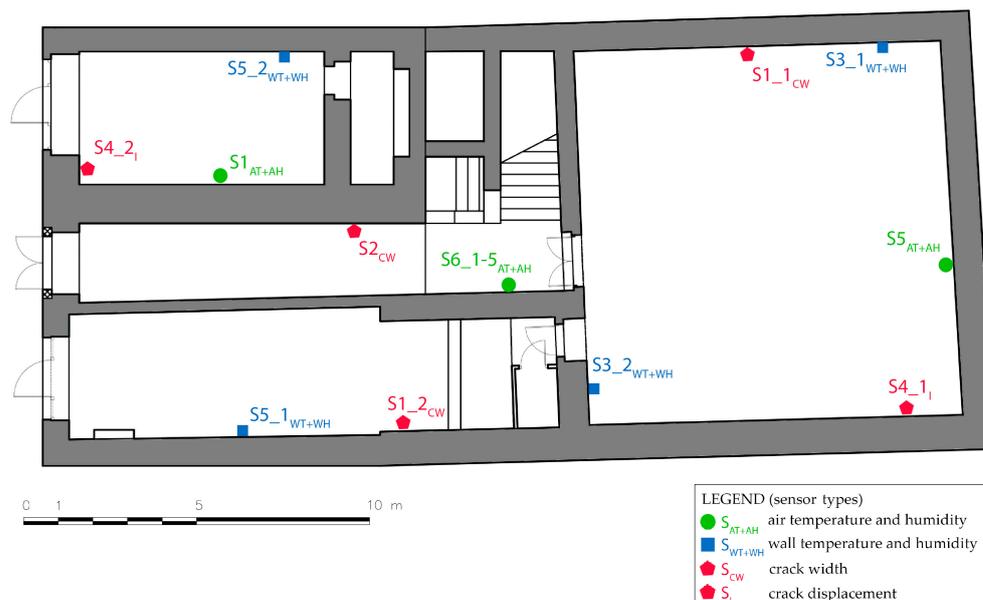
Figure 3. The layout and placement of the used sensors within the building.

To investigate the impact of environmental conditions on the structural integrity of historical masonry buildings, we deployed a network of LoRaWAN-based wireless sensors. These sensors were strategically placed at various heights and locations within the building to ensure comprehensive coverage and even distribution. The placement strategy was developed based on a thorough assessment of the building's structural layout and environmental exposure. Sensors were installed in the areas most susceptible to environmental stressors, such as exterior walls, corners, and regions with visible signs of deterioration. The layout and placement of the sensors are illustrated in Figure 3, and Figure 4 shows one of the installed sensors.

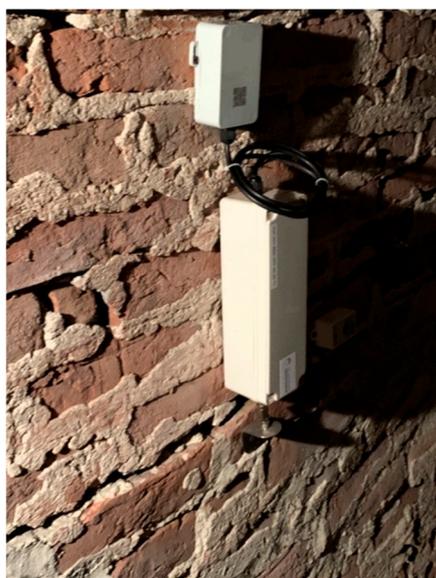
Figure 4. One of the LoRaWAN sensors used during the research.
