Article

Experimental Research on the Seismic Behavior of Reinforced Concrete Column–Beam Joints Connected by II-Shaped Steel Plates

Keywords: reinforced concrete joints; reinforcement and renovation; II-shaped steel plate; experimental study; seismic performance

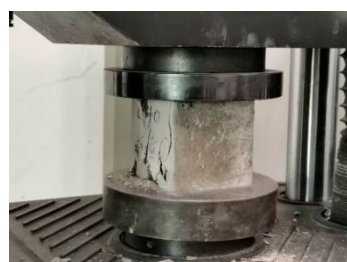
Figure 3. Failure phenomenon of cubic specimens.

The concrete used for the specimens in the fabrication process is poured in 3 batches; the 1st batch of concrete is poured for the column of all specimens (C50-1), the 2nd batch of concrete is poured for the beam of BZJ (C40-1), and the 3rd batch of concrete is poured for the beam of JGJ1–JGJ3 (C40-2). The designed concrete strength grades of the beam and column are C40 and C50, respectively. Three cubic specimens (150 mm × 150 mm × 150 mm) are reserved for each batch to determine the strength of the concrete. According to the specifications of Chinese standard GB/T 50081-2019 [29], the loading speed is established as 0.6 MPa/s. The test results and failure phenomenon are given in Table 2 and Figure 3, respectively.

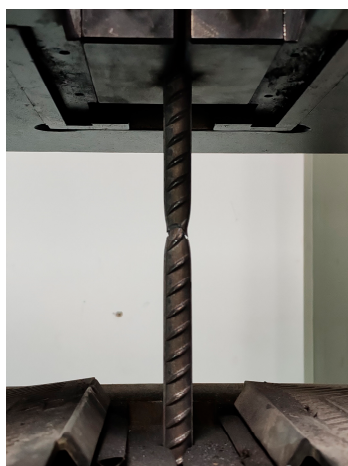
Figure 4. Failure phenomenon of steel reinforcement.

The designed strength grade of longitudinal reinforcement in the columns is HRB500 and the diameter is 20 mm. Meanwhile, the designed strength grade of the longitudinal reinforcement in the beam is HRB400 and the diameter is 16 mm. The strength grade of the stirrups used in the beam and columns is HPB300 and the diameter is 6 mm. According to the requirements of Chinese standard GB/T 228.1-2010 [30], a tensile strength test is carried out on the steel with a loading speed of 1.2 kN/s. The failure phenomenon and experimental data are given in Figure 4 and Table 3.

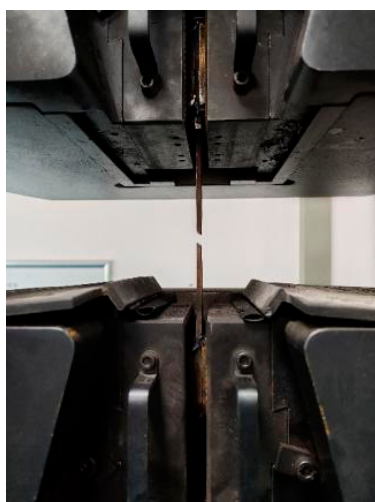
Figure 5. Failure phenomenon of steel plates.

The thickness of the steel plate wrapping the column is 10 mm, while the thickness values of the beams are 2 mm and 3 mm, respectively. The thickness of the steel plate used for manufacturing connectors are 3 mm and 5 mm, respectively. The failure phenomenon is given in Figure 5, and the mechanical properties of the steel plate are shown in Table 4.

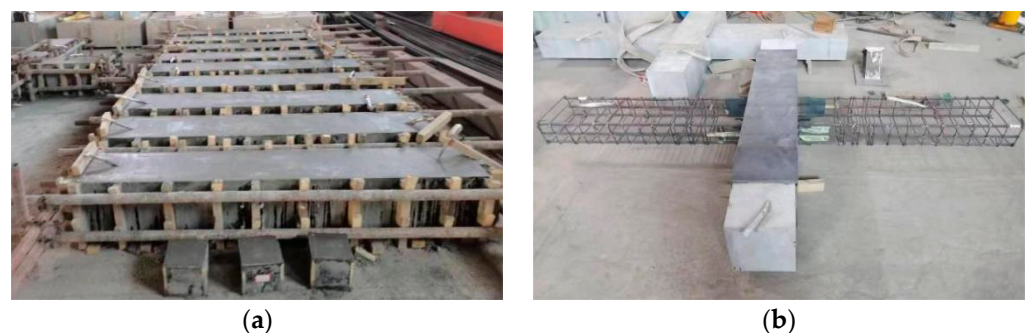
**Figure 7.** Manufacturing of the column: (a) pouring of the concrete; (b) connection of II-shaped steel and the longitudinal bar of the beam.

2. Pouring the column concrete and wrapping the steel plate. For specimens JGJ1–JGJ3, after pouring and curing the column concrete (Figure 7a), the epoxy resin adhesive is applied on the concrete surface and the steel is wrapped. Then, the II-shaped steel is welded onto the wrapped steel of the column. Finally, the longitudinal reinforcement of the beam is welded onto the flange of the connector, as shown in Figure 7b. The wrapped steel used for the column and the beam is formed by welding four steel plates together. All welding mentioned in this paper is carried out using arc welding, including the following two types of welding: welding between steel plates and steel bars. For the first type of welding, the calculated thickness of the weld seam is the thickness of the thinner plate at the welding site. For the second type of welding, the welding thickness cannot be less than 0.3 times the diameter of the steel bar, and the weld width cannot be less than 0.8 times the diameter of the steel bar [31].

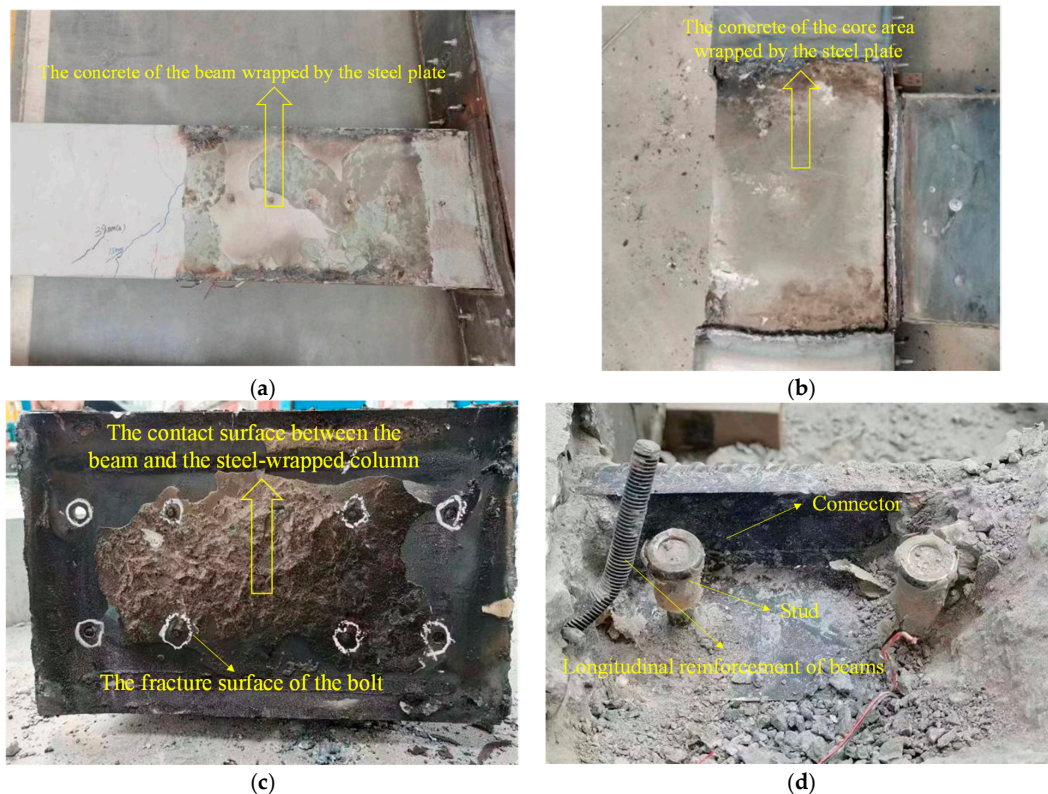
Figure 15. Failure phenomenon of the core area: (a) concrete of the beam near the core area; (b) concrete in the core area; (c) cross-section of bolts after the test; (d) experimental phenomenon of the connector.

To study the damage of the concrete and connector encased in steel plates in the core area, the outer steel near the core area was removed after the experiment.

The states of the concrete and the connector are shown in Figure 15. From the figure, it can be found that there is basically no damage to the beam concrete, indicating that the connection between the concrete, connector, and the wrapped steel of the column is still effective, and the damage is mainly caused by the cracking of the wrapped steel weld, which can be seen in Figure 15a. Due to the restraining effect of the encased steel, the concrete is basically intact in the core area, which is shown in Figure 15b. To ensure the integrity of the specimen, eight bolts are arranged on the encased concrete column. Before the joint failed, the bolts were all pulled off, and then, the cracking of the wrapped steel welds of the column occurred, which can be seen in Figure 15c. The connector sustained no significant deformation when the specimen was broken, and there are no crack at the weld joint connected to the wrapped steel, as shown in Figure 15d.

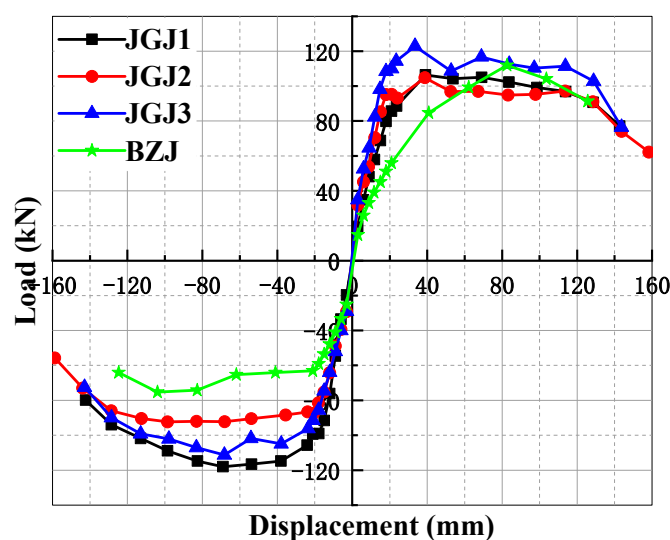
Figure 17. Skeleton curves of the specimens.

- (1) The skeleton curve of BZJ is basically straight in the preloading phase, and the specimen sustains no serious damage, although some cracks have appeared on the concrete of the beam. With gradual accumulation of damage, the growth trend of the curve begins to slow down and decline after reaching the maximum bearing capacity.

- (2) The skeleton curves of JGJ1–JGJ3 are also basically straight in the early stage of the experiment, and at this time, the cracks of the specimen mainly appear on the concrete of the beam without wrapped steel, indicating that the joint has sustained little damage. Then, the weld seam of the wrapped steel begins to crack, decreasing the rate at which the curve increases. After reaching the maximum bearing capacity, the curve begins to decrease, but the decreasing trend is slower than that of BZJ, which indicates that the wrapped steel treatment improves the stress properties of the specimen.

- (3) Comparing the skeleton curves of JGJ1 and JGJ3, it can be obtained that the stiffness of the two specimens is basically the same at the beginning of the test, and the maximum load is 106.4 kN and 122.9 kN, respectively. Then, the carrying capacity decreases slowly. Through the strain gauges arranged on the connectors, it can be found that the strain values of the connectors of all the new type of joints are very small, indicating that the influence of the connectors on the bearing capacity is very small, and the difference in bearing capacity is perhaps due to the poor quality of the weld seam.

- (4) Through the comparison of JGJ2 and JGJ3, it is concluded that the stiffness remains basically unchanged when no damage or less damage occurs. The skeleton curves increase linearly, and the carrying capacity decreases slowly when the specimen has reached the maximum bearing capacity. The bearing capacities of JGJ2 and JGJ3 are 104.8 kN and 122.9 kN, respectively, which indicates that the influence of the thickness of the wrapped steel on the bearing capacity is significant.

- (5) Comparing the characteristic load of the joint, it can be found that the characteristic load values of the specimens treated with a steel plate are higher than those of the standard joint. By comparing and analyzing the test results of the new types of specimens, it can be found that JGJ3 has the highest characteristic load values, indicating that the influence of the thickness of the wrapped steel is relatively significant. At the same time, it can also be demonstrated that the greater the amount of steel used, the more obvious the effect of improving the seismic performance becomes.

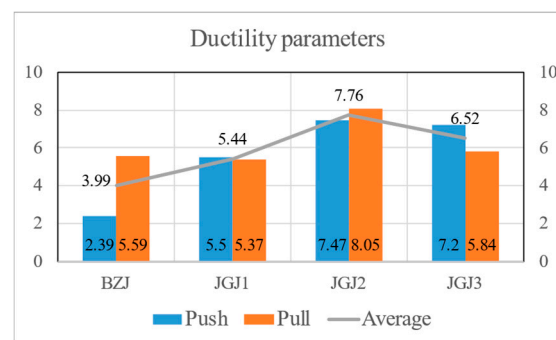
**Figure 18.** Ductility parameters of the specimens.

The ductility coefficients of this test are given in Figure 18. Considering the variability of the ductility in the push and pull directions, the average values are selected for analysis.

- (1) Compared with BZJ, the ductility coefficients of JGJ1–JGJ3 increase by 36.3%, 94.5%, and 63.4%, respectively, indicating that the wrapped steel plates restrain the formation and development of cracks in the internal reinforced concrete part, and the good mechanical properties of the steel plates themselves ensure that the specimens have a good elasticity-plasticity deformation capacity. After reaching the maximum bearing capacity, the specimen can still maintain a certain load capacity.

- (3) The coefficient of JGJ2 increases by 19.0% compared to that of JGJ3, which indicates that the wrapped steel thickness of the beam has an adverse effect on the ductility. This may be due to the fact that as the thickness of the steel plate increases, it shares more load at the beginning of the experiment and its bearing capacity decreases faster after the weld cracks. At the same time, the greater the wrapped steel thickness, the stronger the restraining effect on the RC part, resulting in the smaller plastic deformation of the concrete when it reaches the limit state, which leads to a reduction in ductility.
