Article

The Functioning of Erosion-channel Systems of the River Basins of the South of Eastern Siberia

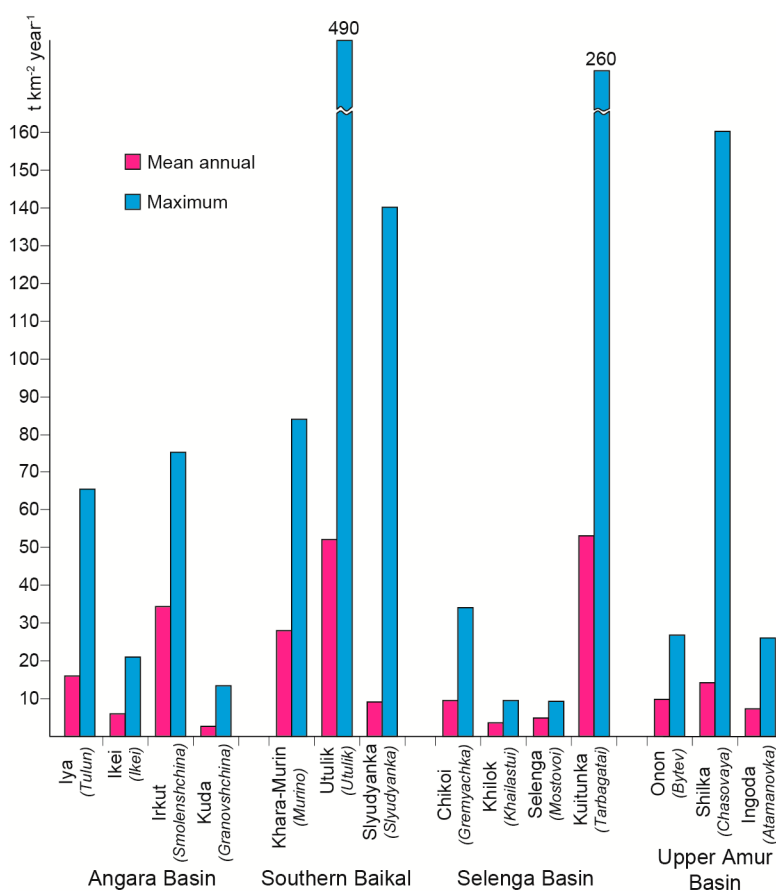
Figure 2. The ratio of the mean annual and maximum modulus of suspended sediment yield in the basins of Angara.

The highest values of sediment yield were recorded on the rivers flowing from the Khamar-Daban ridge into Southern Baikal (see Figure 2). The mean long-term modulus of suspended sediment yield in the whole region is 30 t/km² per year. Maximum values for the observation period reach 490 t/km² per year (the Utulik river), and they are associated with mudflows and characterize the basins of these rivers with extremely high activity. The Angara basins occupy the second place in the intensity of functioning of erosion-channel systems; their rivers (Figure 2) originate in the mountains of the East Sayan. The mean modules of suspended sediment yield are 15 t/km² per year; the mean maximum modules in the region are 44 t/km², and the maximum at the Iya and Irkut rivers reach 65.3 and 75.3 t/km² per year, respectively. These rivers are characterized by rare catastrophic floods with a high risk for human life and high rates of channel deformations.

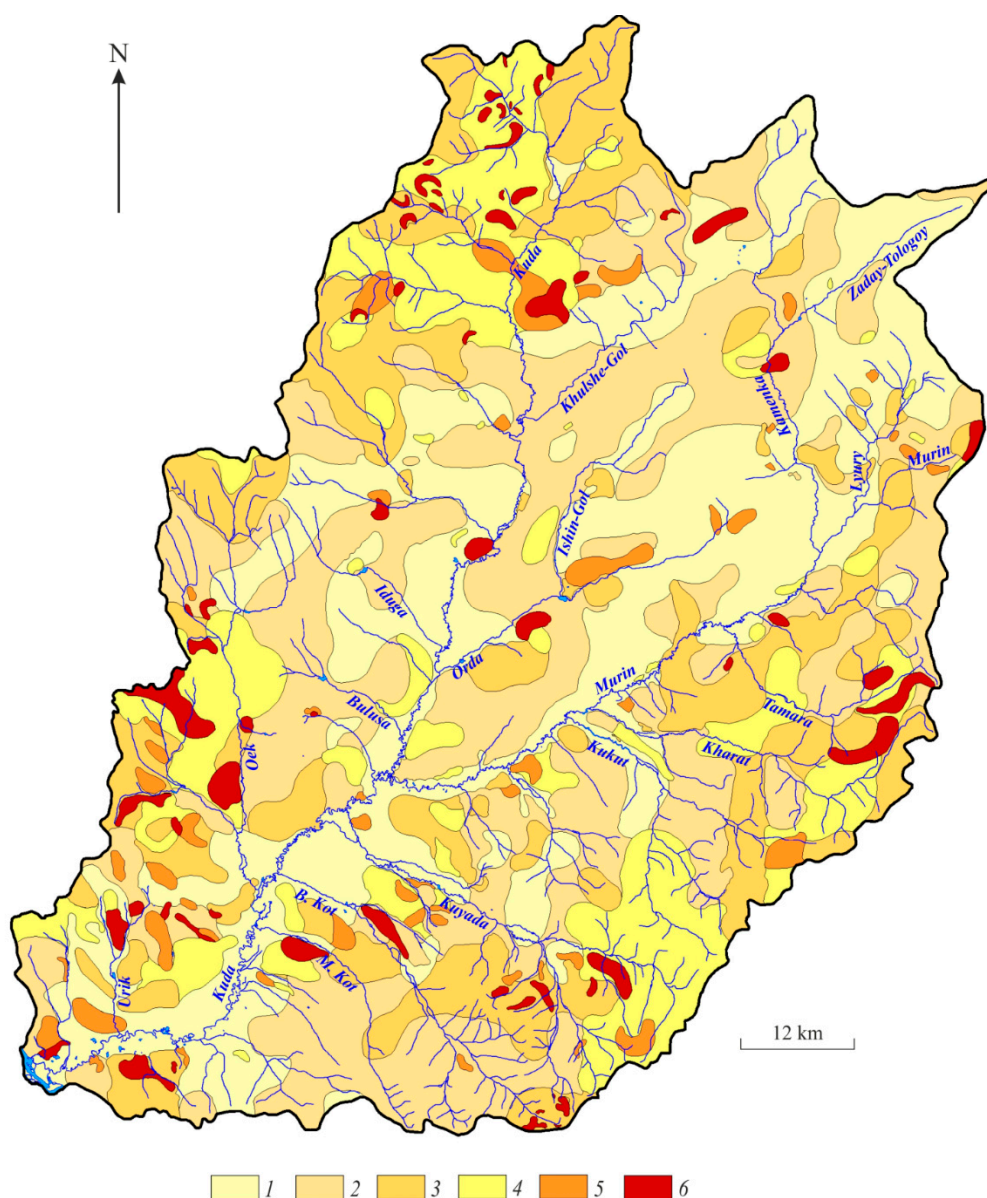
Figure 3. Erosion zoning of the Kuda basin. Zones: 1. no erosion hazard (loss less than 1 tha per year); 2. Weak erosion hazard (loss 1–2.5 tha); 3. Moderate erosion hazard (2.5–5 tha); 4. Medium erosion hazard (loss 5–10 tha); 5. Strong erosion hazard (10–20 tha); 6. Extreme erosion hazard (loss more than 20 tha per year).

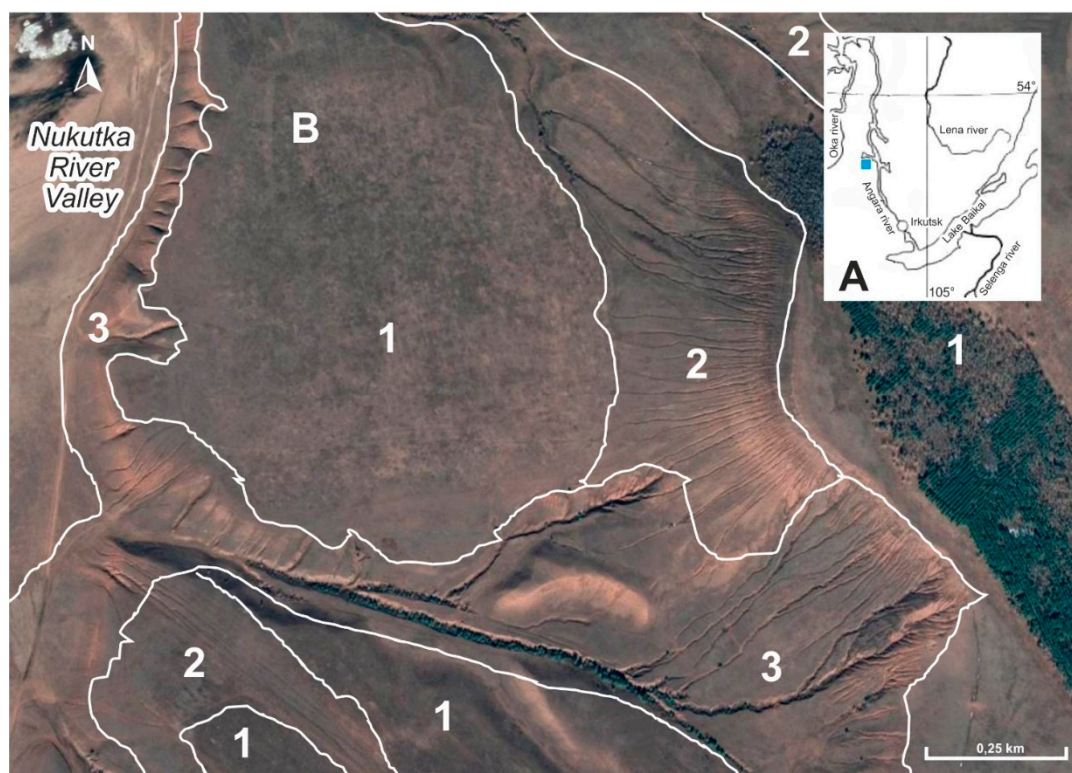
Figure 5. Erosion belts scheme for the area, adjusting to the Unga Bay of the Bratsk Reservoir. (A). Location of the area (marked with a blue square), (B). Erosion belts: 1. splash erosion, 2. Rill erosion, 3. Gully erosion. Based on the satellite image Google Earth. Coordinates: 53°43'37.16" N; 102°49'33.56" E. The image was taken on 4 October 2019.

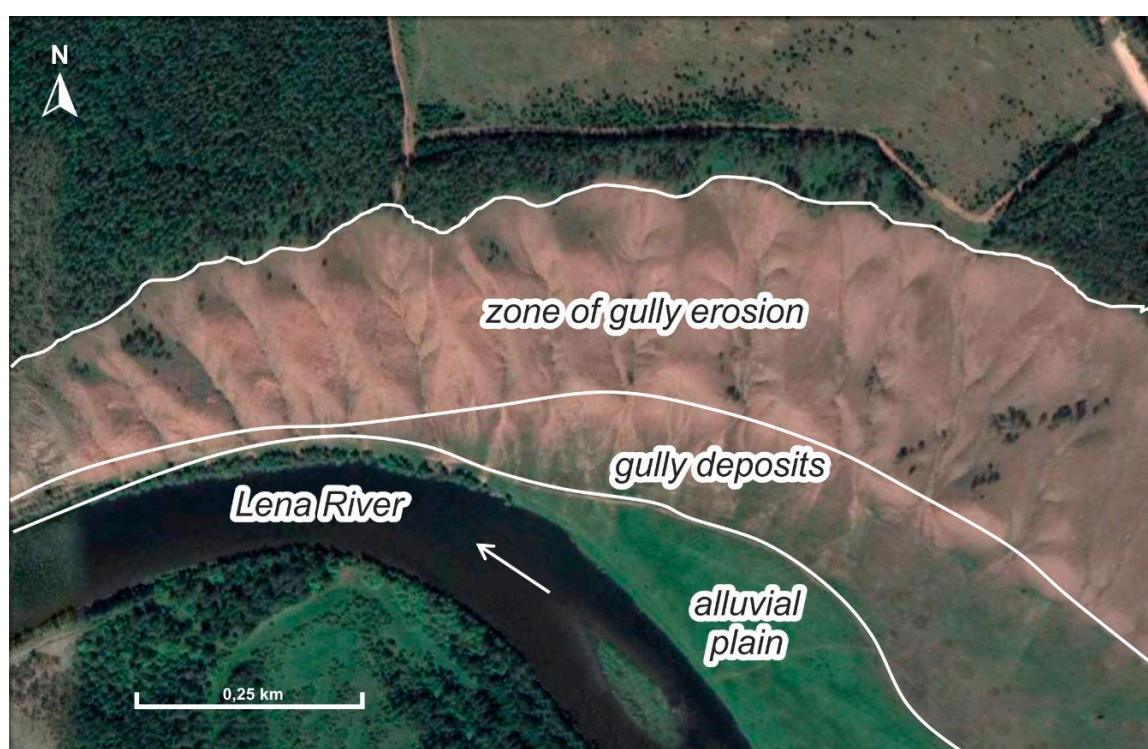
Figure 6. Gullies cutting the steep walls of the Lena river valley near the settlement of Kachug. Coordinates: 53°59′42.93″ N, 105°49′48.40″ E. The image was taken on 19 July 2018. Based on the satellite image Google Earth.

A large number of erosion forms per unit area (25–50 units/100 km²) deeply cut with a V-shaped transverse profile were recorded on the ledges of the high basement terraces of the Lena river near the settlement of Kachug (Figure 6).

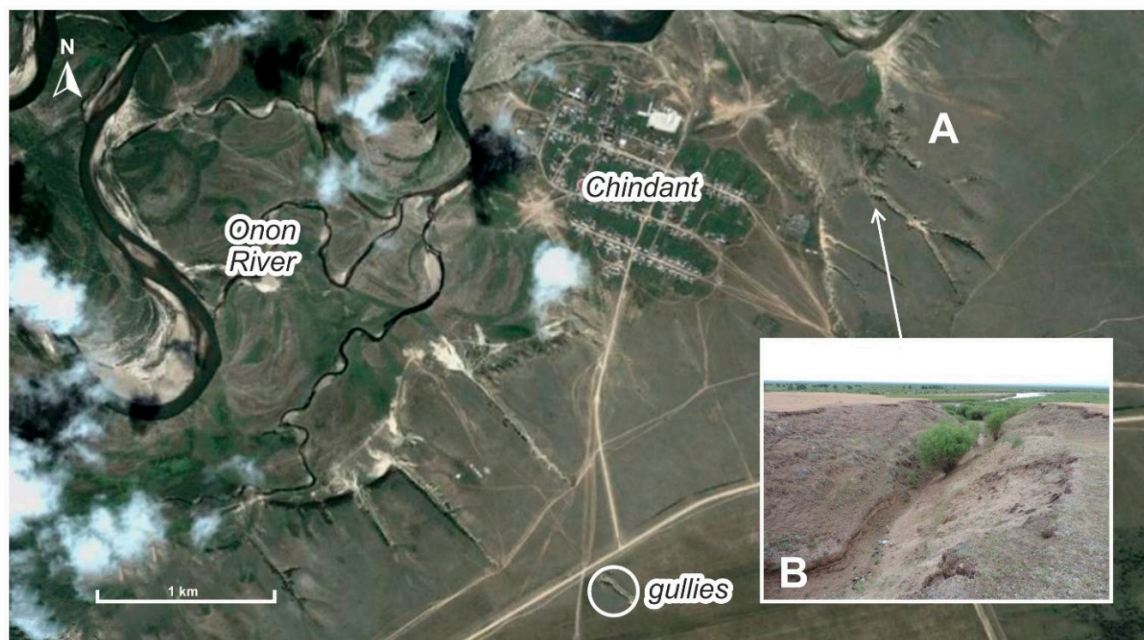
Figure 7. Stretch of the Onon river valley. Coordinates: 50033'44.29" N; 115023'32.13" E. The terrace cut with gullies (A). The image was taken on 8 March 2019. (B) Image of the gully (taken on 16 August 2015), its location is shown with the arrow.

maximum proportions (in loess-like sediments, their length is up to 4–6 km, depth: 20–30 m; in sandy sediments, their length is up to 1 km, depth does not exceed 3–5 m). On the terrace of the Onon river between the villages of Ikaral and Ust'-Borzya, there are 16 large linear gullies with a length of up to 800 m and a depth of 5 m (Figure 7).

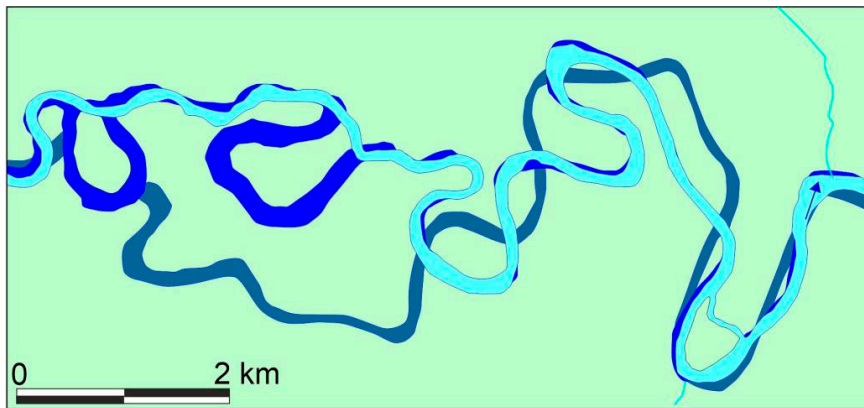
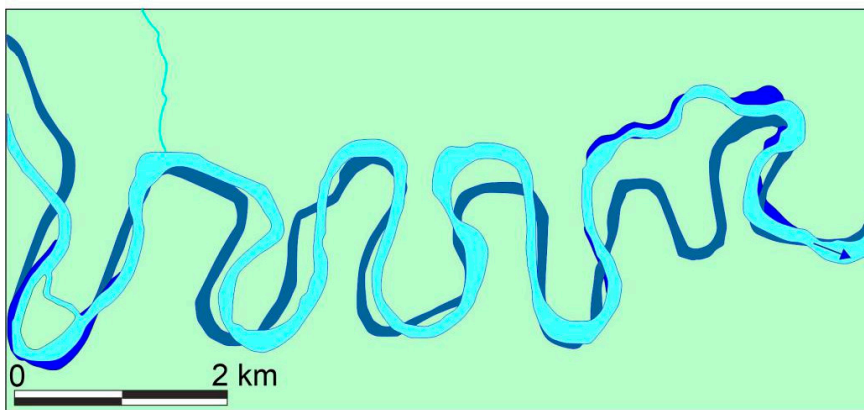
Reorganization of the Irkut channel on the stretch of Lake Barun-Nuga - the Kyren river

Relatively stable position of steep loop-shaped meanders of the Irkut on the stretch of the Kyren river - Lake Bandin-Khol

Figure 9. Comparison of the channel plans of the Irkut river in three time sections.

The analysis of different time images identified the most mobile stretches of the channel within the lowlands of the Irkut river [48]. In two cases, these are floodplain braiding with meanders in the left and right binnacles connected by minor by-channels. Another stretch is the meander in the right binnacle, complicated by the development and dying of by-channels. The main types of horizontal deformations of channels were revealed: In space, these are the forms of local (reformation of meanders) and local (changes within the elements of meanders, dying of transverse by-channels in floodplain braiding, an increase and decrease in the area of islands, caving and accretion of the banks) levels (Figure 10).

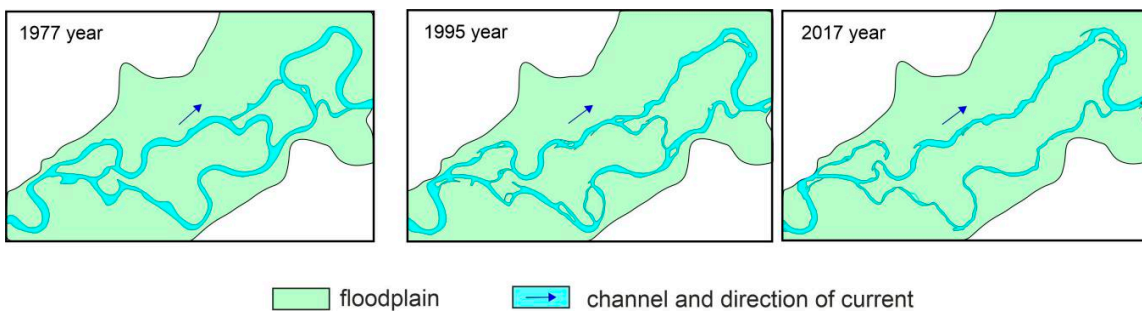
Figure 10. The most dynamic stretches of the Irkut channel (Maksimovshchina—the mouth).

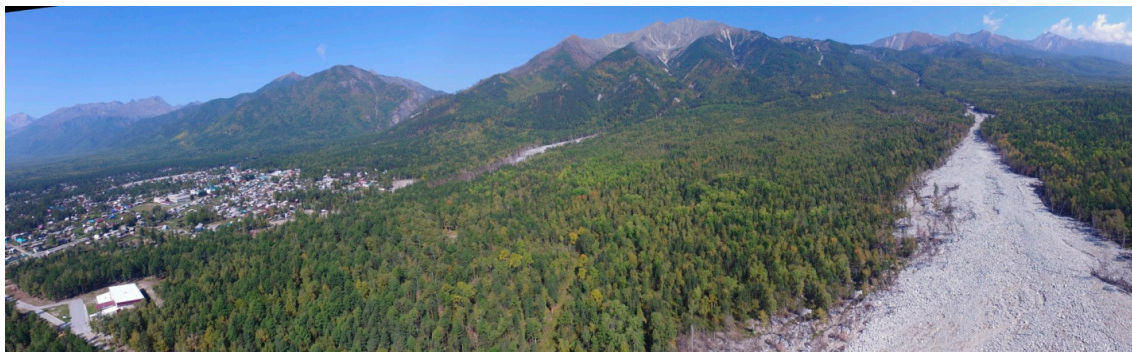
Figure 12. On the right is the frontal part of the mud-stone flow that passed along the river Vtoraya Shikhtolaika, on the left is the vil. Arshan (51°54′29.2887″ N, 102°26′50.9295″ E). The image was taken on 9 September 2016.

In the last 40 years, debris flow activity in the Baikal rift zone has practically not been manifested, with rare exceptions. However, it was established that long periods of a relative calm of debris flow activity were always replaced by periods of their dramatic intensification. Additionally, since 2014, debris flow activity has increased again. On the night of 27–28 June 2014 in the village of Arshan (Tunkinskii district, Republic of Buryatia), storm rainfalls gave rise to debris flows of two types: A water-rock flow on the Kyngarga river, heading from the southern slopes of the Tunkinskie Gol'tsy Range (East Sayan), and mudstone flows along the valleys originating in the cirques of the southern slope of the range [64] (Figure 12).

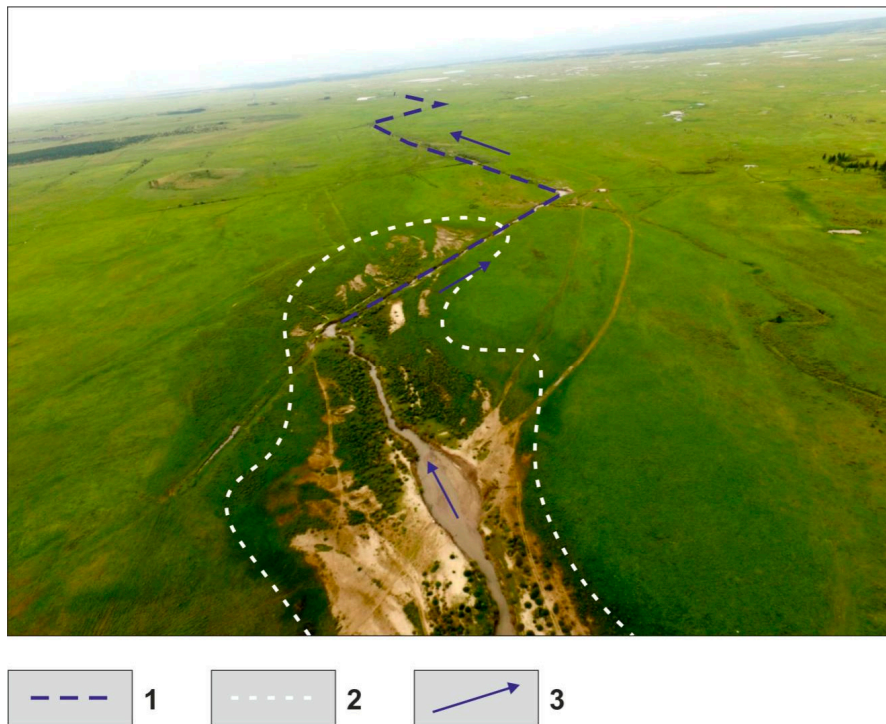
Figure 13. Zone of accumulation of suspended load on the Kyngarga river where it enters the dike. Images were taken on 12 July 2017, from the Phantom 3 quadcopter, at 234 m (51°51′5.36″ N, 102°27′20.09″ E). 1: boundary of accumulation of suspended load; 2: dike; 3: direction of the river.

The volume of sediments washed from the cirques of the southern slope of the Tunkinskie Gol'tsy Range amounted to about 2 million m³. An extensive cone was formed on the plain. In the lower parts of the Kyngarga river fan, with an abrupt decrease in the flow velocity of the water saturated with suspended load, they accumulated on top of the soil cover with a thickness of up to 2 m (Figure 13).

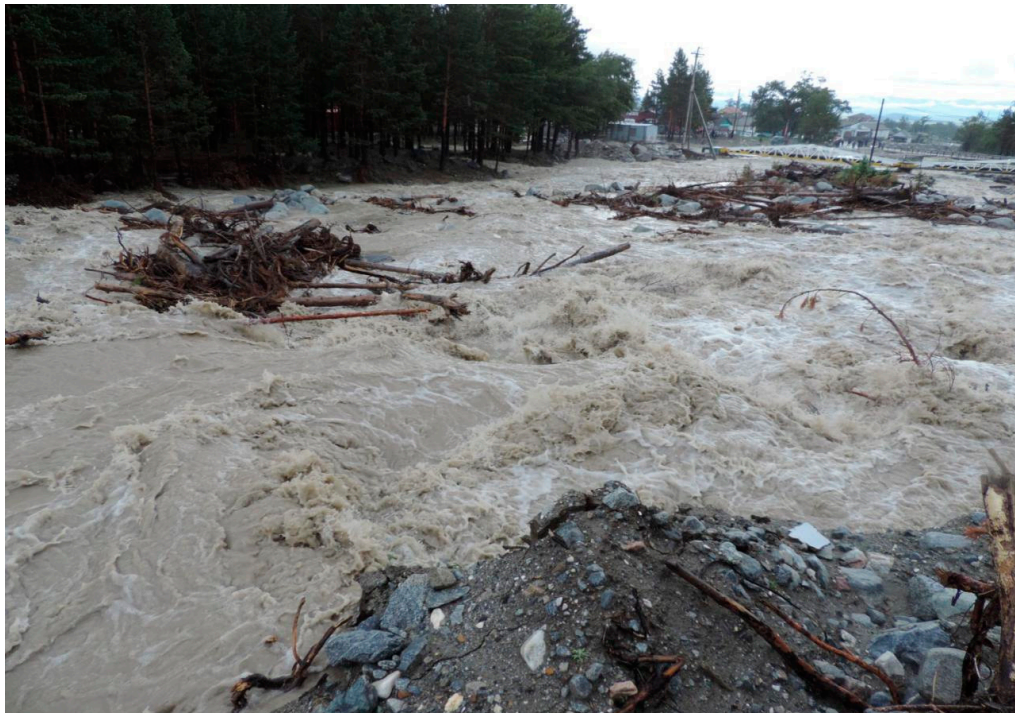
Figure 14. Water-rock flow on the Kyngarga river at the 14 July 2015 peak maximum, time: 11:45.

One year after the passage of disastrous debris flows in the area of the village of Arshan, on 14 July 2015, the Kyngarga river developed a water-rock flow again (Figure 14).

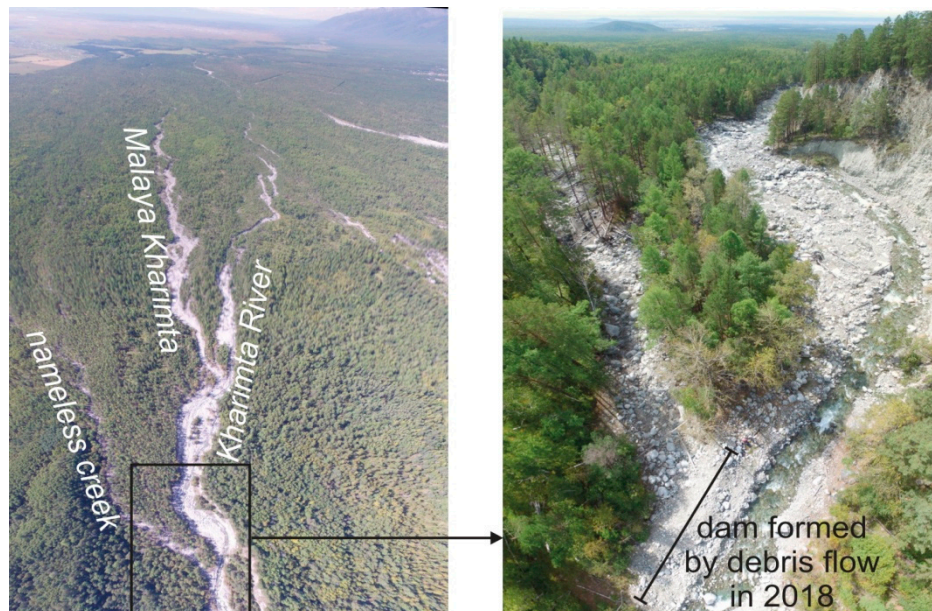
Figure 15. Reconstruction of the river network after the descent of debris flows on the Kharimta and Malaya Kharimta rivers in 2014 and 2018 (Tunkinskie Gol'tsy Range). $51^{\circ}54'1.44''$ N, $102^{\circ}30'55.04''$ E. The image was taken on 1 September 2018.

This event occurred after a long drought in the south of Eastern Siberia. During the passage of water-rock flow on 27–28 June 2014 on the Kharimta and Mal Kharimta rivers, there was a restructuring of the river network. After the mudstone mass clogged the channels of these rivers, the water flow shifted to the left of the Mal Kharimta and moved along the previously dry nameless channel, toward the village of Khurai-Khobok, where it inundated the depressions along the motor roadside. On its way, it crashed into boulder deposits (Figure 15).

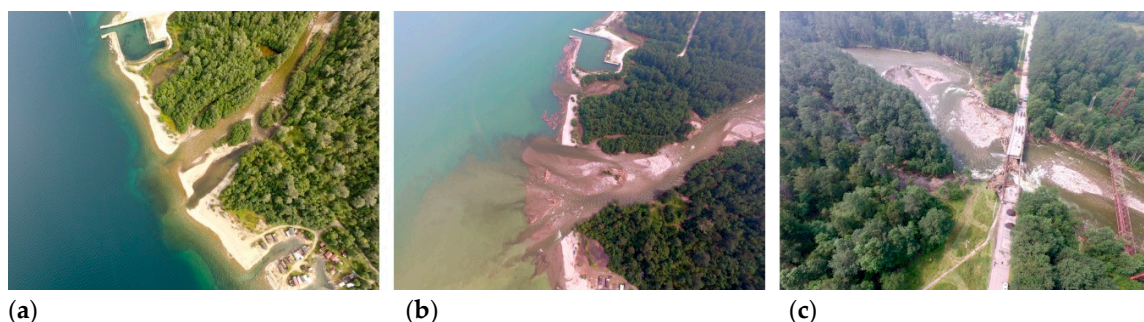
Figure 16. The consequences of the flood on the Solzan river. (a), (b) channel morphodynamics at the mouth of the river. Coordinates: $51^{\circ}31'46.6418''$ N, $104^{\circ}9'27.5627''$ E. Images was taken: (a) 23 August 2017, (b) 31 July 2019; (c) the destroyed technological bridge. Coordinates: $51^{\circ}31'24.6506''$ N, $104^{\circ}9'43.3299''$ E. Images was taken on 31 July 2019.

Above it, a bend of a divided meandering channel was formed. The stream here bends around a large stable side wall, located near the convex left bank and thus reflecting from the opposite bank, passes right at the location of the intermediate bridge support. A powerful water stream eroded the base under the intermediate support, thereby causing its deformation and, as a result,

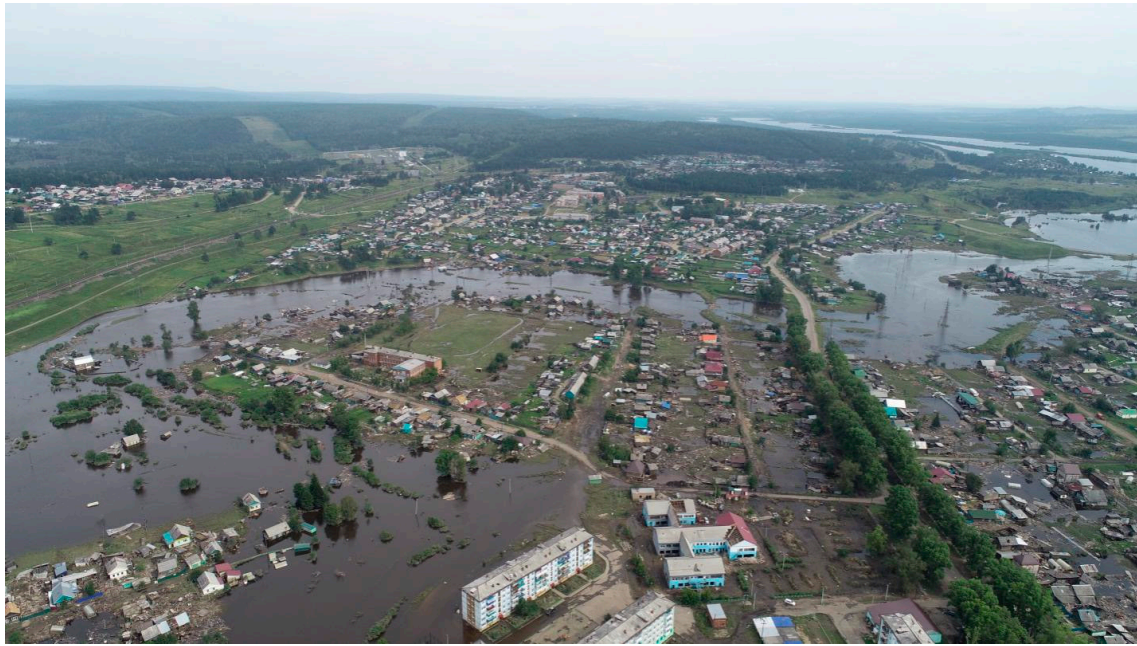
Figure 17. Panorama of a district, Tulun. Coordinates: 54°32′38.9315″ N, 100°37′41.9411″ E. The image was taken on 2 August 2019.

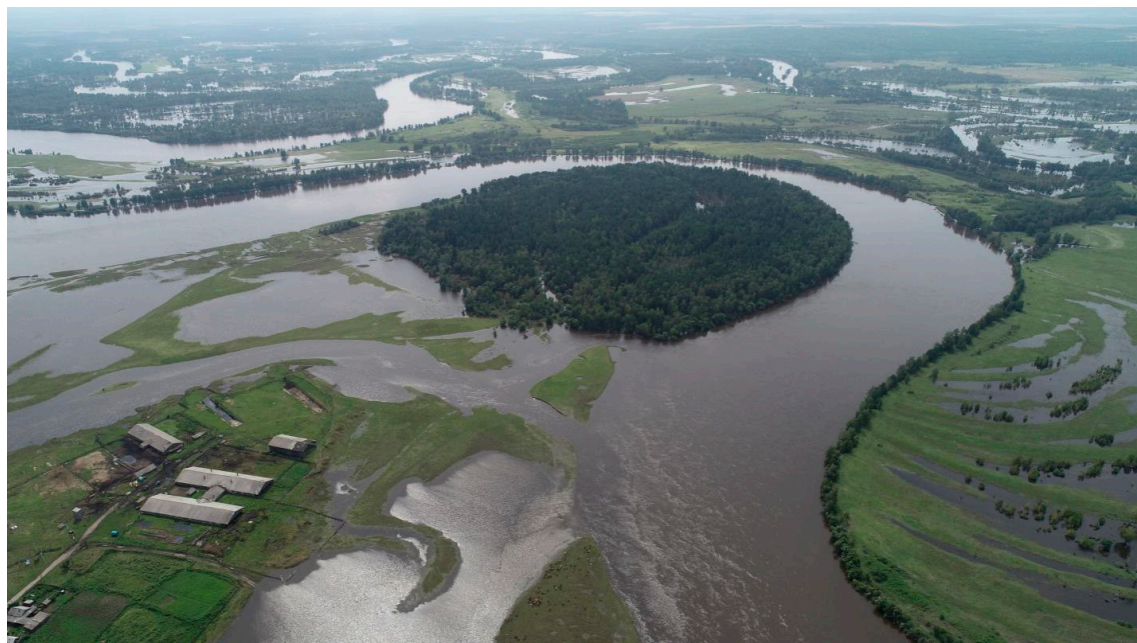
Figure 18. The flooded negative forms of the floodplain topography of the broad floodplain section of the Iya river (the village of Gadalei). Coordinates: 54°24′27.4291″ N, 100°43′23.1787″ E. The image was taken on 2 August 2019 (second wave of the flood in 2019).

Within the broad floodplain area of the Iya river, an additional factor for flood subsidence and distribution in this area was the variety of floodplain types, in particular, the valley-island type and the general predominance of plane accumulative areas (Figure 18). Water-flow retardation was also facilitated by the slight predominance of zones of erosion and wetland-accumulator areas within the floodplain.
