Case Report

A Geotechnical Investigation of 2017 Chattogram Landslides

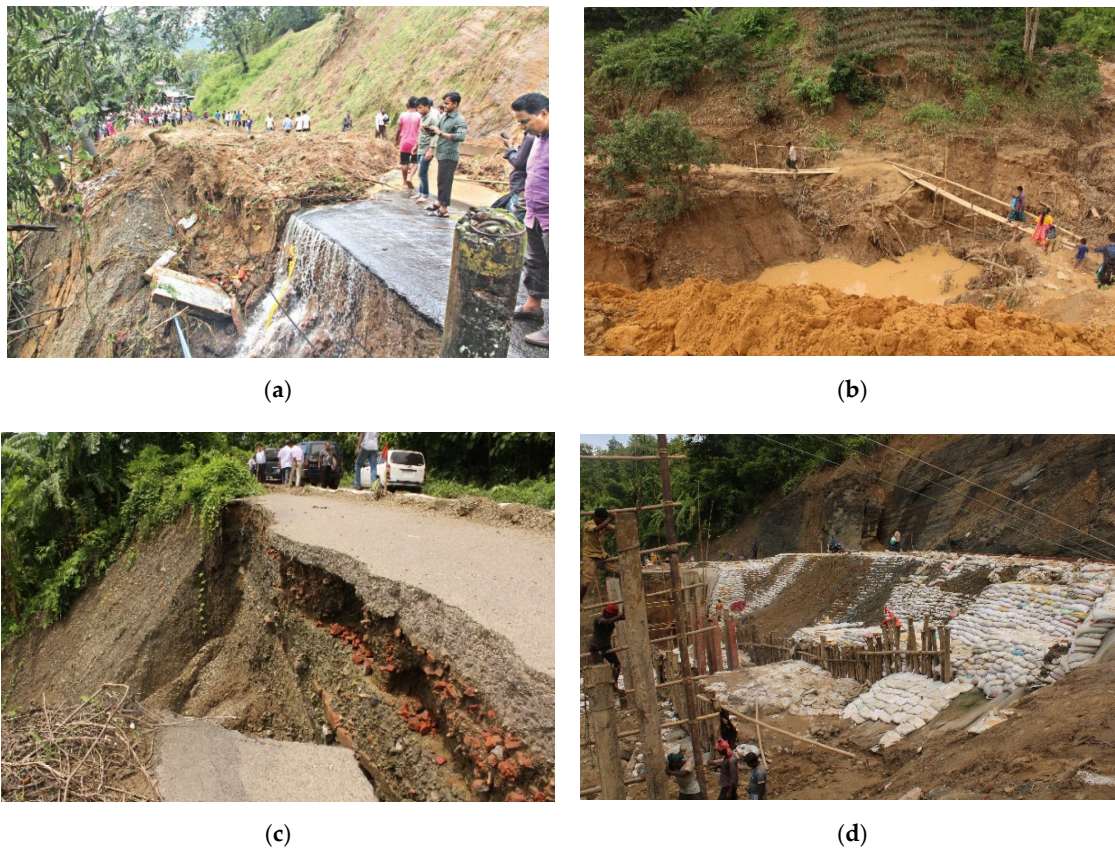
Figure 2. (a) Part of the Rangamati-Chattogram road collapsed at Manikchhari; (b) people had built a temporary solution after the local road had been damaged near the Rangamati-Khagrachari road; (c) heavily damaged Rangamati-Manikchhari road; (d) temporary measures were taken on the Rangamati District road to reestablish the road network.

On 12 June 2017, incessant rainfall (343 mm) triggered multiple landslides and floods in Rangamati, Bandarban, and Chattogram—three hilly regions of Bangladesh, seizing 152 lives. The weather also made it difficult for the rescuers to evacuate the affected communities by causing power outages and telecommunications disruptions across the region. Some incidents of landslides and immediate temporary reactive measures by the local people are shown in Figure 2b,d.

The landslide that occurred in Chattogram had few different types. Various classifications of the landslide have been developed by many researchers among which the Varnes classification is well known [24,25]. According to these studies, the present landslide disaster has been classified. From the field observation, it has been found that mostly ‘transitional slides’ and ‘flow’. Figure 2a shows a location where ‘flow’ landslides occurred, whereas transitional landslides are shown in Figure 2b,d.

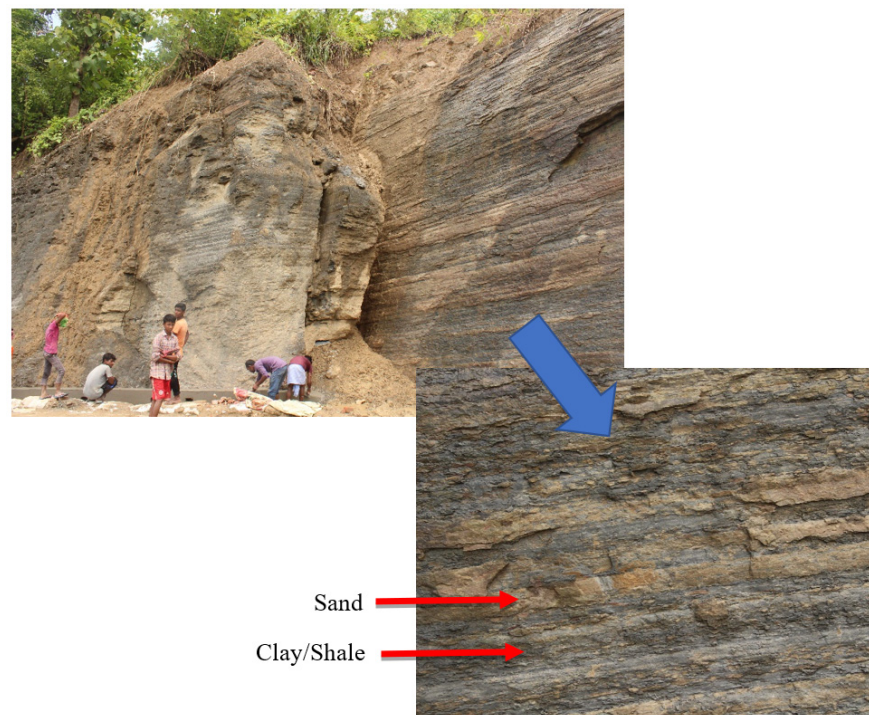
**Figure 5.** Different layers of soils at Shapchari Shal Bagan located in the landslide areas.

Different types of soil such as silty clay, lean clay, clayey sand, etc., were observed during the site investigation. Figure 5 shows two soil layers: sand and clay/shale at Shapchari Shal Bagan near Rangamati-Manikchari road which is located in the landslide areas. The bedding of the soil formation is almost horizontal. It is also observed that an alternate layer of sand and very thin films of clay/shale are present. These mountains and valleys were primarily reddish to reddish-brown sandy silt or clayey sand with little cohesion or friction at the remolded state. It is the view of the authors that the soils of many parts of the mountain region have metamorphosed over geological time and cemented to silty sandstone or shale-like material. According to a study, discontinuities or changes in constituents produce structural fragility below the uniform material, which can turn into preferential failure surfaces, especially when planar [19]. This type of discontinuity was observed in most of the locations where the landslide occurred in CHT in 2017. Discontinuities allow pathways for rainwater seepage through the layers. As a result, the bond between the sand and clay/shale layers becomes reduced over time. Additionally, the drainage facilities of the hill slopes were not designed in most cases. As a result, rainwater cannot seep out of the soil; instead, water percolates through the soil and increases pore pressure with additional hydrostatic force.
