Article

Black Layers of Decay and Color Patterns on Heritage Limestone as Markers of Environmental Change

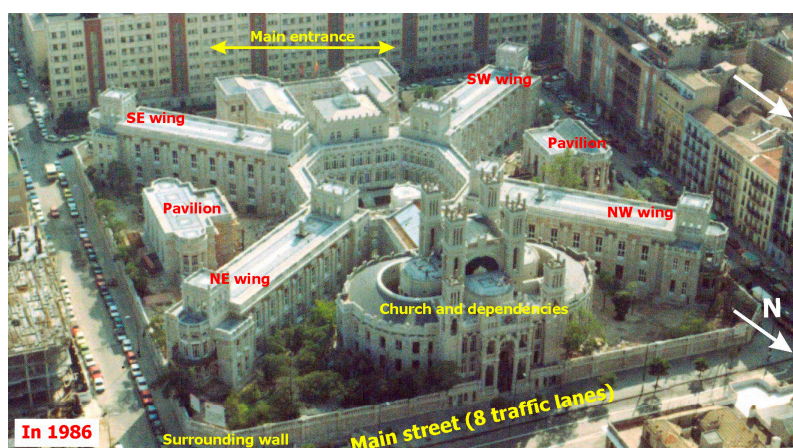
Figure 1. Aerial view of the former hospital ca. 1986, showing the overall layout: church, main entrance, diagonal wings and free-standing pavilions. Enclosed inside a surrounding wall, the compound is bounded by four streets, with very heavy traffic on the one bordering the church portal (courtesy of the Specialized Documents Centre, Madrid Regional Department of Environmental Affairs, Housing and Land Management).

In the plan view, the building comprises four wings forming an “X” attached to a main entrance building and a church. The building, along with two detached pavilions, is surrounded by a wall that contains ground gardens and occupies a full city block bounded by four streets (Figure 1).

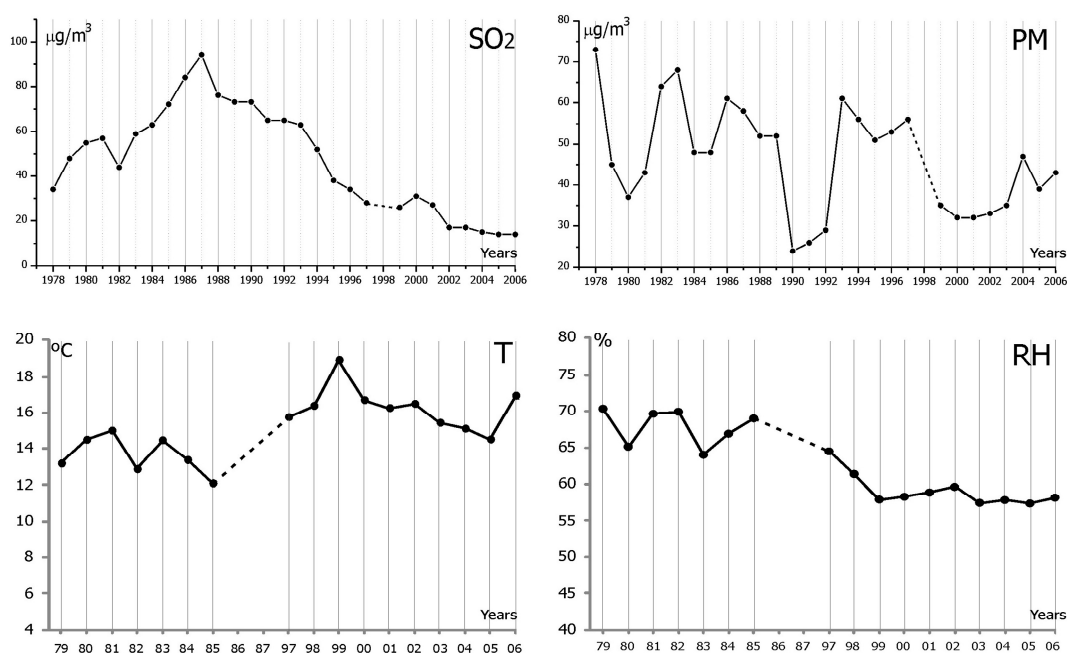
Figure 3. Yearly SO_2 and particulate matter (PM) concentration, temperature (T) and relative humidity (%) in 1978/79–2006, measured at the air pollution and weather stations nearest the former hospital (dashed lines = no data available) (sources: Madrid Municipal Air Protection Service's environmental information system and Spanish Meteorological Agency's Weather Information Unit).

SO_2 concentrations climbed steadily in the first 10 years (from $34\text{ }\mu\text{g}/\text{m}^3$ in 1978 to $94\text{ }\mu\text{g}/\text{m}^3$ in 1987), declining gradually until 2002 ($18\text{ }\mu\text{g}/\text{m}^3$) and flattening thereafter ($14\text{ }\mu\text{g}/\text{m}^3$ in 2006). The progressive decrease recorded since 1987 was essentially the result of the limits laid down in European directives beginning in 1986, which have secured a substantial improvement in air quality. In Madrid these improvements translated primarily into the progressive use of low-sulfur gasoline

and the replacement of coal with gas oil boilers for domestic heating and hot water in the 1980s and nineties [33,34,40]. Although unevenly and with values that promptly are close to $80 \mu\text{g}/\text{m}^3$, PM concentration has declined overall (from $73 \mu\text{g}/\text{m}^3$ in 1978 to $42 \mu\text{g}/\text{m}^3$ in 2006). In the period 1999–2003, the mean values remain near to $35 \mu\text{g}/\text{m}^3$ and from 2003 PM concentration has increased, largely because the new arrangement of traffic in the area mentioned above. The construction of the underpass has changed the impact of airborne pollution on façades, but particle emissions have been risen during its construction. Irregular behavior of PM concentration is attributable primarily to the area's constant busy traffic, being vehicle exhaust quite difficult to control, in addition to the aforementioned factors that contribute to the city's particle concentrations. The variations in Madrid's climate, chiefly rising temperatures (from 13°C in 1978 to nearly 17°C in 2006) and declining relative humidity (from 70% in 1978 to nearly 58% in 2006), are largely due to global climate change and the observed decrease in the concentration of PM may be related with declining humidity [11,41,42]. As the prevailing wind in the surroundings blows from S-SW, the façades exposed to that direction are the ones most affected by airborne pollutants, although the maximum gust speed has tended downward.

Judging from the rise in SO₂ in the city beginning in the 1960s and in particular from the spike in concentration around the former hospital between 1978 and 1984 (Figure 3), the build-up of sulfation crusts on the limestone surface between the 1960s and 1980s must have been particularly significant. Such heavy blackish soiling visible on the façades in the 1970s, considered in conjunction with the date of the onset of intense environmental pollution from 1960s, suggest that the surfaces must have darkened over very few years. The color of the soiling was related essentially to the coal used in domestic heating systems, which emitted thick and very black carbonaceous particles. In fact, the hospital's own coal boilers were in operation until 1970.
