Basic Chemical Tests of Concrete during the Assessment of Structure Suitability—Discussion on Selected Industrial Structures

Jacek Hulimka and Marta Kałuza *

Abstract: Making a decision to perform an overhaul of a damaged reinforced concrete structure should be preceded by an analysis of the real durability of that structure after the repair in connection with the anticipated service life. One of the basic problems is the avoidance of further corrosion of concrete and steel after the repair, which depends on the degree of concrete contamination with harmful chemical factors. It is particularly important to determine the content of chloride and sulfate ions which cause corrosion. Concrete pH is equally significant because it conditions effective passivation of the reinforcement. The paper presents the basic issues related to the main chemical threats, including the main sources of their origin as well as their limit values. It emphasizes the importance of conducting the chemical tests of concrete, which should be treated as one of the methods of determining structure suitability for an overhaul, especially in the context of subsequent durability. This seems obvious to an experienc

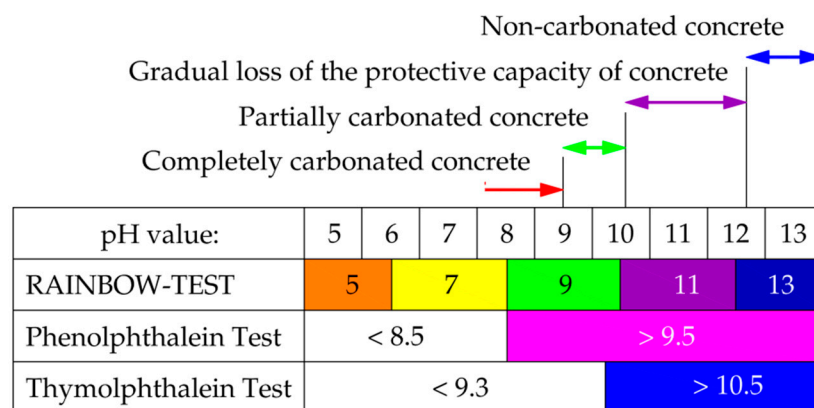
Figure 1 shows the colors obtained for the appropriate pH value at the above indicator tests. The color, and thus the pH value, also identifies the level of carbonation.

Figure 1. The colors used to determine the pH value of concrete and its carbonation level.

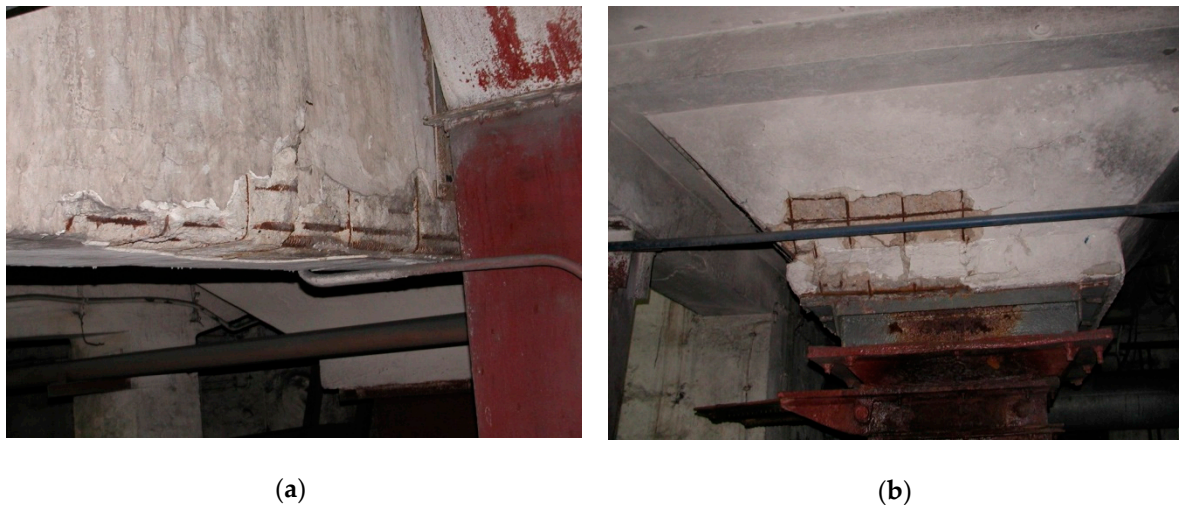
The best condition was demonstrated by all the elements from group B both in underground and above-ground parts. The corrosive damage to rebars was present only in the areas of original defects of the concrete cover which decreased its thickness (Figure 2a,b). The corrosion was visible mostly on the surface, with only small, isolated pitting spots. As shown in Table 3, the pH of all elements of those structures was at least 10.6 which indicates only a partial loss of the protective ability of concrete. Also, the content of chlorine and sulfate ions exceeded the permissible values only in certain areas. Interestingly, those foundations were made of concrete of the lowest class (C12/15), so it could be expected that their corrosion would be the highest. One of the reasons for the high ion concentration is the low density of concrete, which can be identified with its low class. However, the pH value was relatively high and pointed to only a small carbonation of the concrete. It is worth noting that the power boilers supported by group B structures were supplied with imported coal with a very low content of sulfur compounds and hardly any contact with mine water.

Figure 2. Examples of corrosive damage: (a,b) corrosion of steel rebars in defected concrete cover.

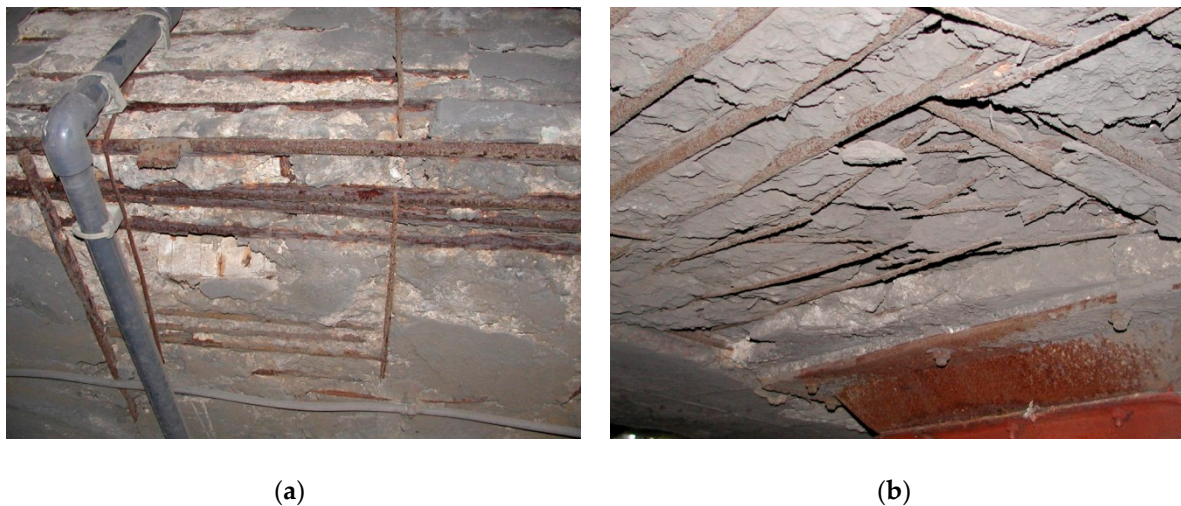
The test results for elements from structures A, C1, and C2 were much worse. The pH value was as low as 10 or even less (except the foundation in structures C). The chloride ion content was enormous—it exceeded the permissible values several times. The worst situation was in all elements from structure A. The same applies to sulfate ion content. The permissible values in the parts of structures C1 and C2 above the ground were drastically exceeded. The underground parts of structures C1 and C2 were an exception because their pH exceeded 11 and the content of chloride and sulfate ions fell within the permissible range. The above was caused by tight flooring which did not let harmful agents come into contact with the concrete surface. The technical condition of the facilities determined on the basis of a visual assessment of the structures (Table 4) perfectly corresponds to the abovementioned test results—all the elements above the ground showed extensive corrosive damage to concrete and rebars; corrosion reduced the original cross-section of some rebars by as much as 50% or more (Figure 3a,b and Figure 4a,b).

Figure 3. Examples of steel damage in one of the structure C: (a) corrosion of steel rebars with concrete damage, (b) locally interrupted reinforcement.

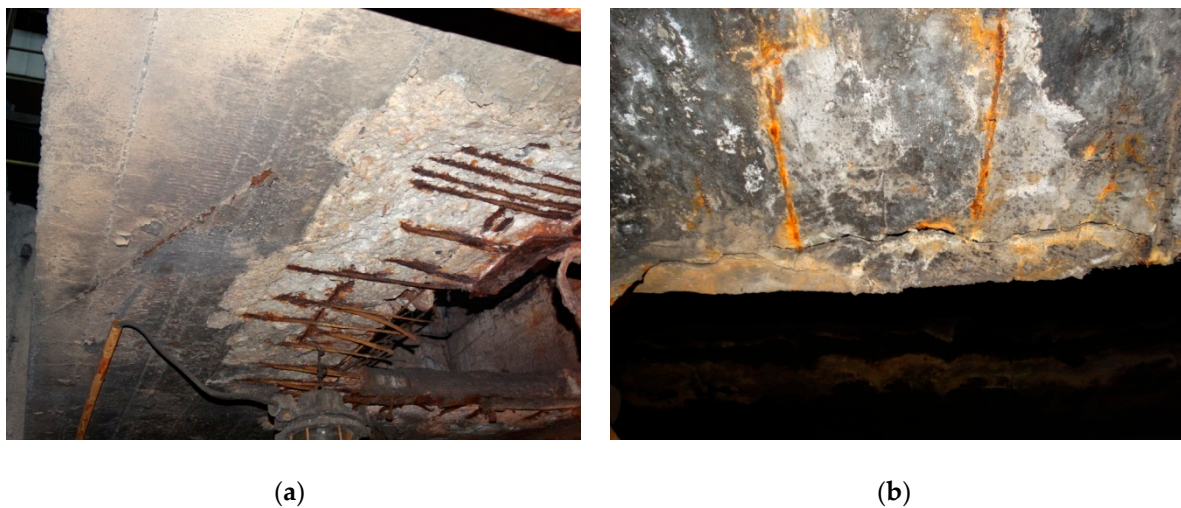
Figure 4. Examples of corrosive damage in A facility: (a) concrete and steel corrosion, (b) traces of completely corroded stirrups.

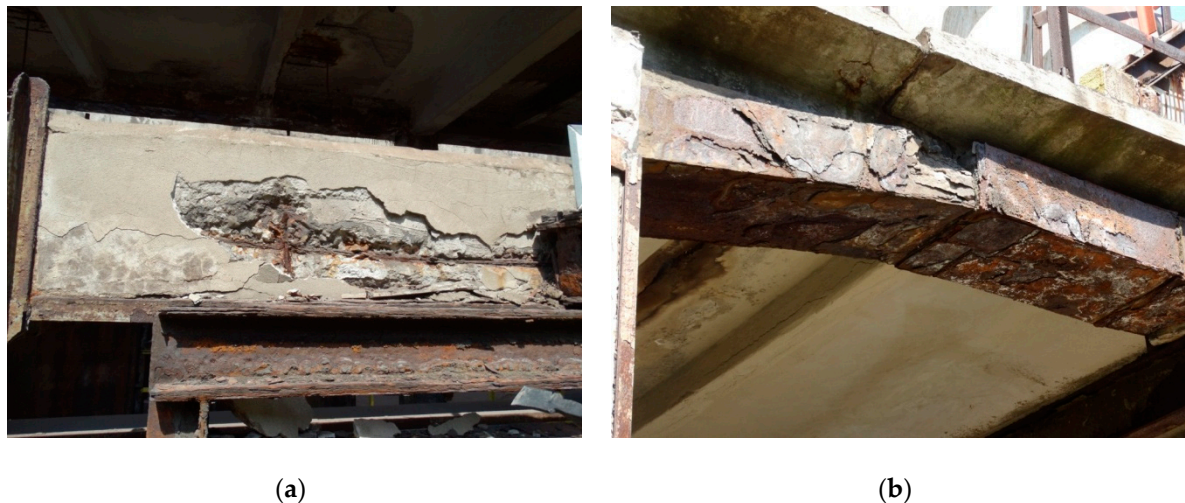
The support structure of pipelines (D) showed relatively diversified results, but in all cases, the condition of structural elements was bad or very bad. In terms of pH value, a high threat of corrosion, especially concerning the columns was observed. The sulfate ion content was exceeded only in the columns, but the chloride ion content was drastically exceeded in all structural elements. The above was perfectly visible as enormous damage to concrete, reinforcing steel and additional steel elements (Figure 5a,b).

Figure 5. Damage of varying intensity: (a) damage of concrete and steel corrosion of rebars and profiles, (b) strong corrosion of steel elements used as the strengthening of concrete beams.

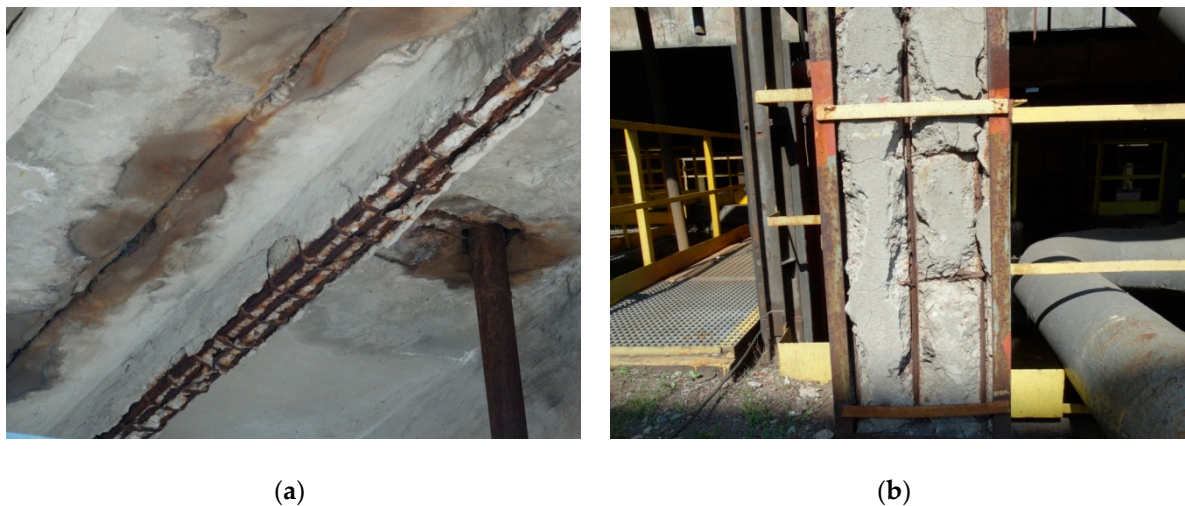
In many cases, the concrete burst by swelling corrosion products (Figure 6a). The structure columns were embedded in concrete and confined in an external skeleton made of steel sections approximately 20 years ago. That concrete was strongly damaged (Figure 6b), which proves that the repairs had been conducted in conditions that had not ensured their effectiveness. Similarly, the repairing layers on the beams, made using one of the PCC systems, were destroyed. It must be mentioned that the sodium chloride source was processed water in the open channels under the support structure.

Figure 6. The very bad condition of structural elements: (a) swelling steel rebars caused damage of the concrete cover, (b) damaged steel strengthening and concrete of columns.
