Article

Full-Scale Train Derailment Testing and Analysis of Post-Derailment Behavior of Casting Bogie

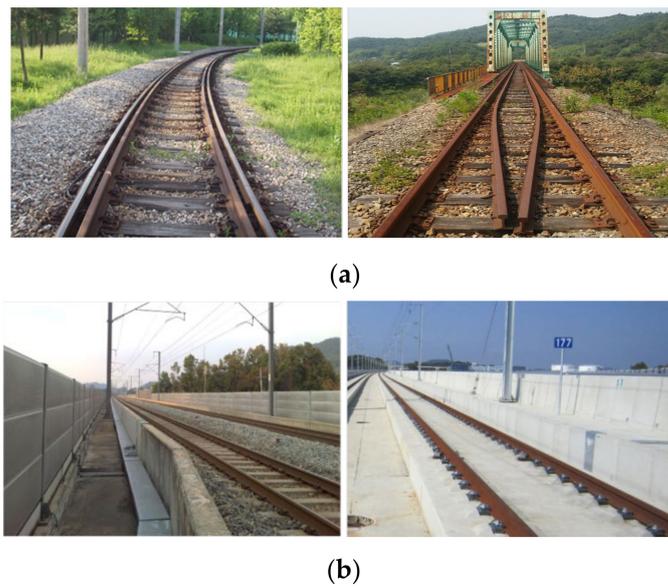
Figure 1. Examples of derailment protection facilities: (a) guard rail and (b) containment wall.

To reduce the damage from derailment accidents, protection facilities can be installed in the railway track. In Korea, guard rails to prevent derailment are used at sharp curves, bridges, and switches, as shown in Figure 1a. Containment walls are also installed on bridges for high-speed railways (where the minimum speed of the line is 200 km/h), as shown in Figure 1b [5–7].

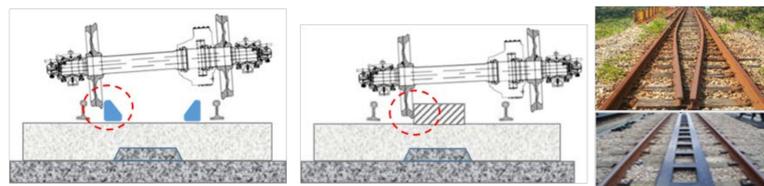
● **DCP Type I**

➤ Installed **Between Running Rails** (Collision at **Wheel Level**)

● **DCP Type II**

➤ Installed **Outside of Running Rails** (Collision at **Wheel Level**)

● **DCP Type III**

➤ Installed **Outside of Running Rails** (Collision at **Bogie Level**)

Figure 2. Concept of derailment containment provisions (DCPs).

In European countries, three different types of derailment containment provisions (DCPs) are used (DCP types I, II, and III), as shown in Figure 2 [8]. The guard rail is one example of a DCP type I facility, where the DCP is installed inside the track gauge. The wheel of the derailed train comes into direct contact with the facility. DCP type II is similar to DCP type I, but is installed outside of the track gauge. DCP type III facilities are installed outside of the track, similar to DCP type II. However, they are different from DCP type II since the axis of the wheel or bogie of the derailed train impacts this type of DCP.

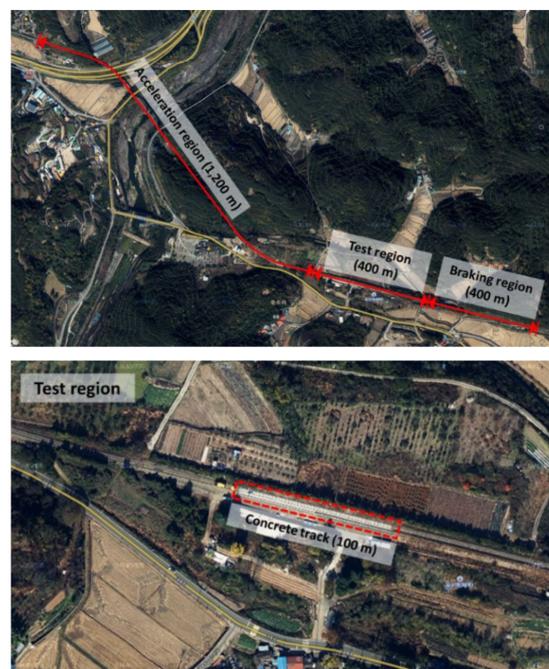
Figure 3. Overview of the test site.

Full-scale train derailment testing requires a large test site. The test site consisted of acceleration, test, and braking regions, as shown in Figure 3. To increase the speed of the train at the point of derailment, a sufficient acceleration region is needed. Also, adequate test and braking regions should be provided to investigate the post-derailment behavior and to ensure safety, respectively. The lengths of the acceleration, test, and braking regions were 1200 m, 400 m, and 400 m, respectively. In the 400 m test region, a region of 100 m was used to construct a concrete track. The total length of the test line was about 2000 m. Once the target speed of the bogie is reached, a test bogie is released at the end of the acceleration region. The test bogie is derailed at the start of the test region and the post-derailment behavior is observed in the test region. A braking region is provided at the end of the test region. This is a margin region to provide safety after the unexpected behavior of derailed bogie or train. The derailment test site was constructed using a closed railway line to save on costs and replicate actual railway operating conditions.

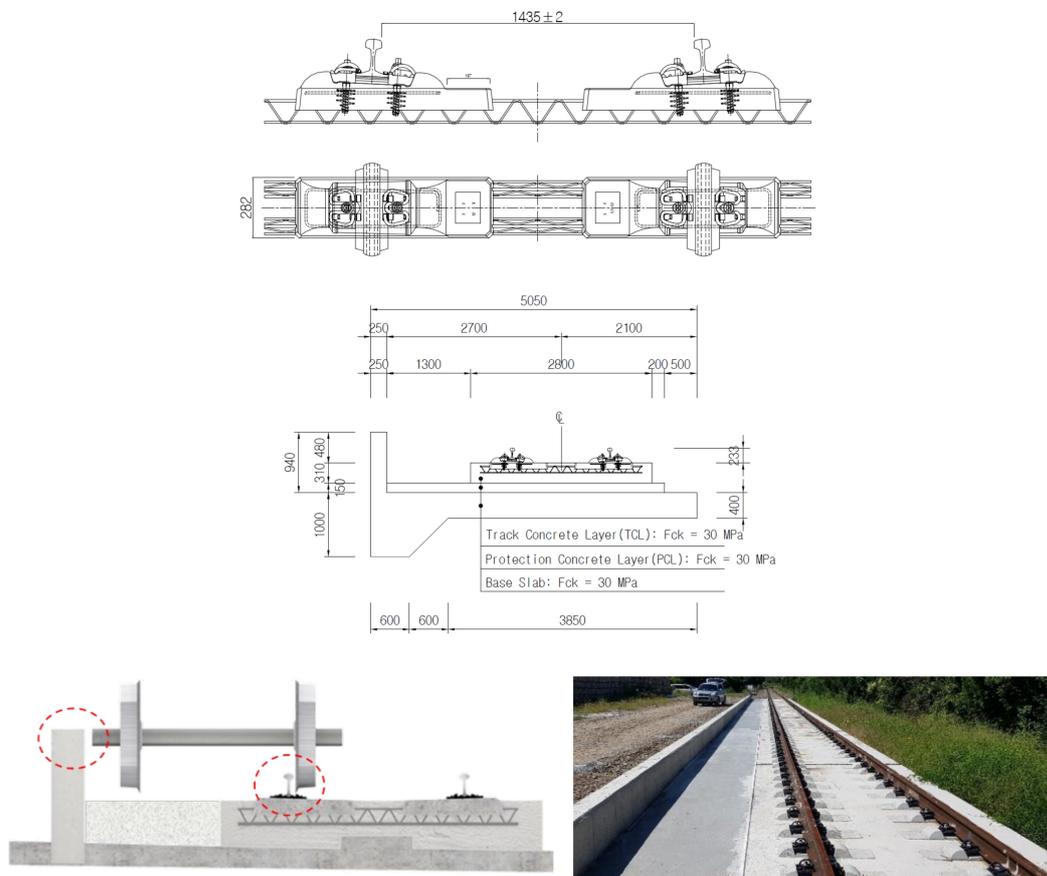
Figure 4. The concrete track used in the test region.

In this study, the focus was on the post-derailment behavior on a concrete track. A Rheda 2000 concrete track, shown in Figure 4, was constructed in the test region where the post-derailment behavior was observed. The Rheda 2000 concrete (ballastless) track was used for the first time in Germany in 2000 as a pilot project on the new rail line between Erfurt and Halle-Leipzig. It was also installed on the high-speed railway in Korea in 2004. Apart for this 100-m concrete track, ballast tracks

were used. It should be noted that the derailment containment wall was installed on the left side of the track, as shown in Figure 4. The distance between the wall and the center of the track was 2700 m, considering the geometric condition of the axle of the test vehicle after the derailment.

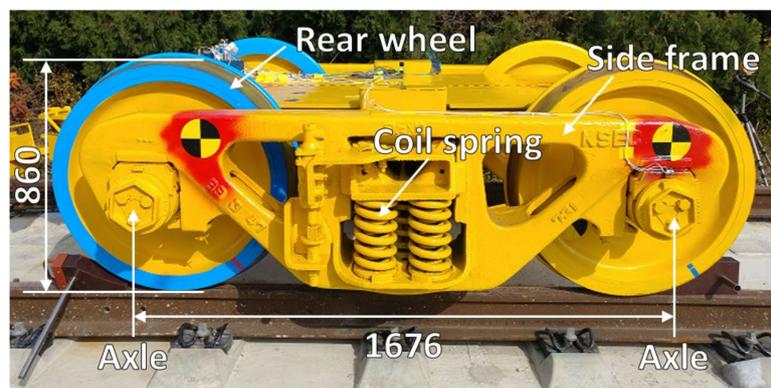
Figure 5. Test bogie (casting bogie for a freight train).

In this study, a bogie-level test was conducted. The bogie used in this study was a casting bogie for a freight train, as shown in Figure 5. The total weight of the test bogie was 40.91 kN and the specifications of the test bogie are listed in Table 1. The frame structure was made of three pieces of cast steel. The fixed wheel base and wheel diameter were 1676 mm and 860 mm, respectively. A suspension system with coil springs was used between the bolster and side frame.

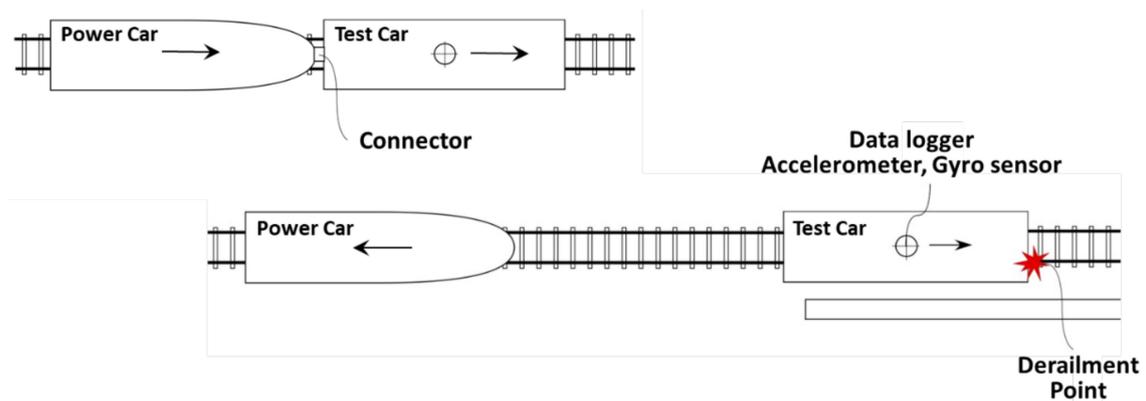
Figure 6. Concept of the push system to accelerate the test bogie.

In order to accelerate the test bogie, several methods can be used, such as a reverse towing system, push system, or remote-controlled system. In this study, the push system shown in Figure 6 was used. The power car was linked to the test bogie with a connector. The test car was accelerated by the power car. Then, the test car was released after reaching the target speed. For this, the releasing system of the connector and braking system of the power car were designed to be controlled by air pressure and a remote controller, as shown in Figure 7. The power car used in this study is shown in Figure 8. The power car had a traction power of 147 kN.

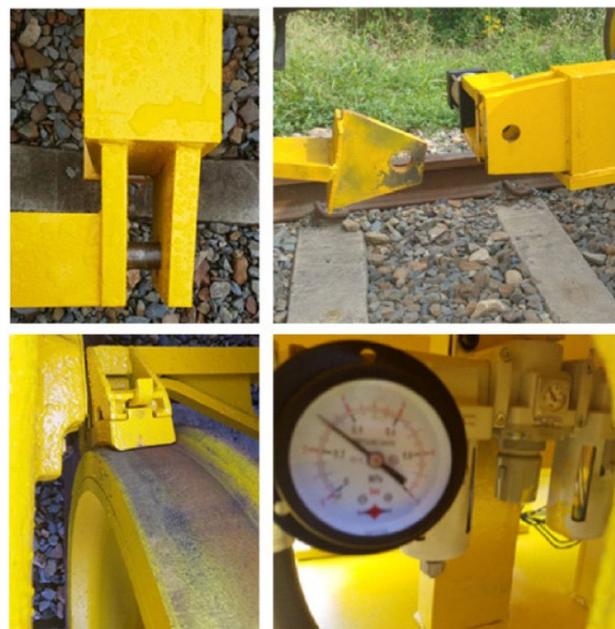
Figure 7. Release and braking system for the test.

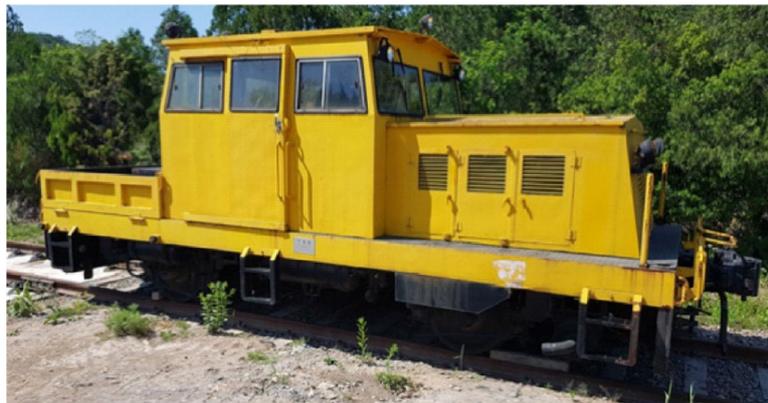
Figure 8. Power car to accelerate the test bogie.

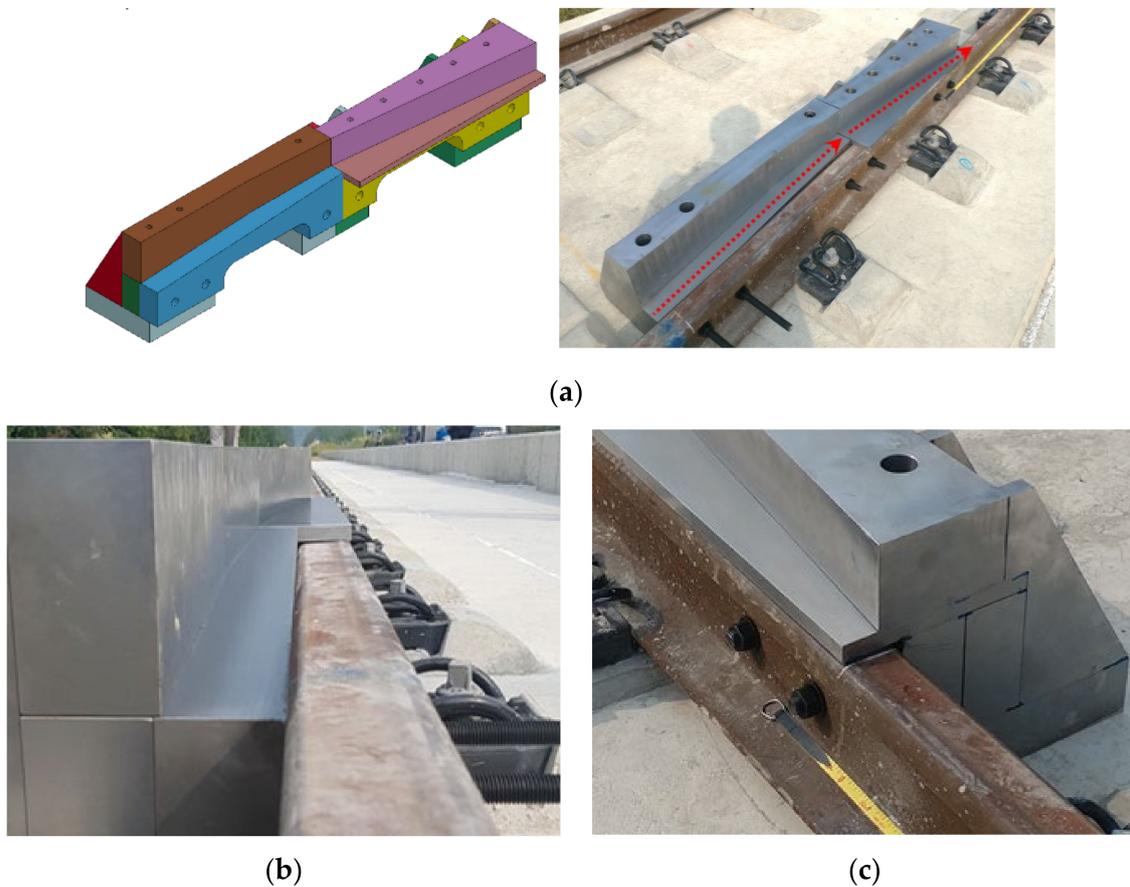
Figure 9. Derailment device: (a) overview, (b) wheel entrance part, and (c) derailment part.

A device to induce derailment was needed for the test. Wheel-climbing derailment is one of the most frequent types of derailment. In this study, a derailment device that can induce wheel-climbing derailment was developed and installed at the derailment point, as shown in Figure 9 [15]. The device consisted of a wheel entrance part and a derailment part. In the wheel entrance part, there is an upward slope, and the entered wheel flange reaches the same height as the surface of a rail head. Then, the wheel climbs the surface of a rail head in the derailment part, shown in Figure 9c. Thus, the train or bogie is derailed due to wheel-climbing derailment.

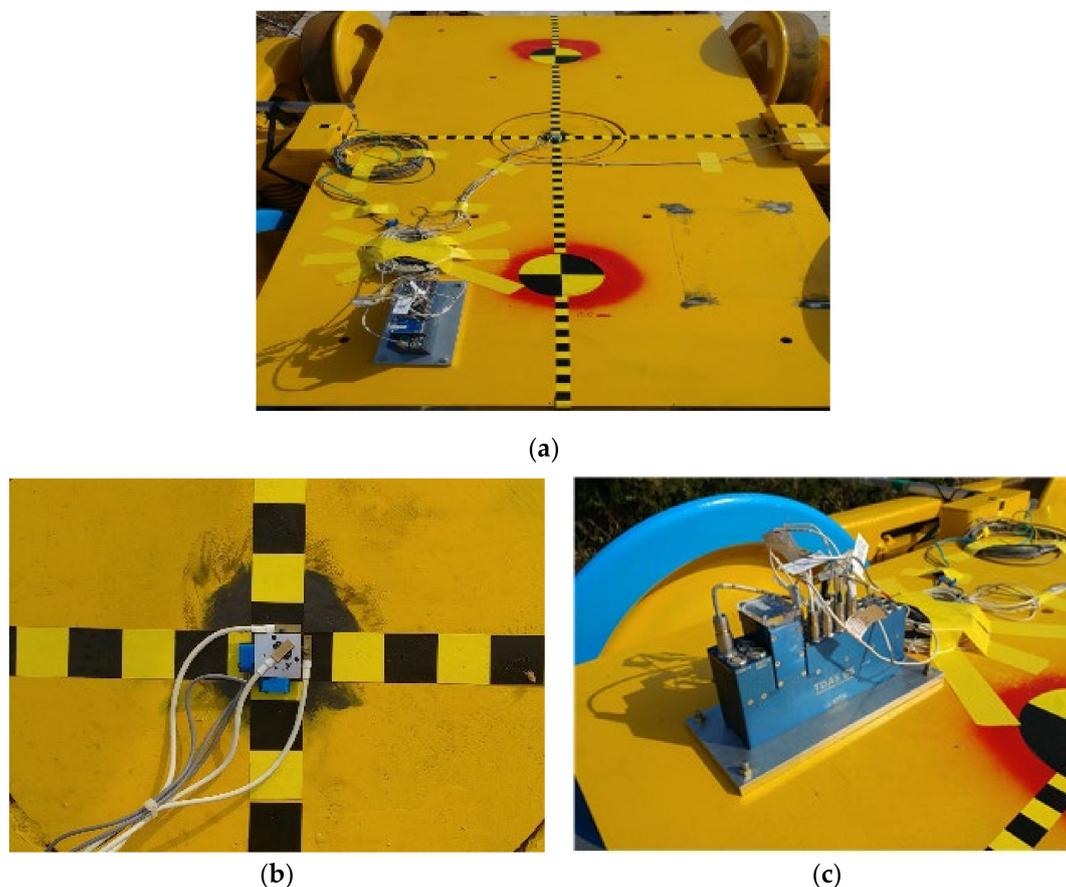
Figure 10. Data acquisition system for the bogie: (a) layout, (b) accelerometer and angular velocity sensor, and (c) a shock-resistance data logger for collision testing.

The position of the derailed train bogie and related data have to be accurately measured during the test. The acceleration and angular velocity of the bogie were measured. For this, an accelerometer and an angular velocity sensor were installed on the geometrical bogie center as shown in Figure 10b, where the capacities of the accelerometer and angular velocity sensor were 2000 g and ± 1500 deg/s full-scale range, respectively. Large impact forces are expected after derailment. Thus, the sensors must be securely fixed to the test bogie. To measure the impact force, special accelerometers such as MEMS accelerometers [16] can be used. However, it is hard to determine the exact impact point after derailment. Thus, the impact force to the rail was estimated from the acceleration data of the test bogie. A data logger was installed on the test bogie, as shown in Figure 10c. The data logger used was a shock-resistance data logger (high shock rating of 500 g) for collision testing and it has high sampling capabilities (max. sampling rate of 100 k samples/s/channel). The sampling rate of the data was 1/10,000 s (10,000 Hz) in this test.

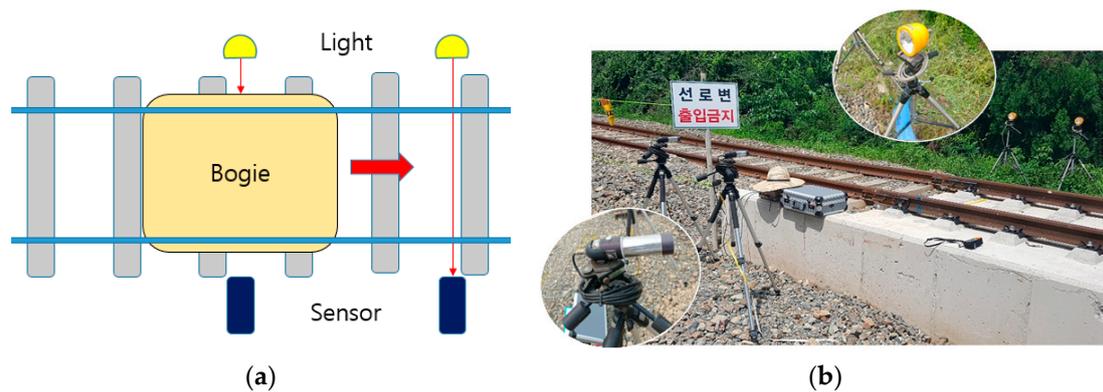
Figure 11. Speed measuring system: (a) system conceptual diagram; (b) photoelectric tube speedometer.

The velocity of the test bogie at the derailment point is important information for the analysis of post-derailment behavior. Since the test bogie was released before the derailment point, it was necessary to set up an additional velocity measurement system at the derailment point, as shown in Figure 11. In this study, a photoelectric tube speedometer was used. Two lights and two receiver sensors were installed at a specific distance. As the test bogie passes, the passing time between the two lights can be obtained. Then, the initial derailment velocity of the test bogie can be calculated.

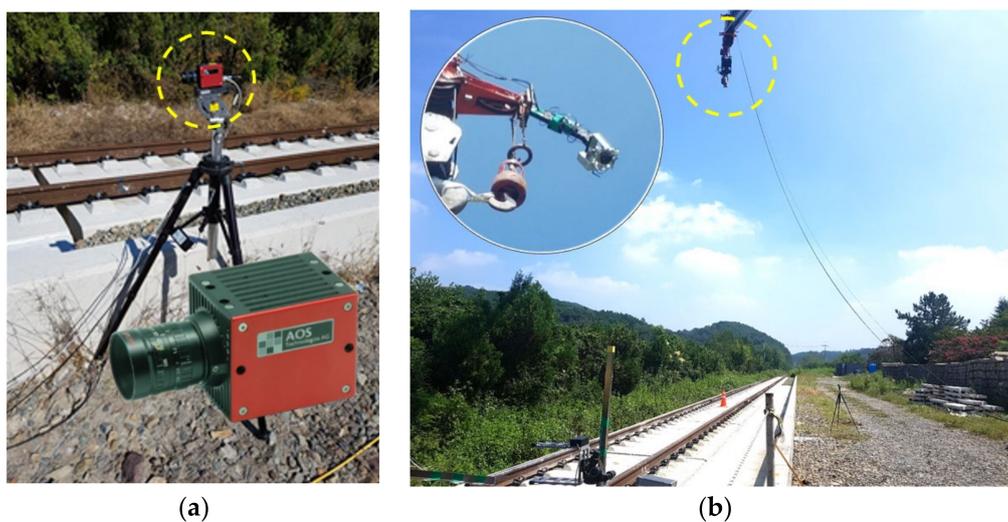
Figure 12. High-speed cameras: (a) side view; (b) top view.

In this study, a high-speed camera was also used to investigate the post-derailment behavior of the test bogie in depth. Image data are very useful to evaluate the trace of the bogie after derailment. The high-speed camera used in this study is shown in Figure 12. According to its specifications, it can store 3.6 s at 1000 fps (frame/s) when the image format is 1024×1024 . In total, three high-speed cameras were used. One camera was used to take the top view with a crane, as shown in Figure 12. The others were used to take the side views. For each second, 500 frames were obtained (500 fps). Also, some ordinary digital cameras were installed to obtain image data from various viewpoints.

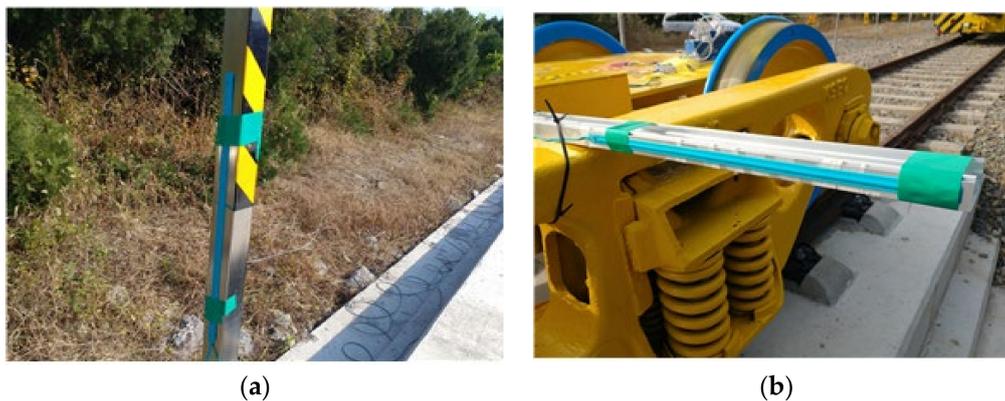
Figure 13. Simultaneous trigger system by a tape switch: (a) trigger for the high-speed cameras; (b) trigger for the data logger.

Trigger systems are used to synchronize several different pieces of measurement equipment. By synchronizing the equipment, data analysis is convenient since the initial time of data recording is the same for all equipment. In this study, the three high-speed cameras and data logger were synchronized by a trigger system with a tape switch, as shown in

The tape switch method is simple and free from spurious operation. The trigger for the high-speed cameras was set up on the test track at the derailment point, as shown in Figure 13a. The trigger for the data logger, shown in Figure 13b, was installed on the test bogie. When the test bogie passes the derailment point, the trigger on the test bogie contacts the trigger for the high-speed camera. Then, data recording is started. It should be noted that the trigger on the bogie was made of flexible materials since the post-derailment behavior could be affected by high stiffness and contact force between the triggers. Figure 13.

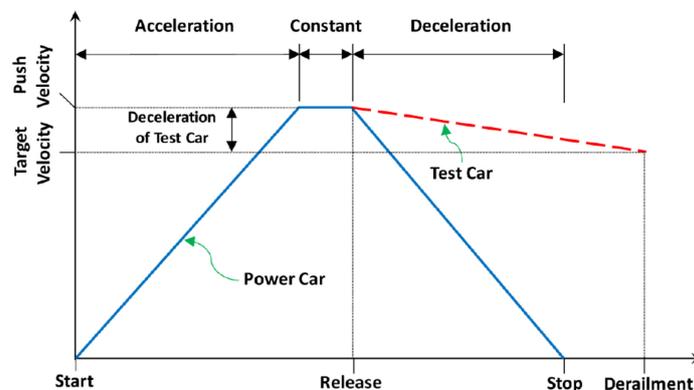
Figure 14. A schematic view of the running diagram of the power car and test bogie.

It was necessary to determine the running diagram of the power car and test bogie to achieve the target speed of the test bogie and to ensure the safety of the power car after releasing the test bogie. Figure 14 shows a schematic view of the running diagram of the power car and test bogie. The blue solid line and red dashed line represent the running diagrams of the power car and the test bogie, respectively. Before releasing the test bogie, the power car and the test bogie move together. The velocity at the release time is larger than the target speed. After releasing the test bogie, the power car reduces its speed and stops before the derailment point. The test bogie reaches the target velocity at the derailment point and is derailed.

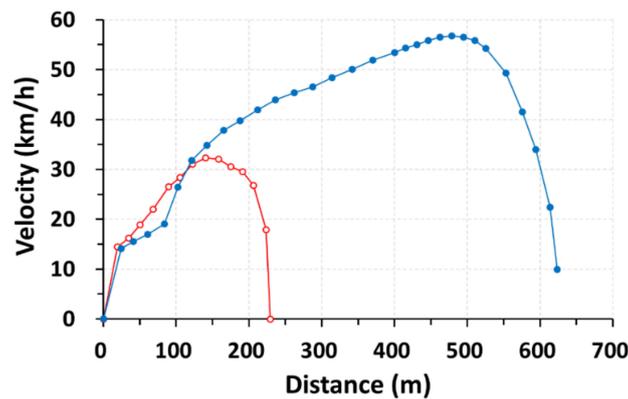
Figure 15. Examples of running diagrams of the power car.

The distance to the release point depends on the target speed and acceleration capacity of the power car. The running diagram was constructed from the results of several preliminary tests. In this study, the target speeds of the test bogie were 30 km/h and 55 km/h. Figure 15 shows a representative running diagram of the power car through the preliminary tests. An acceleration distance of about 480 m was required for the stationary power car to accelerate to about 56 km/h, and a braking distance of about 150 m was required for subsequent stops. The deceleration to the derailment point after the release of the test bogie was approximately 1–2 km/h. Therefore, the running distance of the power car to ensure safety during the experiment with a target speed of 50 to 55 km/h was determined to be 650 m. In addition, an acceleration distance of about 140 m was required for the power car to accelerate to about 32 km/h, and a braking distance of about 90 m was required for subsequent stops. The deceleration to the derailment point after the release of the test bogie was approximately 2–3 km/h. Thus, the running distance of the power car to ensure safety with a target speed of 25 to 30 km/h was determined to be 250 m.

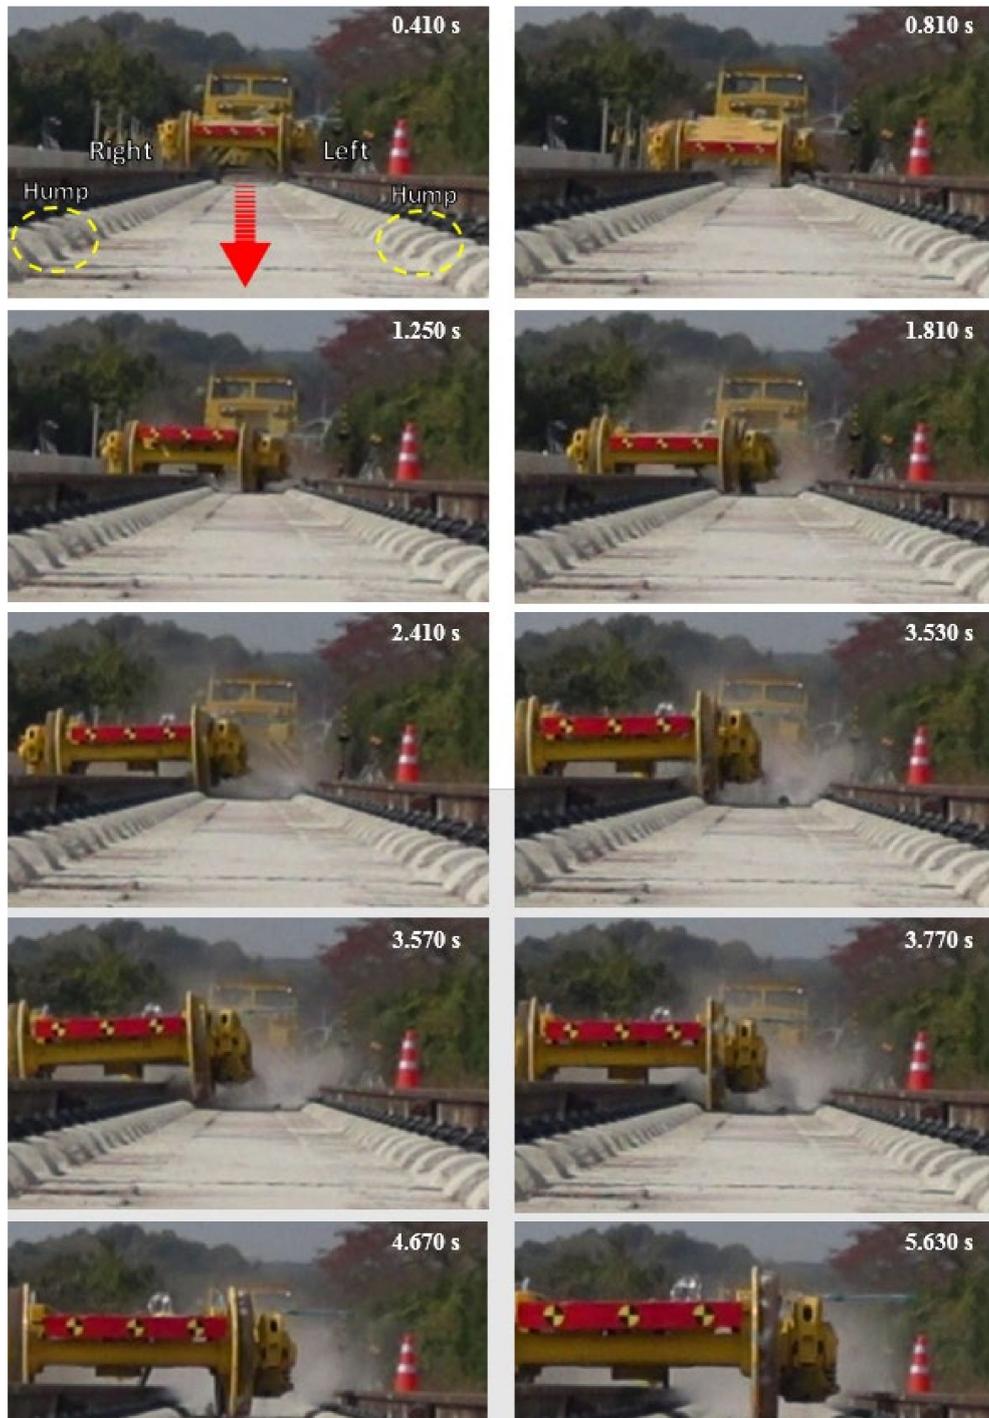
Figure 16. Post-derailment behavior of the bogie for Case #1, front view.

For Case #1, the target speed range was 25–30 km/h. The measured derailment velocity was 28.08 km/h. Figure 16 shows a front view of the post-derailment behavior in Case #1. It can be seen that the bogie ran in the right lateral direction after derailment (0.410–1.810 s), and the left wheel continuously contacted the hump of the concrete track (1.810–3.570 s). Then, the bogie moved to the left direction without contact between the right rail and left wheel (3.570–5.630 s). The direction was changed due to the effect of the hump in this case. In this study, the Rheda 2000 type concrete track was used, and the hump in this track affected the post-derailment behavior.

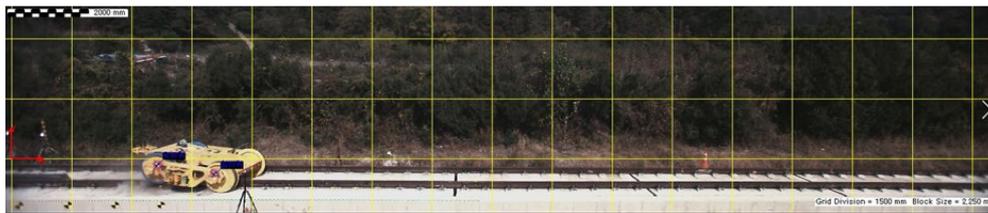
Figure 17. Example of image analysis by target mark tracking.

The acceleration data were analyzed to calculate the velocity and traveling distance of the test bogie. The analysis results were compared with the results obtained in the image data from the high-speed cameras for cross-validation of the data. It is known that the image analysis offers a certain potential for the dynamic investigation [20]. The velocity and traveling distance of the test bogie were also calculated by target mark tracking from the image data, as shown in Figure 17. The results are shown in Figure 18 as a solid line. It can be seen that the velocity obtained from the high-speed camera showed initial fluctuation. However, the overall trend of the velocity was similar to that from the

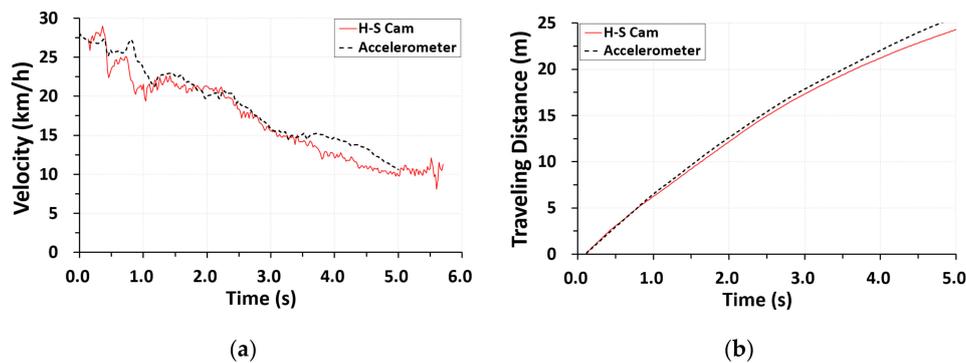
Figure 18. Data analysis results, Case #1: (a) velocity, (b) traveling distance.

accelerometer. The velocity decreased almost linearly, as shown in Figure 18a. The slope of Figure 18a represents the deceleration, and it was approximately -0.97 m/s^2 . By integrating the acceleration data twice, the traveling distance could be calculated, as shown in Figure 18b. The traveling distances obtained from the accelerometer and high-speed cameras were similar to each other. The discrepancy may come from accumulated error during the integration or distortion of the image by the use of a wide-angle lens.

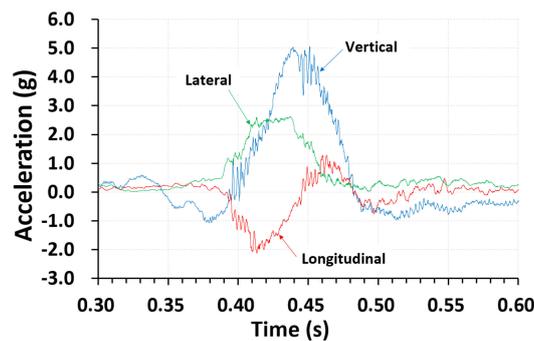
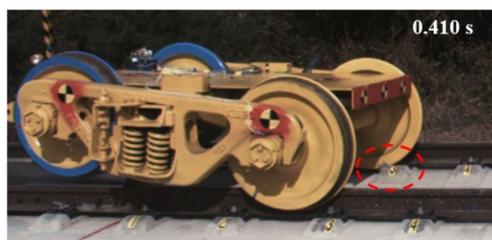
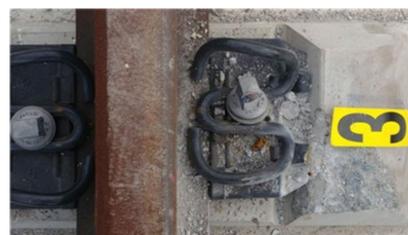
Figure 19. First impact, Case #1: (a) acceleration vs. time (0.3–0.6 s); (b) test bogie at first impact; (c) damage to the hump and rail fastener due to the first impact.

The longitudinal, lateral, and vertical acceleration data of the test bogie were analyzed with the video images together. The first impact was observed at 0.410 s after derailment, as shown in Figure 19. It can be seen that there were sudden changes in acceleration at the time of the first impact, as shown in Figure 19a. The maximum acceleration was found in the vertical direction, and it was 5.07 g (49.78 m/s²). If the total mass of the bogie is included in the calculation of the impact force, it is equivalent to approximately 207 kN of impact force. The first impact occurred between the left wheel and hump, as shown in Figure 19b. Figure 19c shows the damage to the hump and rail fastener due to the first impact.

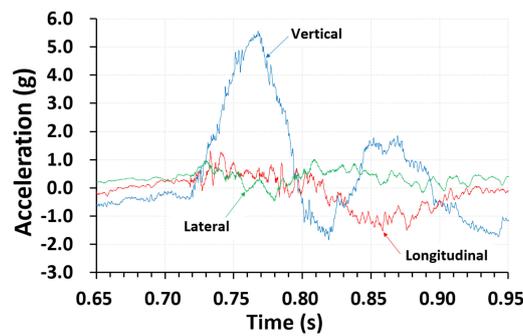
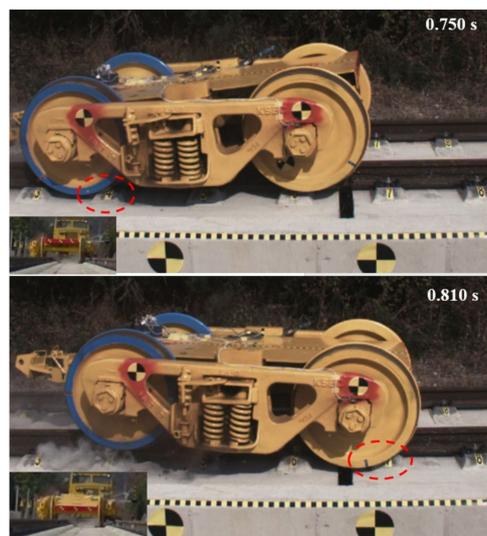
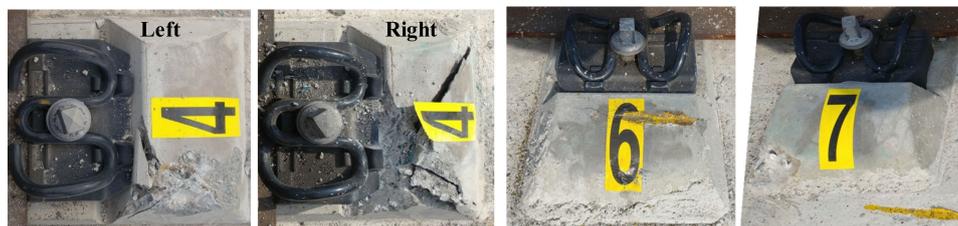
Figure 20. Second and third impacts, Case #1: (a) acceleration vs. time (0.65–0.95 s); (b) test bogie at the second and third impacts; (c) damage to the hump and rail fastener due to the second and third impacts.

Similar to Figure 19, information about the second and third impacts is presented in Figure 20. The second and third impacts were observed at 0.750 s and 0.810 s, respectively. In the second impact, the right and left rear wheels impacted the fourth hump, as shown in Figure 20b,c. The maximum vertical acceleration was approximately 5.57 g—larger than that from the first impact. This may be attributed to the pitching moment of the bogie after the first impact. In the case of the third impact, the front right wheel contacted the sixth and seventh humps in succession. At the third impact, the peak of the vertical acceleration was markedly decreased.

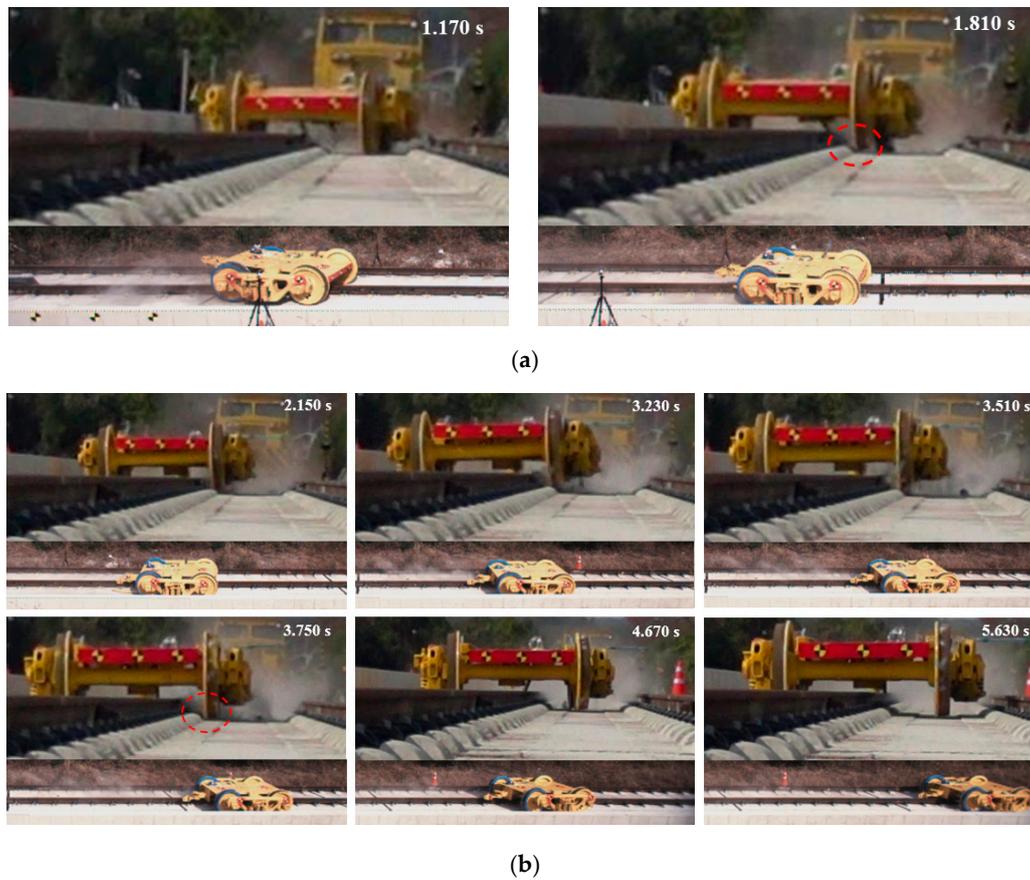
Figure 21. Position of the test bogie: (a) 1.170–1.810 s, (b) 2.150–5.630 s.

After the third impact, the test bogie ran the track without any further significant impact with track components. However, considerable lateral displacement was observed. For example, at 1.170 s, the front left wheel was located at almost the center of the track, as shown in Figure 21a. The lateral displacement continuously increased at 1.170–1.810 s, and the front left wheels contacted the humps in

the left rail at 1.810 s. Then, the test bogie returned to the center of the track at 3.750–5.630 s, as shown in Figure 21b.

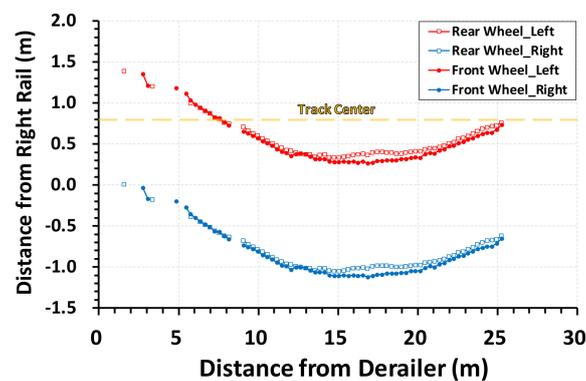
Figure 22. Trace of the left and right wheels for Case #1.

In summary, for Case #1, where the derailment velocity was 28.08 km/h, the derailed test bogie ran the track with considerable lateral movement. The lateral movement was restrained by contact with the humps in the concrete track. Then, the test bogie returned to the center of the track. The whole trace of the test bogie is shown in Figure 22. The maximum vertical acceleration was approximately 5.57 g at the second impact with the humps. The maximum lateral acceleration was approximately 2.62 g at the first impact with the humps. From the results, it can be seen that the effect of the humps on the post-derailment behavior was significant when the Rheda 2000 track system was used. Thus, the type of track must be considered when evaluating the post-derailment behavior of a derailed train.

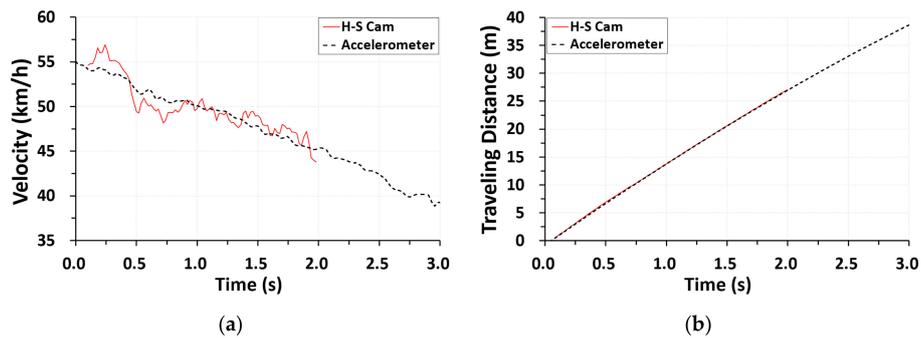
Figure 23. Data analysis results, Case #2: (a) velocity, (b) traveling distance.

In Case #1, the derailed wheel was not guided by the rail or containment wall. However, it was guided by the humps on the track. To identify the effects of the rail and containment wall, the derailment velocity was increased for Case #2. The target derailment velocity range was 50–55 km/h. The measured derailment speed was 55.05 km/h. Figure 23 presents the variation in the velocity and longitudinal traveling distance after derailment for Case #2. The data were obtained by the accelerometer as well as the high-speed cameras. However, the data from the high-speed cameras cannot be interpreted well after 2 s since the test bogie left the camera range due to the increased speed of the test bogie. The deceleration of the test bogie was approximately -1.48 m/s^2 . The traveling length was approximately 38 m at 3 s.

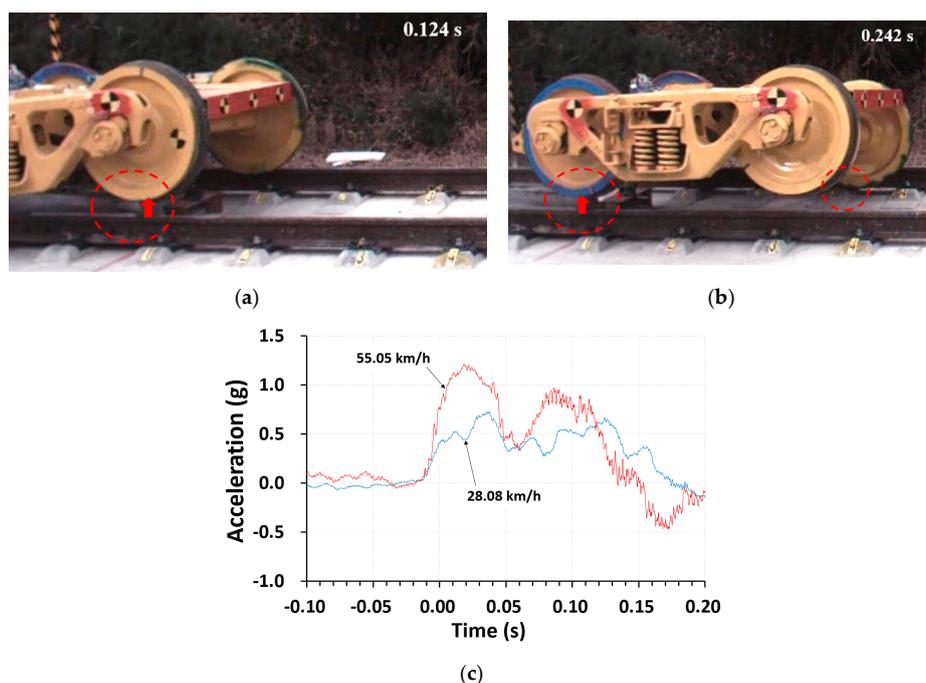
Figure 24. Test bogie at derailment for Case #2: (a) 0.124 s; (b) 0.242 s (first impact); (c) vertical acceleration when derailed (0–0.20 s).

Figure 24 shows the test bogie at derailment. It was found that the test bogie seemed to jump, bypassing the derailment device as shown in Figure 24a. Then, the front left wheel contacted with the third hump and rail fastener at 0.240 s due to the roll of the test bogie, as shown in Figure 24b. When the test bogie passed through the derailment device, the vertical acceleration in Case #2 was much greater than that in Case #1 before the first wheel contact with the track (0.242 s), as shown in Figure 24c. If higher-speed experiments are carried out, the derailment device should be improved because excessive jumping is expected.

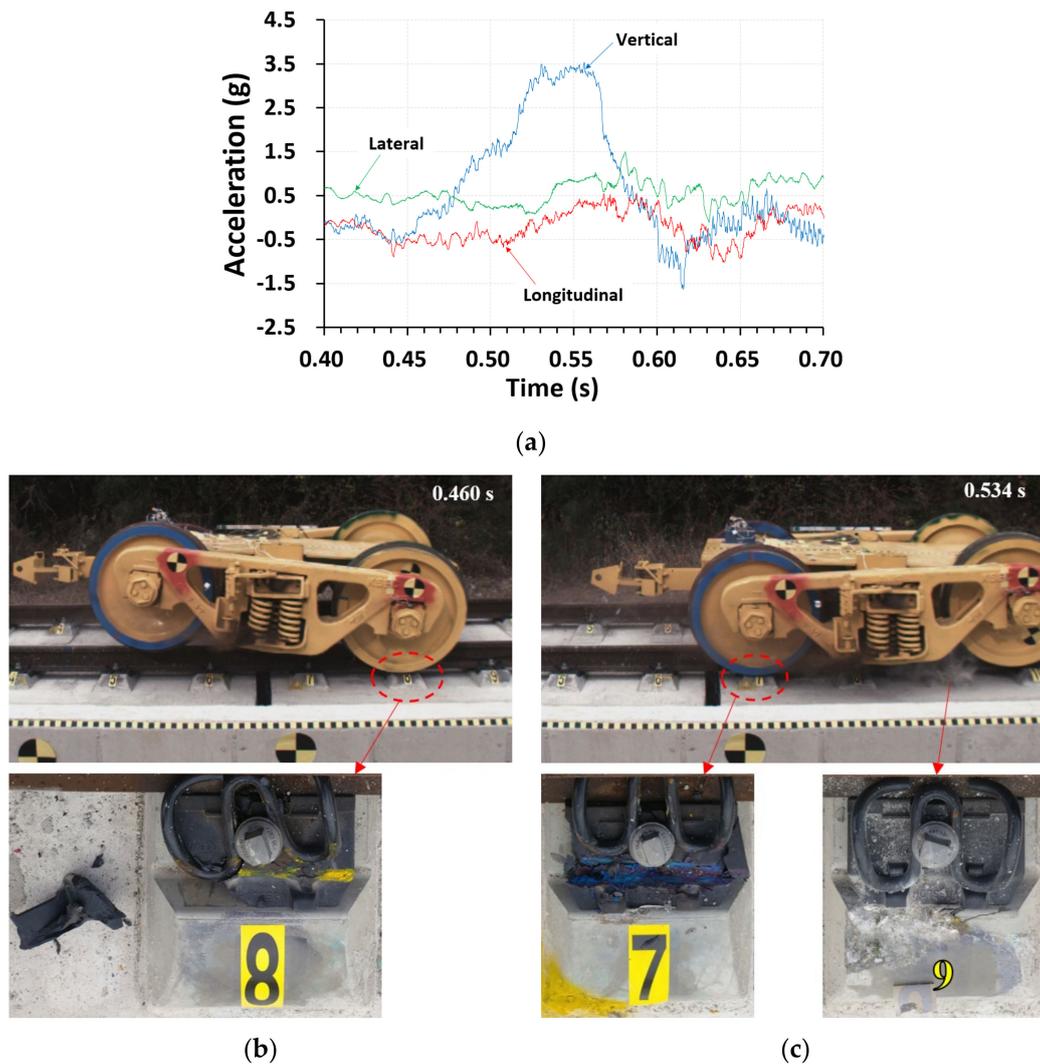
Figure 25. Impact of the test bogie after derailment for Case #2: (a) acceleration vs. time (0.4–0.7 s), (b) 0.460 s; (c) 0.534 s.

The main impact to the track was observed around from 0.4 s to 0.7 s, as shown in Figure 25. At 0.460 s, the front right wheel came into contact with the eighth rail fastener. Then, the front right wheel impacted the ninth hump and the rear right wheel immediately came into contact with the seventh rail fastener. The maximum vertical acceleration was found at this time, and it was approximately 3.53 g. The maximum acceleration in Case #2 was smaller than that in Case #1. This is because increased velocity is related with the longitudinal direction and vertical impact force is mainly a function of the velocity in the vertical direction.

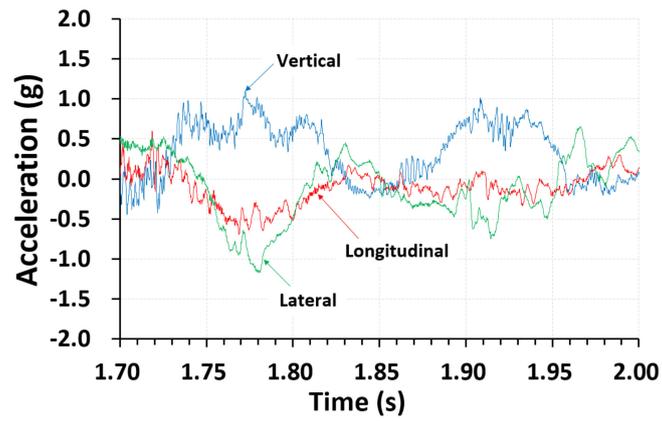
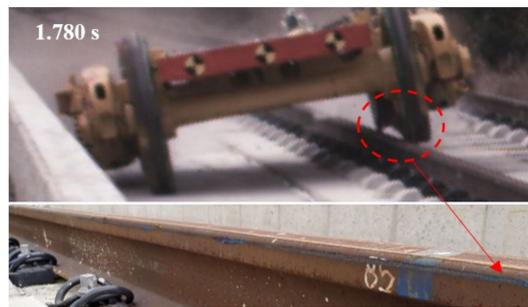
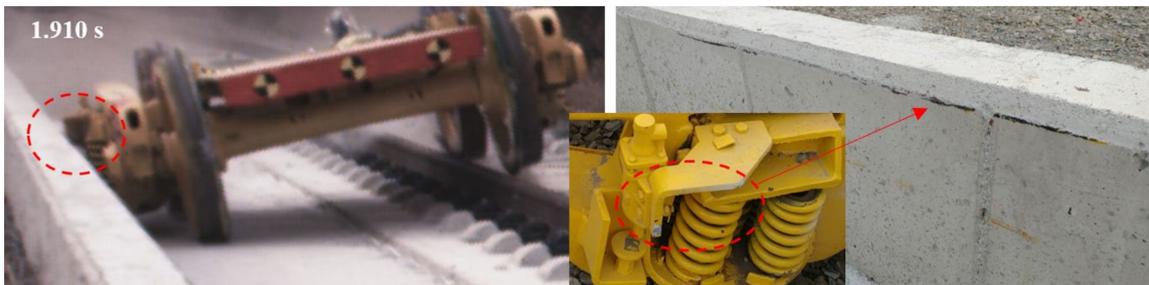
Figure 26. Impact of the test bogie after derailment for Case #2: (a) acceleration vs. time (1.7–2 s), (b) 1.780 s; (c) 1.910 s.

After 0.7 s, the test bogie ran the track with considerable lateral movement, similar to Case #1. However, for Case #2, the wheel flange was in contact with the rail as shown in Figure 26b. Then, the test bogie impacted the containment wall at 1.910 s, as shown in Figure 26c. The lateral acceleration was increased due to the impact with the rail and containment wall, as shown in Figure 26a. The lateral acceleration values were approximately 1.17 g (11.51 m/s²) and 0.75 g (7.36 m/s²) for the rail and containment wall impact, respectively. Thus, it was expected that the impact force on the containment wall would be reduced approximately 36% by the first guide by the rail for Case #2. Finally, the test bogie returned to the track center direction after containment wall impact, as shown in Figure 27.

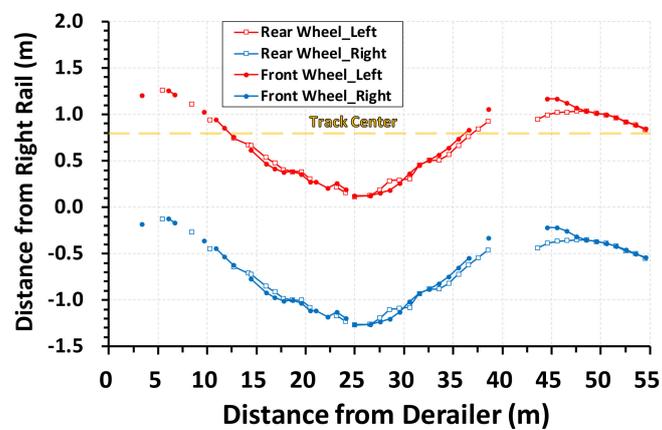
Figure 27. Trace of the left and right wheels for Case #2.

As mentioned in the introduction, the basic concept of DCP type III is that the derailed train is first guided by the rail and the containment wall, preventing excessive lateral movement [8,21,22]. The containment wall installed in this test is DCP type III, and it was seen that the derailed train was effectively guided by DCP type III in test Case #2.
