# Abrasion Behavior of Steel-Fiber-Reinforced Concrete in Hydraulic Structures

**Abstract:** This study investigated two types of abrasion resistance of steel–fiber-reinforced concrete in hydraulic structures, friction abrasion and impact abrasion using the ASTM C1138 underwater test and the water-borne sand test, respectively. Three water-to-cementitious-material ratios (0.50, 0.36, and 0.28), two impact angles (45° and 90°), plain concrete, and steel–fiber-reinforced concrete were employed. Test results showed that the abrasive action and principal resistance varied between the two test methods. The average impact abrasion rates (IARs) of concrete were approximately 8–17 times greater than the average friction abrasion rate (FARs). In general, the impact abrasion loss of the concrete surface impacted at a vertical angle was higher than that of impacted at a 45 degree angle. Moreover, the average FAR and IAR decreased when the concrete was reinforced with steel fibers. The steel fibers acted as shields to prevent the concrete material behind the fibers from abrasion, thus improving abrasion resistance. In both the underwater and waterborne sand flow methods, the resistance to abr

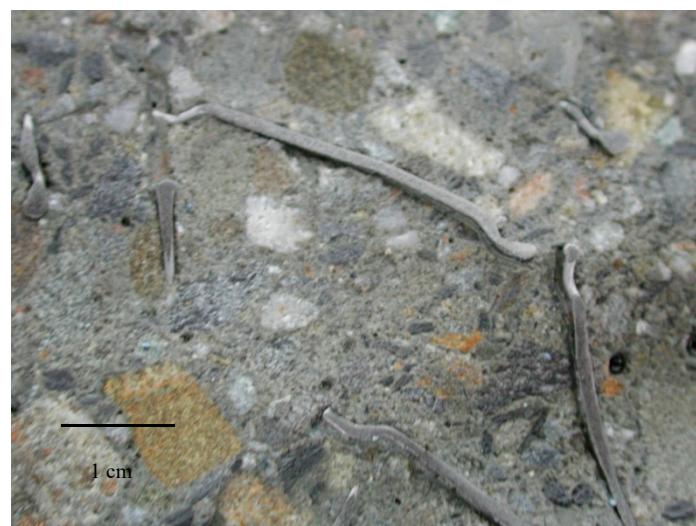
Figure 3. Concrete surface at the end of 72 h of testing (w/cm = 0.50, ASTM C1138).

The underwater method entails using circulating water (1200 rpm) that in turn moves the steel balls on the concrete surface, producing the desired abrasion effects. Figure 3 depicts a photo of the concrete specimen at the end of 72 h of testing. This photo indicates that the surface mortar layer has been worn away, the aggregate has been exposed, and the low strength mortar region has formed an indentation. The surface of concrete prepared with a high w/cm ratio of 0.50 exhibited a strongly nonregular structure, whereas concrete prepared with a low w/cm ratio of 0.28 exhibited a slightly nonregular surface. However, these nonregular surfaces were smooth.

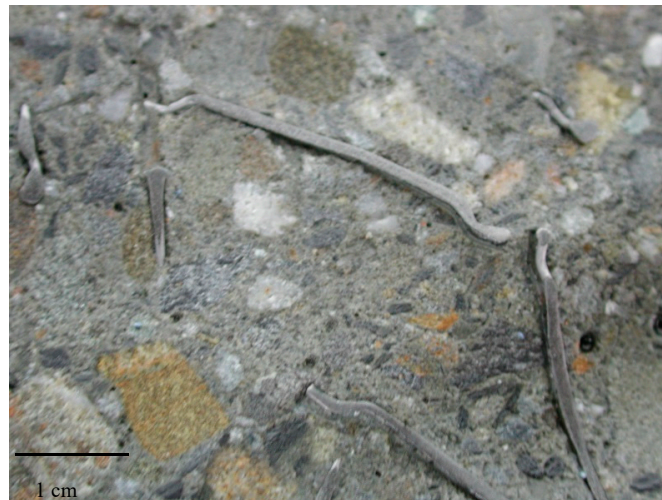
**Figure 4.** Typical abrasion site in steel fiber concrete abraded by friction abrasive action ( $w/cm = 0.36$ , ASTM C1138).

As illustrated in Figure 4, steel fibers added to the concrete, when exposed, were flattened by the rotating steel balls and covered by the mortar during the test period. The hard and the highly erosion-resistant steel fibers acted as shields, preventing the concrete material behind the fibers from being abraded by the rolling steel balls.

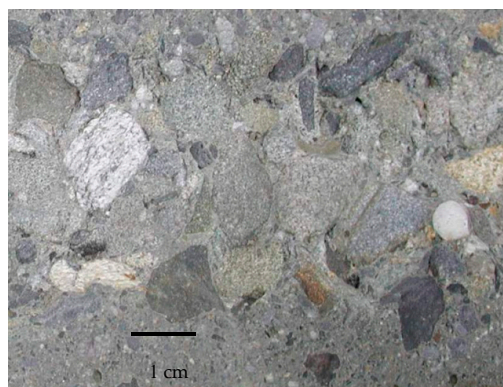
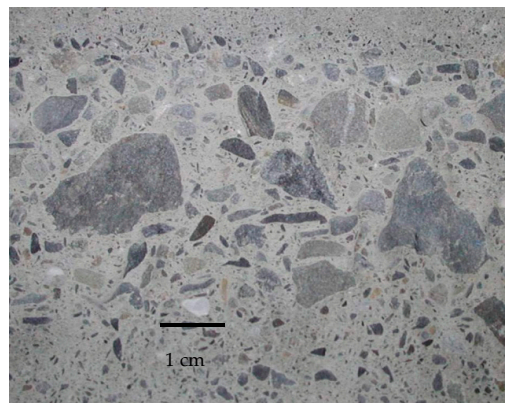
(a)  $w/cm = 0.50$ ; impact angle =  $90^\circ$

(b)  $w/cm = 0.28$ ; impact angle =  $45^\circ$ **Figure 5.** Images of worn concrete surfaces after impact test.

Figure 5 shows various impact abrasions of the concrete after testing. The cement matrix exhibited significant indenting by the exposed erodent, and the aggregate grain appeared to peel away; specifically, the mortar layer was worn away and interfacial cracks became visible on the concrete prepared with a high  $w/cm$  ratio and impacted at  $90^\circ$  (Figure 5a), whereas it appeared to be rather smooth on the concrete prepared with a low  $w/cm$  ratio and impacted at  $45^\circ$  (Figure 5b). SEM revealed the formation of cracks in the cement matrix and the interface between the aggregate grain and the cement matrix (Figure 6a) for the concrete impacted at  $90^\circ$ . Additionally, the concrete impacted at  $90^\circ$  displayed a rougher and more rugged surface than did the concrete impacted at  $45^\circ$  (Figure 6b).

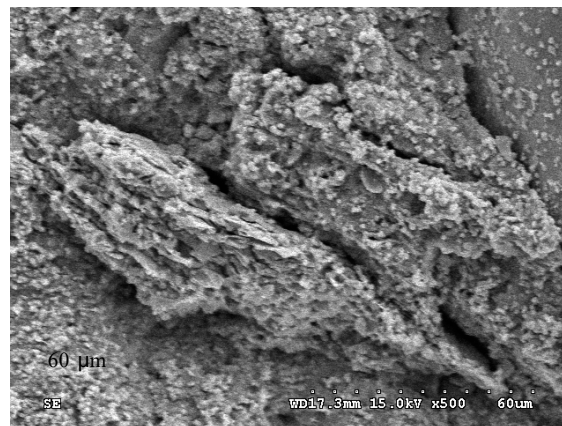
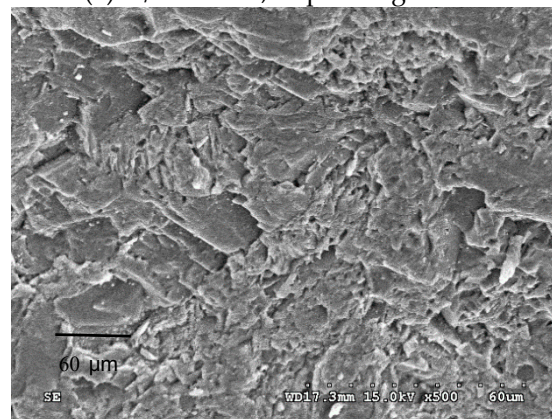
(a)  $w/cm = 0.50$ ; impact angle =  $90^\circ$

(b)  $w/cm = 0.28$ ; impact angle =  $45^\circ$ **Figure 6.** SEM images of worn concrete surface after impact test; scale: 60  $\mu\text{m}$ .

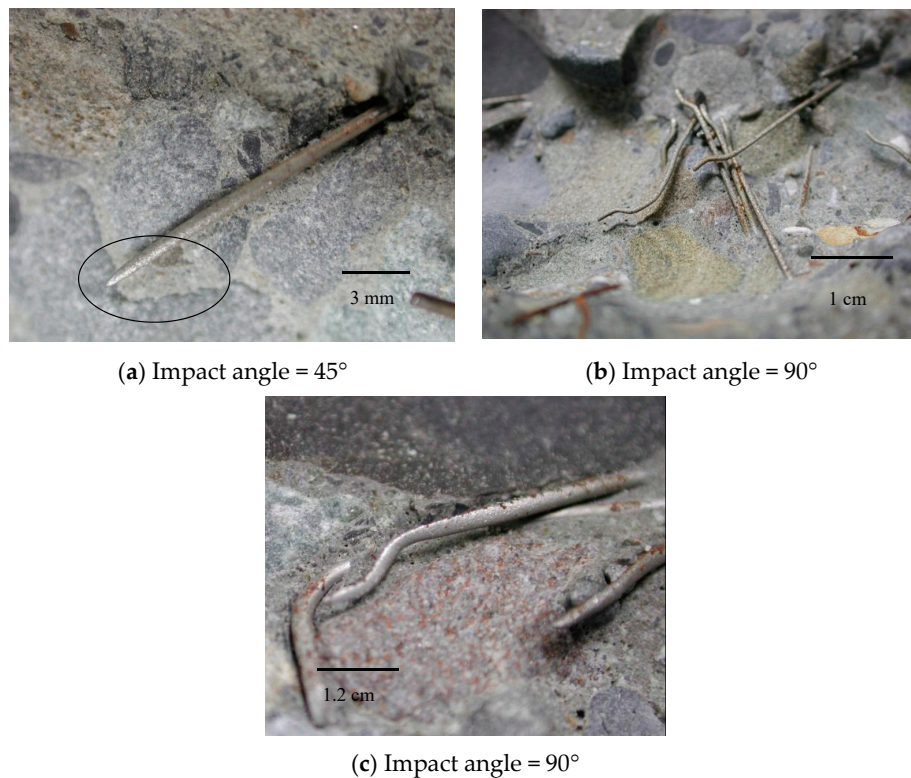
**Figure 7.** Typical abrasion site in steel fiber concrete abraded by impact abrasive action ( $w/cm = 0.36$ , waterborne sand flow).

The presence of steel fibers in the concrete caused some notable phenomena. As Figure 7a illustrates, the partial fiber length separated from the matrix was exposed and the front region tapered to a fine point. Figure 7b shows that the entire circumference of the fiber was exposed to a certain depth, and the amount of exposed fiber was comparatively high for the fiber concrete impacted at  $90^\circ$ . The exposed steel fiber could shield the concrete material from being removed. Another notable observation was the loss of bonding between both the fiber and the matrix for the concrete impacted at  $45^\circ$  and  $90^\circ$  (Figure 7c). This observation demonstrates the weak interface between the fiber and the concrete matrix.

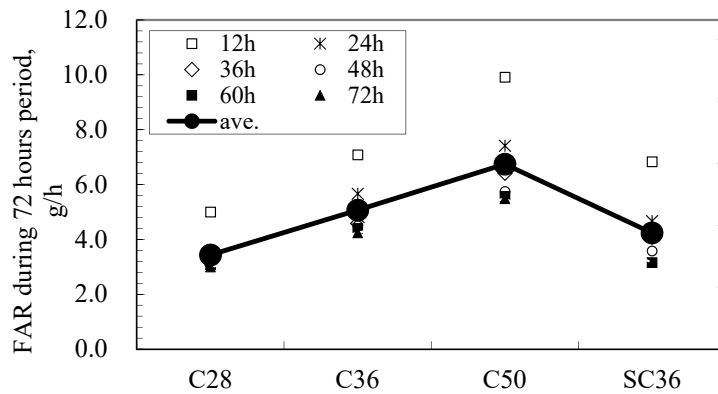
Figure 8. Friction abrasion rate (FAR) of concrete at different time during the 72 h period test.

The abrasion resistance of concrete mixtures was determined at 28 days. It was measured in terms of abrasion loss, and the measurement revealed that the abrasion loss increased with abrasion time in all concrete mixtures. The effects of the  $w/cm$  ratio on the abrasion resistance of concrete are illustrated in Figure 8, which presents a plot of the average abrasion loss of the concrete mixtures at the 72 h test time. Reducing the  $w/cm$  ratio from 0.50 to 0.28 resulted in an approximately 50% improvement in abrasion resistance at 72 h. Furthermore, the FAR during the first 12 h was generally greater than that during the rest of the test period; this is because the surface mortar layer was easily abraded, and the FAR decreased as the mortar layer wore away, consequently resulting in the exposure of the more homogeneous specimen core. This behavior was more apparent in concrete prepared with a high  $w/cm$  ratio. Specifically, for the concrete prepared with a  $w/cm$  ratio of 0.50, the abrasion rate stabilized after approximately 48 h of the test. Concerning the concrete prepared with  $w/cm$  ratios of 0.36 and 0.28, the variations in abrasion rate became small after 24 h of the test (Figure 9).

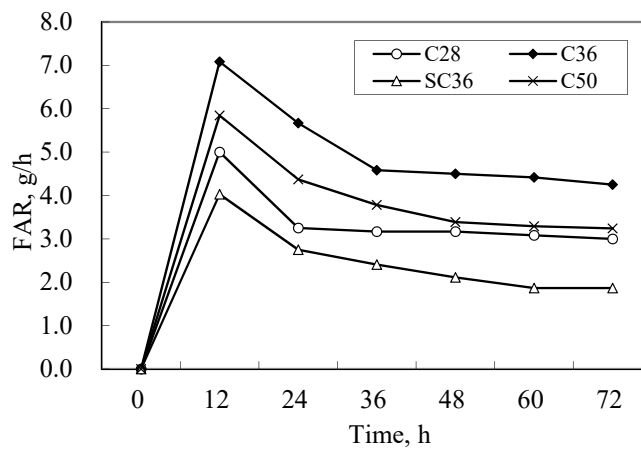
Figure 9. Friction abrasion rate (FAR) of concrete (SC36 with steel fibers, others without).

A comparison of the abrasion resistance of concrete with and without steel fiber reinforcement and prepared with the same w/cm ratio of 0.36 is shown in Figures 9 and 10. The concrete containing steel fiber reinforcement exhibited similar abrasion loss during the first 12 h to plain concrete. However, the abrasion rate decreased after 24 h, and the total abrasion loss of steel the fiber-reinforced concrete at 72 h was approximately 17% less than that of the plain concrete. Because of the protection provided by the hard and highly erosion-resistant steel fibers (Figure 4), the concrete material behind the fibers could not be abraded, thus improving the abrasion resistance of the concrete.

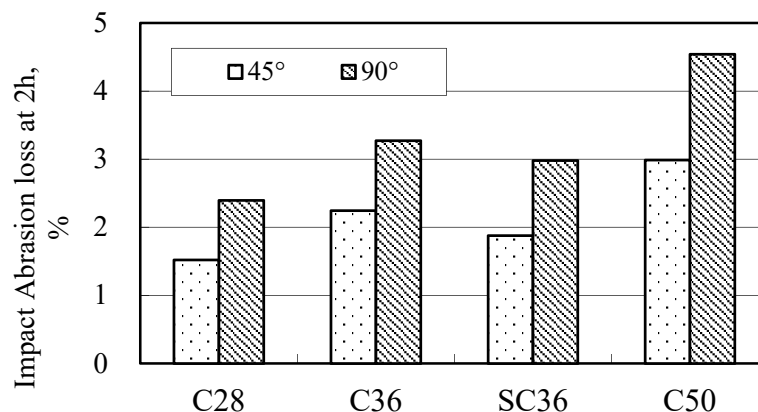
Figure 11. Total impact abrasion loss of concrete at 2 h.

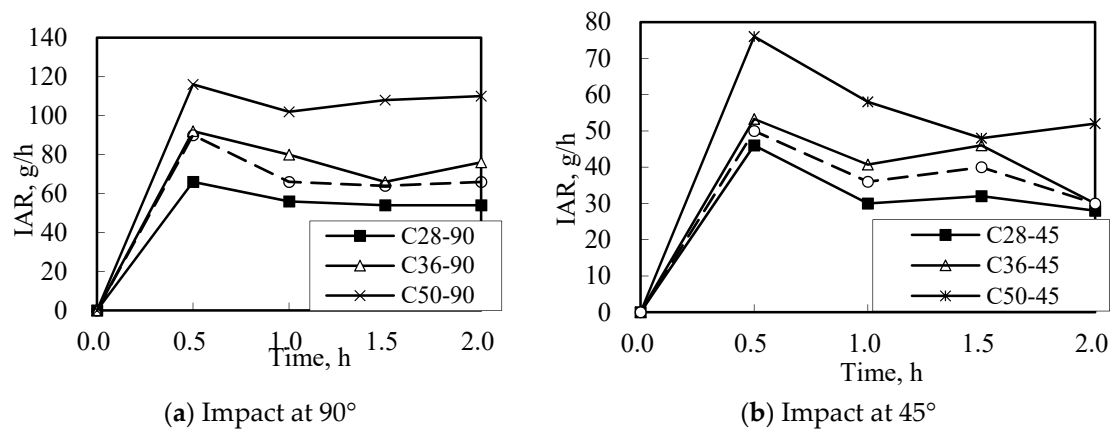
Figure 12. Impact abrasion rate (IAR) of concrete.

During the impact abrasion test, concrete abrasive wear occurred readily in the small holes and pits. The IAR was also influenced by the aggregate, regardless of whether it was peeled off. When the aggregate was removed through prising, the IAR increased. Consequently, the IAR trend was nonregular (Figure 12). For the concrete made with a low w/cm ratio (0.28) and impacted at 45° and 90°, the IAR stabilized after 1 h of the test. This can be attributed to the fact that a low w/cm ratio results in a denser and stronger matrix, improving the homogeneity of concrete and thus leading to a stable abrasion rate. Regarding the other types of concrete, during the impact abrasion test, removing the aggregate engendered an increase in abrasion loss and consequently increased the IAR.

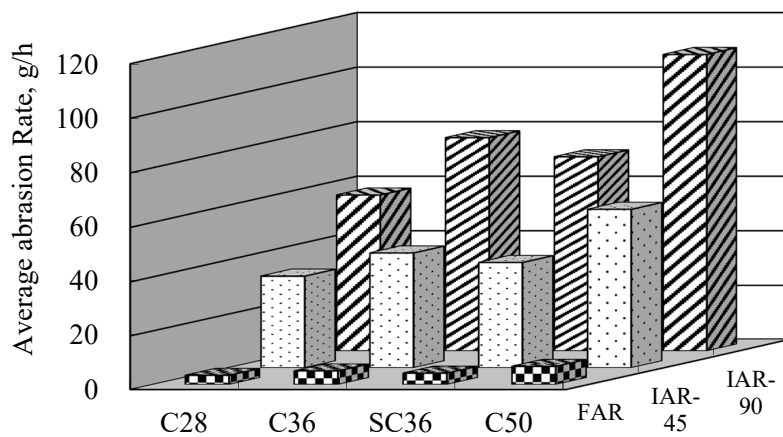
Figure 13. FAR and IAR of concrete.

The two abrasion test methods of this investigation differed in abrasive action, and this had a significant influence on the derived average abrasion rate. In Figure 13, when the w/cm ratio increased from 0.28 to 0.36 and then to 0.50, the average IARs of the concrete impacted at 45° were approximately 9.9, 8.4, and 8.6 times the average FARs, respectively. For the concrete impacted at 90°, the gains in the average IAR were about 16.7, 15.4, and 16.1 times those of the average FAR. These results reveal that the concrete attacked by waterborne sand flow impact abrasion exhibited greater abrasion damage than did that attacked by waterborne particle friction abrasion at the same abrasion time. This result confirms that the waterborne sand more easily wears a specific region of a hydraulic structure than water flowing over a structural surface does.

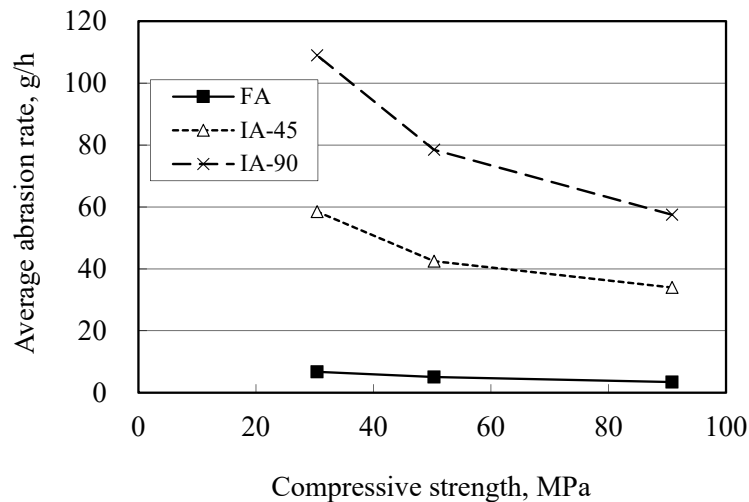
**Figure 14.** Relationship between average abrasion rate and compressive strength of concrete without steel fiber.

The abrasion resistance of concrete without steel fibers with a compressive strength ranging from approximately 31 to 91 MPa was investigated. The relationship between the average abrasion rate and compressive strength of concrete is illustrated in Figure 14. The results indicated that the average abrasion rate of concrete increased as the compressive strength decreased. As the compressive strength decreased from 50 to 31 MPa, the average FAR, IAR-45°, and IAR-90° increased to 0.08, 0.80, and 1.53 per MPa, respectively, and they increased to only 0.04, 0.21, and 0.52 per MPa, respectively, as the compressive strength decreased from 91 to 50 MPa. The result confirms that compressive strength was a crucial factor affecting the abrasion resistance of the concrete without steel fibers. This can be attributed to the fact that increases in the compressive strength of concrete, which consequently

enhanced mortar strength, were comparable to those of the coarse aggregate; both the aggregate and concrete were concurrently subjected to the same abrasive forces in the water-jet test or particle wear test. Additionally, the interfacial bond strengthened, and the equivalent peeling and grinding on the aggregate and mortar enhanced the overall performance of the concrete in terms of abrasion resistance. This finding confirms the results from other studies [5,7,16].
