Proposal of a Methodological Universal Guide to (Re)discover the Heritage: Palazzo Gastaldi-Lavagna

Proposal of a Methodological Universal Guide in Carrying out the Process of Renovation of a Historic Building

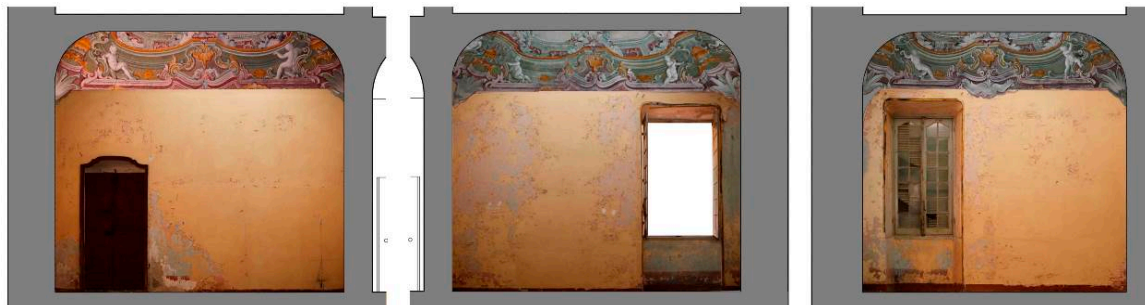
Figure 8. Survey carried out for the first room.

In light of the complexity of the subsequent design and construction phases, it was decided, using the existing geometric survey, to proceed with a photographic campaign with subsequent straightening to obtain a photogrammetric survey on which to carry out a material survey

and degradation analysis (Figure 8), which could constitute a precise basis for the diagnostic campaign and, subsequently, for the control and calculation of the measures and accounting of the planned interventions.

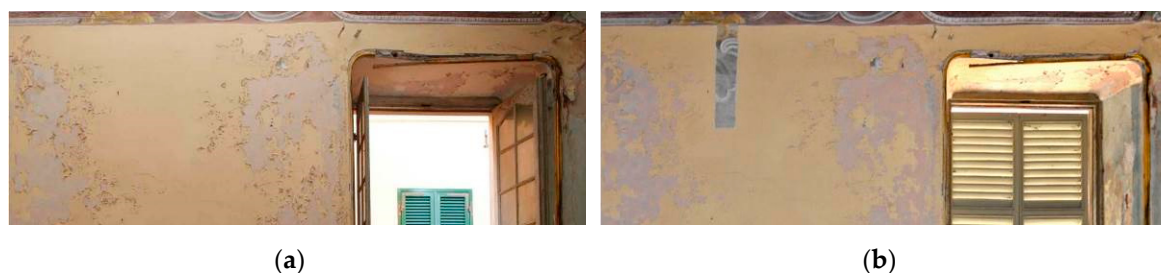
Figure 9. (a) Before the stratigraphical analysis (first room) and (b) after the stratigraphical analysis.

This type of investigation was carried out by making samples of different sizes in specific areas of the walls of the accommodation (walls and ceiling), removing each unit layer-by-layer, both mortar and painting, with manual or mechanical processes (scalpel, hammers, etc.) or a chemical one (with inorganic salt solution in deionized water) to highlight any decorations or painting prior to the restoration and dating back to the time of the construction of the building. In relation to the characteristics of the environments analyzed and the execution costs, the tests were carried out in significant numbers in the first three rooms. Four small tests were performed for the first chamber; two were made in the central part of the walls, at a height of about 1.5 m, and two in the upper part, at a height of about 3.5 m (starting point of the vault) (Figure 9).

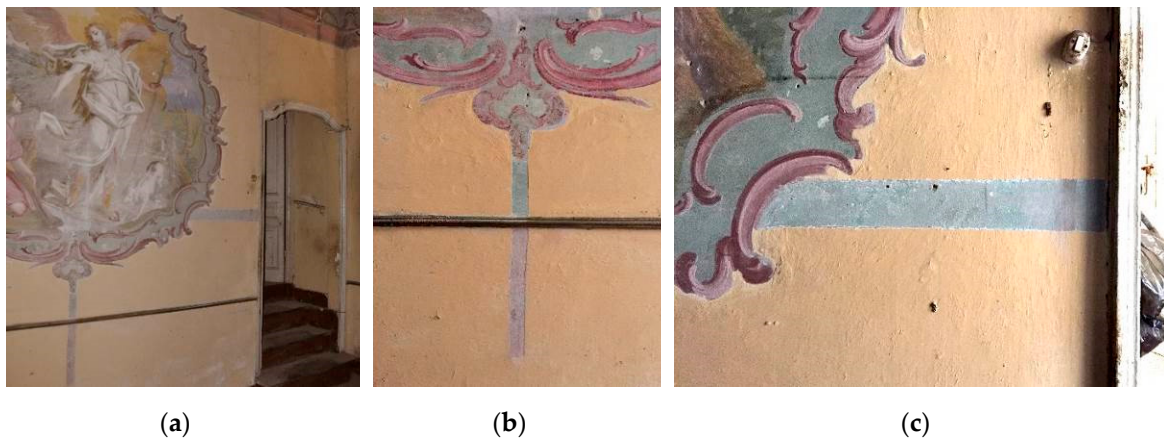
Figure 11. (a) Test performed in the second room (wall with San Giovanni Battista: vertical strip of 100×6 cm), (b) detail of the test with different plaster coloring in the lower and upper parts of the wooden molding and (c) test performed in the second room (wall with San Giovanni Battista: horizontal strip of 100×10 cm).

In the second room, different results were obtained in relation to the different points analyzed, leading also, in this case, to the discovery of a complex wall decoration. The tests revealed a water-green plaster in the upper part of the horizontal wooden molding that characterizes the walls and a red ochre one in the lower part (Figure 11). From these results, it was possible to understand that the wooden fascia is most likely coeval with the creation of plaster and frescoes and used as decoration to delimit the basement band. A hypothesis that has been also confirmed by the presence of iron elements (at a regular distance) drowned in the masonry of the other rooms and positioned at the same height as the wooden band in the second room, a sign that this type of decoration was present and was lost over time.

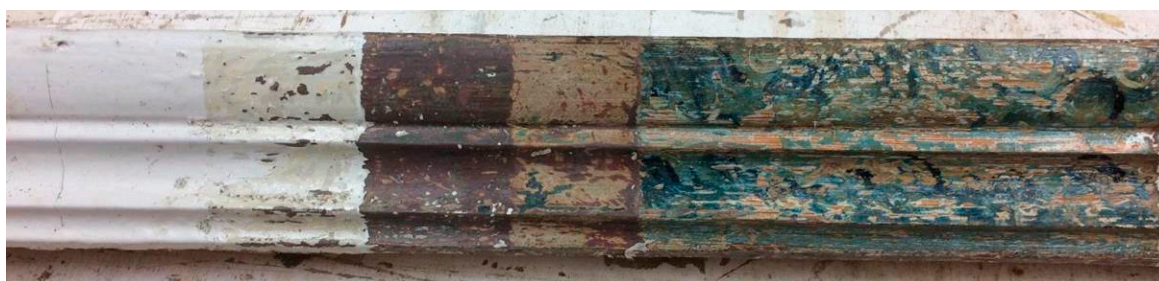
Figure 15. Stratigraphical analysis of the wooden moldings (entrance door, first room).

The stratigraphic analyses carried out on the wooden elements involved windows, doors and related internal moldings. The first investigations were conducted on the windows of evident eighteenth-century workmanship, on which traces of ancient polychrome decorations were found. It was therefore decided to proceed with the study of the wooden moldings of the doors and windows in order to obtain a complete and exhaustive knowledge profile of the state of affairs; from the analyses, it was, in fact, possible to understand the materials, state of conservation and period of realization of the analyzed elements to make the restoration project in compliance with the existing and its possible integration, replacements or possible removals. The investigation was carried out with manual, mechanical and/or chemical processes (with gradual variations of an acid solution), bringing to light the deeper layers. The original decorations, hidden beneath different layers of paint, were found to be rich in decorations with floral motifs (Figure 15) with green-blue shades similar to the designs that emerged on the windows and with the decorative wall system.

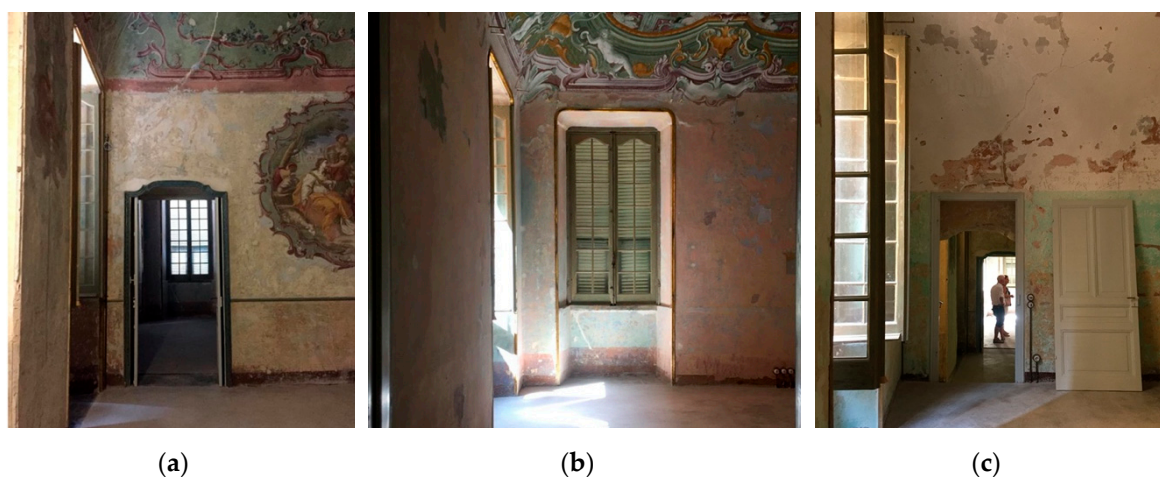
Figure 16. (a) Restoration of the walls of the second room, (b) restoration of the walls of the first room and (c) restoration of the walls of the room with the alcove.

Following the concept expressed by John Ruskin in the book “The seven lamps of architecture”, the conservation project wanted to follow a line of total respect, conservation and protection of the historical matter rich in that “golden stain of time” described by the English theorist. For the already visible frescoed surfaces and for those found during the stratigraphic investigation, a specific restoration project was therefore prepared by a restorer officially enrolled in the register. For the painted wall surfaces, the removal of all the superficial layers of paint in exfoliation up to the achievement of the original pictorial layer still present was provided; these were then treated with a transparent anti-dust protective layer able to maintain the pigmentation present (Figure 16); for this operation, a consolidating and transparent fixative primer (based on stabilized potassium silicate) was chosen for the anti-dust, consolidating treatment of the surfaces.

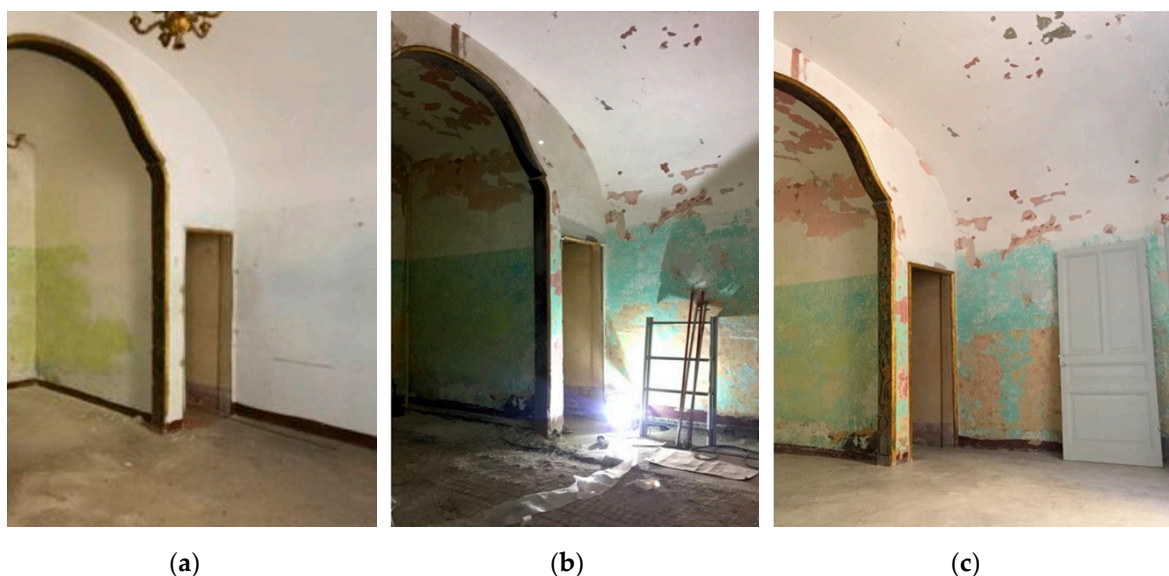
Figure 18. (a) Floor before starting work (room with alcove), (b) demolition of the floor and (c) new floor.

At the beginning of the works, the accommodation was already equipped with a meter for the supply of electricity and other supply lines (water, gas and telephone) centralized and distributed already during the general restoration of the building. The intervention provided for the passage under the track on the floor for all the systems. This choice was feasible in the light of the results obtained from the analyses carried out on the pavement, which demonstrated its subsequent realization and its possibility to be expendable. Its removal and subsequent remaking in a mixture was carried out with the use of aggregates of a size similar to the existing ones (Figure 18). The mixture was obtained with local aggregates found in neighboring quarries and lime as a binder. The use of lime (and not cement) is related to the historical and chemical compatibility of the material with respect to existing ones.

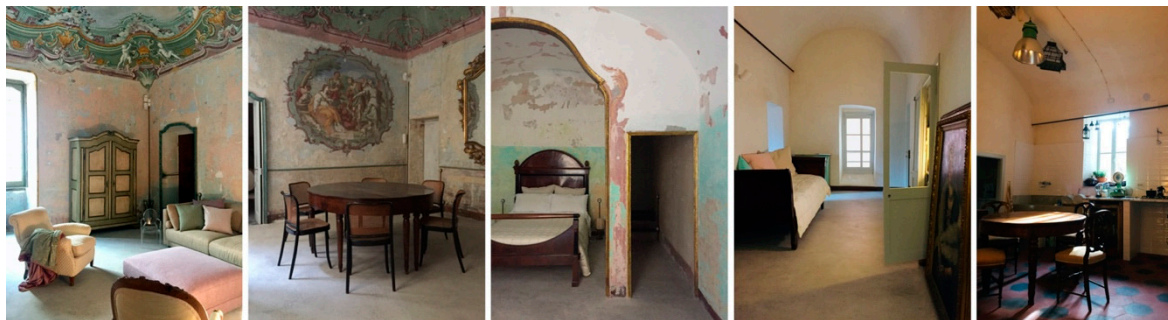
Figure 19. Image of the completed work with new functions for the different rooms.

The new floor was carried out onsite with a continuous surface and subsequent application of a final protective treatment, carried out by impregnating the floor with natural oils and waxes. This choice, in addition to repositing the current flooring, must be sought in its physical-mechanical characteristics that give it impact resistance, easy maintenance and a low humidity content, as well as the ability to accumulate heat and release it slowly. This makes this floor the ideal compromise between compatibility in the logic of the restoration and energy redevelopment of the accommodation. For this reason, this choice has been extended to all rooms, except for the service rooms, such as the bathroom, kitchen and pantry, for which the current type has been preserved. Finally, the electrical system was built with passages under the floor for the main lines, while the continuation in the external lines was made with copper pipes for the walls with frescoed surfaces in order not to make cuts in the walls and, therefore, a loss of the material (Figure 19).
