# From the Point Cloud to BIM Methodology for the Ideal Reconstruction of a Lost Bastion of the Cáceres Wall

**Keywords:** laser scanner; georadar; BIM; cultural heritage; virtual reconstruction; Cáceres; Spain

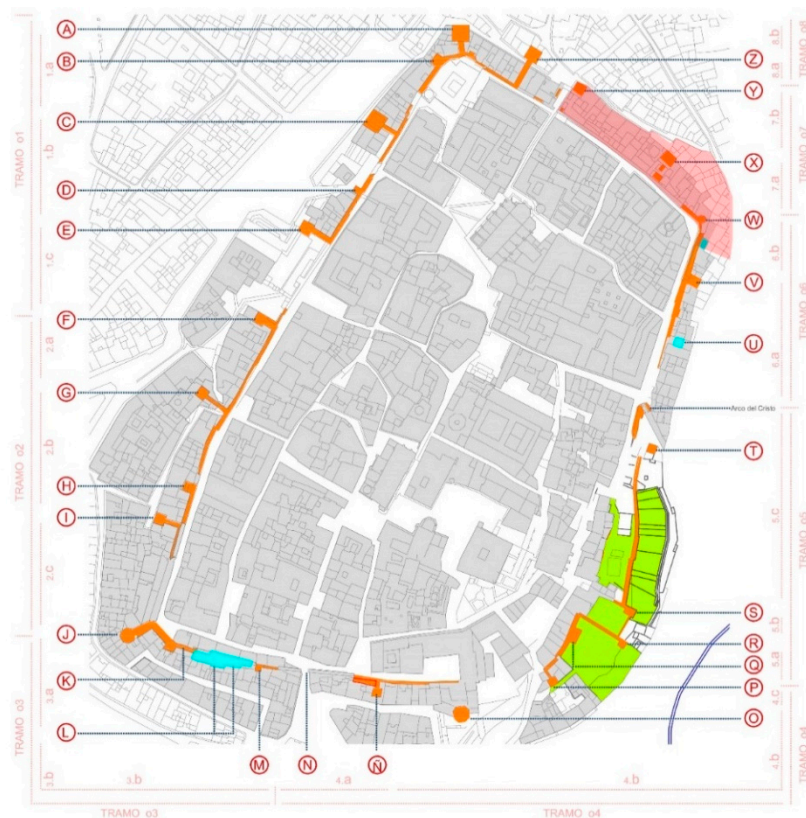
**Figure 1.** Location map of the intervention. A—garbage tower; B—Spain arch street tower; C—Bujaco tower; D—pulpit tower; E—Yerba tower; F—oven tower; G—Postigo tower of Santa Ana; H—tower of Calle Adarve del Padre Rosalío; I—Aver tower; J—octagonal tower; K—tower for private use; L—hidden towers (historically located); M—Cornudillas Street tower; N—Mérida gate tower; Ñ—Torremochada street tower; O—Torre mochadi; P—Hernando Pizarro street tower; Q—Covacha tower; R—tower of the cisterns; S—water well tower; T—river tower; U—southern tower of Caleros Street; V—Caleros tower; W—round tower; X—air tower; Y—relief tower; Z—king’s tower.

This text summarizes all of the actions carried out for the virtual reconstruction of the lost canvas of the wall of the historic city of Cáceres [1–3], a World Heritage City. For this, both preliminary studies (architectural, archeological, historical, etc.) and works executed with the first results on the study of the immediate surroundings of this section of the Cáceres fence served to demonstrate the main hypothesis, namely the existence of a lost door of access to the city at this exact point in the wall. For this, exhaustive data and work were taken with remote sensing. In Figure 1, we can see the area of action within the intramural enclosure of the historic center of Cáceres, and in Figure 2 you can see the starting path of the wall at that particular point.

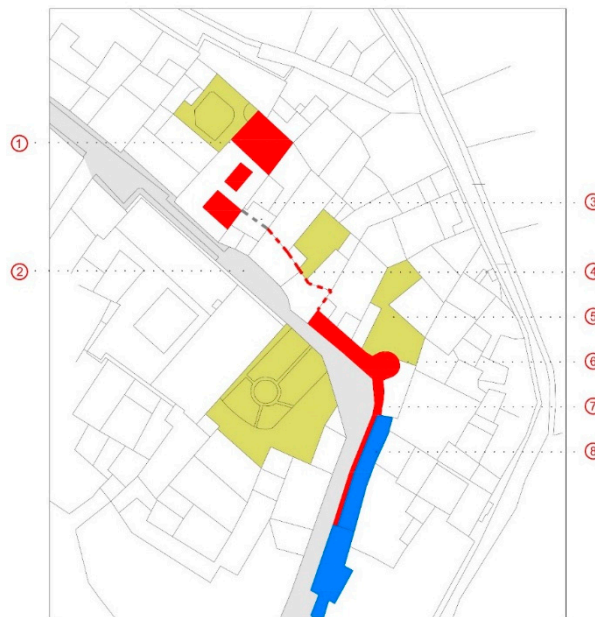
**Figure 2.** Identification of archaeological elements of the fence from the studies carried out in the area. 1—air tower; 2—Adarve del Cristo; 3—supposed layout of the wall based on the hypothesis; 4—wall canvas hypothesis; 5—patios; 6—Ochavada tower; 7—conserved wall plot; 8—preserved antemural shape.

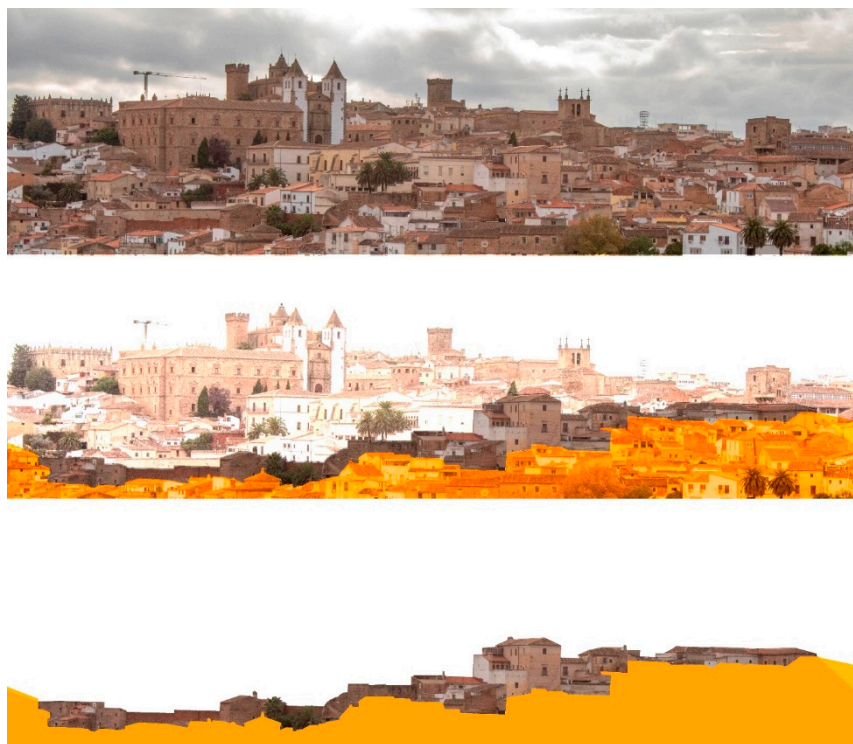
**Figure 3.** Location of the intervention within the defensive line currently absorbed by existing buildings. View from the Cerro de la Butrera.

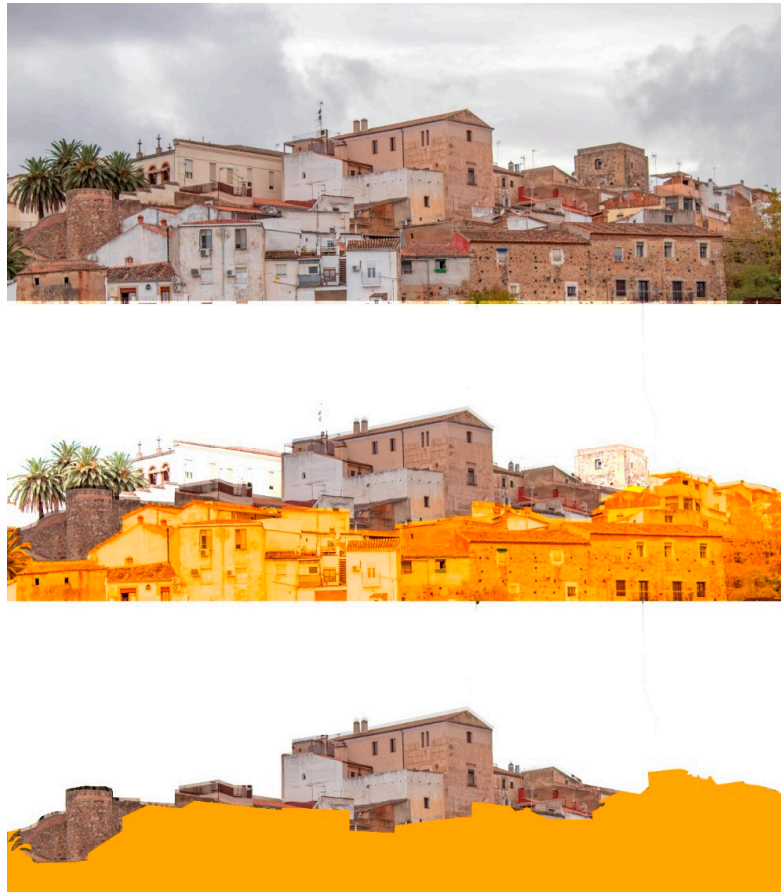
**Figure 4.** Location of the intervention within the defensive line currently absorbed by the existing buildings. View from the surroundings of the Rivera del Marco.

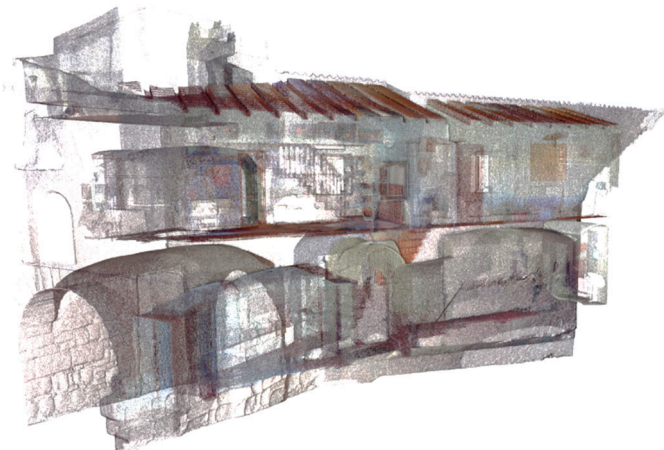
**Figure 6.** The methodology developed to elaborate the general mesh of the project allows for including the survey of the interior point cloud of the palaces and buildings they are carried out.

First, with the laser scanner, a massive capture of points was obtained with which the cartographic base was created, which served as the basis for the subsequent implementation of the rest of the techniques. In Figure 6, we can see the point cloud taken with a laser scanner from the interior of one of the referenced buildings of the general mesh of the project.

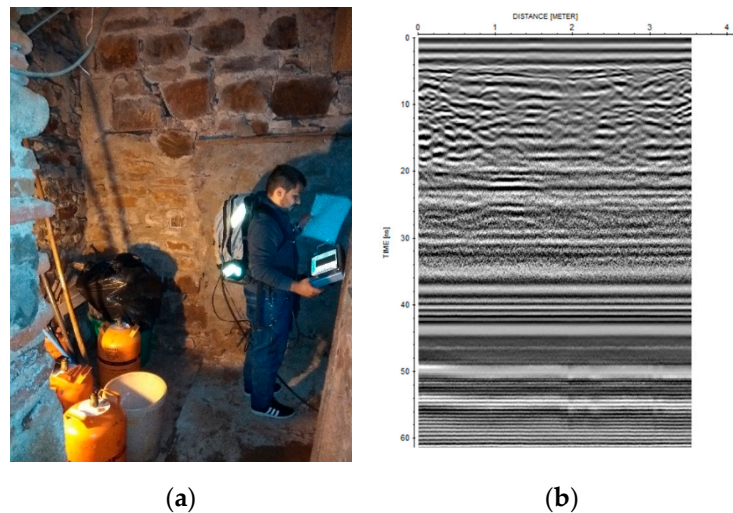
**Figure 11.** (a) Field work photography; (b) radargrama obtained in one of the walls with when attempting to obtain the thicknesses of wall and hidden cavities.

In addition, a GPR study was carried out in order to refine the thicknesses of these layers and to control what was happening inside the wall—we were looking for holes and gaps that also explained the construction model followed for each material [23–25]. One of these radargramas it is shown in Figure 11, where the discontinuities in the wall can be seen.

Thanks to this methodology, it was possible to detail a sharp change of material to 2.4 m, which is understood as the original rock or foundation of the wall at this point in the city, something that, until now, had not been known, and that greatly facilitates our the understanding of this unique element cataloged and protected within this context [26,27].

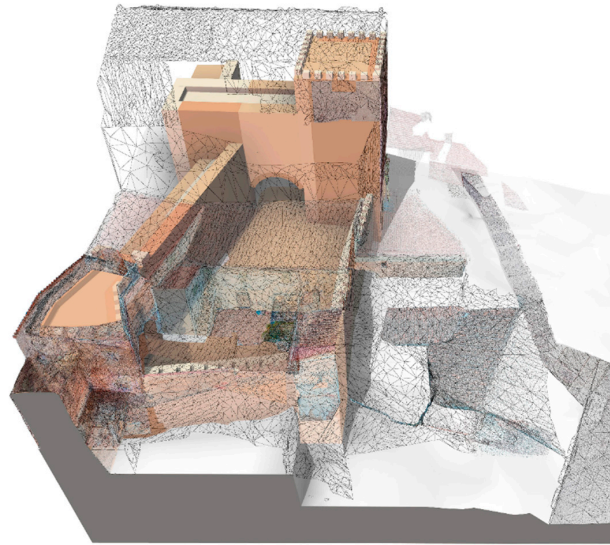
**Figure 12.** Modeling and digital documentation work. Concept of a possible bastion located between the Torre del Aire and the corrala to which our building allows access. The recreation is modeled in Revit, IFC format, from laser scanner shots that guarantee centimeter accuracy, which allows us to analyze reality.

Then, the detailed and non-invasive analysis of the urban settlement of the wall and its surroundings reflected data of great interest that, until now, remained hidden, either because they were not visible to the naked eye or because they did not have the visible spatial-dimensional relationship between different elements that, having them raised with clouds of points, it has been possible to understand their relationship. In fact, it was possible to sort the points in the layers in such a way that it was possible, for the first time, to “turn off” those layers of existing buildings that “made noise”, in order to understand the whole. An example of this can be seen in Figure 12.

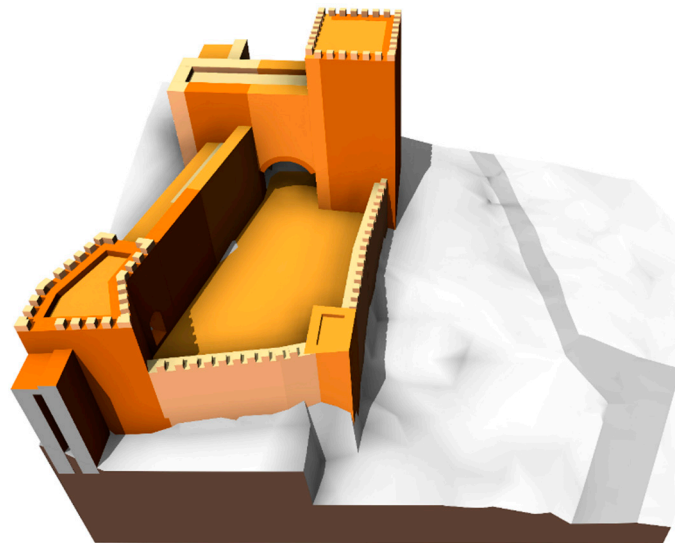
**Figure 13.** Virtual recreation of the hypothesis proposed in the studied area executed in IFC in a collaborative way.
