# Numerical Investigation of the Collapse of a Steel Truss Roof and a Probable Reason of Failure

**Abstract:** This study investigated the failure of the roof, with steel truss construction, of a factory building in Tekirdag in the northwestern part of Turkey. The failure occurred under hefty weather conditions including lightning strikes, heavy rain, and fierce winds. In order to interpret the reason for the failure, the effects of different combinations of factors on the design and dimensioning of the roof were studied. Finite element analysis, using the commercial software Abaqus (Dassault Systèmes, Vélizy-Villacoublay, France), was performed several times under different assumptions and considering different factors with the aim of determining the dominant factors that were responsible for the failure. Each loading condition gives out a characteristic form of failure. The scenario with the most similar form of failure to the real collapse is considered as the most likely scenario of failure. In addition, the factors included in this scenario are expected to be the responsible factors for the partial collapse of the steel truss structure.

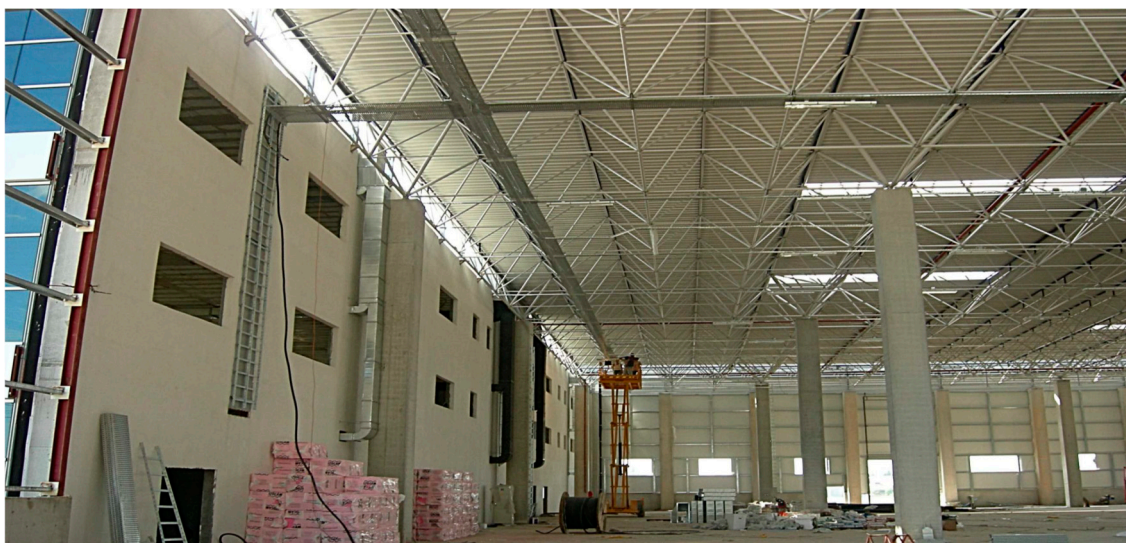
**Figure 3.** Overview of the roof structure.

The steel space truss roof structures are mounted on reinforced concrete columns that are 11 m tall with an 80 cm by 80 cm cross-section. The number of columns and their configuration can be seen in the plan view of the building, which is given in Figure 1. No failure, no deformation, and no cracks were observed on these columns during the investigations. Only some broken wings were observed on their top section, which was assumed to have happened during the collapse of the roof. Thus, it was concluded that the columns did not play a significant role in the collapse mechanism of this building. On top of the columns, the spherical joints are welded to the bearing plates. Figure 3 represents an overview of the real building structure, and Figure 4 shows the damaged roof of the space frame system on the night of the incident.

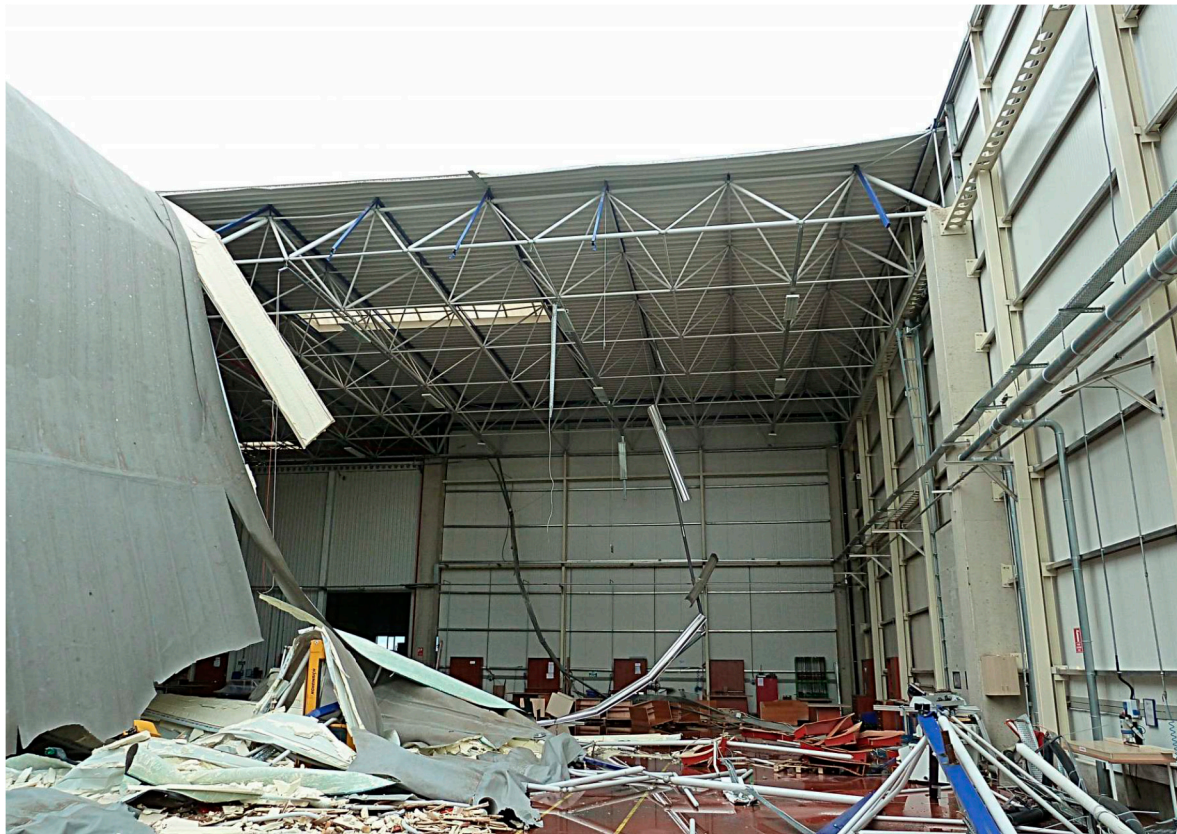
**Figure 4.** Damage to the roof's space truss system.

On the day of the incident, more than 500 lightning events were detected in the region by the British Meteorological Office's (The Met Office) ATDnet (Arrival Time Difference Network) system and the Vaisala Global Lightning Dataset GLD360. It was determined that lightning struck the building and the lightning rods worked. Meteorological data indicate that the thunderstorms were rainy and the wind blew from 40 to 60 km/h from the north and northeast directions and up to 70 to 80 km/h locally. The rainfall was 22.6 mm during the collapse, although equally heavy local rainfalls had occurred several times in recent years. Around the roof, there are several siphonics at 5 cm height. The heights of the parapets on the roof are 15 cm and 25 cm. Although no scuppers are required to be used on such a shallow parapet, there are several scuppers of 15 cm height on the roof structure.

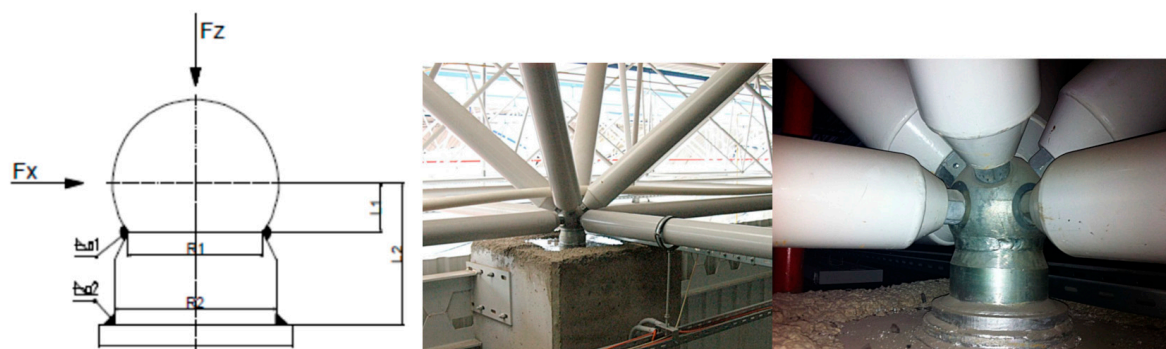
Figure 5. View of the spherical joints and the supports.

The support spheres are fixed onto the concrete columns by using square or circular plates bolted to the columns. The supports are made of EN C45 steel, and Teflon plates are placed under the sliding supports to reduce friction. The details of the joints and supports are given in Figure 5.
