Article

Flexural Behavior of Post-Tensioned Concrete Beams with Multiple Internal Corroded Strands

Chi-Ho Jeon and Chang-Su Shim *

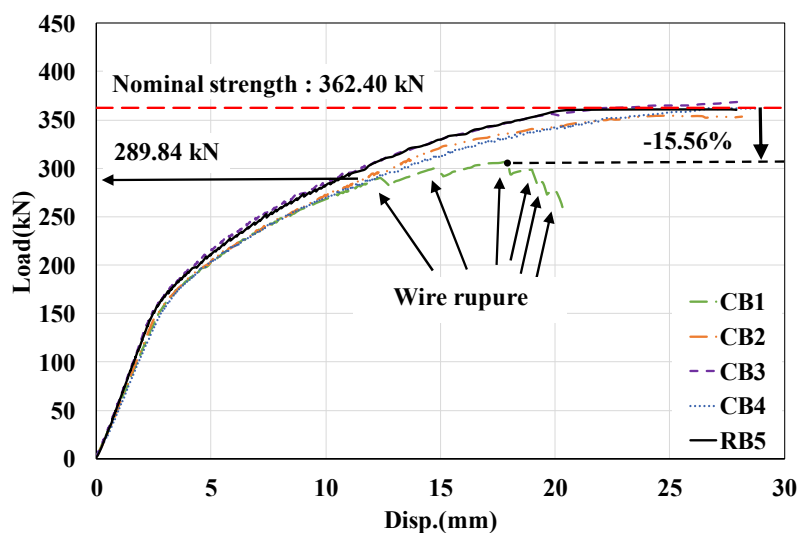
Figure 5 shows the load-displacement behaviors of the test specimens, and the results are summarized in Table 3. The nominal strength of the PC beam with non-corroded strands was calculated as 362.40 kN, which was based on the conventional concrete stress block theory and the bilinear elasto-plastic model of steels. Using this calculation, the effective prestress of the strands was 688 MPa due to the somewhat large loss, as the prestressing of the three strands and anchor caused large short-term losses. RB5, which had no corrosion, faced a situation where a support slightly went out of place (about 10 mm in total), and the load no longer increased after a displacement of 20 mm. Therefore, although the strength was estimated to be 361.13 kN, it is expected to be higher than the original nominal strength.

Figure 5. Load-displacement behaviors from test results.

CB2, CB3, and CB4 did not show any noticeable difference in load-displacement behaviors. The cracking loads were the same as RB5, and the maximum loads were also similar to that of RB5. Only CB2, which had the second greatest tendon-unit section loss, exhibited reduced strength (2% less than the nominal strength). However, it was difficult to know if this difference was due to corrosion, as CB3 had the highest strength even though it had the second highest wire-unit section loss, and it

exhibited similar post-cracking stiffness to RB5. This could be explained by the fact that the corrosion occurring in the parabolic tendon near the supports was below the level of corrosion represented here and did not significantly affect the global behavior—possible reasons may be the generation of a low bending moment as well as the tensile stress due to its location near the neutral axis in the section. Coronelli et al. [25] also found this phenomenon in their study whereby the remaining portion of a wire could provide residual prestressing effects when wire failure occurred close to the support. In addition, the effective bond length from wire-unit section loss in Table 1 did not seem to be valid. When considering effective bond length from strand-unit or tendon-unit section loss, the degradation of bond strength due to the degree of corrosion in the PC specimens did not affect the global behaviors.

CB1, which had the greatest section loss in the middle of the span, exhibited six wire ruptures during the loading. The load suddenly dropped by 9 kN when the load reached 289.84 kN with the first wire rupture. The maximum load was 306.01 kN when the third wire ruptured, which decreased the load from the nominal strength by 15.56%. The proportion of the three wires lost in the total strand cross-sectional area was about 14%. The rupture of the wires in the governing section of the PC beams showed a very close correlation with the ultimate strength. However, since it is not possible to predict how many corroded wires will fail during the ultimate stage of evaluating the behavior of the member, it would be reasonable to define the first wire rupture as the moment at which the life of the member ends. The load at which the first wire failed is referred to as the ultimate strength from here on.

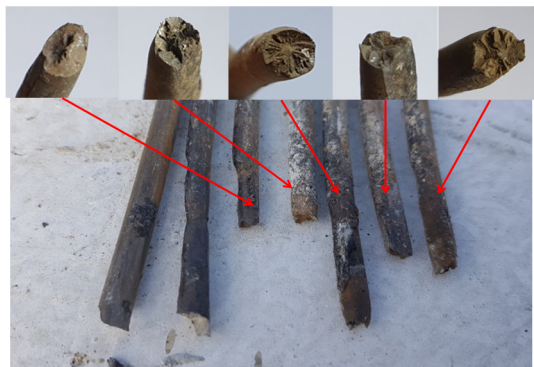
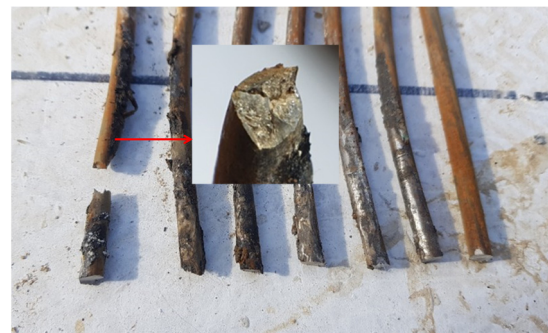
Figure 6a shows the side view when CB1 was deconstructed after the experiment, and Figure 6b,c show the failed sections of the 1st and 2nd strands recovered from CB1, respectively. The section losses in Table 4 were measured before those applied to the specimen using section loss measurement method with Figure 3 and Equations (1), (2) and (3). The number of failed wires was found to be six as shown in the load-displacement behavior in Figure 5—however, it did not occur evenly among the corroded strands. Five wires failed at the 1st strand even though the section losses were not much different from the 2nd strand. This may mean that the stress distribution occurs only between the wires within a strand, but not between adjacent strands. To clearly explain this phenomenon, further study is required, including unbonded cases.

Figure 6. Deconstruction of CB1 after the loading test. (a) Side view, (b) failed section of 1st corroded strand, (c) failed section of 2nd corroded strand.

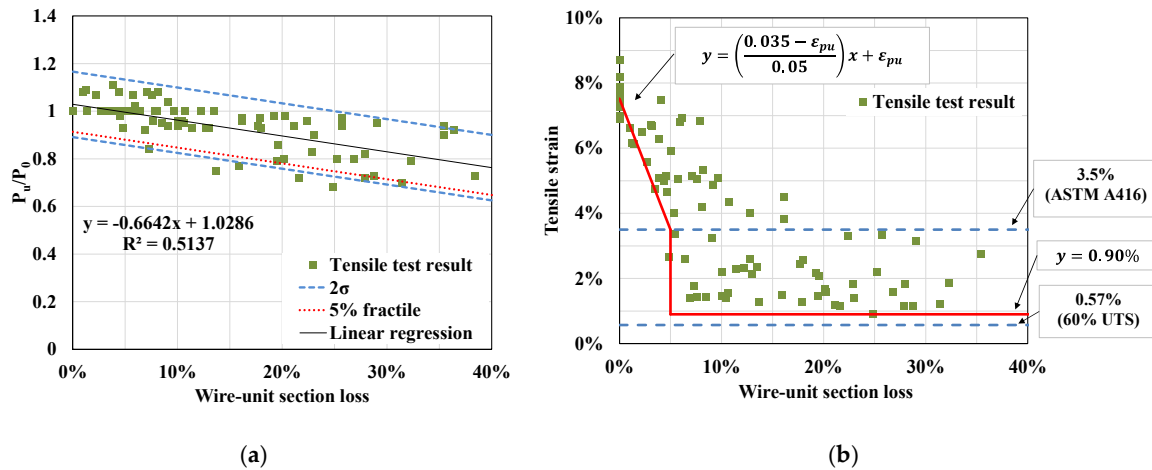
deteriorated behavior of corroded PC beams. Therefore, the term ultimate strain was used as an indicator of the average decrease in tensile capacity due to corrosion induced section loss so that the tensile capacity could be expressed by the material model, even though ultimate strain of “metal” has no correlation with corrosion induced section loss. The ultimate strains of corroded strands could be obtained by dividing the elongation by the target length.

Figure 7. Tensile test results of corroded strands, (a) relationship between the ultimate load and the wire-unit section loss, (b) relationship between the ultimate tensile strain and the wire-unit section loss.

Unlike the previous research [18], a new approach to the residual ultimate strain of the corroded strands was considered as shown in Figure 7b. With cross-sectional losses within 5%, the ultimate strain tended to decrease linearly; however, it sharply decreased with large deviations, after which it converged to a certain value. Therefore, the relationship between the residual ultimate strain and the section loss could be defined by dividing it into “before” and “after” 5% loss categories. Because the total elongation of 7-wire strands should not be less than 3.5%—according to the American Society for Testing and Materials standard ASTM A416 [26]—the residual ultimate strain for section loss less than 5% was defined by a straight line connecting 7.52% of the ultimate strain of non-corroded strands and 3.5% of ASTM A416 [26].

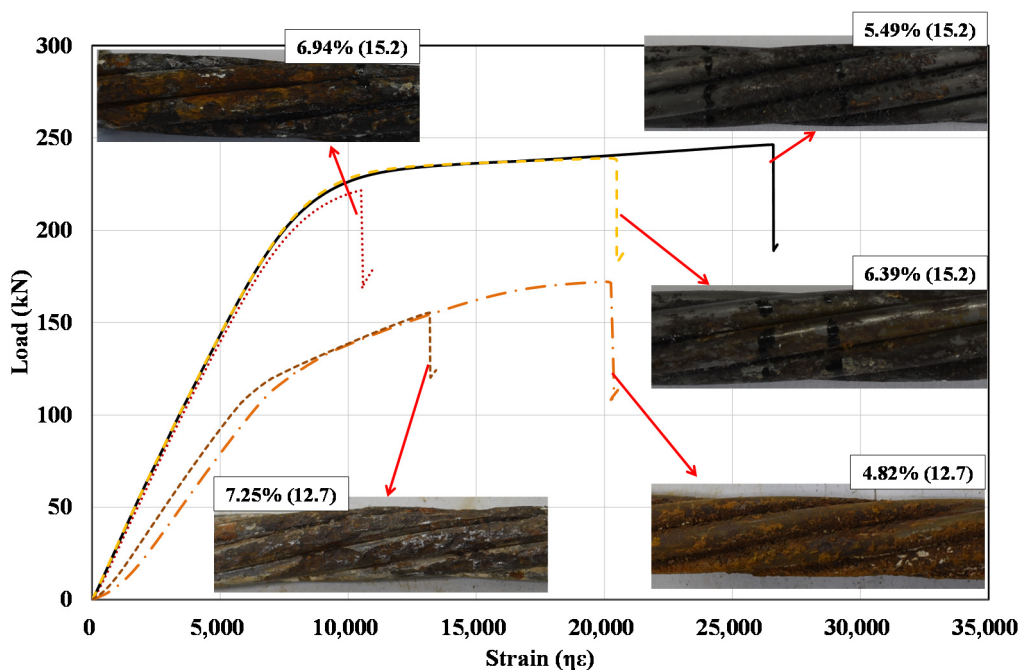
According to the previous research [16], it has been found that the elongation capacity of the corroded strand decreases linearly and rapidly at around 5% of cross-sectional loss, using finite element analysis. This was also observed in a few tensile test specimens as shown in Figure 8, which shows five examples of tensile test results and their corrosion features with “wire-unit section loss (type of strand)”. The test results imply that there can be a large reduction in elongation capacity of corroded strands even in moderate corrosion of 5% section loss.

Figure 8. Tensile test results of corroded strands.

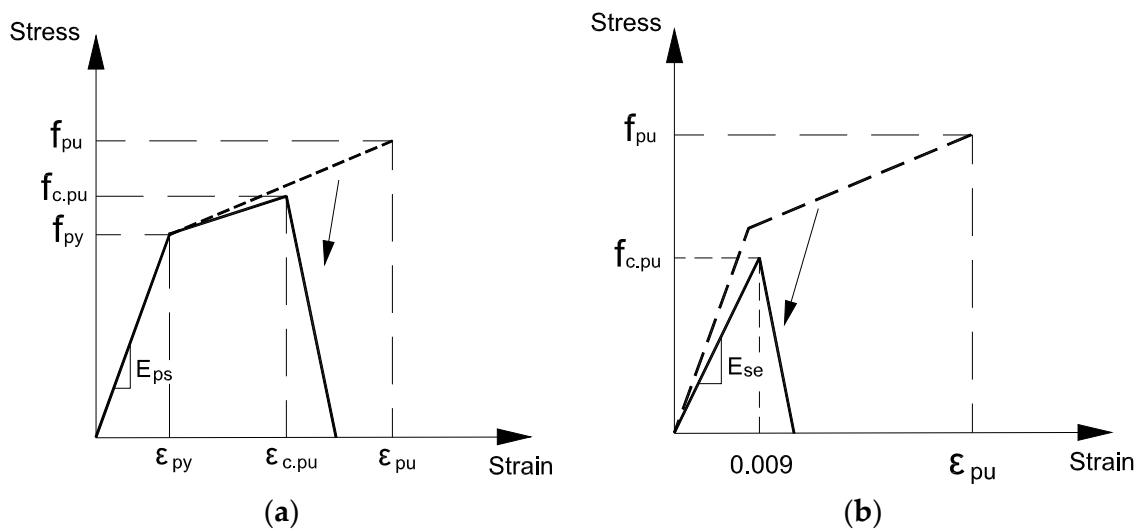
Based on the material properties shown in Table 2, the bi-linear model was used for the non-corroded strands. In the case of $\eta \leq 5\%$, the material model of corroded strands was defined as shown in Figure 11a. Because the yield properties were not affected significantly by corrosion [18], f_{py} was unchanged, and the ultimate properties were defined using Equations (6) and (7). The $f_{c,pu}$ can be obtained by dividing $F_{c,pu}$ by the gross sectional area of the strand, A_{ps} . A_{ps} is used to reflect the corrosion effect on the stress–strain curve. In the case of $\eta > 5\%$, the ultimate properties were lower than the yield properties, and brittle behaviors were observed in the tensile tests. Therefore, the material model of corroded strands was built based on the brittle material model (as shown in Figure 11b) considering only the ultimate properties from Equations (6) and (7), with the stiffness changed to the secant stiffness, E_{se} . After the $f_{c,pu}$, a sharp decrease in strength was modeled in both corroded cases to simulate the wire rupture. These were modeled using the multilinear material model predefined in OpenSEES [28].

Figure 11. Material models of corroded strands in case of (a) $\eta \leq 5\%$ (b) $\eta > 5\%$.

The strain-compatibility method resulted in relatively more accurate estimations because the f_{ps} approximation method could not include the rapid strain reduction. Furthermore, the material model—as shown in Figure 11b—resulted in the initial stiffness reduction in the corroded strands.

To calculate the difference in strength evaluation of the corroded PC beams, between the strain-compatibility method and the f_{ps} approximation method, Monte-Carlo simulation was conducted. The Monte-Carlo simulation is a traditional probabilistic technique and is very useful to evaluate the probability of failure [31]. Random variables for the simulation were the section losses of the strands in the interval of 0 to 30% and applied to the three strands separately. Consequently, the total interval of variables was (0%, 0%, 0%)–(30%, 30%, 30%). Based on the section loss, the material models were changed based on Figure 11.

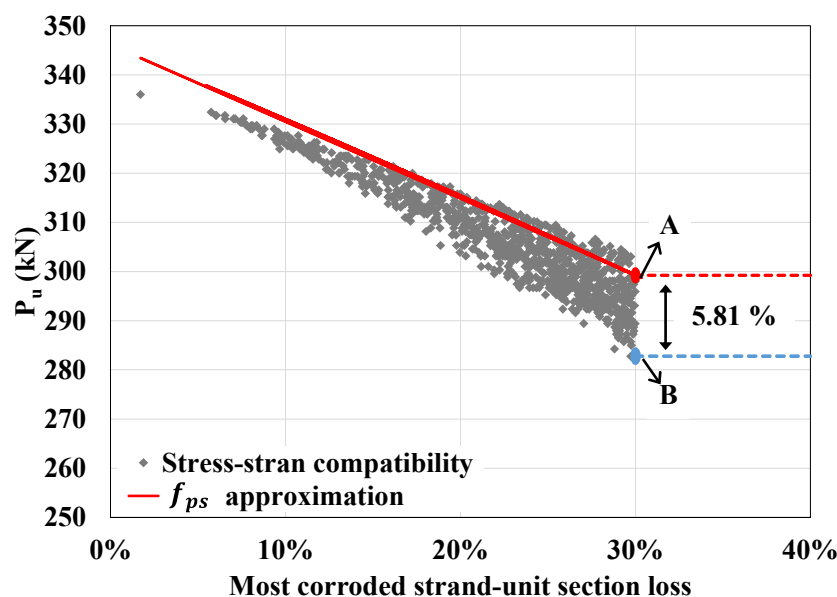
Figure 12 shows the results of the Monte-Carlo simulation on CB1 with respect to 1000 random variables. Because the f_{ps} approximation method considered only the ultimate strength of the most corroded strand, there was no variation at the same point of cross-sectional loss. Point A denotes the strength at 30% loss, which was 299.22 kN. On the other hand, the strain compatibility method showed a different flexural strength even in the same section loss of the most corroded strand, because it reflected three different corrosion properties, and the variation increased with the amount of section loss. Point B shows the flexural strength to be 282.78 kN when the three strands exhibited section losses of (30%, 30%, 30%). The difference between A and B was 5.81%. When it comes to existing PC beams, only the outer strands in tendons can be inspected for section loss; therefore, it is required to assume that all strands have the same section loss as the inspected most corroded strands. B represents this situation—the result of A provides a somewhat overestimated strength. In addition, this gap could be larger in full-sized PC girders because those had dozens of strands in a tendon

Figure 12. Monte-Carlo simulation of CB1.
