# Mechanical Properties of Historic Masonry Stones Obtained by In Situ Non-Destructive Tests on the St. Agostino Church in Amatrice (Italy)

**Featured Application:** The use of non-destructive diagnostic techniques for the in situ and non-invasive mechanical characterization of historic stone masonry.

**Abstract:** The design of strengthening and securing work for historic buildings requires knowledge of the masonry mechanical characteristics, often obtainable through laboratory tests that require invasive samples. The non-destructive techniques, applicable in situ in a rapid and non-invasive way, represent a valid alternative to estimate mechanical strengths without destructive sampling. In this study, a methodology was calibrated which, by combining the results of the ultrasonic and impact tests, makes it possible to reach a good estimate of the compression strength and elastic modulus of a particular rock: sandstone. Most buildings in Amatrice, the city devastated by the violent earthquake of Central Italy in 2016, were built by means of this sedimentary rock. By carrying out a diagnostic campaign on the remaining walls of the St. Agostino church in Amatrice, it was possible t

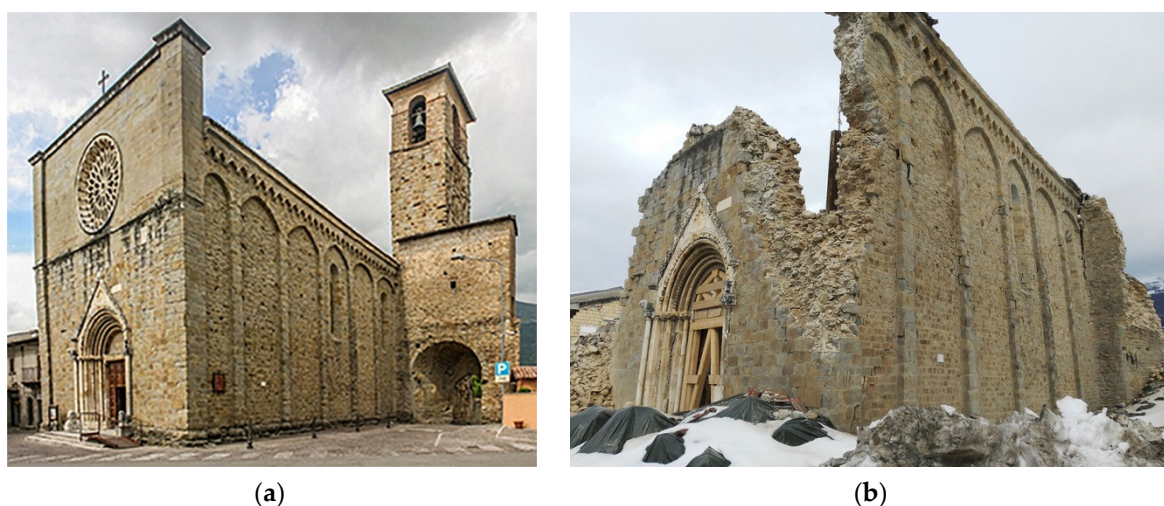
**Figure 1.** St. Agostino church in Amatrice before (a) and after (b) the seismic earthquake swarm of 2016 in Central Italy.

took place with stones quarried in the same sites from which the building stones were obtained, they were capable of giving only “poor” lime. From this lime, a mortar, as the binder of the masonry, was obtained with low calcium content, which over time degraded more rapidly, no longer binding the stones of the masonry. In particular, one of the symbolic damaged buildings in the historic center of Amatrice was the St. Agostino church, a Romanesque-Gothic construction built in 1428 (Figure 1a), which suffered an almost total collapse that occurred in progressive phases during the long seismic earthquake swarm after the first violent earthquake of 24 August 2016 (Figure 1b) [9]. The façade was composed of sandstone, and the interior was made from a single nave with a wooden roof and exposed trusses.

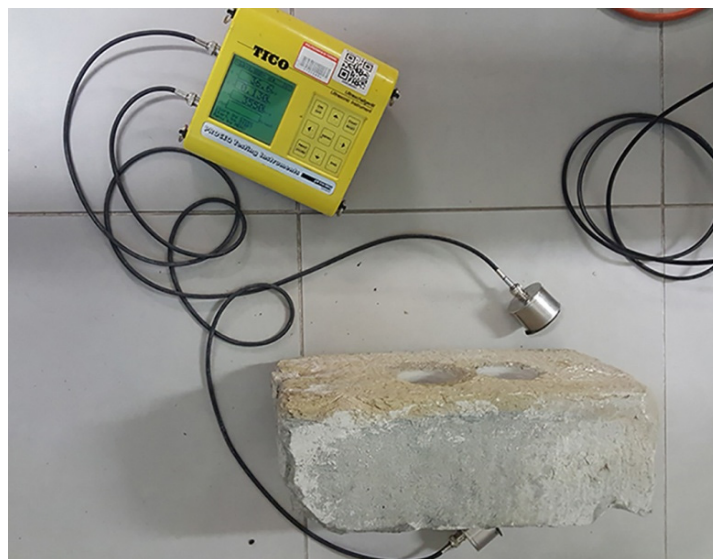
**Figure 4.** Ultrasonic test setup.

- Ultrasonic tests for the determination of the elastic dynamic modulus performed on the same stones (Figure 4);
- Impact tests carried out on the same stones (Figure 5).

Ultrasonic tests were also conducted on the same stones to estimate the dynamic elastic modulus ( $E_d$ ). Ultrasonic inspection is a non-destructive method, in which high frequency sound waves are introduced into the material to be examined, in order to highlight any surface or internal defects. Longitudinal waves were produced by means of an electro-acoustic transducer (emitting probe in piezoelectric or magnetostrictive material) placed in contact with the stone surface under test; after passing through a path of known length, the train of waves was converted by a second transducer (receiving probe) into an electrical signal processed by electronic timing circuits that allow measurement of the transit time of the impulses. The ultrasonic test device consisted of: a Proceq Tico<sup>®</sup> pulse generator; two transducers of 54 kHz (one emitting and the other receiving); a pulse amplifier; and an electronic device for measuring the time interval (Figure 4). The speed of the wave ( $v$ ) depends on the presence of any defects inside the material, and is related to the value of the dynamic elastic modulus ( $E_d$ ) through the density ( $\rho$ ) and the Poisson's ratio ( $\nu$ ) of the material. Therefore, the value of the dynamic elastic modulus ( $E_d$ ) of the stone can be obtained using the following relationship, in accordance with the technical standards ASTM D2845 1995 and UNI EN 12504-4: 2005 [27,28]:
