Application of Anti-Moisture Technologies in Historical Constructions from the Perspective of Sustainability

Department of Building Technology, Faculty of Civil Engineering, Slovak University of Technology in Bratislava, 810 05 Bratislava, Slovakia; jozef.gasparik@stuba.sk (J.G.); oto.makys@stuba.sk (O.M.); barbara.chamulova@stuba.sk (B.C.); sylvia.szalayova@stuba.sk (S.S.)

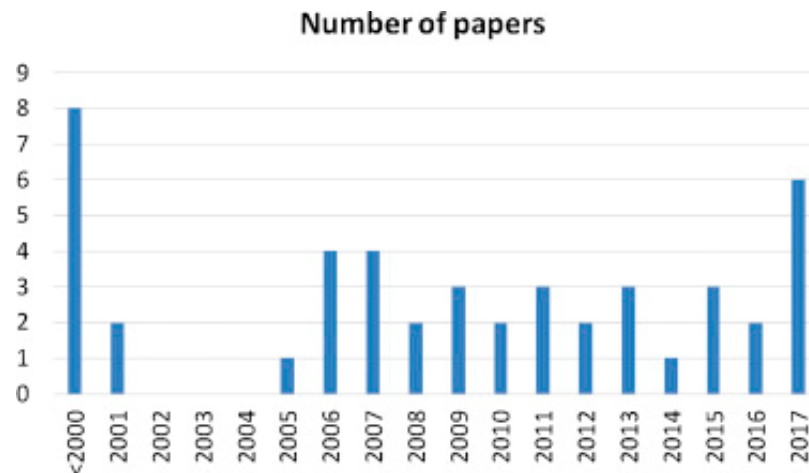
Figure 1. International papers per year [8].

19th century. Unfortunately, this problem has been overlooked for many years and has not been considered as a real threat from a professional point of view. As a suitable example can be assigned research [8], which dealt with the creation of an overview of international works that dealt with the removal of rising damp. The article lists publications that were collected by 2017. The Figure 1 shows that publications with this theme began to have a rising tendency after 2005.

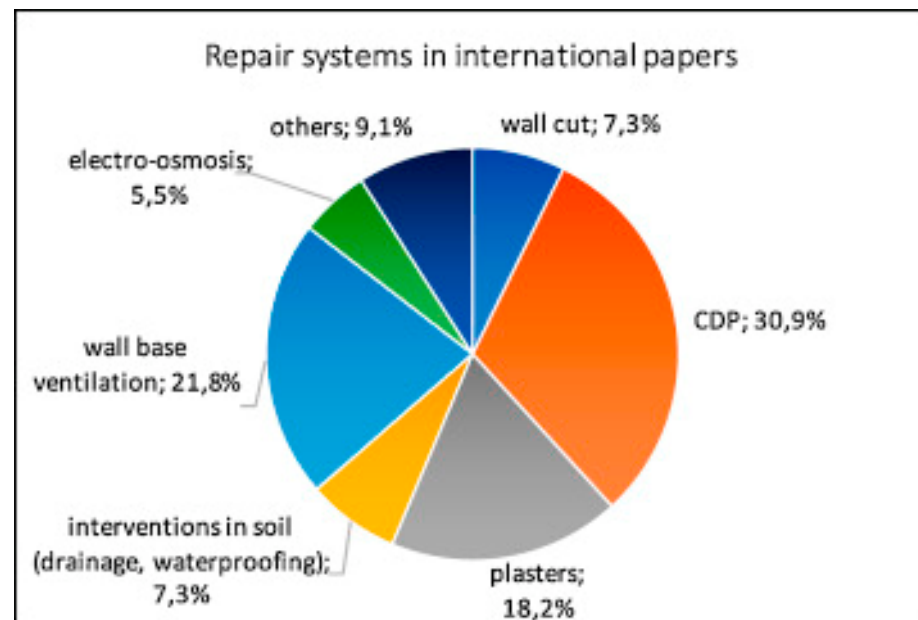
Figure 2. Repair systems considered in the 46 scientific papers examined (papers investigating more than one system were counted more than one time) (CDP: Chemical Damp Proofing) [8].

Publications according to multiple criteria were analyzed in this contribution. Interesting for us can be Figure 2. Here is the percentage of remediation technologies usage in listed research. In our contribution we will focus on remediation technologies (undercutting, magnetokinesis) that have had a relatively small representation in this research. We also describe the efficiency of ventilation systems that had a high percentage of representation.

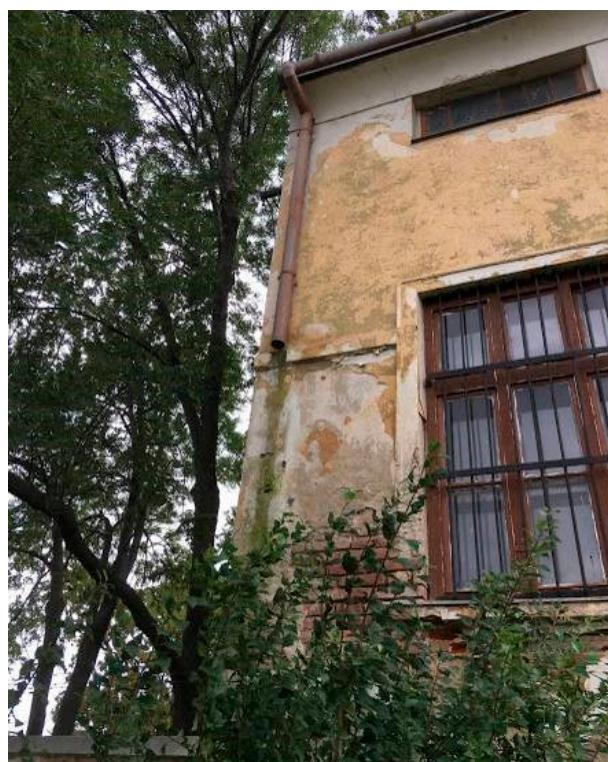
Figure 3. Facade condition before applying remediation intervention.

The problem of the building was mainly in interiors and exteriors plasters (Figure 3). These were in ramshackle state, which also restricted the use of a building.

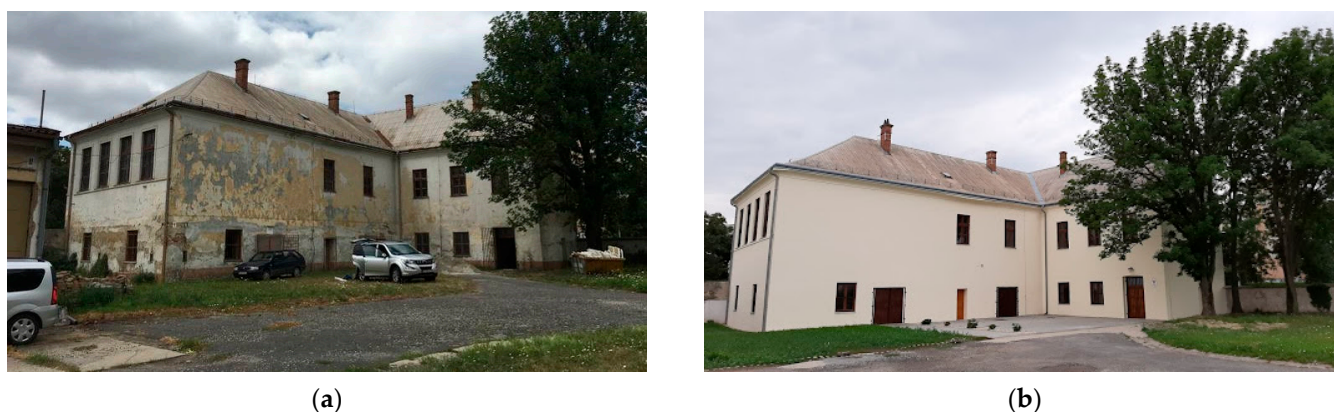
Figure 5. View on the state of building (a) before and (b) after recovery.

As values state, after application of the invasive method of undercutting (in combination with other methods in parts of the building), moisture from the point of view of the ČSN P 73 0610 standards significantly decreased. Walls can be considered as surface dry. This phenomenon occurred after a relatively short time. This fact has helped to restore the building from its original state (Figure 5a) to a new state (Figure 5b). For a comparison of functionality, reference may be made to another publication [9]. Here, the authors researched several similar objects where invasive remediation interventions were applied. These interventions can be considered very successful from a technological point of view. Properly implemented, a new impermeable layer will be created that can withstand rising humidity. From the perspective of the sustainability of historical buildings, this intervention may be considered as a very positive. At all inspected points, the level of wetting dropped significantly by an average of 65% of the original moisture value, which indicates the success of remediation interventions. The building also found new use as a depository for storing archaeological findings. New use of this building can be evaluated as one of the most positive in terms of sustainability of historical buildings.

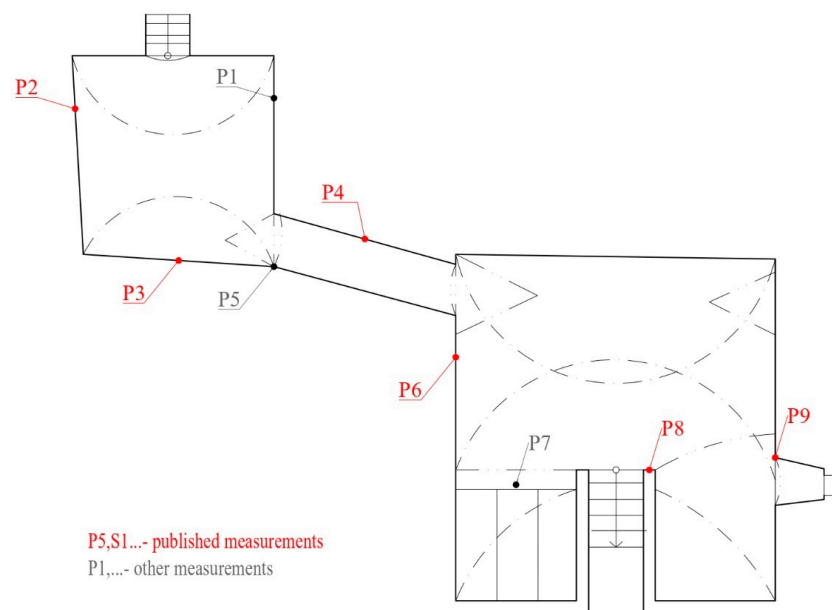
Figure 6. Humidity measurement points (2nd researched building).

The selected measurement points represents Figure 6.

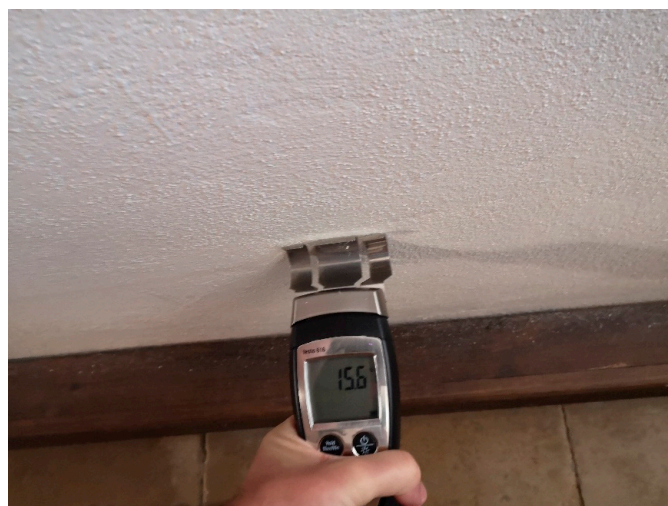
Figure 7. A picture representing the moisture rate of the structure.

On 17 July 2020 at 9:20, inspection of a historical structure was performed, where a device that protects from humidity is installed. This device works on the principles of magnetokinesis. A few assessment measurements for randomly selected sites have been accompanied by the inspection. Measurements demonstrated the surface moisture of the structure ranging from 6.9% to 15.6%. In some places the masonry showed only small level of humidity. However, this phenomenon can be attributed to the remedial plasters that are applied to a larger part of the object. However, in many places, mainly due to their age, they lost their functionality. However, from the first survey could be deduced that the object is considerably damp in some places. The measured values (Figure 7) are also evidenced of this.

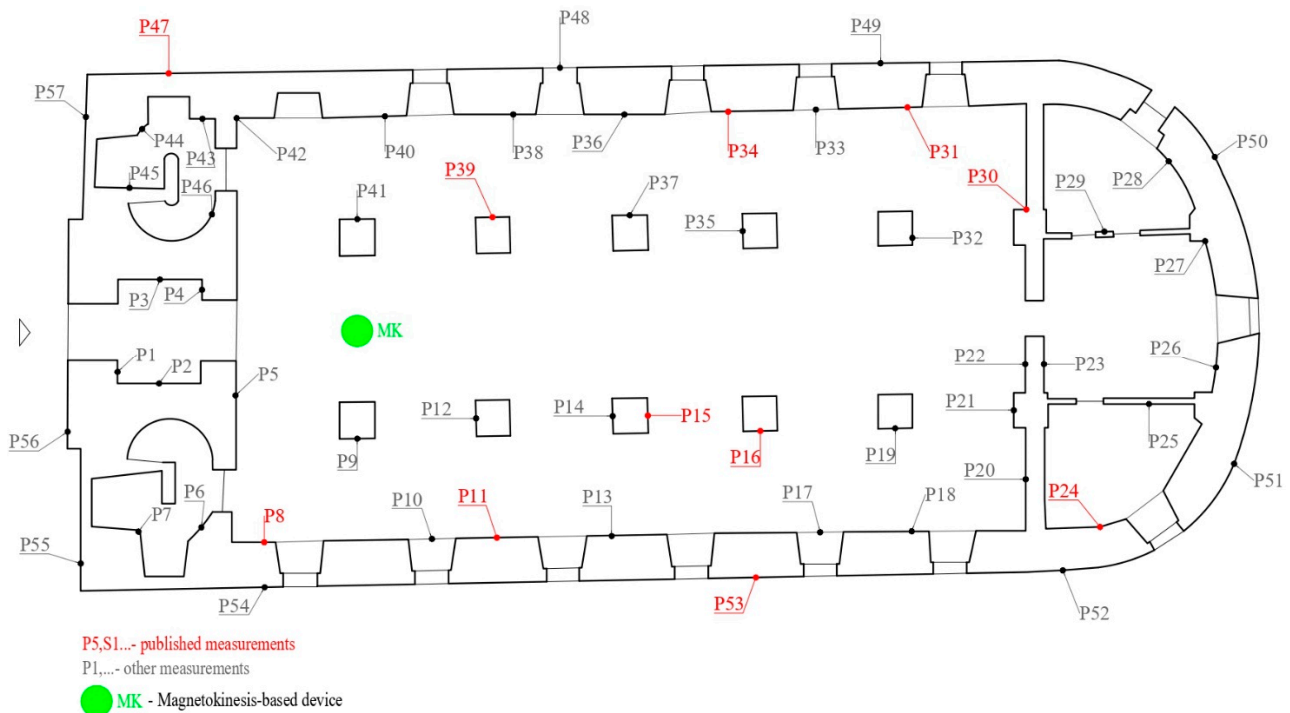
Figure 8. Humidity measurement points on a historic construction (3rd researched building).

Figure 8 represents the selected places where the measurements were realized.
