# Comparative Test on the Bond Damage of Steel and GFRP Bars Reinforcing Soft Rock Slopes

**Abstract:** Soft rock slopes were anchored with traditional steel bars and new Glass Fibre Reinforced Polymer (GFRP) bars. The difference in the anchorage performance of the two kinds of anchorage elements in soft rock and expansive soil was studied by an in-situ test. The results show that cyclic load can aggravate the bond damage of the interface between grouting body and both kinds of bars used in soft rock. Compared with the number of cyclic loads applied, the previous maximum load is the main factor that influences the bond damage of the anchorage bar. Under constant loading, the interface bond behaviour of GFRP bar is better than the steel bar. Because of the small difference in elastic modulus between the GFRP bar and the grouting body, the interface bond around the GFRP bar can invoke more resistance of the grouting body efficiently which demonstrates its more effective anchorage performance than the steel bar under the same conditions. The anchorage structure of steel bar in soft rock can generate larger interfacial relative displacement with increasing load than the GFRP bar in th

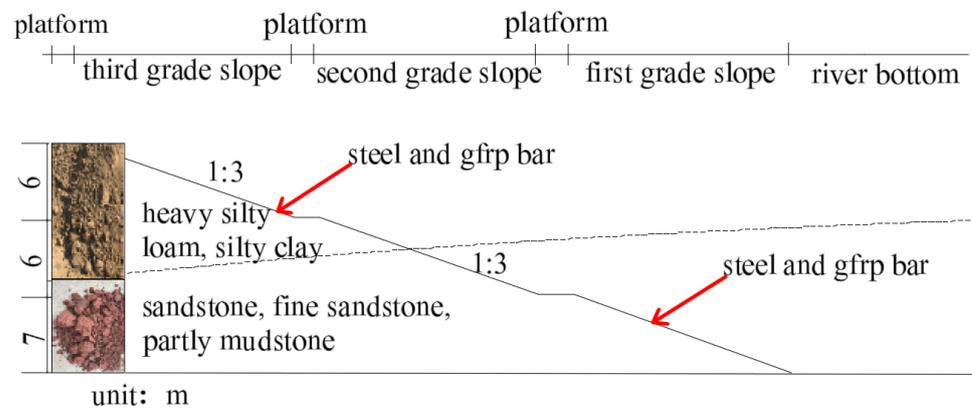
Figure 2. Stratigraphic profile of the testing bar.

The test site was located in the project of Yangtze-to-Huai Water Diversion. The overlying strata were mainly Holocene silty loam, sandy loam, upper Pleistocene silty loam, silty clay, sandy soil, and some middle Pleistocene gravel clay. The underlying bedrock was mainly Jurassic siltstone, fine sandstone, mudstone, sinian and pre-sinian dolomite, gneiss, and some intrusive rocks such as granite and quartz-syenite. The location of the test site is shown in Figure 1. The stratum section and the location of the bar are shown in Figure 2. The physical and mechanical properties of the argillaceous sandstone and the expansive soil are shown in Tables 1 and 2. The compressive strength was 5.0 MPa, and the rock mass was defined as extremely soft rock according to the Code for Investigation of Geotechnical Engineering [22].

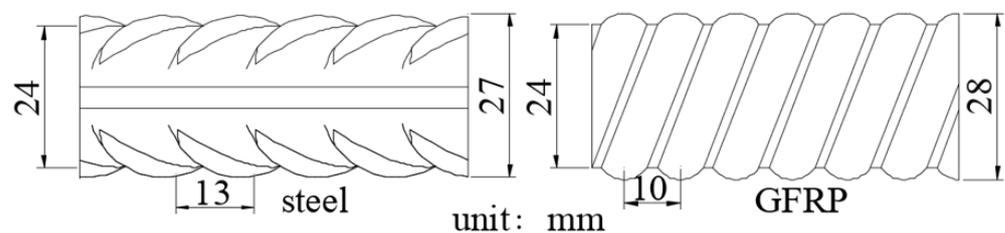
Figure 3. Surface properties of the steel and GFRP bar.

The bars used in this study were HRB400 threaded steel bars and GFRP bars. The GFRP is a new functional material made of synthetic resin and glass fibre through composite process. The mechanical properties of the steel and GFRP bars are shown in Tables 3 and 4, respectively. The test plan and surface properties of the bar are shown in Table 5 and Figure 3, respectively.

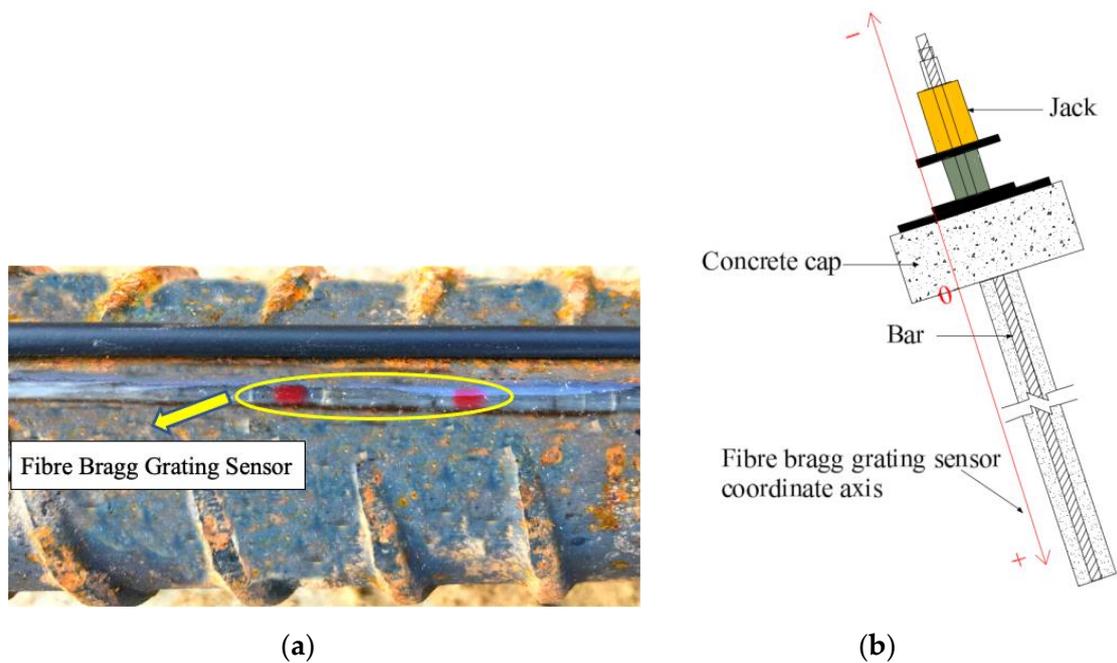
**Figure 4.** Installation of the Fibre Bragg Grating Sensor. (a) Position of Fibre Bragg Grating Sensor (b) Coordinate axis of Fibre Bragg Grating Sensor.

Grooves (1 mm × 1 mm) were made along the axis on the surface of the bar body. The grooves were cleaned with alcohol and then air-dried. The Fibre Bragg Grating Sensor was placed in the groove, which were fixed at both ends of the bar, and the grooves are covered with epoxy resin glue, as shown in Figure 4a. The junction of the concrete cap bottom surface and bar was the coordinate of zero. The direction of the anchor segment was a positive coordinate, and the free top part of the bar was a negative coordinate, as shown in Figure 4b.

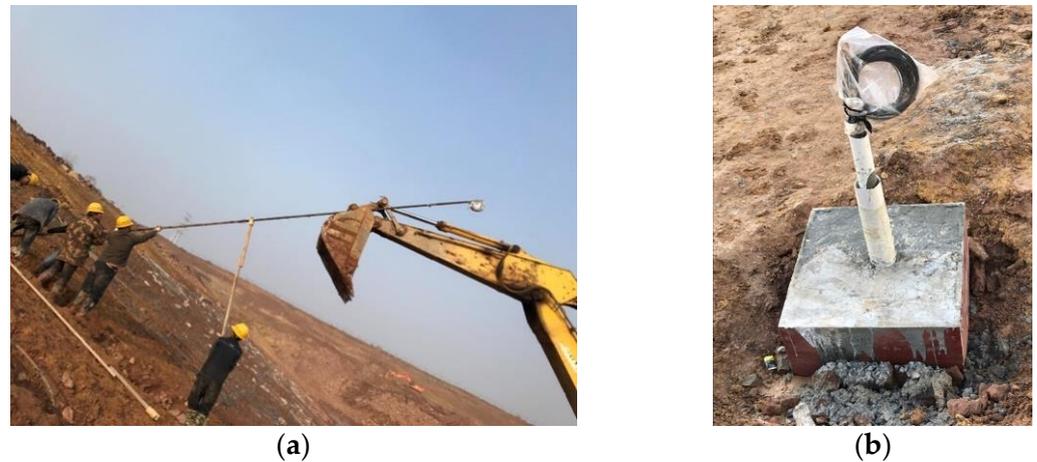
Figure 5. Bolt installation and concrete pile cap. (a) Bolt installation (b) Concrete pile cap.

The air compressor is used to drill the bolt with a hole diameter of 110 mm, and then the bolt is installed into the hole. In order to prevent the sensor from being damaged by the excessive deflection of the bolt, the installation process is coordinated with the excavator as shown in Figure 5a. After the bolt is inserted into the hole, pressure grouting is carried out. After the bolt is placed in the hole and grouting is completed, the concrete pile cap formwork prepared in advance is fixed around the bolt, and the size of the formwork is 50 cm × 50 cm × 30 cm. Then the PVC pipe is installed around the bolt to prevent the concrete from bonding with cement slurry and bolt during the pouring of the concrete pile cap. Watering curing shall be carried out after pouring, and pull-out test is carried out after 28 days. Both of these are shown in Figure 5b.

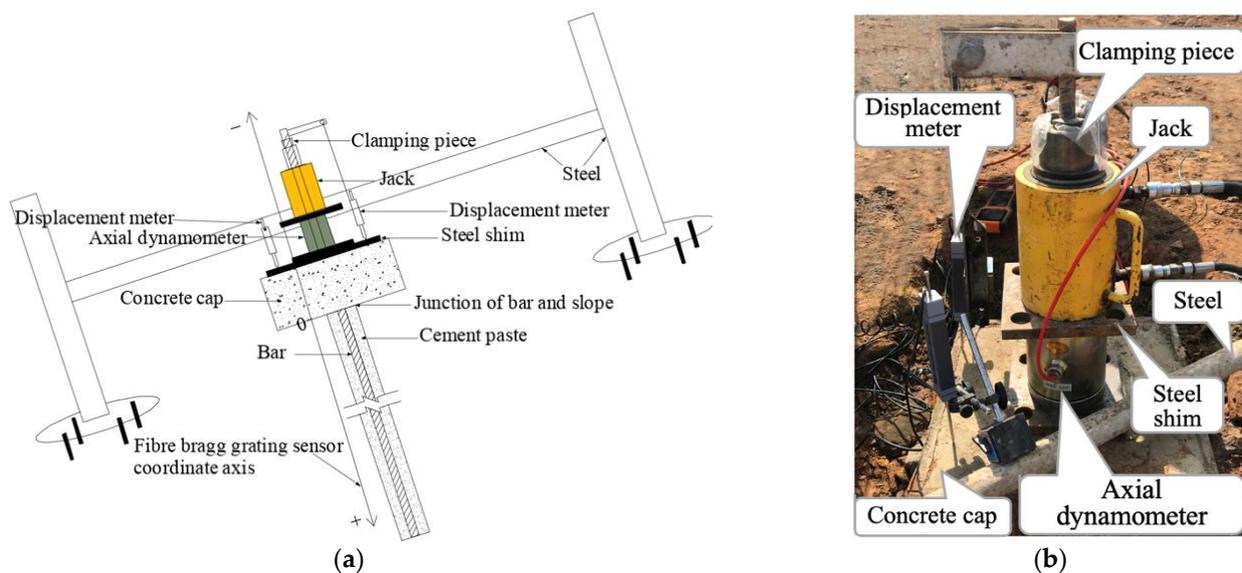
Figure 6. Test device. (a) Schematic diagram of the testing device (b) Field drawing of the testing device.

The top part of the test bar adopted the traditional clamping piece method. The test device includes steel pipes, steel shims, an axial dynamometer, a displacement meter, a hollow hydraulic jack, and a clamping piece. The axial dynamometer used a three-string load cell, and the data were collected by a vibrating string frequency reader. An MOI

SM125 demodulation instrument was used to collect the Fibre Bragg Grating Sensor data. The diagram of the test device is shown in Figure 6.

During loading, the hollow hydraulic jack acted on the clamping piece, which transferred the tension to the test piece.

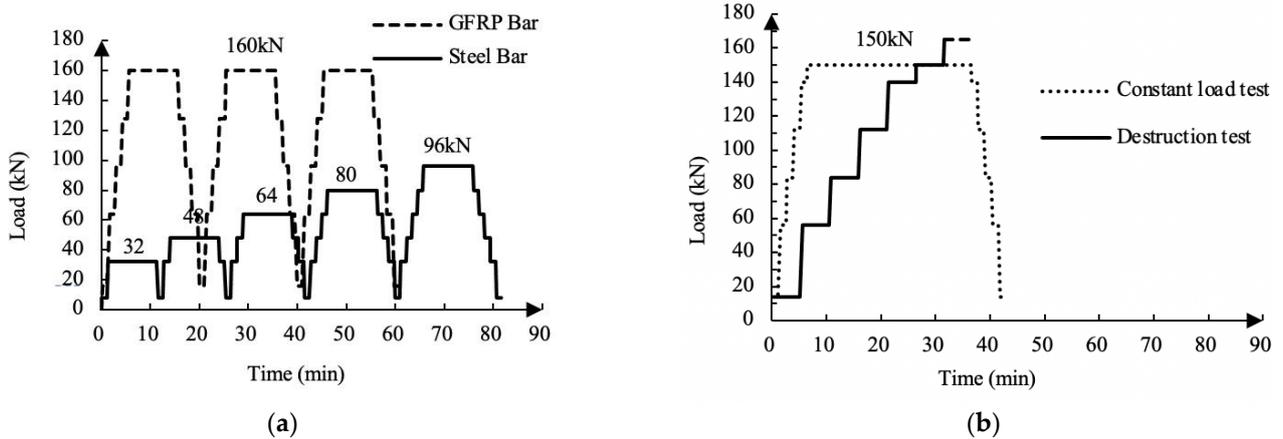
**Figure 7.** Test loading curve of the steel and GFRP bar. (a) Loading curve of the cyclic test (b) Loading curve of the constant load test and destruction test.

The test referred to the Technical Code for Engineering of Ground Anchorages and Shotcrete Support. A steel bar and a GFRP bar were used as a control group. The cyclic test adopted the loading sequence shown in Figure 7a, with multiple cyclic load levels of the steel bar and the GFRP bar. The constant load test adopted the single cyclic load method, as shown in Figure 7b. The failure test adopted the graded loading method, as shown in Figure 7b, until the bar was damaged. Failure criteria of the bar: ① the top part of the bar body did not converge, and ② the bar body was damaged. The load cell reading, strain value of the bar, displacement metre reading, and elongation at the top part of the jack under this level of load were recorded in the test procedures.

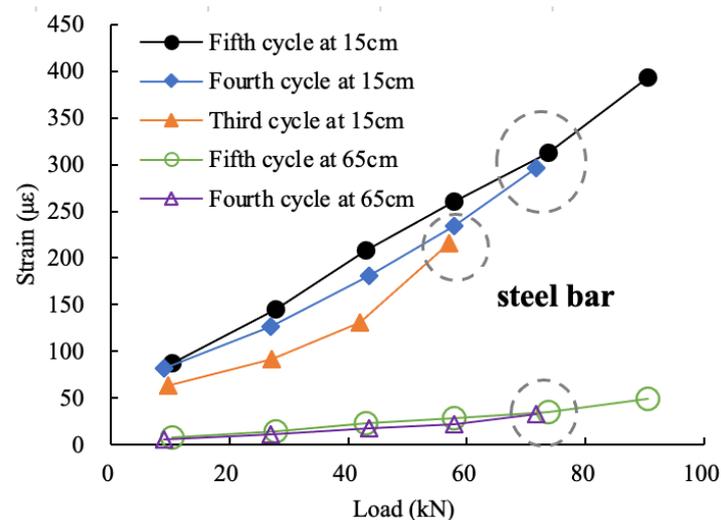
**Figure 8.** Strain-load relationship curve of the steel bar at 15 cm and 65 cm away from the zero point [23].

Figure 8 shows the test results of the relationship between the strain and load in the steel bar specimen at different depths and load. Figure 8 shows that: (1) the larger the anchorage depth was, the smaller the bar strain would be, that is, the bar strain at 65 cm away from the zero point was generally less than that at 15 cm, which was caused by load attenuation with depth; (2) in the case of similar loads, the strain of the bar body corresponding to the subsequent cyclic load was greater than that by the previous one, resulting in the strain of the bar body increasing with the increase in the number of cycles, a phenomenon indicating that the loading cycle might aggravate the bond damage of the bar body interface; (3) when the load reaches the maximum value of the previous load, the strain of the bar body was approximately equal to the previous strain. This last phenomenon indicated that the cyclic load level had little effect on the bond damage of the bar interface when the load is not greater than the previous load.

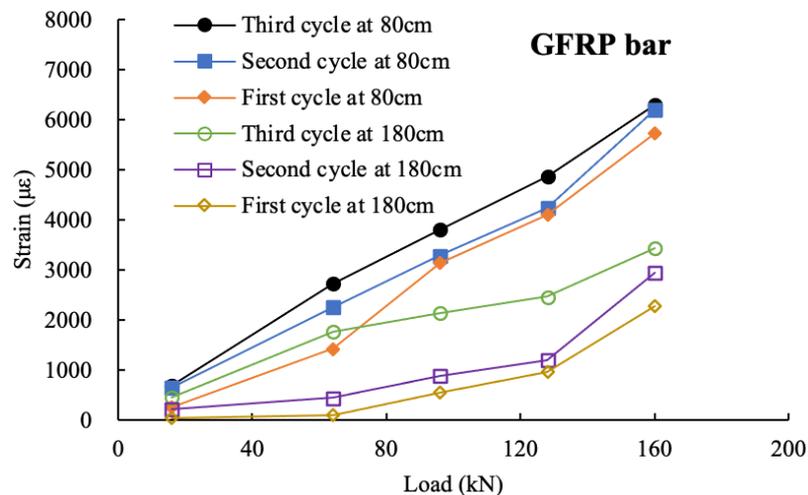
**Figure 9.** Strain-load relationship curve of the GFRP bar at anchorage depths of 80 cm and 180 cm.

Figure 9 shows a similar phenomenon to Figure 8 in the GFRP bar; (1) the strain at 80 cm away from the zero point is generally greater than that at 180 cm, which is caused by the attenuation of the axial force; (2) at the same depth and under the same load, the strain increases with the number of cycles, thereby indicating that cyclic load aggravates the bond

damage at the bar interface; (3) when the cycle reaches the maximum value of the previous cycle, the strain is slightly larger than the previous cycle. In the actual loading process, due to the low accuracy of the jack oil gauge, it was difficult to accurately load to the exact value. When loading to the maximum, the specimen was loaded to a value slightly over the target value, and then part of the force was unloaded to reach the ideal value.

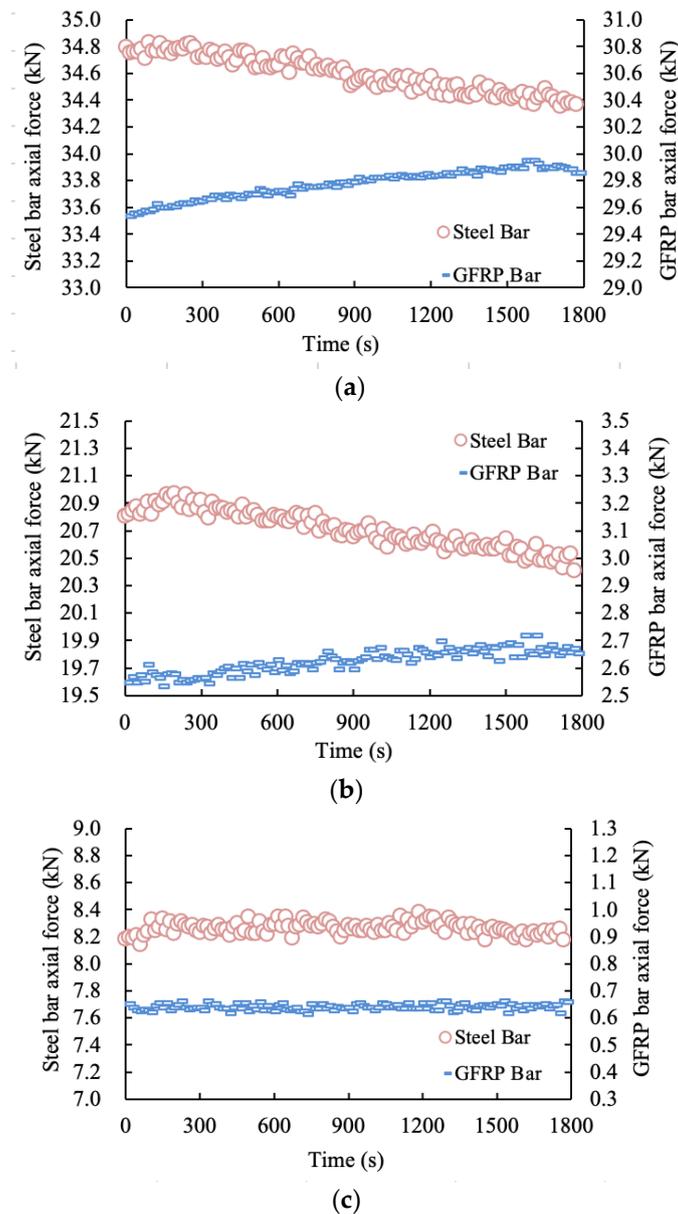
**Figure 10.** Strain-time curve of each point of the bar body under constant load 150 kN. (a) Anchorage depth at 0.75 m away from the zero point. (b) Anchorage depth at 1.25 m away from the zero point. (c) Anchorage depth at 1.75 m away from the zero point.

When the load of the bar was maintained at a constant value, the axial force-time curves of the bar at different anchorage depths under soft rock condition are shown in Figure 10, including the steel and GFRP bars.

Figure 10a shows that the axial force of the steel bar decreased with time at 0.75 m away from the zero point of the steel bar when the tensile load was 150 kN, indicating that bond degradation of interface occurred at this point on the bar body when the tensile load was less than 150 kN. At 0.75 m away from the zero point of the GFRP bar, the axial force of the GFRP bar increased first to a peak value and then decreased with time, indicating that when the tensile load was 150 kN, the bond state of this point on the bar body appeared to degrade. Therefore, when the tensile load was 150 kN, bond degradation occurred at the bar interface 0.75 m away from the zero point. The bond between the bar and cement was destroyed, and the bond force failed. The load was borne by a friction force or biting force and transmitted along the bar to the depth of the anchorage.

As shown in Figure 10b, when the bar was under a constant load of 150 kN, the axial force-time curve of the steel bar peaked at 1.25 m away from the zero point and then showed attenuation characteristics, indicating that the bond degradation phenomenon appeared at this point. At 1.25 m away from the zero point, the axial force-time curve of the GFRP bar showed an upward trend, indicating that the bond state at this point on the bar body was in the process of being triggered and would reach a peak or stable value in the future.

Figure 10c, shows that the axial force-time process of the steel and GFRP bar was stable at 1.75 m away from the zero point under a constant load of 150 kN, indicating that the bond state of the bar body at this point is stable and had no bond degradation [24].

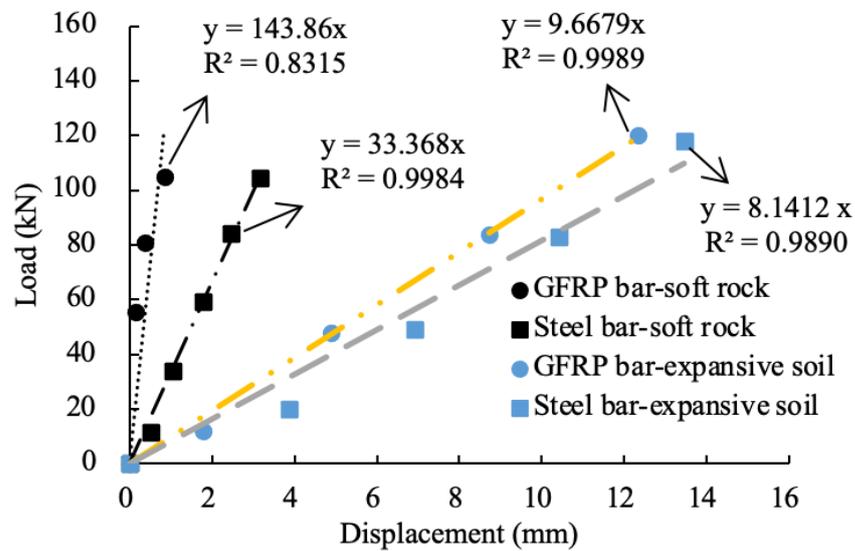
Figure 11. Bars displacement of anchorage section under loading.

anchorage section and other indexes are calculated, as shown in Table 6. Figure 11 shows the bars displacement of anchorage section under loading, showing a linear relationship. Figure 12 shows the gradients of displacement of anchorage section of two kinds of bars at different layers to compare the difference between the indexes of steel bar and GFRP bar in the anchorage section.

under the condition of expansive soil. According to Figure 11, the small gradient means large displacement under the same load condition.

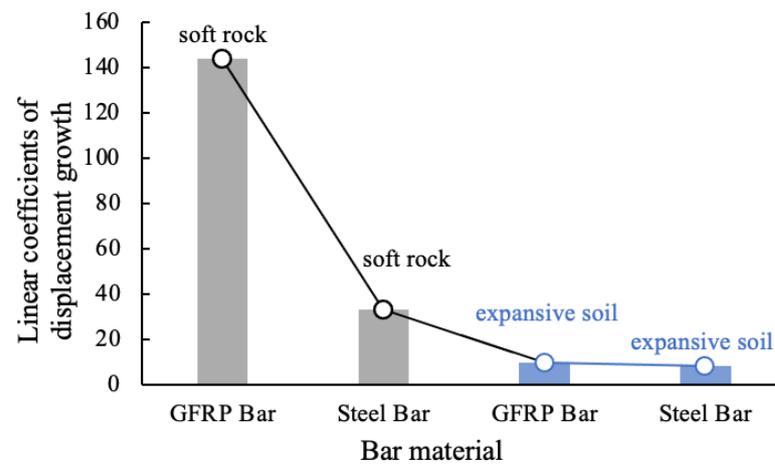
Figure 12. Gradients of displacement curve of anchorage section.

The relative difference is equal to the ratio of the difference of displacement gradient of GFRP bar and steel bar to the displacement gradient of GFRP bar, and the calculating results are shown in Table 7. The gradient of the steel bar displacement curve is much smaller than the GFRP bar under the condition of soft rock, while the gradients are similar

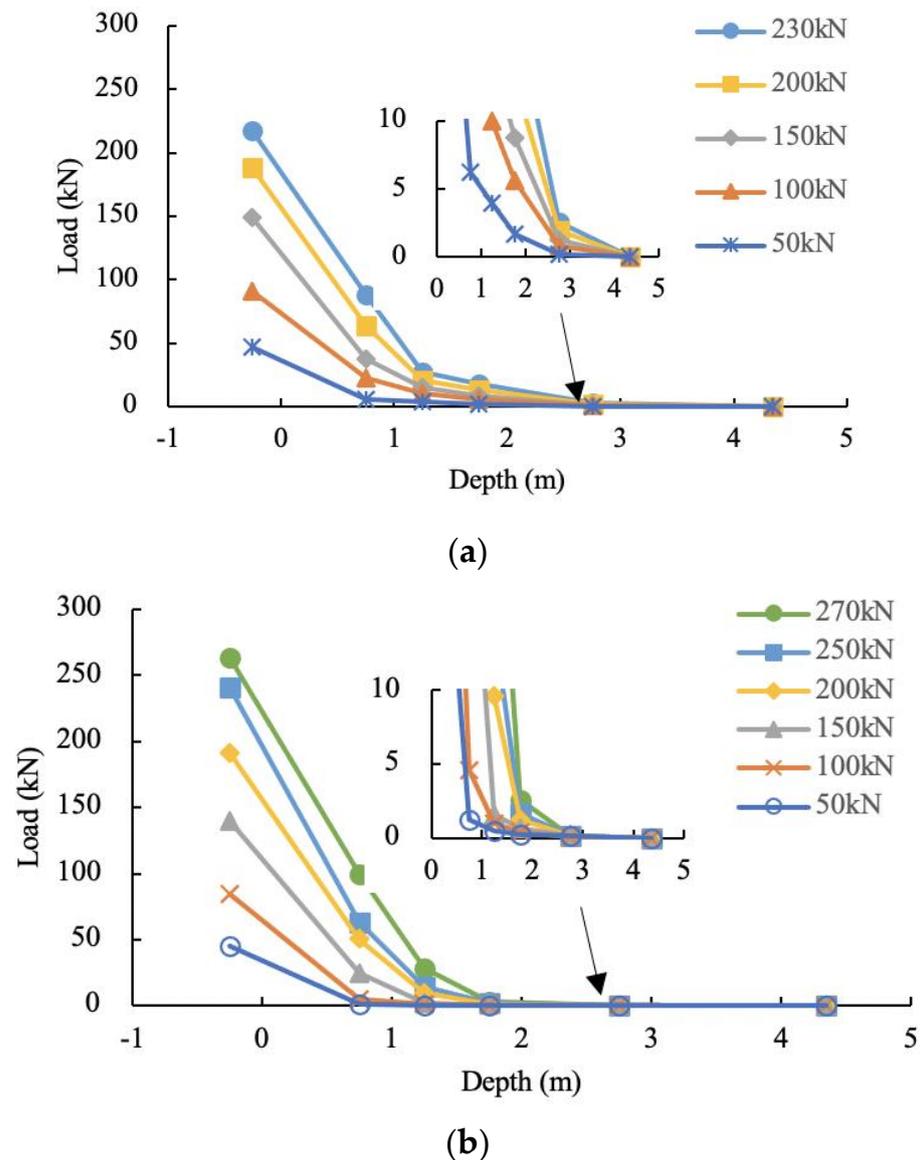
Figure 13. Curve of the bar anchorage depth. (a) Steel Bar. (b) GFRP Bar.

Figure 13 shows the relationship between the axial force and the anchorage depth of the two bars. It is obvious that the effective anchorage depth of the two bars is different, with the steel bar at approximately 4.35 m away from the zero point and the GFRP bar at approximately 2.75 m away from the zero point. The distribution range of the axial force of the GFRP bars was smaller than the steel bars. The elastic modulus of the GFRP bar is approximately 1/4 of the steel bar. Therefore, under the same axial force level, the deformation of the steel bar was smaller than the GFRP bar, and the shear force of the grouting body around the steel bar was smaller. To balance the axial force of the steel bar, a longer range of the grouting body was required to provide shear. That is, under the same load condition, the damage of the grouting body in the steel anchorage system was greater than GFRP anchorage system.

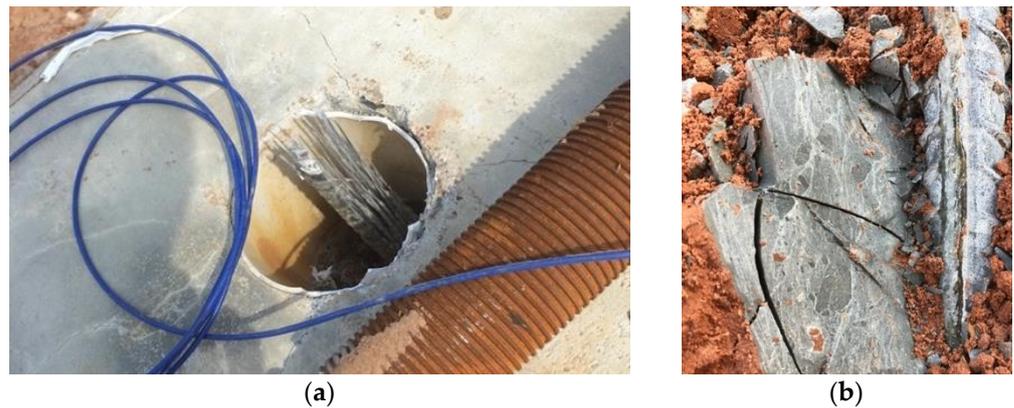
**Figure 14.** Failure mode of the bar body. (a) Failure mode of the GFRP bar (b) Failure mode of the steel bar.

Table 8 shows the corresponding characteristic and phenomena of the specimens when they reached the ultimate state under tensile load. Figure 14 shows the failure mode of the bar during the test. Figure 15 shows the load displacement curve of the steel and GFRP bars under the soft rock slope excluding the bar body deformation of the free section.

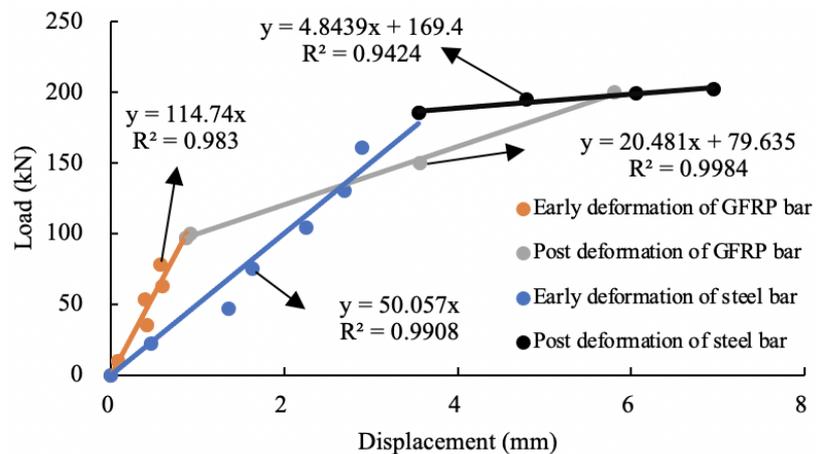
**Figure 15.** Load displacement curve of the bar excluding the bar body deformation of free section.

To further prove the above conclusion, the bar body deformation of free section is subtracted from the displacement at the end of the bar body, so as to obtain the curve of load displacement of anchored part in Figure 15.

Figure 15 shows that when the tensile load reached 200 kN, the gradient of the load displacement curve of the steel bar decreases rapidly and is close to zero, indicating that the deformation increased sharply, and the interface was about to reach the limit state. When the load reached 230 kN (not exceeding the strength of the bar itself), the strain measured at the deepest part of the bar was  $10 \mu\epsilon$ . It shows that the interface between the bar and the grouting body was very likely to produce relative slip. Combined with the analysis in Section 3.3, the damage between the steel bar and the grouting body is extensive when the force is small. The sudden change of the gradient of the load displacement curve also occurs when the tensile load of the GFRP bar was 100 kN. This is because the length of the grouting body mobilized by GFRP bar in the early stage was small. The shear force was concentrated and reached the limit state more quickly. Part of the bond force was transformed into friction, and the deformation of the bar body in the anchorage section continued to extend downward, resulting in large deformation. However, due to the good deformation coordination between the GFRP bar and the grouting body, the grouting body interface is not completely destroyed, while the bar body itself had reached the ultimate strength. Figure 16 shows schematic diagrams of two kinds of bar failure.

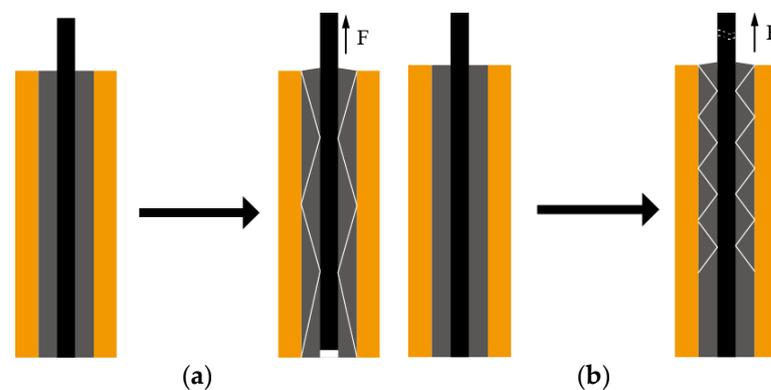
**Figure 16.** Schematic diagram of bars failure. (a) Schematic diagram of the steel bar failure. (b) Schematic diagram of the GFRP bar failure.
