Shear Behavior of Concrete Encased Steel Truss Composite Girders

Abstract: In this study, experimental tests were performed to evaluate the shear performance of encased steel truss (EST) composite girders that can resist loads at construction and composite stages. Four full-scale EST composite girders were fabricated, where the truss type (Pratt truss and Warren truss) and presence of stirrups were set as main test variables. The test results showed that in specimens applied with the Pratt truss, horizontal shear cracking occurring along the interface between concrete and steel was the dominant failure mode. Based on the crack pattern and failure plane observed from the test, the horizontal shear strengths of the Pratt truss specimens were calculated, which provided conservative results. On the other hand, in the specimens with the Warren truss inside, the strengths of the specimens were governed by the shear failure occurring in the screw rod connecting the truss elements prior to the yielding of the diagonal member. The shear strengths of the Warren truss specimens calculated based on the shear failure of the screw rod were similar to that obtained from the test.

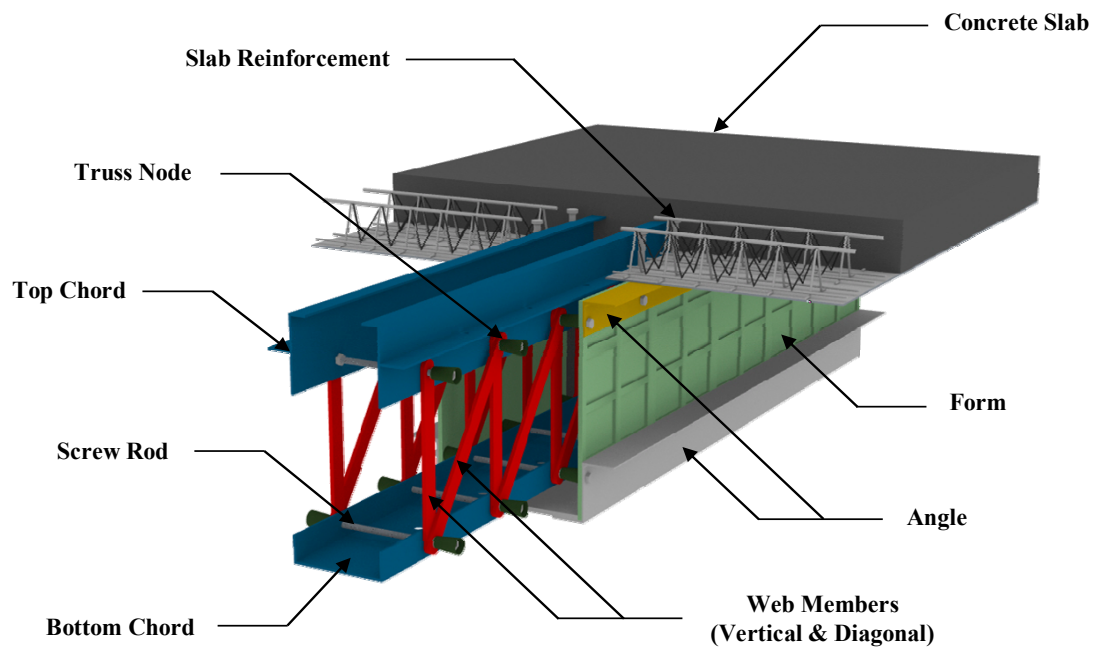
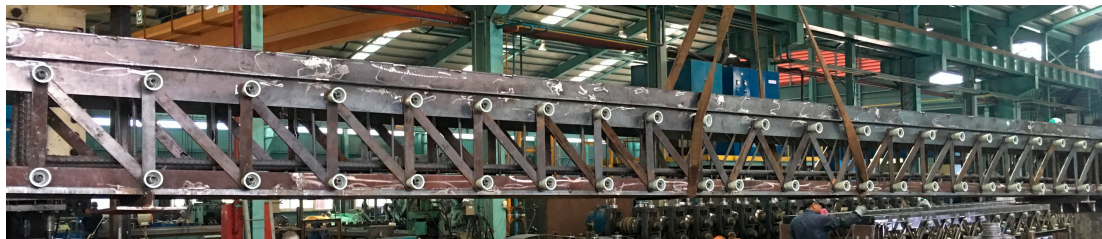
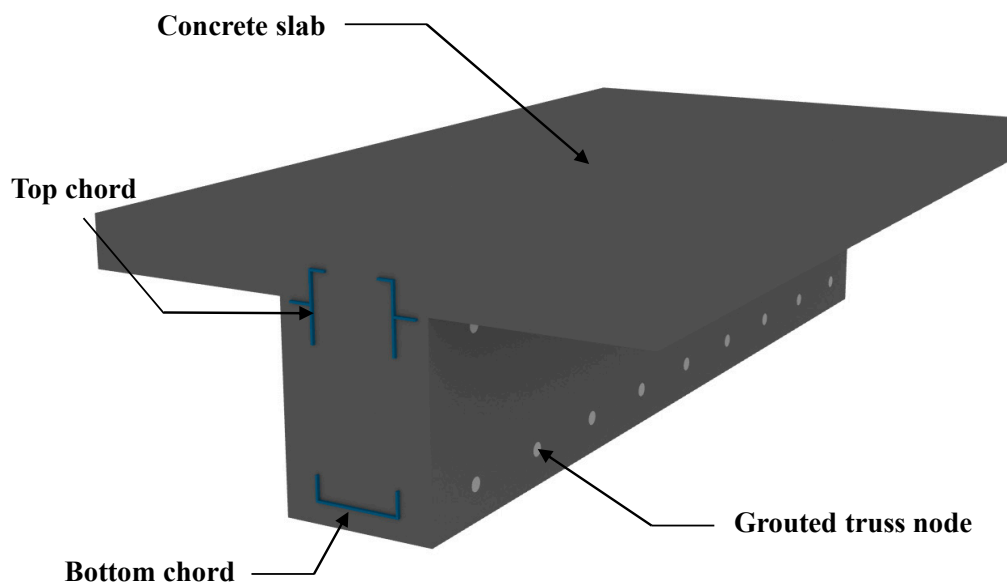
Figure 1. Schematic description of encased steel truss (EST) composite girder.

(a) EST composite girder at construction stage

(b) EST composite girder after composite with cast-in-place concrete

Meanwhile, although studies regarding composite members have actively been conducted in recent years, the demand for a composite structural system demonstrating excellent structural performance while ensuring economic feasibility and constructability is still prevalent in the construction market. Accordingly, in South Korea, encased steel truss (EST) composite girders with steel trusses embedded in concrete have been developed recently, as shown in Figure 1. In the EST composite system, the truss member supports the formwork self-weight and construction load, thereby minimizing temporary work processes, such as shore installation. Figure 1a shows the EST composite girder. The steel truss fabricated in a plant comprises top and bottom chords as well as transverse and diagonal members. Furthermore, the truss and external formwork are installed at the site. After cast-in-place (CIP) concrete is poured and cured, grout is injected into the truss connection, as shown in Figure 1b. Figure 2 shows the connection details of the EST composite system. The bolt hole with a diameter of 18 mm was drilled at the end of the truss members and penetrated through a screw rod of 15.9 mm in diameter and 400 MPa yield strength; subsequently, the chord and diagonal members were fastened together using D-corn and bolts. The D-corns, which served as a spacer between the diagonal members and the form, were removed after the concrete was poured and cured, and subsequently the remaining space was filled with mortar. In the EST composite girder, an efficient load transfer was possible because the top and bottom chords of the truss resisted compressive and tensile forces due to bending moments, whereas the transverse and diagonal members as well as concrete resisted shear forces.

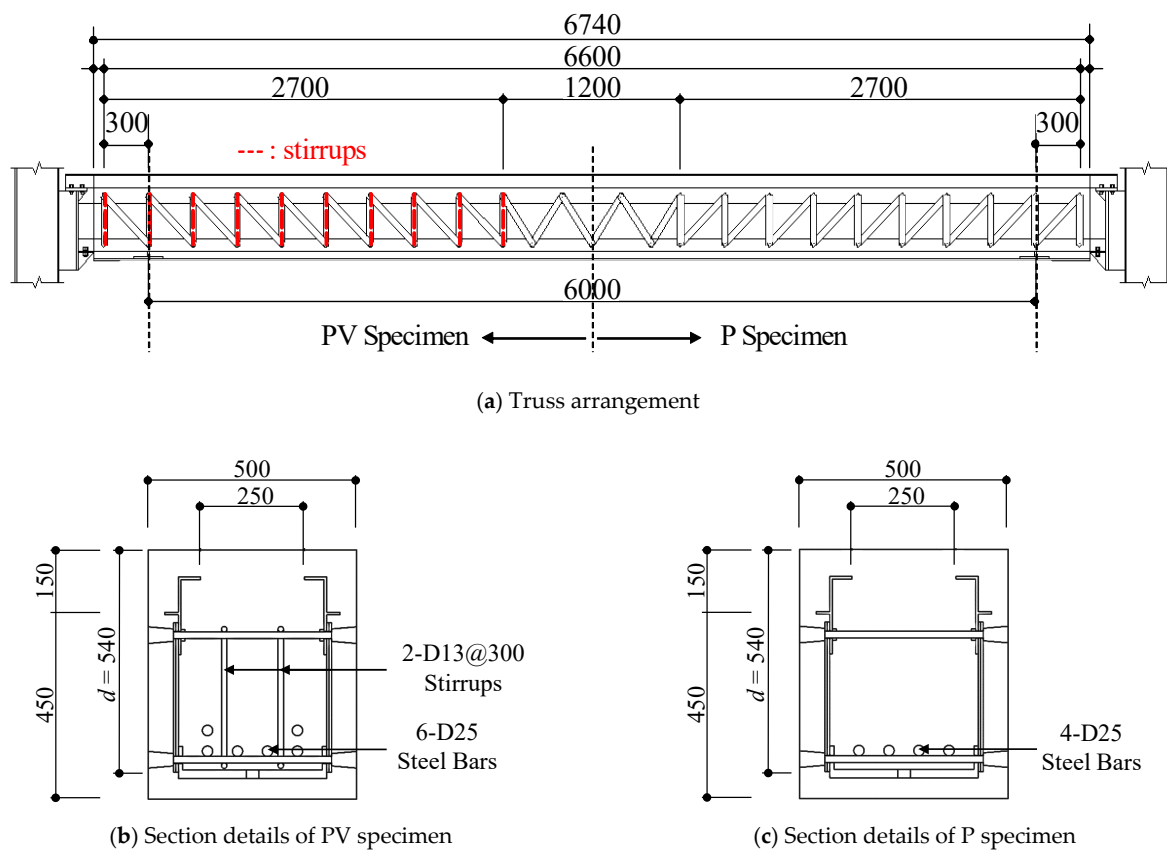
Figure 3. Dimensional details of P specimen series.

To identify the shear performance of EST composite girders, four full-scale specimens were fabricated to conduct a test. As shown in Table 1, the truss type (Pratt truss (P) and Warren truss (W)) and the presence of stirrups were set as main test variables. Reinforcing bars of 13 mm in diameter were used for the stirrups, and 25-mm-diameter rebars were used as tensile reinforcements. Figure 3 shows the details of the P-specimen series (specimen PV, specimen P) to which the Pratt truss was applied. In addition, PV and P represent the specimens with and without vertical stirrups, respectively. As shown in Figure 3a, the Pratt truss was composed of top and bottom chords as well as vertical and diagonal web members; furthermore, vertical shear reinforcements were placed at 300 mm intervals in the PV specimen, as shown in Figure 3b. In addition, six D25 tensile reinforcements were placed to prevent flexural failure and induce shear failure, and the thickness of the bottom chord was 20 mm. The bottom chord was considered as tensile reinforcement in the calculation of flexural strengths of the specimens. As shown in Figure 3c, the stirrup was not placed in the P specimen, and four D25 tensile reinforcements were placed on the tension side of the section. Except for the presence of stirrups and the tensile reinforcement placement, all the section details were the same for both specimens. The side cover thickness of the top chord, which corresponds to the resistance surface of concrete against horizontal shear, was 40 mm, whereas the top cover thickness was 65 mm. Meanwhile, the side cover thickness of the bottom chord was 72 mm, whereas the bottom cover thickness was 50 mm.

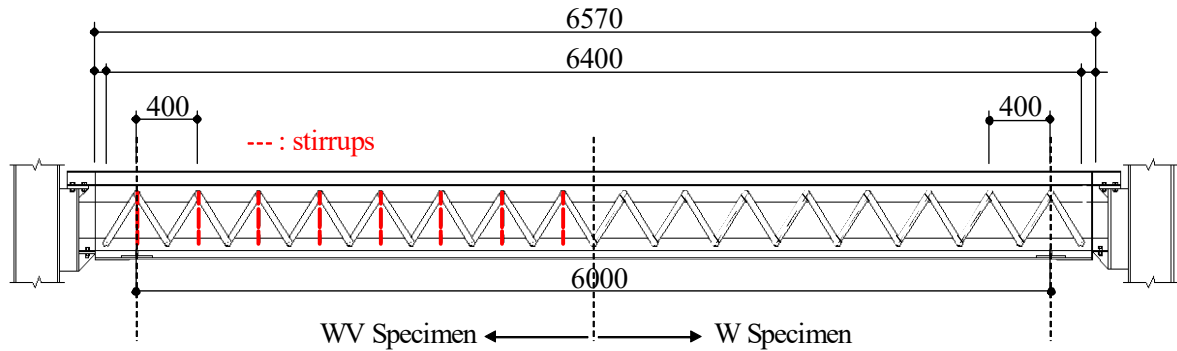
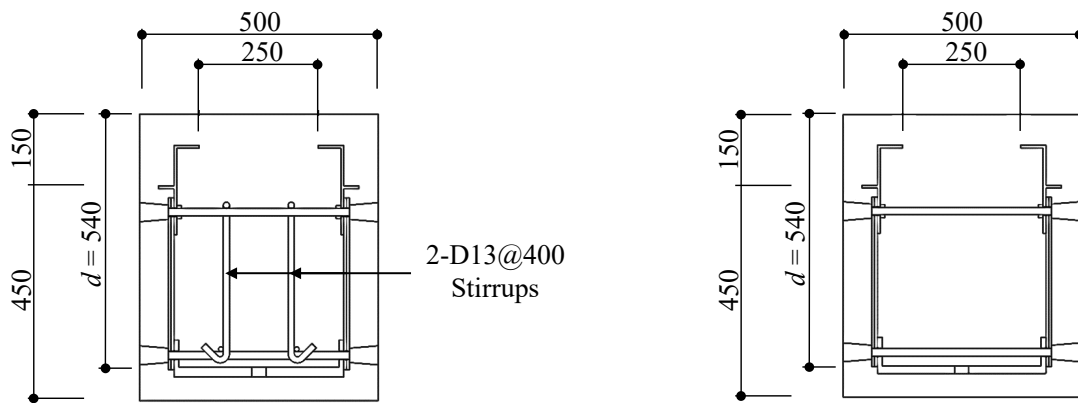
Figure 4. Dimensional details of W specimen series.

Figure 4 shows the details of the W specimen series (specimen WV, specimen W), to which the Warren truss is applied, and WV and W represent the specimens with and without vertical stirrups, respectively. The thickness of the bottom chord placed on the tension side of the section was 20 mm in the WV specimen and 16 mm in the W specimen. Except for the presence of stirrups and the thickness of the bottom chord, all the section details were the same for both specimens. In addition, the top, bottom, and side cover thicknesses were the same as those of the P specimen series. Figure 5 shows the dimensional details of the top and bottom chords. In the bottom chords, holes with a diameter of 30 mm were drilled at 300 mm intervals such that concrete could be secured tightly on the tension side of the section at the lower end of the bottom chord, preventing air voids.

(a) Truss arrangement

(b) Section details of WV specimen

(c) Section details of W specimen

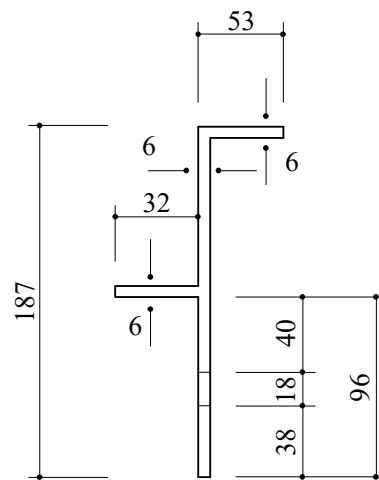
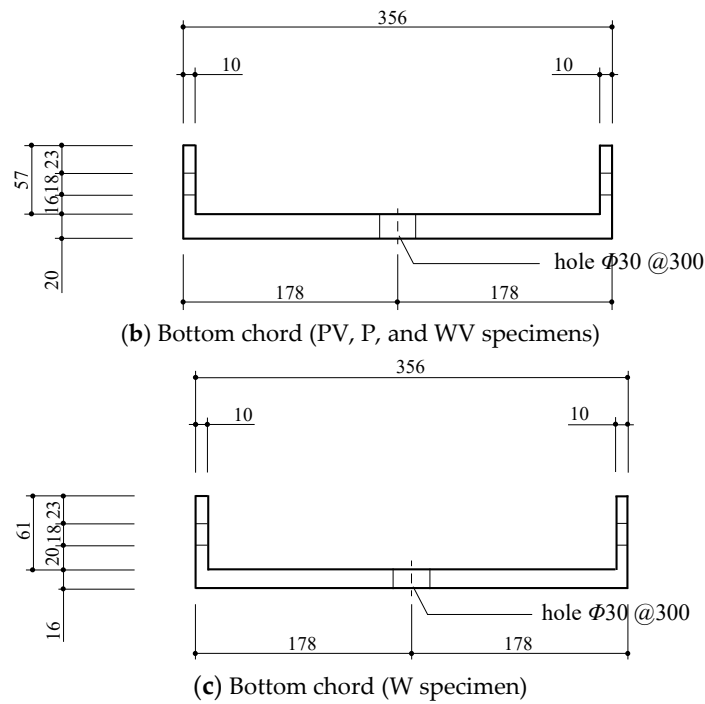
Figure 5. Dimensional details of top and bottom chords.

(a) Top chord

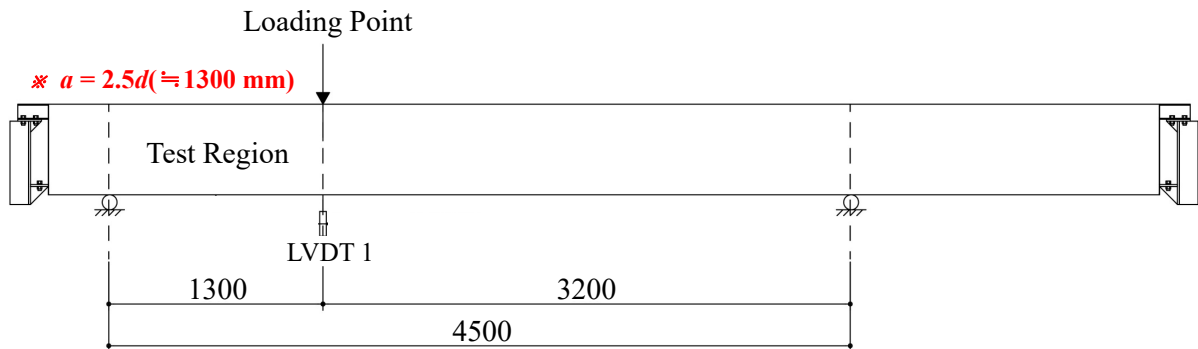
Figure 6. Loading details.

Table 2 summarizes the material test results of steel plates and reinforcing bars used for the specimen fabrication. The yield strength of the 13 mm diameter stirrups (f_{vy}) was 465.8 MPa, whereas that of the 25 mm diameter tensile reinforcement (f_y) was 643.0 MPa. Meanwhile, the yield strength of the steel plate (F_y) used in the truss production ranged from 334.1 to 482.0 MPa, and the compressive strength of concrete (f'_c) used in the specimen fabrication was 29.7 MPa. Figure 6 shows the supports and loading points of the specimens. The lengths of the left span (test region) and right span were differently set to 1300 and 3200 mm, respectively, by which the shear force generated in the left shear span was about 2.5 times higher than that in the right shear span; thus, shear failure could be induced

in the left shear span. The shear-span-to-depth ratio (a/d) was set to 2.5, and one-point loading was applied using a universal testing machine with 3000 kN capacity. To measure the deflection of the specimen, a linear variable differential transformer was installed at the loading point as well as in the lower part of the section located in between the loading point and support.

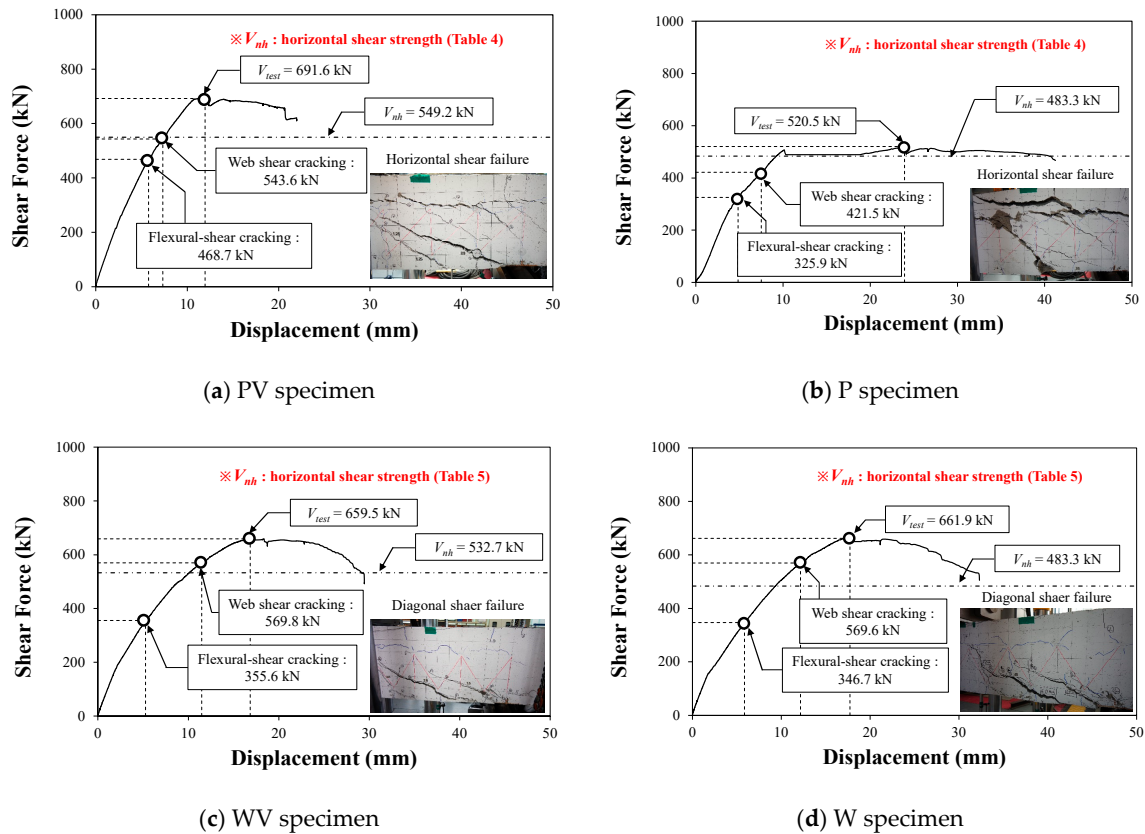
Figure 7. Shear force-deflection response curves of test specimens.

Figure 7 shows the shear force-deflection relationship of the specimens. As shown in Figure 7a, in the PV specimen with the Pratt truss applied and the vertical stirrup placed, the first flexural-shear cracks occurred at a shear force of 468.7 kN, and web shear cracks were observed at a shear force of 543.6 kN. Even after the web shear cracks appeared, the stiffness decrease in the specimen was insignificant. Meanwhile, at a shear force of

Figure 7c shows the shear force-deflection relationship of the WV specimen with the Warren truss applied and vertical stirrup placed. In the WV specimen, flexural-shear and web shear cracks occurred at shear forces of 355.6 and 569.8 kN, respectively, and the specimen underwent shear failure as the width of the diagonal cracks increased rapidly at a shear force of approximately 659.5 kN, as shown in Figure 8c. Furthermore, the behavior of W specimen without stirrups was very similar to that of the WV specimen, as shown in Figure 7d. In particular, although the stirrup was not placed in the W specimen, the failure mode (i.e., diagonal shear failure) and maximum shear force (661.9 kN) were similar to those of the WV specimen in which the stirrup was placed. The cause can be inferred from the behavior of the diagonal web member of the EST shown in Figure 9. As shown in Figure 9a, the tensile strain of the diagonal member—measured using a strain gauge during the maximum shear force—was $1155 \mu\epsilon$, which was approximately 49% of the yield strain ($2343 \mu\epsilon$) derived from the material test. This implies that in the W specimen series, the diagonal web member failed to fully contribute to the shear resistance. Figure 9b shows the shear failure of the screw rod observed from the EST node area of the W specimen series after the test had completed. It was assumed that as the diagonal web member lost its shear resistance performance due to the damaged screw rod during the test, the W

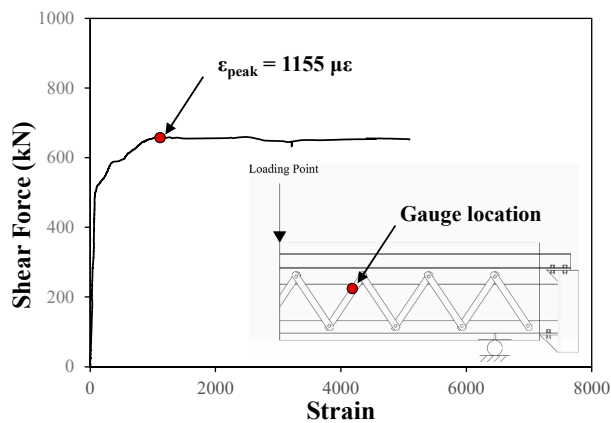
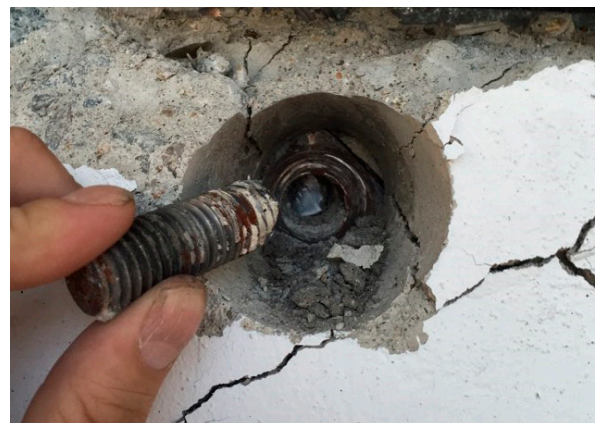
Figure 9. Shear resistance mechanism of web members.

specimen series underwent premature failure. If the screw rod is affected by shear failure prior to the yielding of a diagonal member, then the diagonal member loses its anchorage performance, and the tensile force is exerted only by the bond between steel and concrete. In general, the bond strength between steel and concrete is extremely small compared with that between deformed bars and concrete. Therefore, when the anchorage at the truss node fails, the shear resistance performance of the diagonal member decreases rapidly, which may result in the brittle fracture of the member. Hence, it was assumed that because of the failure of the screw rod during the test, the stirrup placed in the WV specimen did not effectively contribute to the shear resistance.

(a) Diagonal web member behavior at critical section

(b) Shear failure of screw rod at truss connection

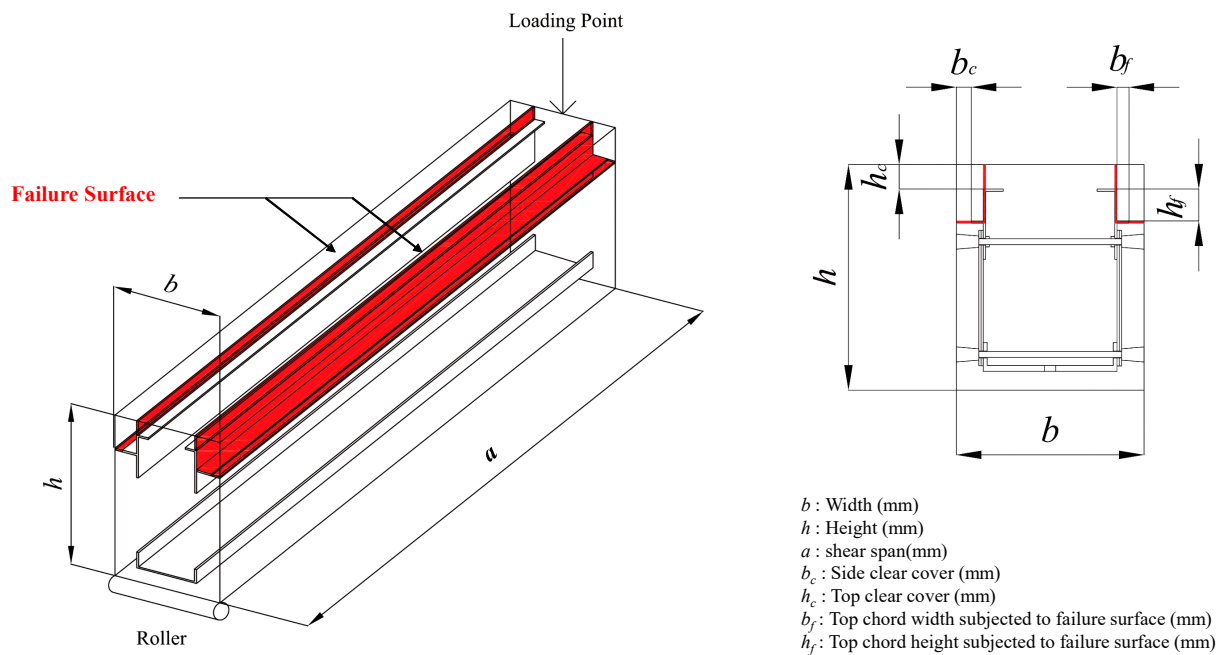
Figure 10. Horizontal shear failure surface.

Figure 10 shows the failure surface and resistance area against horizontal shear in the EST composite girder. It is noteworthy that the failure surface due to horizontal shear observed from the shear test was consistent with the area indicated in red in Figure 10, i.e., horizontal shear cracking occurred along the failure surface with the lowest horizontal shear resistance. The horizontal shear strength (V_h), considering the failure surface, can be calculated as follows:

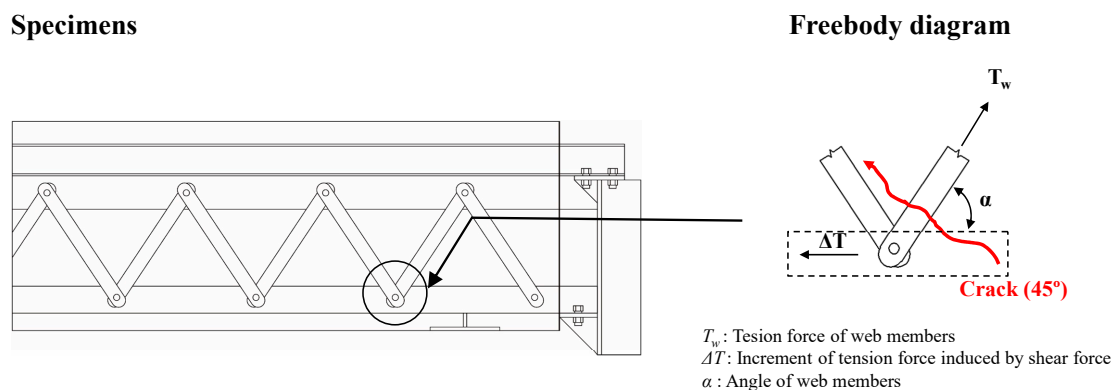
Figure 11. Freebody diagram at truss connection.

As described earlier, in the case of the W specimen series applied with the Warren truss, the diagonal web member failed to exhibit effective shear resistance owing to the shear failure of the screw rod at the EST node. Figure 11 shows a free-body diagram at the Warren truss node. When diagonal cracking occurred, the diagonal web member was subjected to tensile force, and a shear force occurred on the screw rod. The shear strength of the specimen was calculated considering the screw rod failure and then compared with the test results. In this study, the crack angle was assumed to be 45° , and the force of the diagonal member, which was exerted parallel to the crack direction, was disregarded for a simple calculation. In addition, because the bottom plate was fully anchored with bolts at both ends of the member and the bond stress between the steel plate and concrete was extremely small, the tensile force increment (ΔT) of the bottom plate was disregarded as well. Under some assumptions, the tensile force acting on the diagonal web member (T_w) at the instant of the screw rod failure can be expressed as follows:
