# Performance Evaluation of Rigid Braced Indirect Suspended Ceiling with Steel Panels

**Abstract:** In Korea, the earthquakes in Gyeongju (2016) and Pohang (2017) have led to increased interest in the seismic design of nonstructural elements. Among these, the suspended ceiling can cause personal injury and property damage. In addition, most suspended ceilings that are used in Korea neither have seismic design details nor meet the current seismic design standards. There are two seismic design methods for suspended ceilings using a perimeter clip and a brace. In the United States and Japan, seismic design of ceilings is typically used, but the concepts of applying and installing braces are different. This is because the typical ceiling systems are different in the United States and Japan. In this study, a brace-applied ceiling system that is suitable for a suspended ceiling with a steel panel was applied in the indirect suspended ceiling mainly used in Korea. In addition, the seismic performance was verified through a shaking table test. All the specimens were applied with anti-falling clips that are designed to prevent the panels from falling, and they satisfy KDS 41 17 00, which i

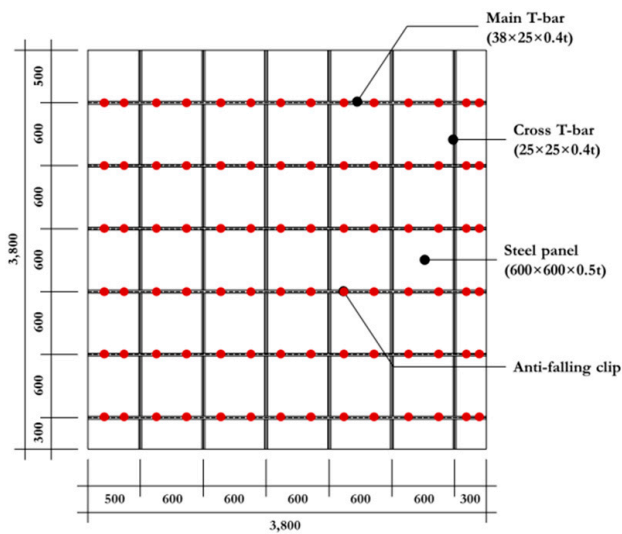
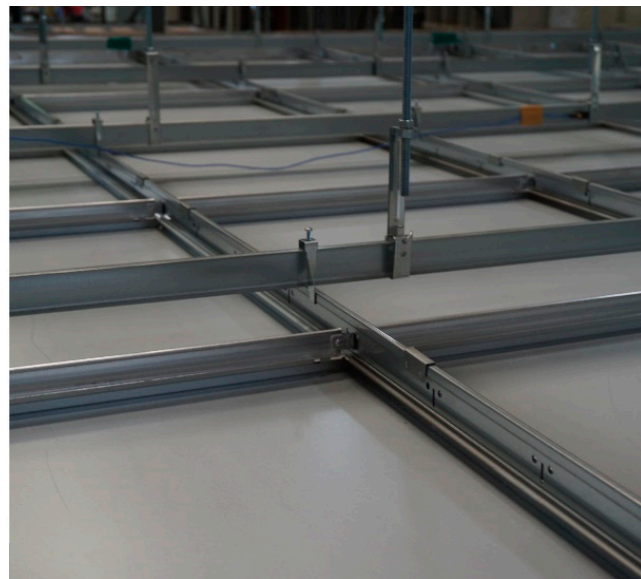
Figure 5. Main T-bar and the cross T-bar plan: (a) plan view of the specimen (main T-bar-cross T-bar), and the (b) installation view of the specimen.

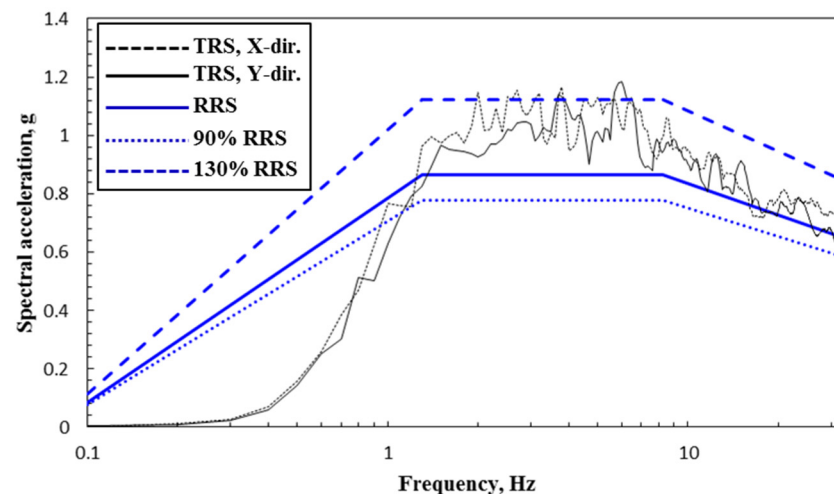
**Figure 10.** Test response spectrum (TRS) and the required response spectrum (RRS) (Test 2, 0.864 g, A1, SDB-2 specimen).

Table 3 lists the artificial seismic wave levels applied in the test, and Figure 10 shows the test response spectrum (TRS) in Test 2 (0.864 g) that was measured on the shaking table surface (A1) for the SDB-2 specimen.

Figure 10 shows the test response spectrum (TRS) and the required response spectrum (RRS) for each direction of the shaking table surface (A1). The TRS is located in the RRS of 90% or more and 130% or less on the graph. This means that the artificial seismic wave was designed to satisfy the AC156 standard, and the experiment was conducted. The TRS refers to the acceleration response spectrum of the time history data that were measured by an accelerometer attached to the surface of the shaking table.

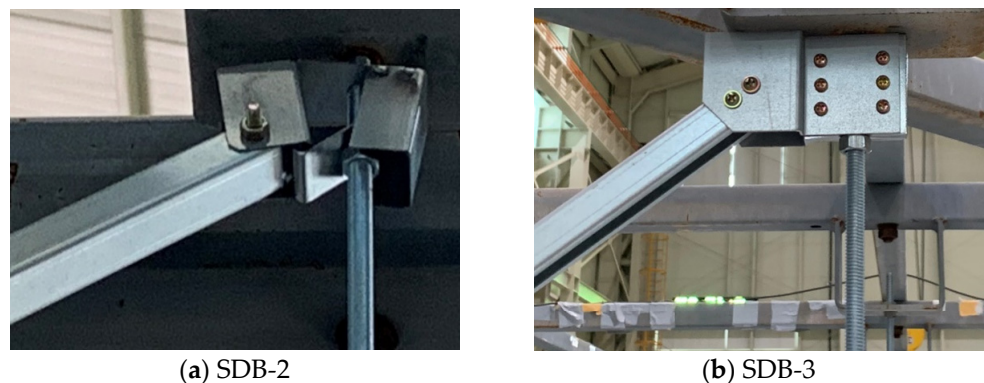
Figure 11. Brace-hanger bolt connection, Test 8 (2.16 g), (a) yield of the SDB-2 connection and (b) SDB-3.

In the case of the brace and hanger bolt connector, which was used in SDB-2, it is joined to the brace with bolts, but it can easily yield because of its long and thin shape. The connector that was used in SDB-3 was developed by supplementing this easily yielding shape and it was joined to the brace by using screw bolts.
