Preliminary Failure Frequency Analysis of Receiving Bins in Retention Bunkers Operated in Underground Copper Ore Mines

Abstract: Ore retention bunkers and receiving bins are important for continuous operation of transport system in a mine. Although the designs of the bins used in the KGHM PM S.A. mines have undergone modifications, their operating principle has remained unchanged since their initial commissioning. Their operation entails many problems, which are caused by the durability and functionality of the entire structure. Preventive actions and research into directions for possible modernizations require the type of damage and its reasons to be identified in the first place. This article presents an evaluation of the documented types of damage and an analysis of the repair works performed for the entire population of the receiving bins operated in one mine. The comparative evaluation of the bin failure rate is here proposed to be performed with the use of a number-based failure indicator and of a mass indicator. The key problem identified in the research was the wear and tear on steel elements due to abrasive processes. The linings of the bin elements were observed to under

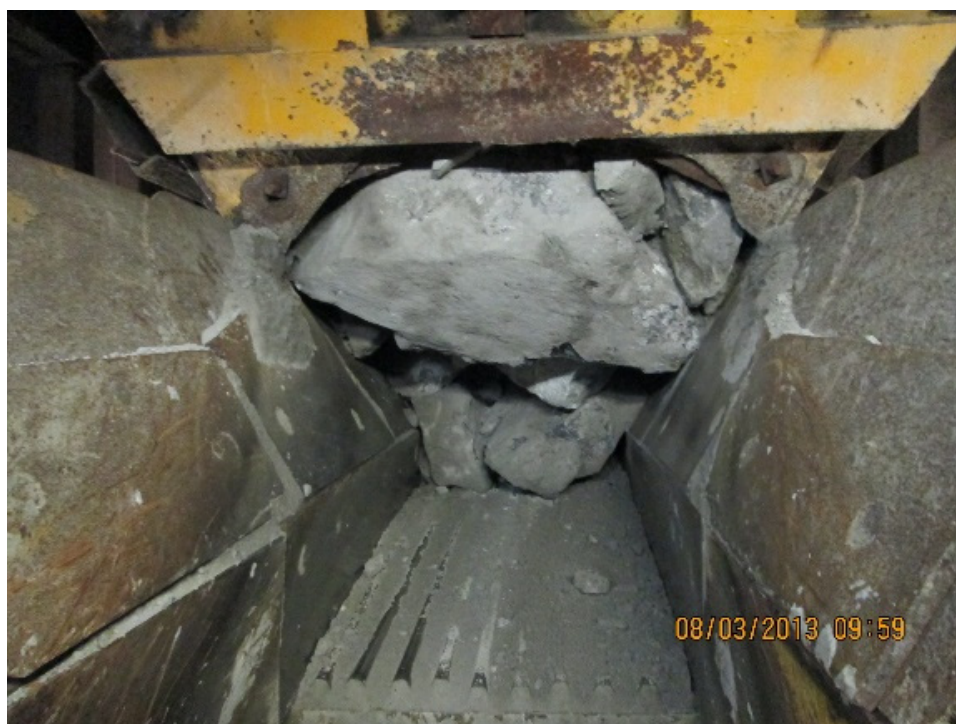
Figure 3. Blockage in the feeder carriage.

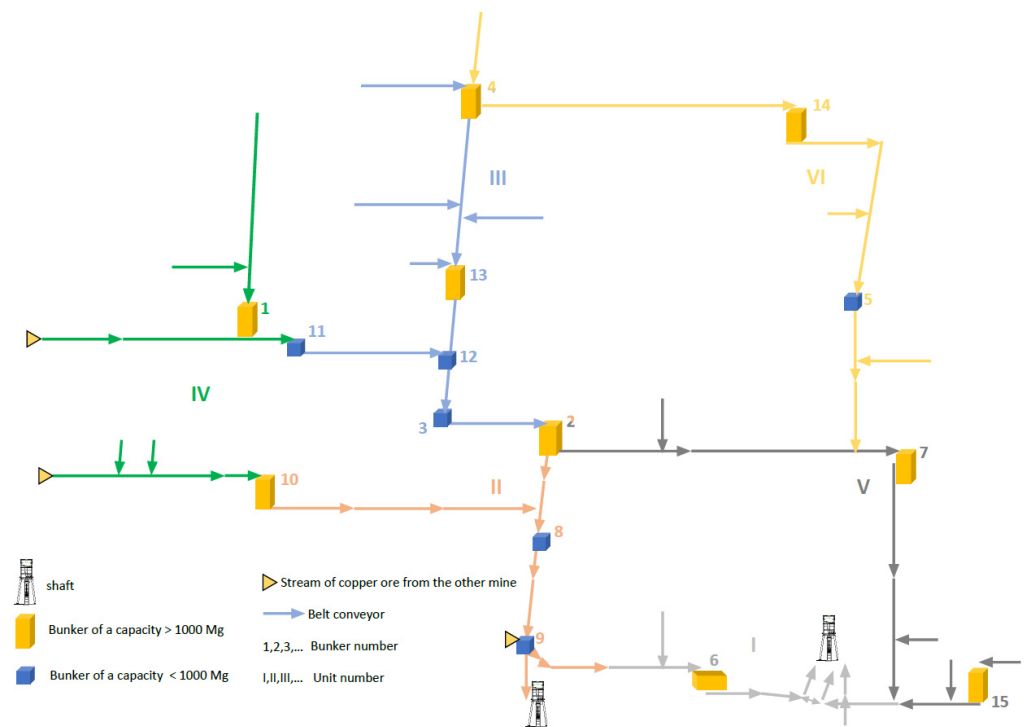
Figure 4. Locations of the bunkers within the transportation system of the mine.

The qualitative failure evaluation was performed on the basis of observations and photographic documentation. A visual inspection of the technical condition of individual elements and an inventory list of the observed surface changes allowed the identification of typical damage in the receiving bin and in the feeder carriage. The quantitative analysis of damage occurring in the operation of ore retention bunkers was performed on the basis of data collected and pre-processed for a 30-month period (between January 2018 and June 2020). The data concerned 41 receiving bins installed in 15 bunkers located in six units of a copper ore mine selected for the research. It provides information about the repairs and replacement of receiving bins' elements including the date, work shift, the name of mine unit, and the name of the retention bunker including number of receiving bins. The essential part of the research is that the analysis bases on the assumption that repair data reflects bunker failures. Furthermore, because the analysis is carried out for bunkers within the transportation system of the mine, Figure 4 schematically shows the locations of the bunkers (1–15). In the figure, blue color indicates smaller bunkers of a capacity up to 1000 Mg, and yellow color indicates larger bunkers capable of storing more than 1000 Mg of copper ore. Additionally, colors of belt conveyors define mining units (I–VI) and show the ore-flow routes.

The main objective of the analysis was to identify bunkers in which the receiving bins are most prone to failure. Therefore, durability analysis requires the receiving bins to be assigned to the individual bunkers. Figure 4 shows the locations of bunkers (1–15) within the structure of the ore transportation system, along with the indicated mining units (I–VI) and the ore-flow routes. Table 3 lists the repairs performed for bunkers 1–15 over the analyzed 30-month period. The last column in Table 3 contains number-based failure indicators per single receiving bin. The significant range of this indicator (1–17) results from different operating conditions, and justifies the durability analyses of the bin elements with respect to a particular receiving bin.

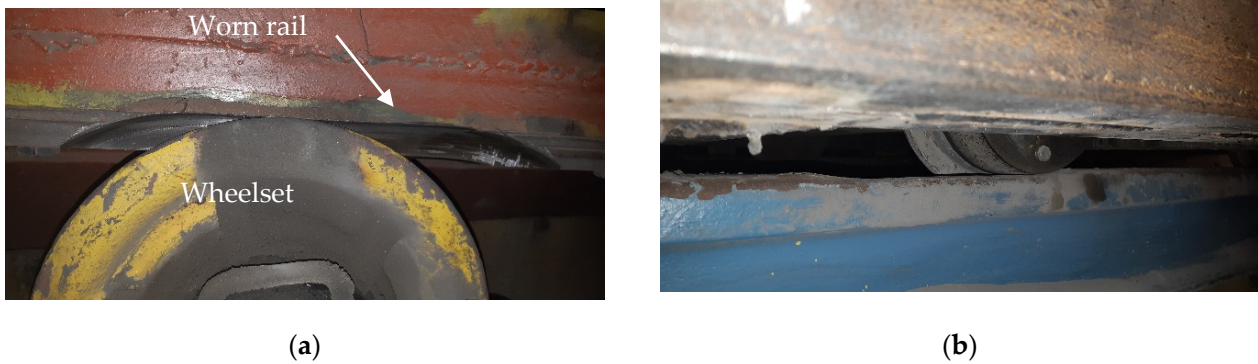
Figure 6 shows the wear on the running rail of the feeder carriage. In this case, the wear is due to rolling friction [24]. The rail, together with the entire feeder trough, reciprocates on the wheelsets. In the case of this element, the rate of the wear process is influenced not only by the aggressive operating condition, but also the pressure force exerted on the wheelsets by the trough. The wheelsets are typical for rail transportation systems. Therefore, they can be modeled and their behavior can be simulated on the basis of the solutions from the railway industry, which follow the Archard model [25].

Figure 6. Example of the wear on the wheelset: (a) abrasive wear on the running rail in contact with the wheelset, (b) material loss in the running rail.

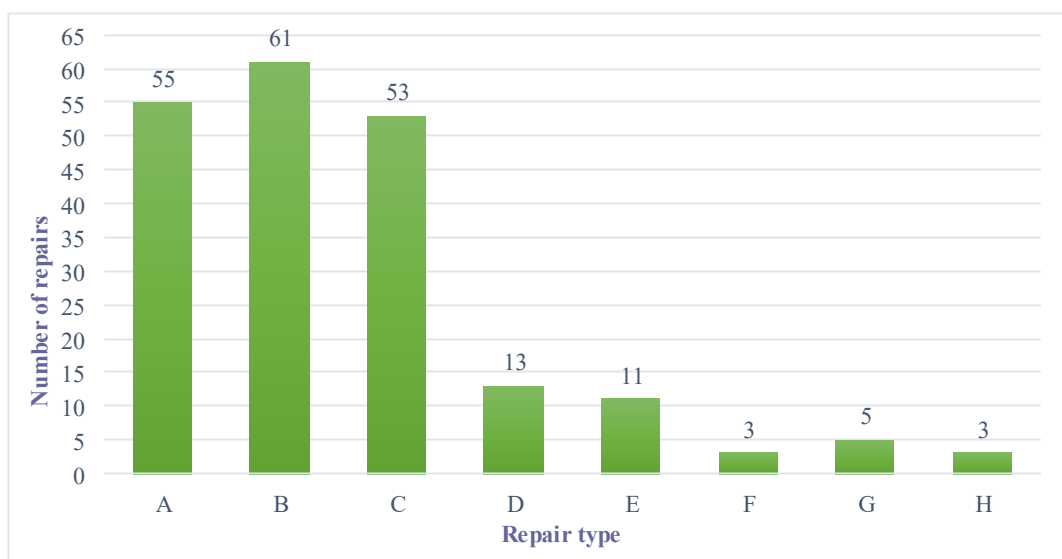
Over the analyzed period, a total of 147 service works were performed, consisting of 204 repairs. The preparatory and service works required 979 workers, and this number does not include rescue workers, who participate in the preparatory works. The most common repairs included replacements of the vertical sealings B, replacements of the through lining A, and replacements of hopper linings C. Less frequent repairs were required in the case of the feeder trough G, the running rails F and the lining on the back wall of the hopper H. The number of repairs made to individual elements is presented in Figure 8.

Figure 8. Total number of the A-H elements repairs.

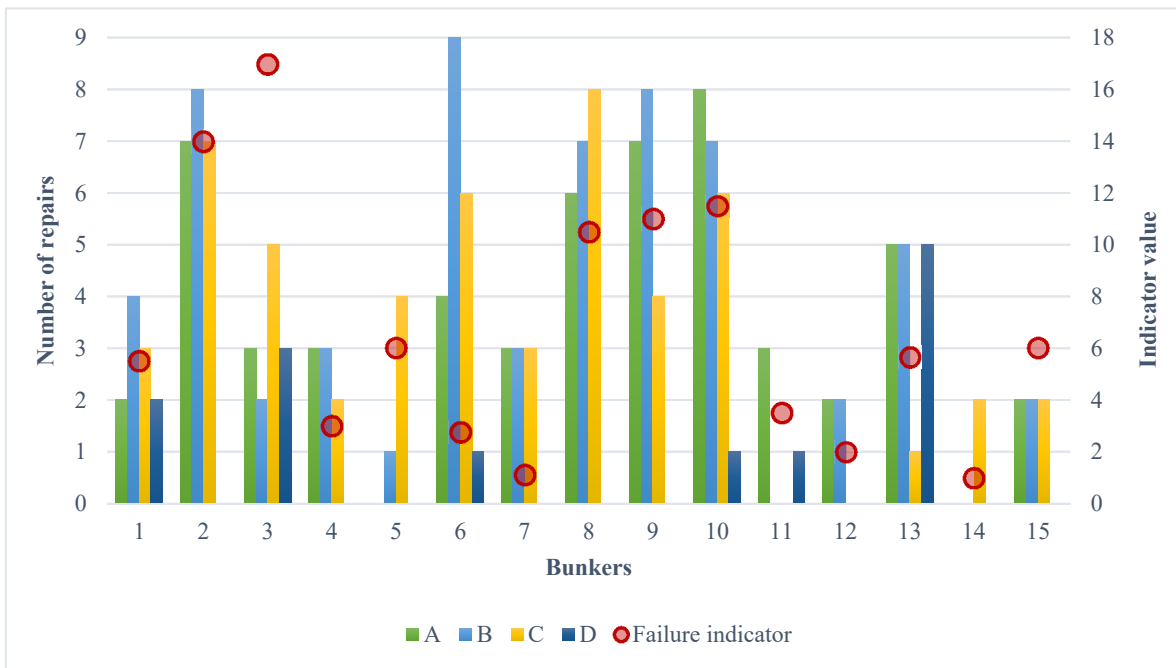
Analyses of the number of individual replacements together with the identified number-based failure indicator suggest that bunkers 3, 2, and 10 are most prone to failure. They show the highest number of repairs per one receiving bin. Importantly, the above-mentioned bunkers are located in the mining units in which the main haulage conveyors are also situated, and these have the highest daily capacities.

The smallest value of the number-based failure indicator is observed for bunkers 7 and 14. In the case of bunker 14, this fact is due to its location in the transportation system, and the resulting smaller amount of the ore transported on the unit conveyors. Importantly, despite one of the highest amounts of the passing ore, bunker 7 showed a very low failure indicator, which directly results from the fact that it has as many as eight receiving bins.

Figure 12. Number of repairs for the elements A, B, C, and D, and the daily failure indicator for the 15 receiving bins.

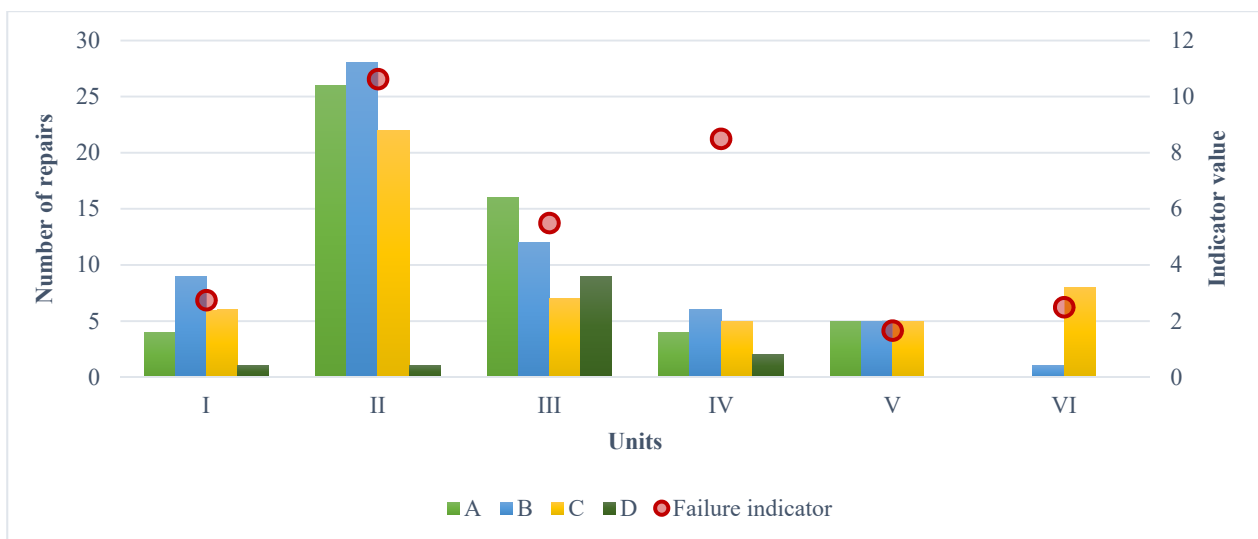
An additional analysis, which was conducted separately for each of the mining units indicated in Figure 4, focused on the service works performed in order to repair the operating failures. The greatest number of service works on the receiving bin was performed in unit II, which receives the cumulative stream of ore transported on the main haulage conveyors (Figure 13). Unit IV also showed a significant number of repairs per one bin. This case can also be accounted for by the amount of the transported ore mass, but most importantly by a significantly variable lithology and high moisture content (Figure 14). Importantly, very large amounts of ore pass through the bunker. The explanation in this case seems to lie in the lithology or high moisture content of the transported ore. The third analyzed unit is unit III, whose bunkers are partially located along the main conveyors, albeit the number of bins in the bunkers located in this unit is between one and three.

Figure 13. Number of repairs for the elements A, B, C, and D, and the daily failure indicator for the individual mining units in the mine.

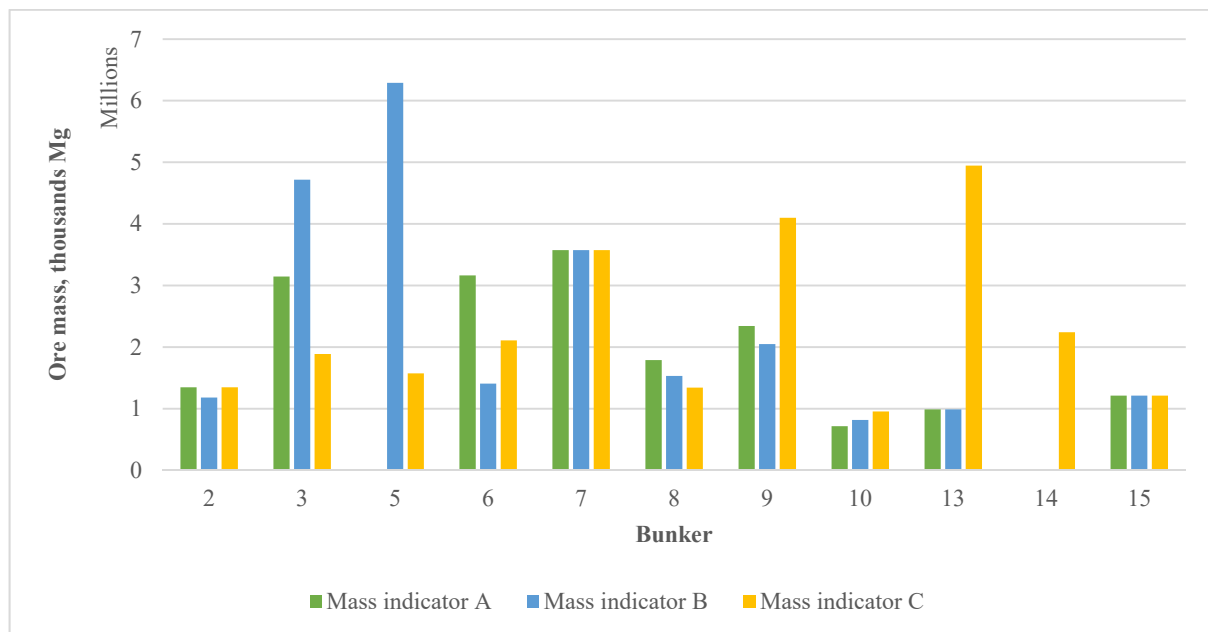
Figure 15. Mass indicator values for the elements A, B, C of the analyzed bunkers.

The greatest amounts of ore passed through bunker 9 (unit II), 6 (unit I), 7 (unit V), and 8 (unit II). Taking into account repairs for the elements A, B, C, and D, the indicators were calculated respectively for each of the bunkers. The results provided in the graph do not include the indicator for the element D, as its failures were occasional.

The mass indicators demonstrate that in bunkers 2, 7, 8, 10, and 15 the elements A, B, and C undergo wear at a comparable speed, but with intensity different for each bunker. Failures of the vertical sealings B dominate in bunkers 3 and 5, while in bunkers 9, 13, and 14 the majority of failures (critical wear) occur in the case of linings on the side walls of the hopper C. The most frequent repairs were performed for bunker 10—every 0.8 million Mg, on average. In the case of bunkers 2, 7, 8, and 15 the repair frequency is every 1.3 million Mg, 3.6 million Mg, 1.5 million Mg, and 1.2 million Mg, respectively. In bunkers 3 and 5, the vertical sealings are replaced rarely in comparison to other repairs (on average every 4.7 million Mg and 6.3 million Mg). A different scope of repairs is observed in the case of bunkers 9, 13, and 14, in which the linings on the hopper walls C are replaced at the greatest intensity, every 4.1 million Mg, 4.9 million Mg, and 2.2 million Mg, respectively. In general, the linings in the feeder trough A were replaced in all bunkers after approximately 2.0 million Mg of ore had passed through it, the vertical sealings B were replaced after 2.4 million Mg, and the hopper wall linings C—after 2.3 million Mg.
