GPR and Digital Survey for the Diagnosis and the 3D Representation of the Battle of Issus Mosaic from the House of the Faun, Pompeii (Naples, Italy)

Keywords: mosaic of alexander; GPR; digital survey; pre-conservation diagnosis

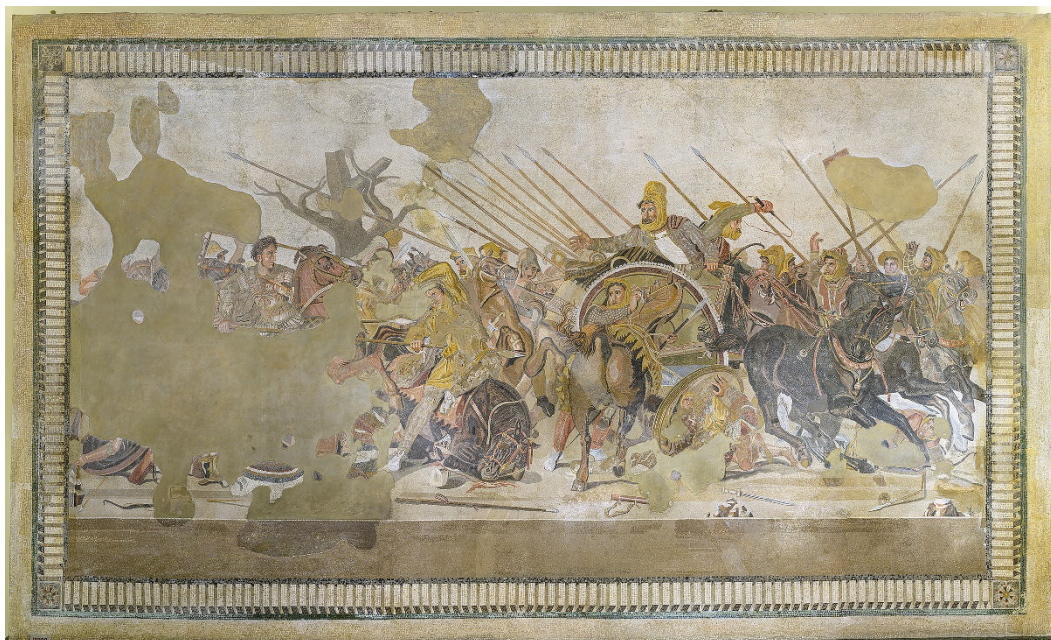
Figure 2. A close-up picture of the Battle of Issus Mosaic.

The events briefly explained profoundly affected the state of conservation of the work, which is currently affected by important instability phenomena highlighted by the appearance of significant detachments of tiles (the occurrence is emphasized by the vibrations transmitted by car and railway traffic outside the museum), superficial lesions and swelling of the surface. In addition, it must be considered that the mosaic was designed and built to be placed on the floor, and consequently, the detachment from the site of discovery produced a significant alteration. In fact, the almost complete, albeit brief, removal of the rudus (the layer of lime, sand and aggregates, such as gravel or pebbles, which formed a concrete of consistent thickness) and the transport from the lower to the upper floor significantly affected the nucleus (the layer of mortar mixed with fragments of bricks that served as a support for the floor made of tiles). This procedure unnaturally transformed a floor mosaic into a wall mosaic [29].

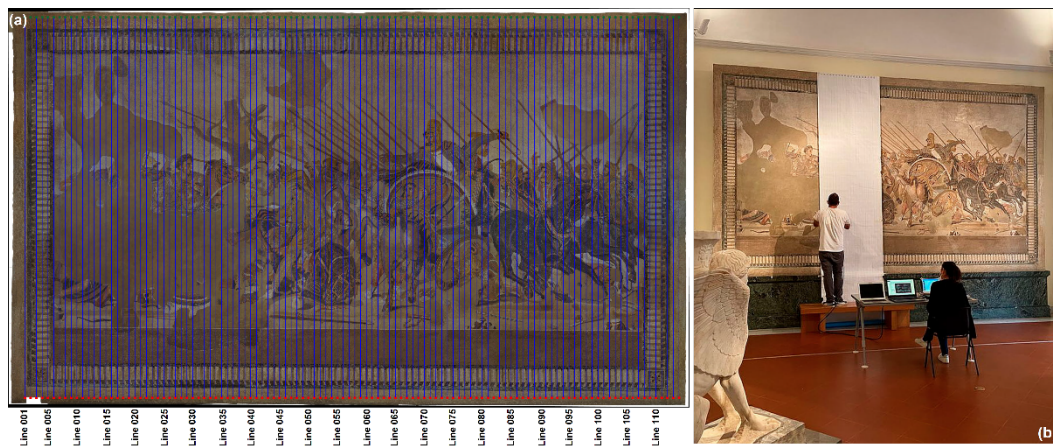
Technically, data acquisition took place on 114 lines, from top to bottom every 5 cm, where instrumental readings were executed in continuous mode (Figure 3). In addition, several horizontal profiles and some profiles on the sides of the mosaic were acquired.

Figure 3. Grid data acquisition (a) with an IDS georadar (b).

The georadar surveys were carried out on the entire surface of the mosaic in its actual vertical position. An IDS georadar RIS-K2 with a 3000 MHz high-resolution antenna was used for the data acquisition, whose features were considered sufficient and suitable for an overall assessment of the conservation status of the mosaic with respect to the type of target to be investigated and the thicknesses of surfaces to be analyzed.

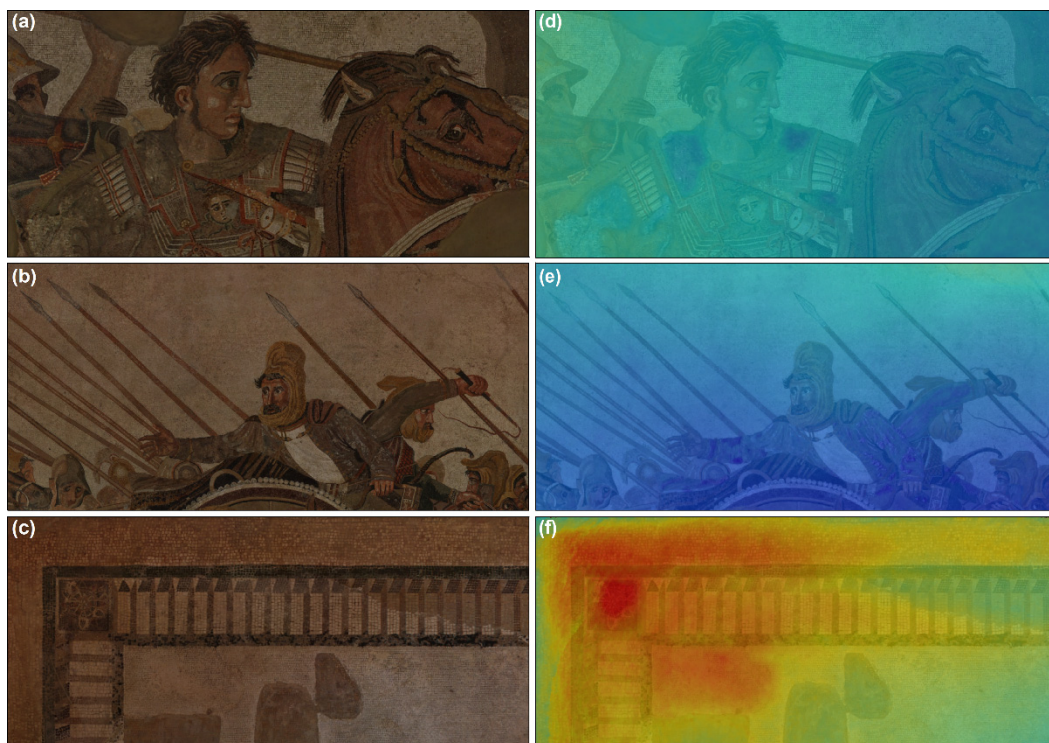
Figure 5. Details of the orthophoto obtained in 2020 (a–c) and DEMs transparently overlaid on them (d–f).

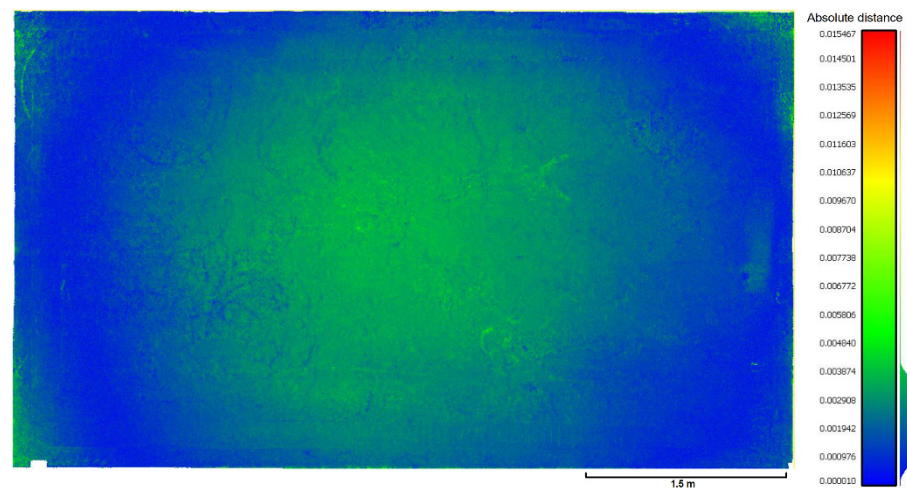
those of 2018. On a global scale, a uniform swelling of the central part of the mosaic was estimated to be in the range of about 4 mm.

Figure 6. Absolute distance obtained by subtracting the 2020 data from 2018 data.

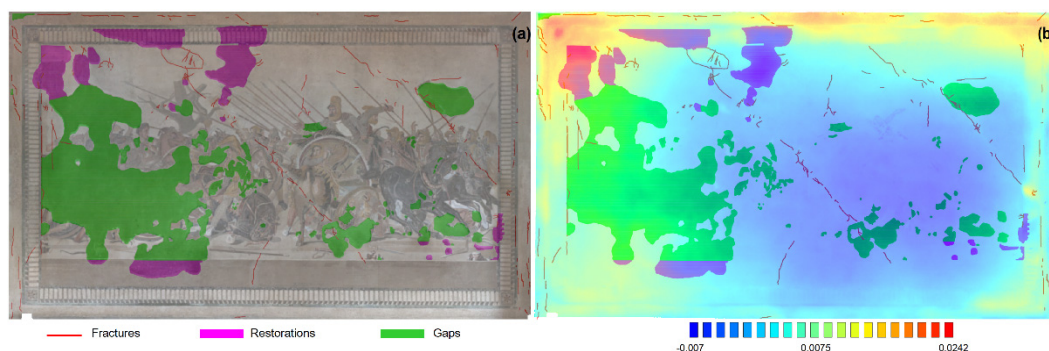
Figure 7 shows the images obtained in 2018 from the visual analysis of the orthophoto in which the areas affected by restorations, the detachment of tesserae and fractures are highlighted. The indication of the fractures was just quantitative and therefore they were not classified by taking into account the elevation, thickness and dimensions. The visual analysis of the orthophoto made it possible to detect in detail every single fracture and the detachment of tesserae present on the surface. The latter phenomenon, caused by multiple factors, was aggravated by the vertical position of the mosaic, which, compared with the original horizontal position, determined the displacement on the ground and the irreversible loss of the individual tiles or portions of the mosaic. The fractures had two main alignments: one vertical/horizontal, which mainly affected the edges of the mosaic, and one diagonal to the mosaic, which concerned the central/right portion of the panel. The latter was particularly relevant and fell into the areas of greatest depression recorded in the digital surface elevation model. The presence of restored and consolidated areas on the left side may have increased the resistance of the surfaces, avoiding the onset of superficial lesions.

Figure 7. Restorations, detachments of tesserae and fractures reported on the orthophoto (a) and the DEM (b).

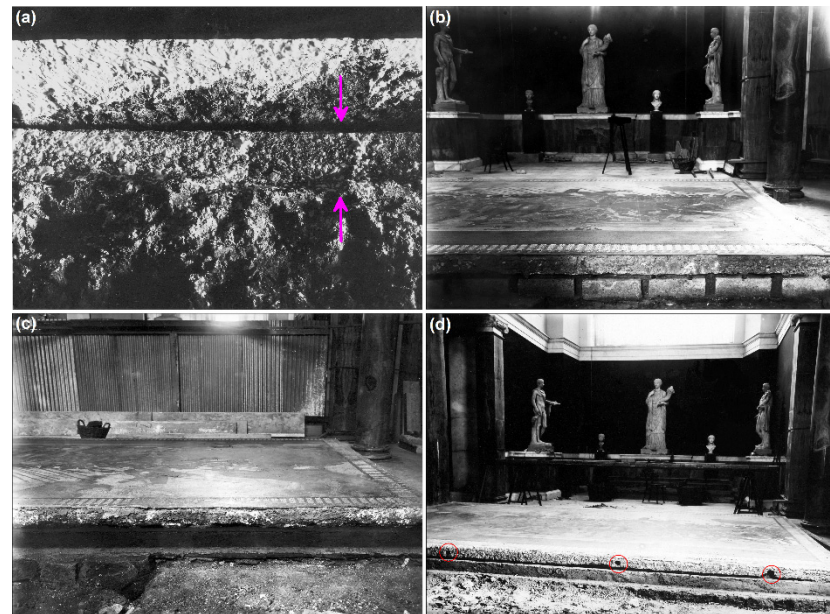
In order to understand the inner structure, in the following part, the analysis of photographic documentation, made between 1916 and 1917, which records all phases of the moving and the final vertical installation, was jointly analyzed with GPR radargrams and slices. Following the images, it is known that the mosaic was housed on some blocks of rock. In Figure 9a, it is possible to note the original stratigraphy by recognizing, from top to bottom, the nucleus, the rudus and the screed covering the stone beams. Subsequently, the section was cleaned, the screed was removed and the stone structure was brought to light. Some wedges separated the rudus from the blocks of rock (Figure 9b). Then, the surface of the section was leveled and the rudus was cleaned of residual lime for the realization of the support frame (Figure 9c). In the next phase, equally spaced holes were drilled in the rudus, three of which are visible in Figure 9d.

Figure 9. Photo no. 4138-1916-EX 306 (a), photo no. 4131-1916-EX 299 (b), photo no. 4129-1917-EX 297 (c) and photo no. 4130-1916-EX 298 (d).

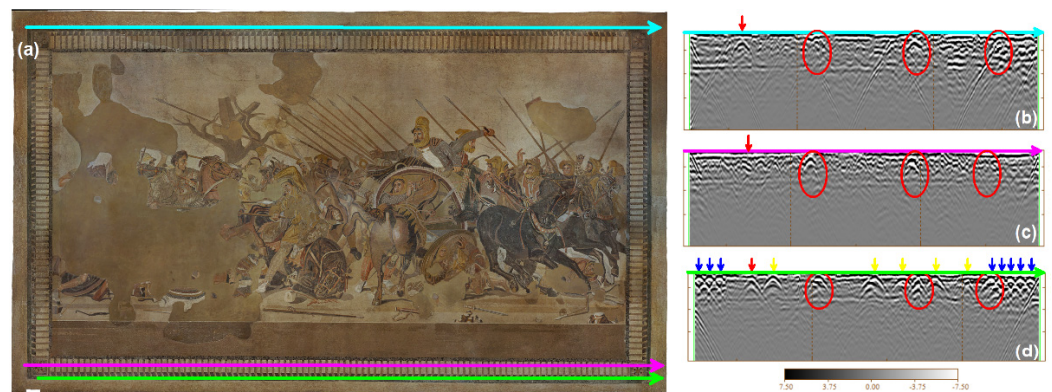
From the analysis of the georadar results, it was assumed that these holes were drilled to anchor the rudus to the frame under construction by means of pins. Figure 10b shows the acquired radargram at the edge of the frame, as indicated by the green arrow on the mosaic orthophoto (Figure 10d). With red circles, the positions of the holes visible in the photos are indicated. At those points, hyperbolas are attributable to the presence of iron pins. However, there are other anomalies (indicated with yellow arrows) of the same nature. At the edges, the close hyperbolas reflected the positions of the nails used to fix the iron L-bars (blue arrows) installed in the following stages. Figure 10c shows the radargram acquired at the edge of the original frame, as indicated by the magenta arrow on the mosaic. The anomalies persisted and another one was highlighted on the left (red arrow). There were no more anomalies in the upper band. Then, the pins penetrated the mosaic by at least

15 cm (a few cm in the original one). The radargram acquired in the upper band, again at the edge of the original mosaic, highlighted the same anomalies found below (Figure 10a). Here, the pins are still visible from the top of the frame.

Figure 10. Location of the anchor pins (indicated by red circles) and further anomalies on three horizontal radargrams (b–d) located at the positions of the colored arrows (a).

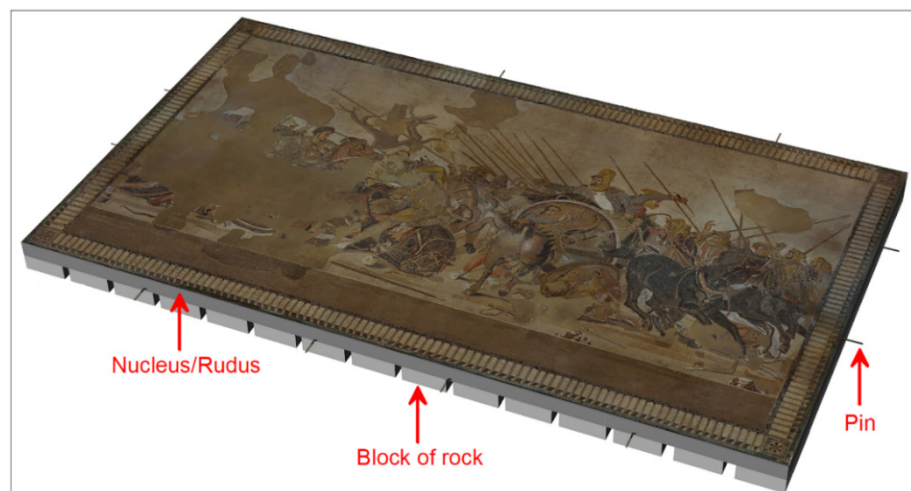
Figure 12 shows the digital model of the processes followed before applying the frame and removing the stone.

Figure 12. Digital model with the locations of the blocks of rock and the anchor pins.

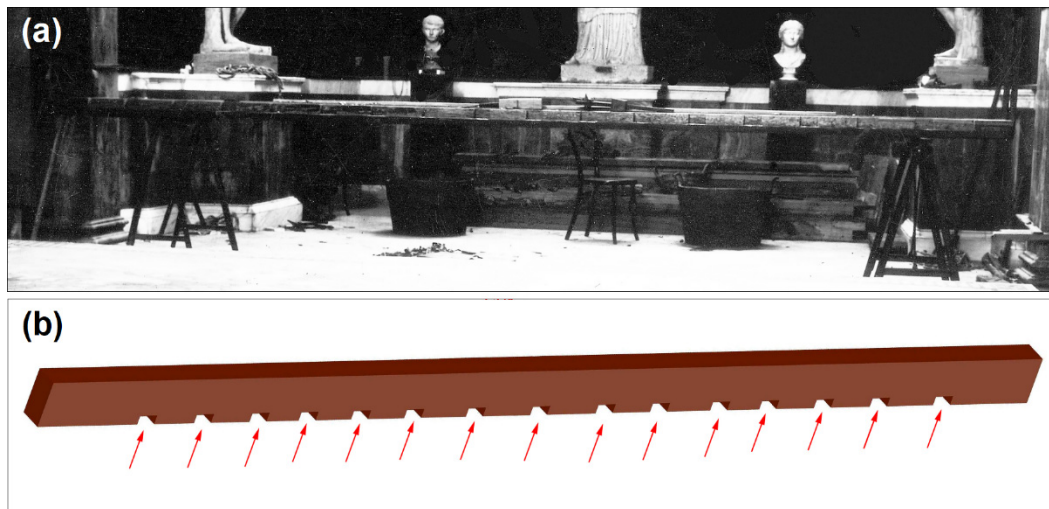
The external frame was probably made using wooden crosspieces measuring 25×13 cm. Figure 13a shows a detail of Figure 9d (photo no. 4130-1916-EX 298), where in the background,

a wooden crosspiece appears with regular carvings. They were assumed to be about 10 cm wide and placed at intervals of about 22 cm. Figure 13b shows the digital model of the carved frame. It was assumed that this element is related to the underlying part of the longitudinal crosspiece that was specially prepared to house the elements of the internal filling.

Figure 13. Photo no. 4130-1916-EX 298 (a) and digital model of the frame with indication of the notches using red arrows (b).

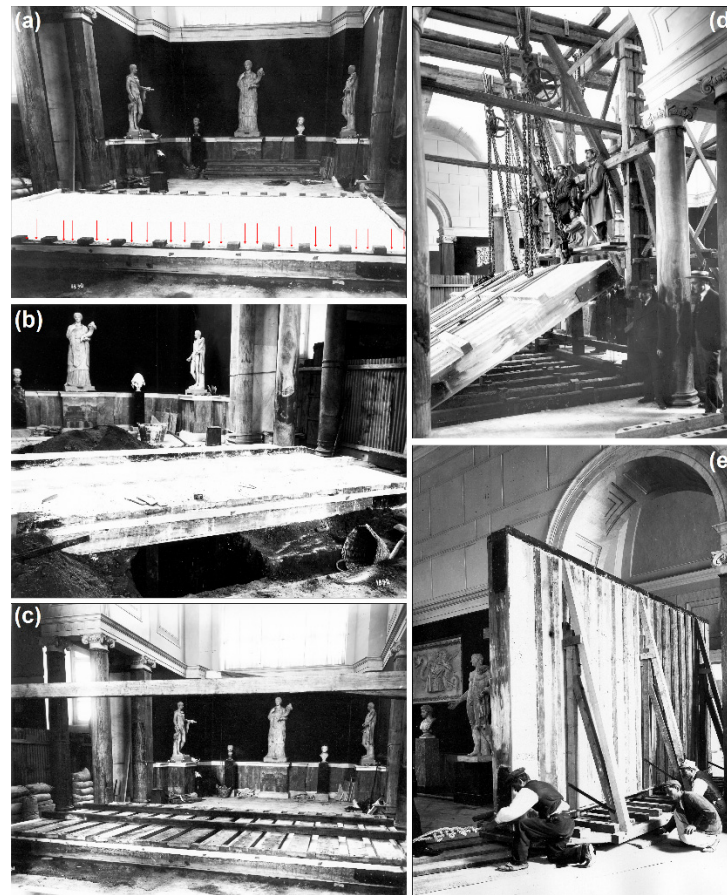
A protective sheet was added to the surface, which was blocked with a board on the edge by means of nails in the pre-drilled points in the previous step (Figure 15a). Some sides were added (10 cm wide and 5 cm high) in between where the wide boards were to be placed (Figure 15b). The gaps were subsequently sealed with mortar (Figure 15c). After

which, the lifting of the recessed mosaic began (Figure 14d), which was placed in a vertical position on a support (Figure 15e).

Figure 15. Photo no. 4133-1916-EX 301 (a), photo no. 4134-1916-EX 302 (b), photo no. 4135-1916-EX 303 (c), photo no. 4157-1917-EX 325 (d) and photo no. 4173-1917-EX 341 (e).

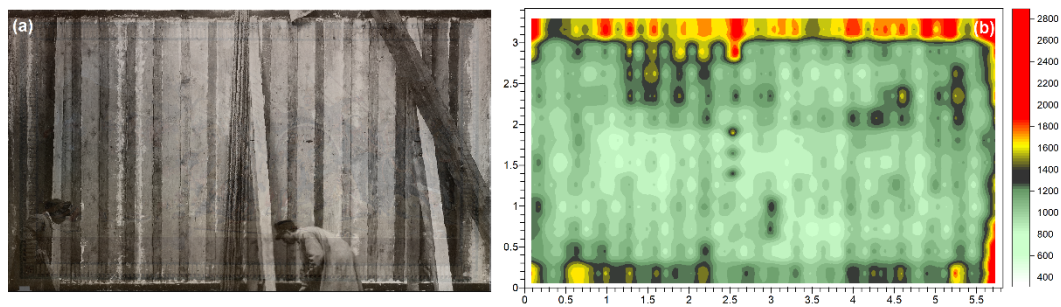
On the back, from a historical photo, an alternation of narrow dark boards and wide light boards, 10 cm and 22 cm wide, respectively, can be noted (Figure 16a). In the GPR slice relating to the time window 1.88–2.4 ns (Figures 8b and 16b), a series of vertical anomalies were highlighted that began directly in contact with the rudus. It was plausible that the wooden structure placed at the rear of the mosaic traced this structure in some way. In particular, it is likely that the narrow boards were actually beams or murals 10 cm wide (with a maximum length of 14 cm, depending on the thickness of the shaving made under the rudus), which rested directly under the mosaic. As can be seen from many of the radargrams, some profiles seemed to be characterized by the presence of metal elements as brackets to block the vertical wooden beams from the rudus. An example is shown in Figure 17, where three identifiable hyperbolas emerged clearly with the rudus, the filling lime and the closing table. Hyperbolas 1 and 2 (Figure 17a) often penetrated the mosaic and probably represented a system for anchoring the possible wooden beam (vertical georadar anomalies) directly to the mosaic. At approximately hyperbola 3, a sort of reinforcement was evident under the vertical structures (Figure 18). The spaces were probably filled with plaster and closed everything with the boards that were visible on the back. The slice (Figure 17b), which was related to the time window between 3.34 ns and 3.87 ns, was enhanced to visualize the three anomalies jointly, even if detected at different depths.

Figure 16. Historical photo (photo no. 4172-1917-EX 340) straightened and positioned on the back of the mosaic (a) and time slice relating to the time window 1.88–2.4 ns (b).

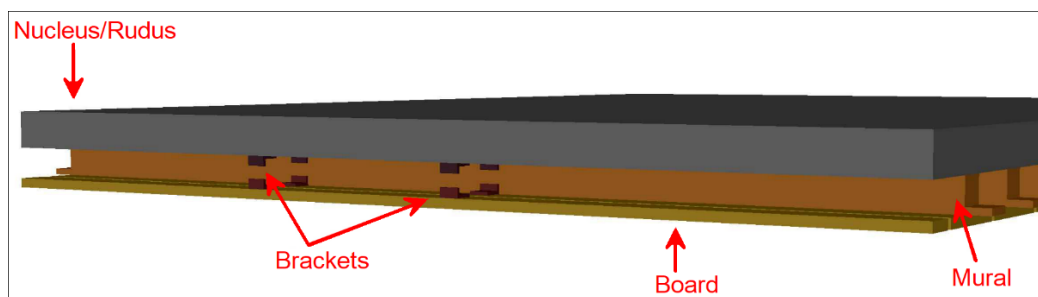
Figure 18. Anchor system digital model.

Therefore, after the removal of the blocks of rock, the vertical beams would have been housed (directly or indirectly) thanks to the notches located at the base of the longitudinal beams of the frame. In this system, it is possible to make four hypotheses based on the presumed depth of the notch, the location of the vertical beams and the closing plank. The hypotheses in question took into account the position and shape of the acquired georadar anomalies:

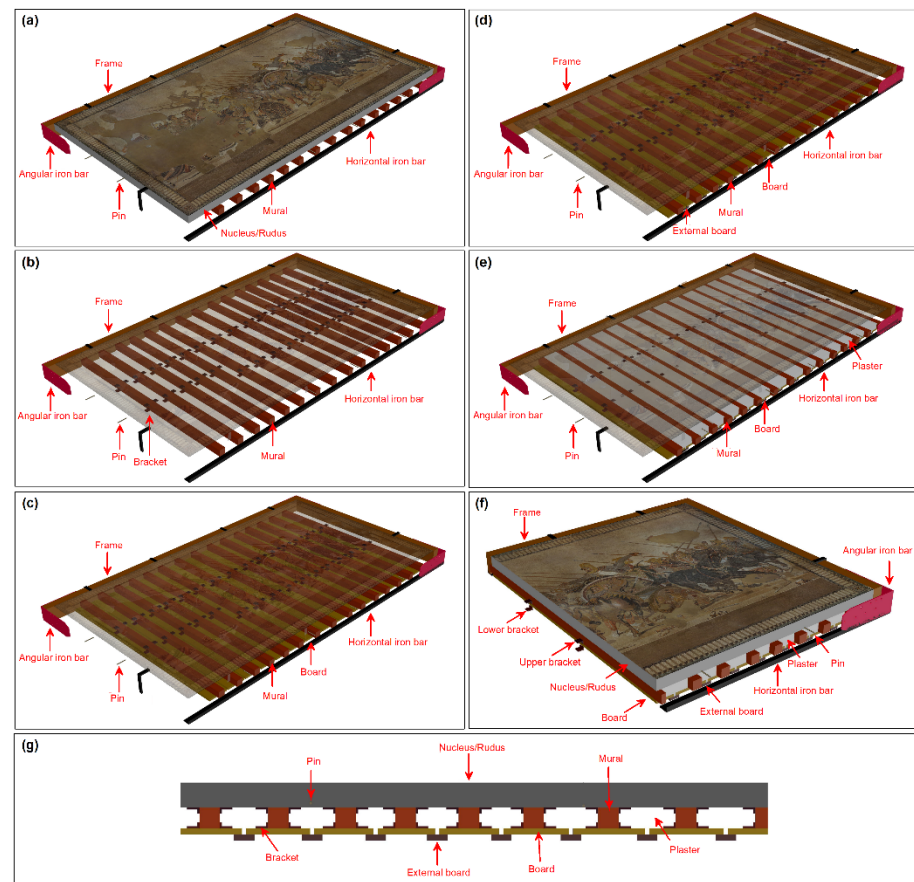
Hypothesis 4. (Figure 22): The planks were anchored to the vertical beams by means of brackets according to a “T” system. Closing tables were inserted between one plank and the other. The gaps left empty between the beams were filled with plaster. This is the hypothesis that best matches the shape and position of the georadar anomalies.

Figure 22. Hypothesis 4 digital model: vertical beam positions (a), anchoring bracket locations (b), board arrangements (c), external board positions (d), complete support system (e), cross-section (f) and longitudinal section (g).
