Seismic Assessment and Retrofitting of an Historical Masonry Building Damaged during the 2016 Centro Italia Seismic Event

Keywords: masonry building; Centro Italia earthquake; seismic behavior; retrofitting interventions

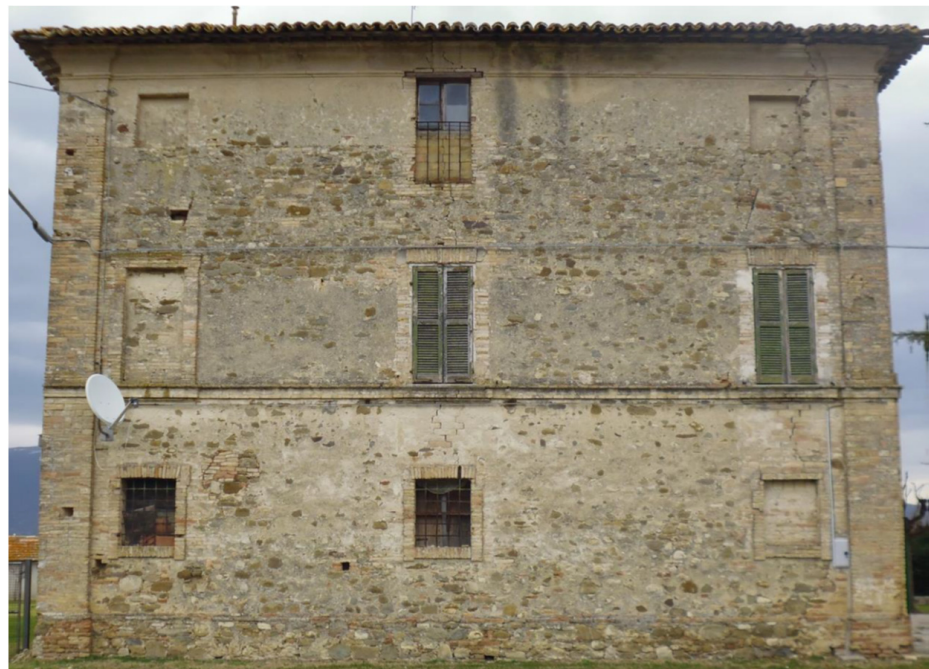
Figure 1. The analyzed building: side elevation and typical plan.

The analyzed building was constructed around the 1600s in Perugia, and it is characterized by a rectangular plan with dimensions 20.65 m \times 13.15 m (Figure 1). The construction presents three floors above ground and is made of uncoursed squared rubble masonry (Figure 2) whose mechanical properties, evaluated according to [25,26], are summarized in Table 1, where γ is the unit weight, E is Young's modulus, G is the shear modulus, f_m is the mean compressive strength and τ_0 is the mean shear strength. The masonry walls of the building are characterized by a thickness equal to 45 cm.

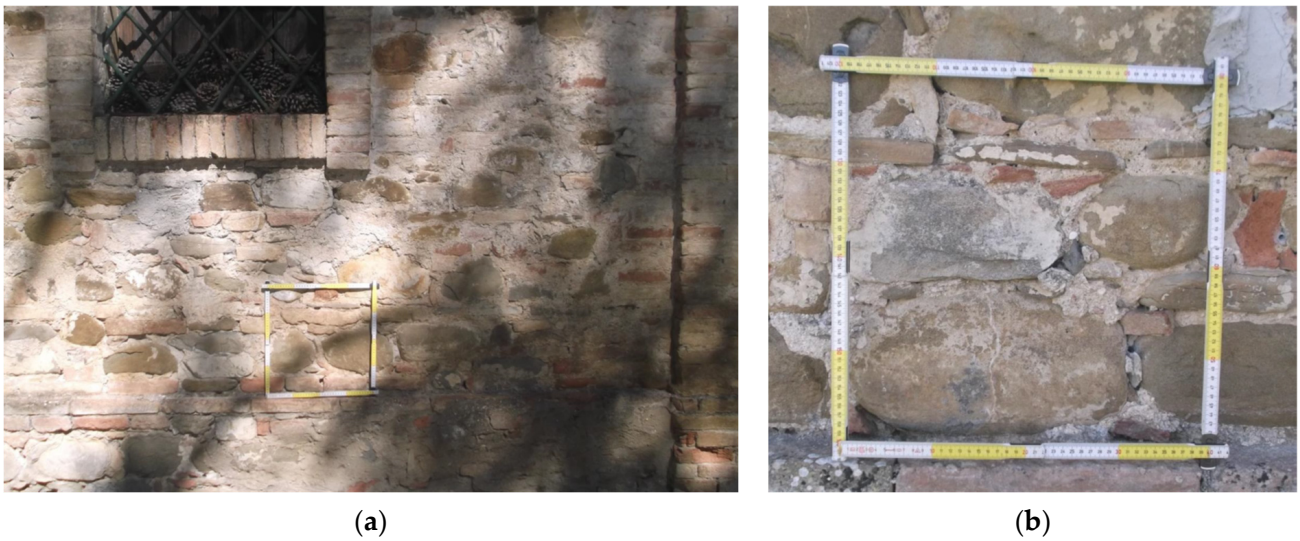
Figure 2. (a) Detail of the masonry walls of the building; (b) Masonry texture (inspection window dimension 40 × 40 cm).

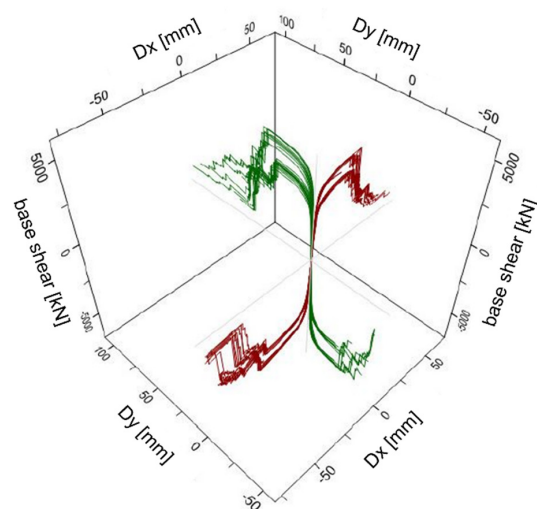
Figure 11. Capacity curves (retrofitted configuration).

Pushover analysis has been carried out considering the same horizontal load profiles used for the evaluation of the seismic behavior of the current configuration. Figure 11 shows the capacity curves obtained for X (red curves) and Y (green curves) direction considering the retrofitted configuration.

Table 6 summarizes the results of the non-linear static analysis performed for the retrofitted configuration in terms of minimum value of risk indices calculated considering the different capacity curves shown in Figure 11.

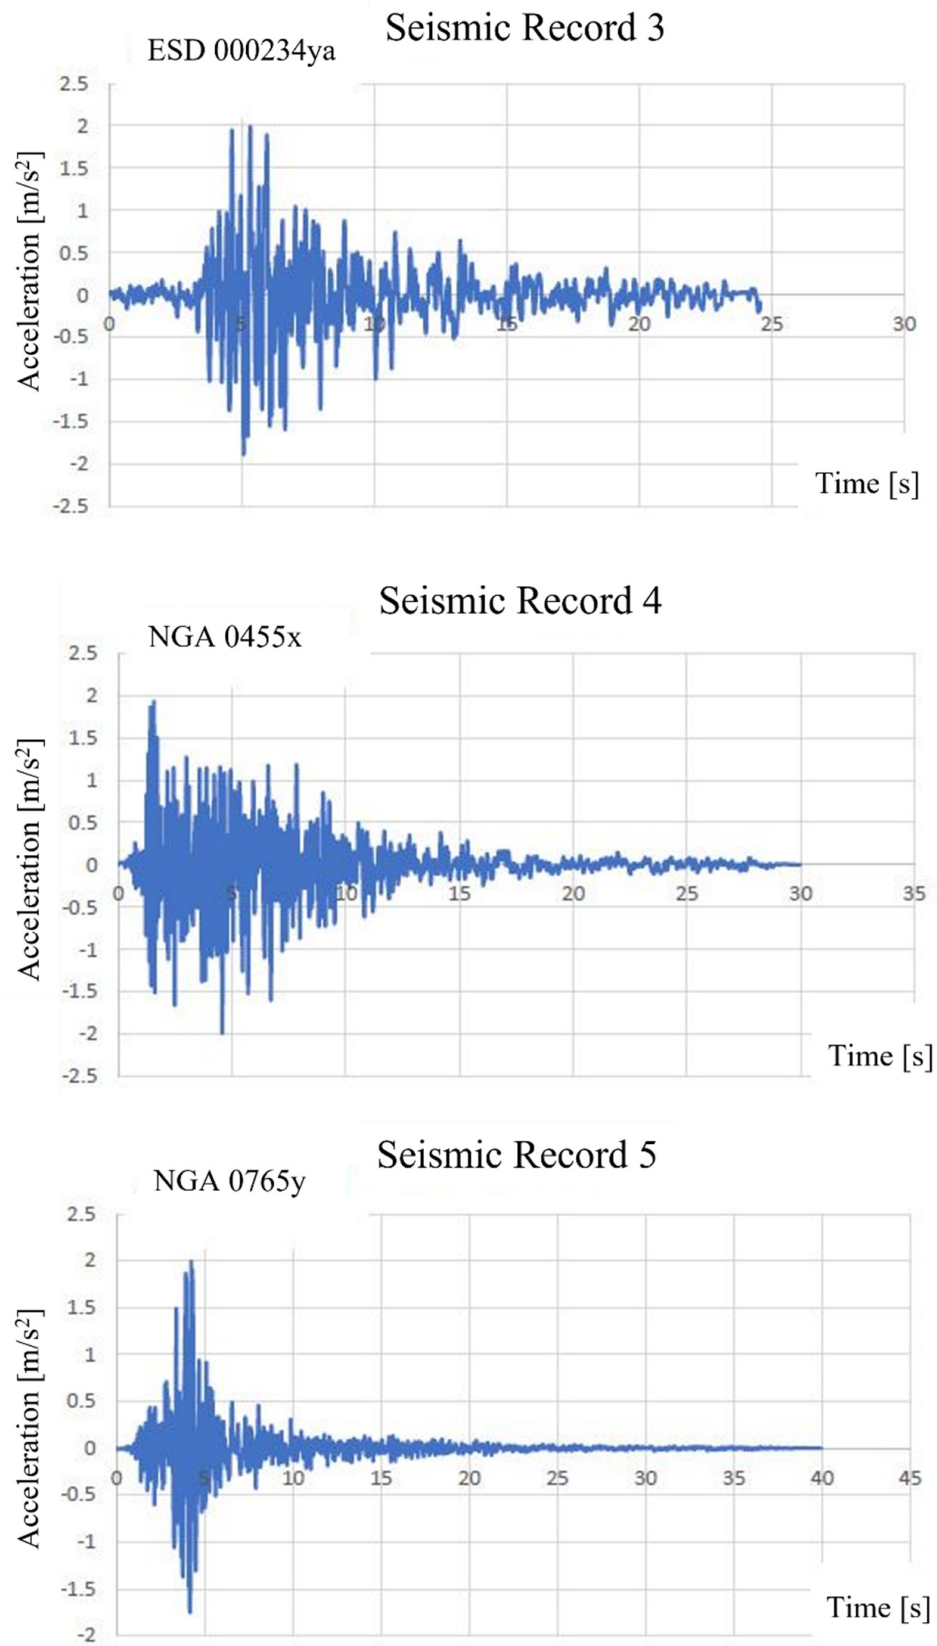
Figure 16. Seismic records.

A non-linear time history analysis considering Rayleigh damping has been performed using the seven spectrum-compatible accelerograms reported in Figure 16, obtained using REXEL software [35] by considering the site seismic parameters listed in Table 2.

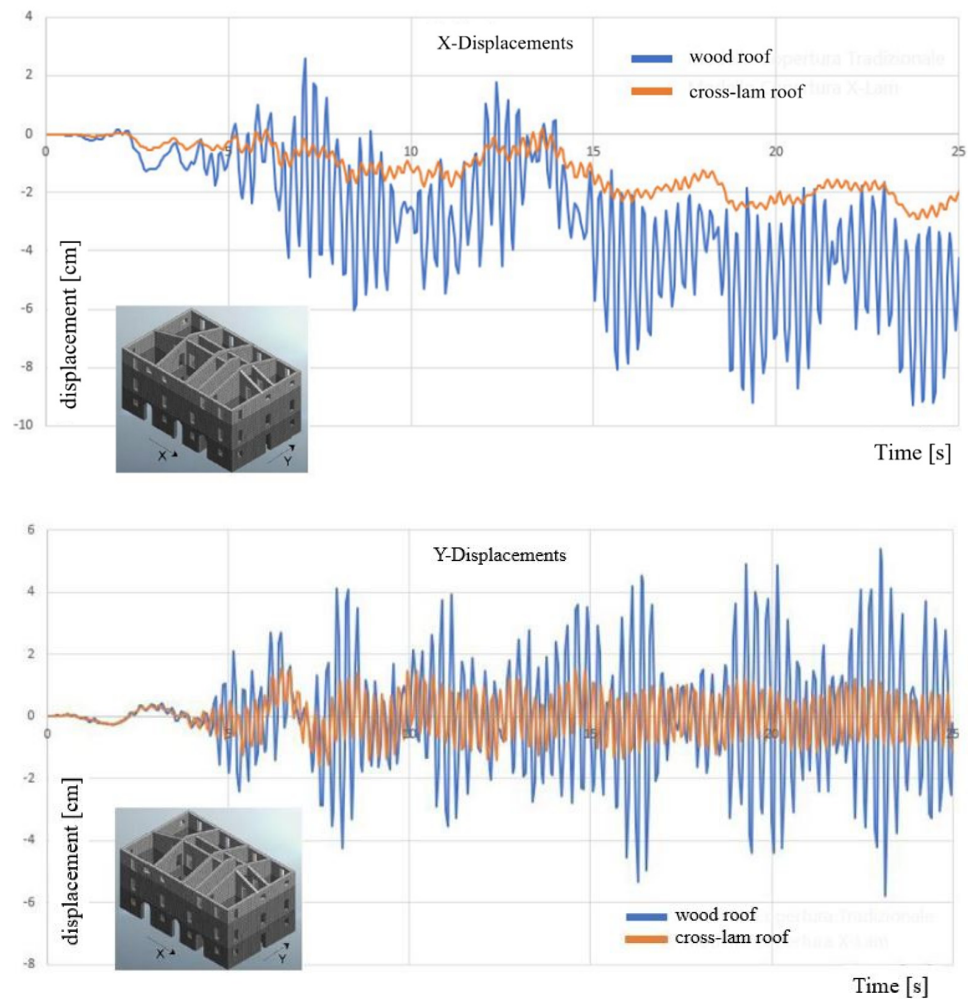
Figure 17. Comparison between the obtained maximum displacements of the roofs in X and Y direction considering the cross-laminated roof structure (14 cm thickness) and a single plank wooden roof (4 cm thickness).

Figure 17 shows the results in terms of X and Y displacement histories comparing the cross-laminated roof structure with a classic wood roof solution (with 4 cm-thick single planks). The results show the displacements of the roof for the first 25 s of the time history analysis representing the most significant part of the seismic events. The trends shown in Figure 17 represent the average value among the seven spectrum-compatible accelerograms combined according to what is reported in [25].

The results show an important decrease in the displacements in both directions. The maximum displacement in X direction is about 2.5 cm in comparison to that (about 9 cm) obtained by the single plank roof structure. In addition, in Y direction, the reduction is significant because the maximum displacement is about 1.8 cm in comparison to the value (about 5.8 cm) obtained with the single plank solution. The displacement reduction is due to the dissipation of the energy occurring in the inelastic springs.
