Article

Deposition of Different Metallic Coatings as Repair Materials for Concrete by Using a Twin-Wire Arc Thermal Spray Process

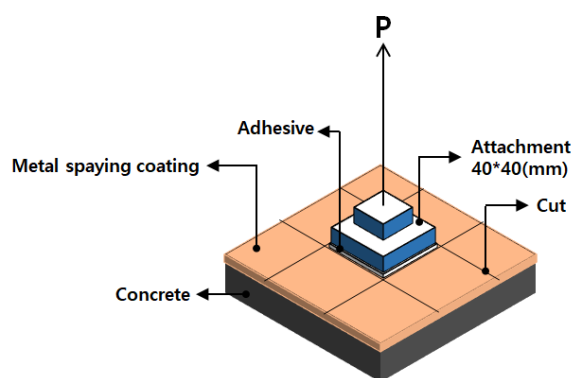
The bond strength of the deposited coating on the concrete surface was measured by selecting a 40 mm × 40 mm area at different locations, following the KS F4716 Standard [30]. Before measuring the coating bond adhesion, epoxy was applied on the surface and dried for 24 h [31]. Subsequently, the extent of adhesion was determined using a Proceq DY-216 instrument. A schematic of the bond adhesion measurements is shown in Figure 1.

Figure 1. Schematic for bond adhesion measurement.

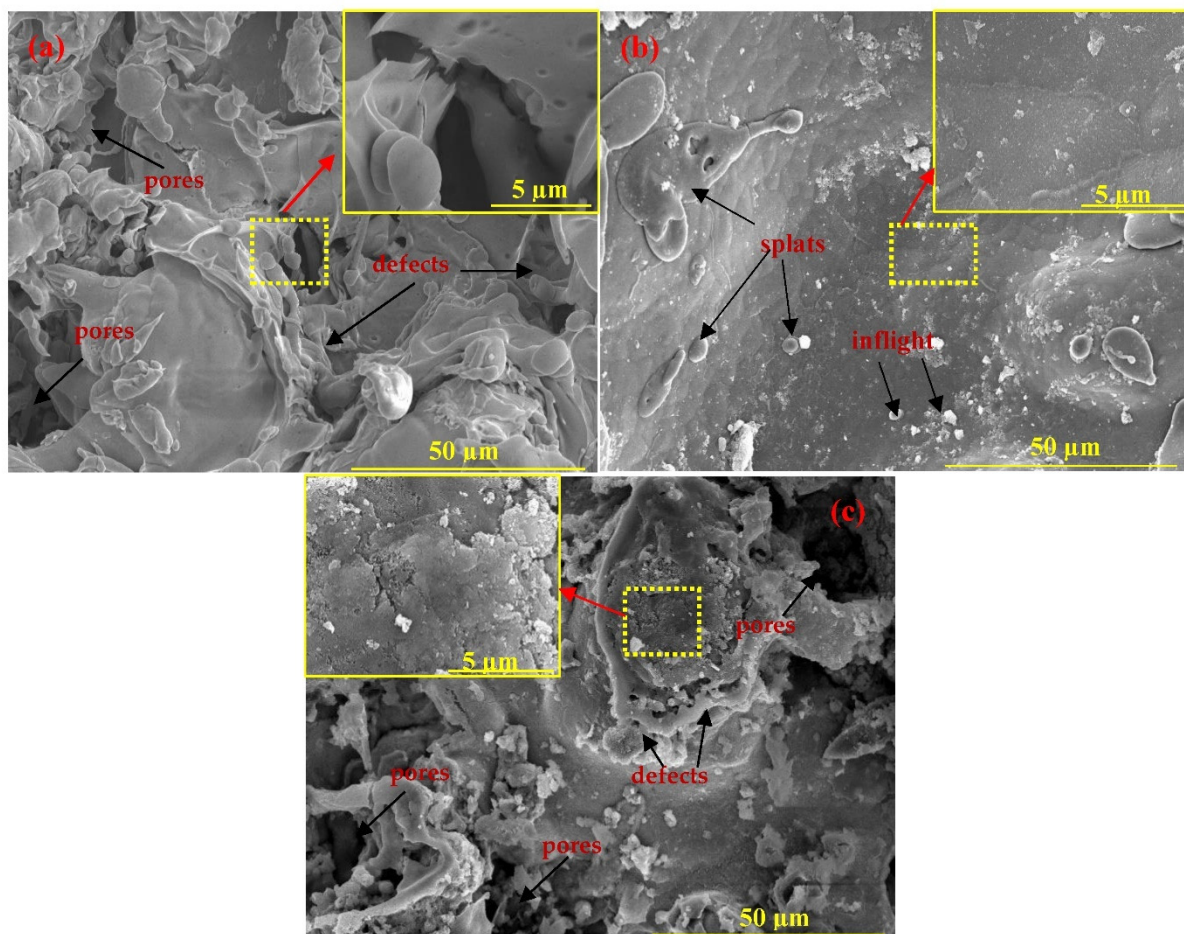
The surface morphologies of the deposited coatings, as characterized by SEM, are shown in Figure 2. The Cu coating showed the presence of micro- and macropores along with splats [34,35], which led to the formation of severe defects (Figure 2a). There were many semi-molten metal particles of different shapes, such as globular, disk, and plate, which caused irregularities in the morphology of the coatings. By contrast, a comparison of the Ti coating morphology with that of Cu showed a uniform and compact structure [19] with inflight particles, as shown in Figure 2b. The melting point of Ti is very high; therefore, the completely molten metal particles become suspended in the atmosphere, settle during the cooling process, and partially oxidize the coating. Some splat particles are observed in Figure 2b, owing to the sudden cooling of the molten metal particles, which were later deposited on the surface and caused defects. The 85Zn-15Al alloy coating exhibited severe defects and pore formation, as shown in Figure 2c. This is attributed to the different metals used in the coating, that is, Zn and Al, which have different melting points and densities. Al has a high melting point and low density, compared with Zn; therefore, it melts at high temperatures and is deposited later owing to its low density [34], leading to the creation of defects. Moreover, if the molten Zn particles cool down with Al, it is possible to obtain a less defective coating; however, owing to atmospheric conditions, they are difficult to cool down simultaneously. Therefore, this coating exhibited severe defects along with splats and inflight particles of different sizes. The surface morphology of the coatings was correlated with cross-sectional SEM images, as shown in Figure 3. The thickness of the coating was found to be 200 (± 10) μm , which correlated well with the thickness measured by using an Elcometer. Some defects were observed in the Cu coating (Figure 3a), while the Ti coating exhibited a dense morphology (Figure 3b). Therefore, this coating could exhibit

Figure 2. SEM of (a) Cu, (b) Ti, and (c) 85Zn-15Al coatings at 1000 \times and 10,000 \times (inset SEM images) deposited on the concrete surface.

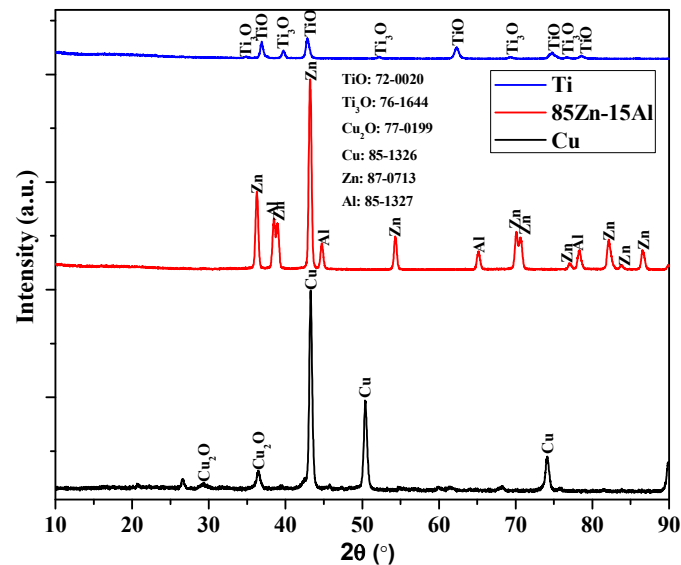
EDS analysis revealed that the Cu and Ti coatings were partially oxidized; therefore, oxidation likely occurred. The phases formed during this process, along with the respective JCPDS number after the deposition of the coating, were determined via XRD, and the results are shown in Figure 4. No oxides were formed in the 85Zn-15Al coating, neither in the Zn (JCPDS:87-0713) nor in the Al (JCPDS:85-1327) phase. By comparison, a slight oxidation of the Cu coating occurred owing to the atomization of molten metal particles in the air [36], which was confirmed through EDS; therefore, it showed very small intensity peaks of Cu₂O (JCPDS:77-0199) with the Cu (85-1326) phase. Our finding is corroborated by those of Sharifahmadian et al., who observed Cu₂O along with the Cu phase [35] in a Cu coating deposited via an arc thermal spray process. The oxygen content in EDS was found to be 5.16%, which meant that the coating was partially, rather than completely, oxidized. The Ti coating was completely oxidized, owing to its high melting point; therefore, there was no Ti in the coating. This coating showed TiO (JCPDS:72-0020) and Ti₃O (JCPDS:76-1644) phases. The oxygen content in EDS was very high, which corroborates the XRD results, according to which the Ti coating exhibited oxidation.

Figure 4. XRD of the coatings.

The volume fraction ($V_f\%$) of each phase present in the coatings was determined using the JADE software built with XRD data. The results are listed in Table 2. Notably, 19.04% Cu₂O was observed in the Cu coating, while no oxides of Zn or Al were found in the 85Zn-15Al coating. There is a possibility that native oxidation occurred, but due to the limitation of the XRD analysis, it was not observed. Most importantly, the content, that is, $V_f\%$ of the Zn and Al phases, was almost identical to that observed in the EDS analysis. No Ti was observed owing to its oxidation during the coating process. Ti₃O and TiO were

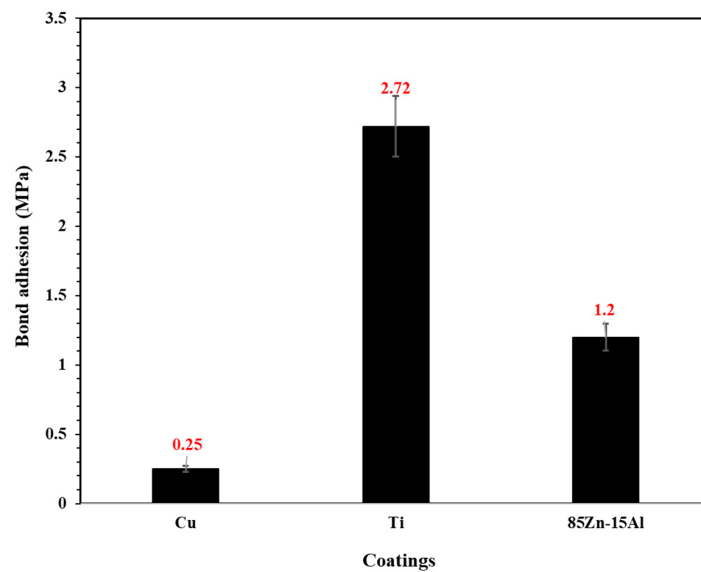
The bond adhesion values of the metallic coatings deposited on the concrete surface are shown in Figure 5. The bond adhesion values of Cu were found to be very low, i.e., 0.25 (± 0.02) MPa, even lower than the minimum value recommended in KS F4716 [30], which is 1.1 MPa, and EN1504-3 [10], which is 0.8 MPa. The concrete surface exhibited very low toughness; therefore, the energy dissipation from the molten metal particles was negligible for transferring the heat from the metal to the concrete [39,40]. The interfacial bonding of the Cu coating with the concrete surface was very weak; therefore, it exhibited minimum bond adhesion values. Moreover, this result agrees well with the surface and cross-sectional morphology of the coating, which revealed severe defects and pore formation. Defects and pores lead to the destabilization of the interfacial bonding between metal and concrete. However, the 85Zn-15Al coating satisfied the minimum bond adhesion values recommended by KS F4716 and EN1504-3. This coating also exhibited defects and pores; however, owing to the low melting point and high density of Zn, it adhered to the concrete surface first. In this case, Zn completely melted after which the Al started to melt at the arcing point, thus filling the voids and defects of the 85Zn-15Al coating and enhancing its bonding strength [22]. In contrast, the Ti coating exhibited the highest bond adhesion value, which was much higher than those mentioned in earlier standards. The bond adhesion value of Ti was found to be 2.72 (± 0.24) MPa. It was almost 11 and 2 times higher than those of the Cu and 85Zn-15Al coatings, respectively. This is attributed to the dense and uniform coating morphology, as observed in Figure 3b, which leads to a smaller interfacial space between Ti and the concrete surface [41]. Therefore, Ti properly adhered to the concrete surface and improved the bond adhesion.

Figure 5. Bond adhesion measurement.

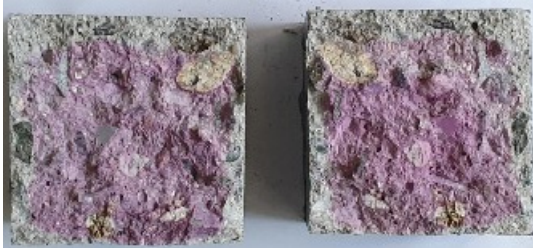
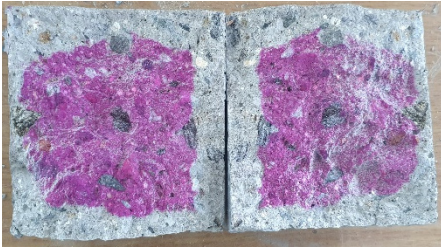
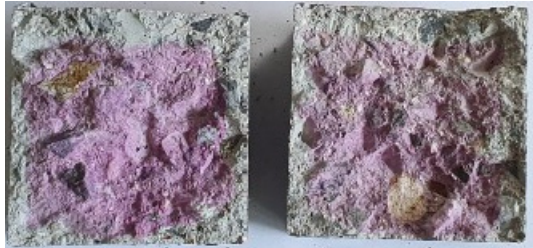
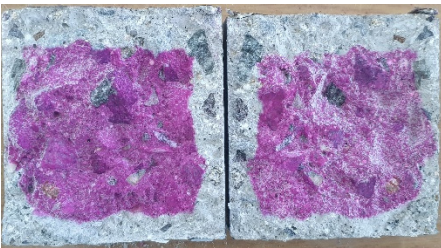
Table 3. CO₂ penetration depth and resistance measurement.

The carbonation depth (mm) and digital images of the coatings after four and eight weeks of exposure are listed in Table 3. The concrete surface (without coating) exhibited 14.4 and 18 mm penetration of CO₂, and discoloration was mostly observed on the outer surface. With the increase in the exposure periods, the penetration depth increased because of the porous nature of the concrete surface, owing to the easy ingress of CO₂. Moreover, an interesting observation in the Cu coating was that the CO₂ penetration depth was higher than that without coating (concrete) even after four and eight weeks, which was attributed to the lower bond adhesion, the greater affinity of Cu with CO₂ (chemical reactivity), and porous surface morphology, which causes CO₂ to easily penetrate and reach beneath the coating. This result suggests that the Cu coating cannot function as a barrier to the ingress of CO₂ even though it accelerates the carbonation reaction. The Cu coating had a penetration depth of 20.2 mm after eight weeks of exposure. In comparison, the Ti coating exhibited the lowest penetration depth, at 9.2 mm after four weeks and 12.5 mm after eight weeks. This is attributed to its dense and compact morphology, as shown in Figures 2b and 3b, and oxide formation, which restricts the movement/diffusion and chemical reaction of CO₂. The carbonation depth results were in good agreement with those of the surface morphology, where the Ti coating exhibited the least porosity and a dense microstructure (Figure 3b), resulting in the least penetration of CO₂. The 85Zn-15Al coating after four weeks of exposure showed a 13.3 mm penetration, which was lower than that without coating (only concrete); however, once the exposure period was extended to eight weeks, it exhibited the highest penetration, that is, 21.2 mm. This might be attributed to the porous nature of the corrosion products, as CO₂ easily penetrates and reacts with Zn or Al, thus forming oxides, which later initiate the corrosion of the steel rebar embedded in the concrete. Owing to the high reaction affinity of Zn with CO₂ to form hydrozincite (Zn₅(CO₃)₂(OH)₆), it showed the highest CO₂ penetration depth after eight weeks of testing. The present findings suggest that Cu and 85Zn-15Al cannot be used as repair materials due to their high CO₂ penetration. By contrast, the Ti coating exhibited an almost 1.5–2 times lower CO₂ penetration even after four and eight weeks of exposure. This means that Ti can be used as a repair material for concrete and can extend the service life of exposed structures in industrial areas.

Sample ID	4 Weeks	8 Weeks
Concrete	14.4 mm

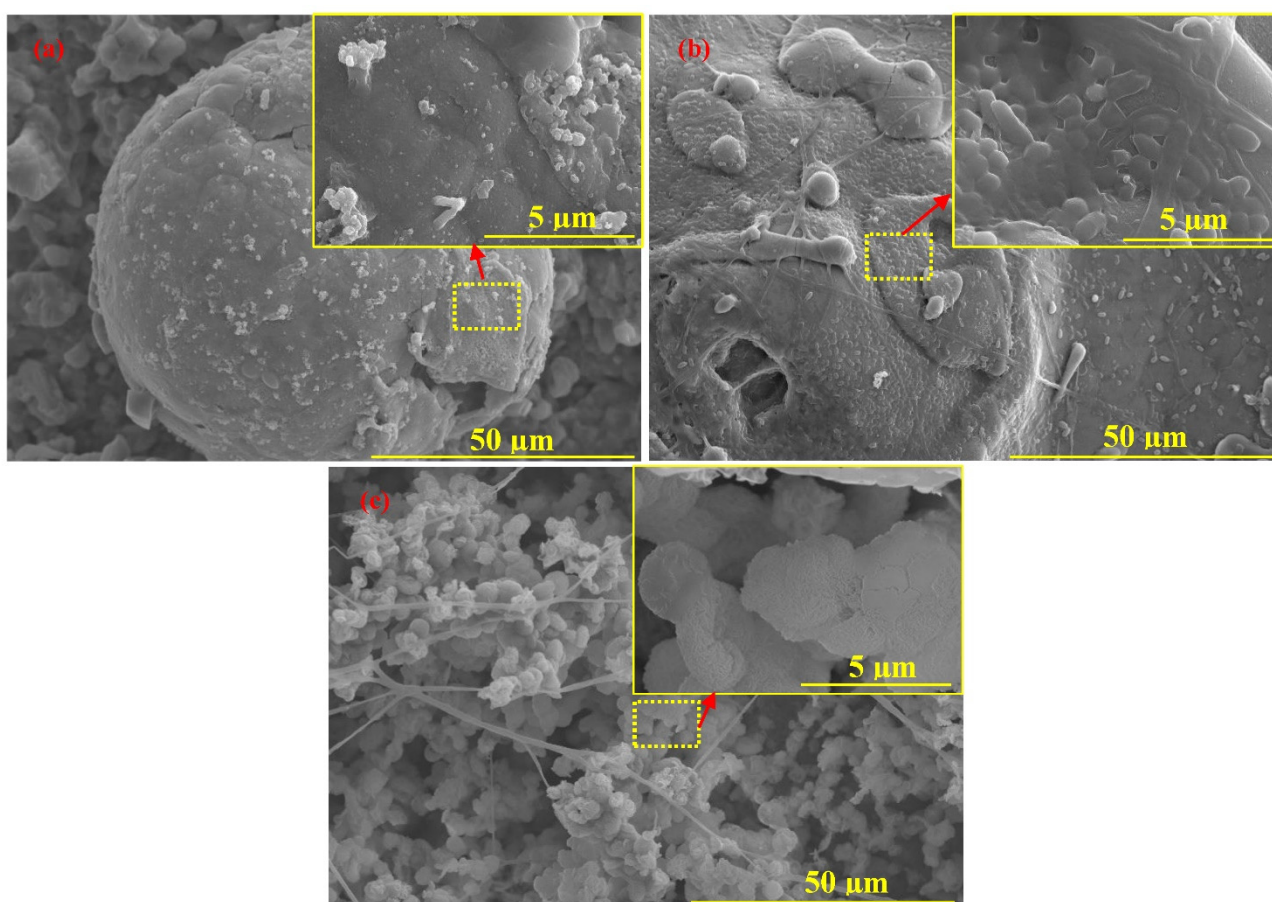
The surface morphology of the corrosion products after 28 d of immersion in a 5% NaCl solution is shown in Figure 7. The globular Cu particles observed in Figure 7a suggest the formation of copper oxides or chlorides because the solution became blue-green. This assumption was confirmed with the EDS and XRD analyses of the corrosion products. The

Figure 7. SEM of corrosion products formed on (a) Cu, (b) Ti, and (c) 85Zn-15Al coatings after 28 days of immersion in 5 wt.% NaCl solution.

details are described in subsequent sections. In addition to the globular shape, the concrete surface revealed coating delamination. This result was in good agreement with the digital images shown in Figure 6a, which illustrates the concrete surface and some Cu particles. In comparison, the Ti corrosion products were homogenous and uniformly covered the surface with fine particles (Figure 7b), which filled the remaining pores, as observed after the deposition of the coating (Figure 3b). The corrosion products formed on the 85Zn-15Al coating exhibited filamentous, globular, and flake-like morphologies (Figure 7c). The globular and flake-shaped morphologies might be attributed to the formation of simonkolleite ($Zn_5(OH)_8Cl_2$), while a needle structure reveals active Zn particles in the coating [31,43,44]. As the corrosion products were also defective, the ingress of aggressive ions, that is, Cl^- and CO_3^{2-} ions from the atmosphere, is also possible. Therefore, the 85Zn-15Al coating exhibited the highest penetration depth of CO_2 after eight weeks of exposure (Table 3).

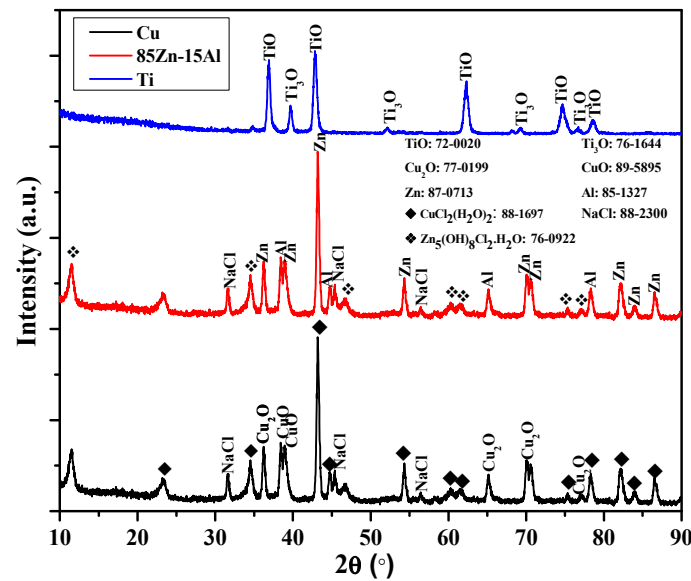
The XRD results of the corrosion products after 28 d of immersion in a 5% NaCl solution are shown in Figure 8. The Cu phase disappeared in the corrosion products of the Cu coating, which was attributed to the delamination of the coating or the formation of thick corrosion products, which hindered the formation of the coating. However, Cu₂O remained in the coating after immersion in the NaCl solution. This means that Cu₂O was not dissolved in the solution. Along with Cu₂O, CuO and CuCl₂(H₂O)₂ were also formed as corrosion products. The formation of CuCl₂(H₂O)₂ corroborated the EDS analysis, based on which Cl was present in high amounts. NaCl was found in the corrosion products of the Cu coating, suggesting that it penetrated the defects/pores of the coating and filled them, as detected by XRD. No phases other than TiO and Ti₃O were observed in the corrosion products of the Ti coating. These phases were identical to those found in the Ti coating after deposition. This result indicates that NaCl does not affect the deterioration of Ti coatings deposited via a twin-wire arc thermal spray process. In contrast, the corrosion products of the 85Zn-15Al coating were Zn and Al along with simonkolleite (Zn₅(OH)₈Cl₂·H₂O) and NaCl. Simonkolleite is typically formed in the corrosion products of Zn when exposed to saline conditions [43]. NaCl filled the defects and pores of the corrosion products, as corroborated by the SEM images (Figure 7c) and observed by XRD.

Figure 8. XRD of the corrosion products formed on the coating surface after immersion in 5% NaCl solution for 28 days.
