Study on the Structural Performance of UHPC Pavement and Hinge Joint Reinforcement for Hollow Slab Girder Bridges

Abstract: To address the problem of structural performance degradation caused by hinged joints and pavement damage, we utilized actual engineering to conduct a construction study on the overall replacement of pavement and hinge joint reinforcement in ultra-high-performance concrete (UHPC) hollow slab girder bridges. A replacement and reinforcement design was developed and reconstruction was undertaken. By using UHPC and reinforcement bars, the adjacent slab girders were designed to work together under specific construction process guarantees for the characteristics of UHPC. The corresponding interface treatment and a combination of planting bars and steel mesh were necessary. According to the strain and deflection monitoring results, the overall performance of the bridge after pavement and hinge joint reinforcement was verified. The strain amplitude of the reinforcement was approximately $10 \mu\epsilon$, and that of the concrete was approximately $5 \mu\epsilon$. The deflection difference of the adjacent girder was similar, which proved that the hinge joints connect g

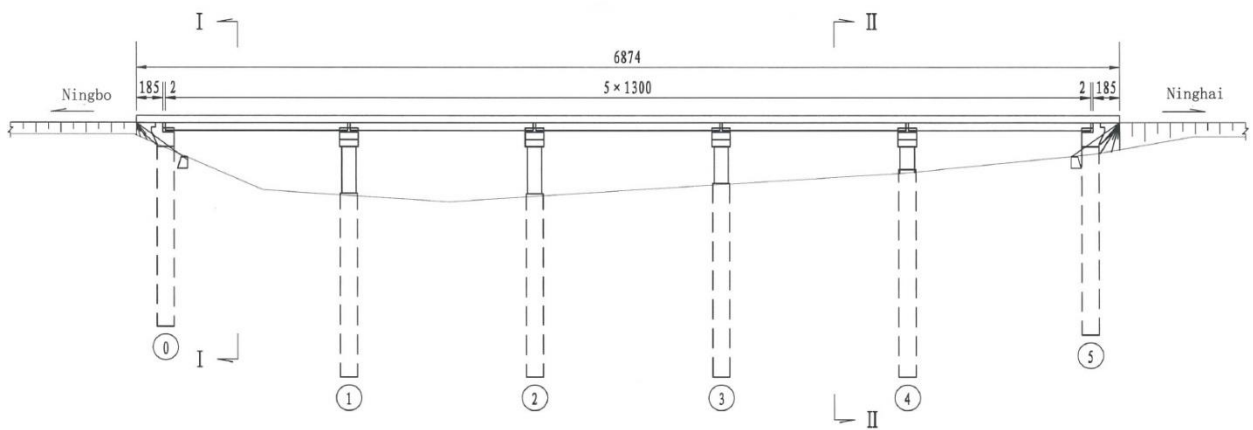
Figure 1. The bridge layout (unit: cm).

The Zhuxing Bridge is located on the S214 Yonglin line in Ninghai County, Zhejiang Province. It was completed and opened in 1997 (Figure 1). The current bridge deck pavement consists of 10 cm thick concrete pavement.

(a) Bridge elevation drawing

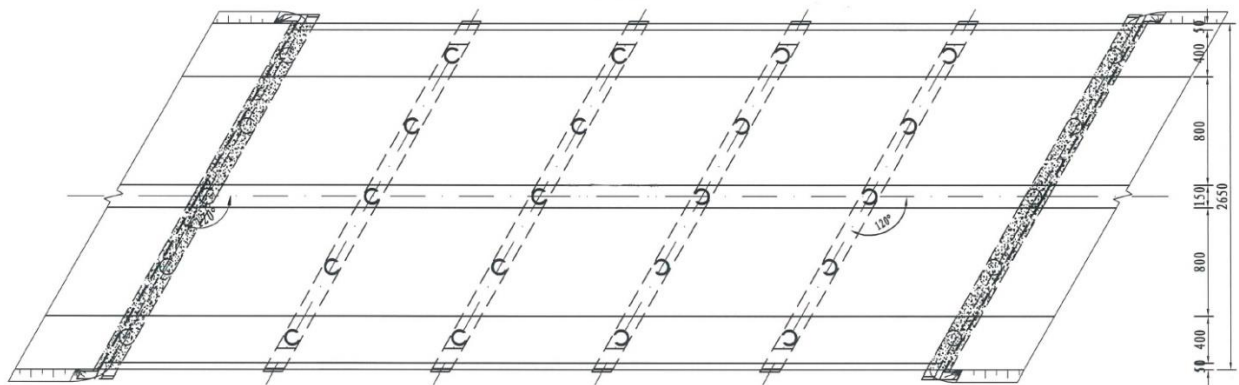
(b) Bridge plan layout

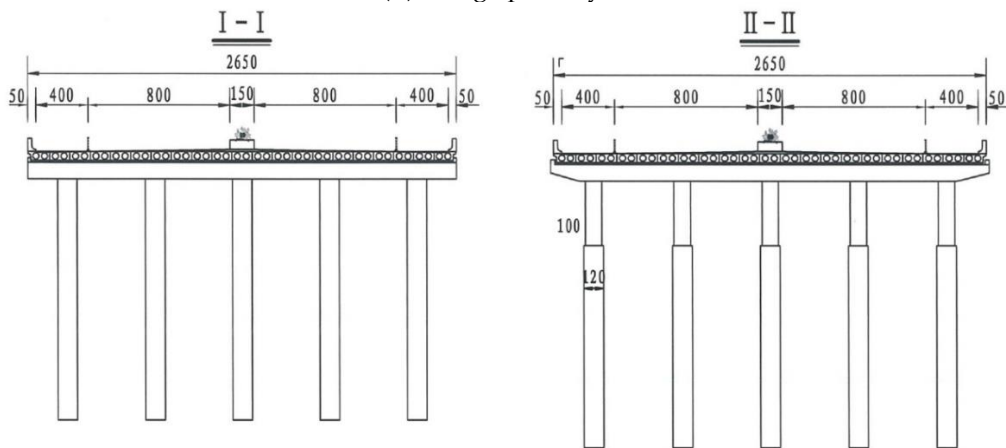
(c) Section of bridge

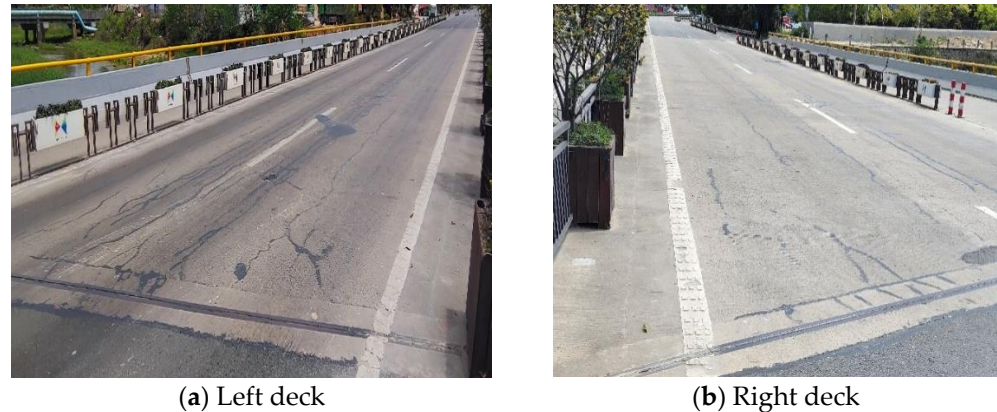
The traffic flow on the Zhuxing Bridge is relatively heavy, resulting in obvious damage to the bridge. In particular, the bridge deck pavement continued to show longitudinal cracks after multiple reinforcements, and the cracking locations basically extended along the hinge joints (Figure 2). This is consistent with the particular stress and damage commonly found in the hollow slab girder bridges. Under the long-term heavy traffic load, the pavement in the hinge joint area cracked and gradually extended. The main reason is that the replacement of the pavement layer failed to fundamentally solve the synergistic service of each hollow girder because of the weak transmission capacity of this pavement layer.

Figure 2. Status of the pavement of the bridge.

Based on the investigation and study of the characteristics and application of UHPC, the highway management department decided to update the bridge pavement again with UHPC.

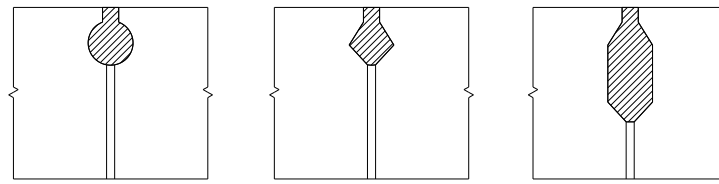
To ensure that the assembled plate girder jointly bears the vehicle load, it is necessary to set the transverse connection with sufficient strength in the transverse direction. Welded steel plate and concrete hinge connections are the most commonly used connection methods. However, due to the high cost of welded steel plate connections, the use of this application is not always practical. At present, the transverse connection of the hollow plate usually adopts a concrete hinge. The common forms of the concrete hinge are round, diamond and funnel, as shown in Figure 3. Usually, the hinge joints are filled with fine aggregate concrete. In the case of a small vehicle load, this hinge joint can theoretically ensure the transfer of the transverse shear force and ensures that each plate cooperates with the force. This is also the basis of the hinged plate method in the calculation of the transverse distribution coefficient. This method is based on the fact that the hinge joints only transmit vertical shear, and the pavement structure layer does not participate in the force [21]. The calculation model is shown in Figure 4a.

Figure 3. Common hinge joint form of the hollow plate beam.

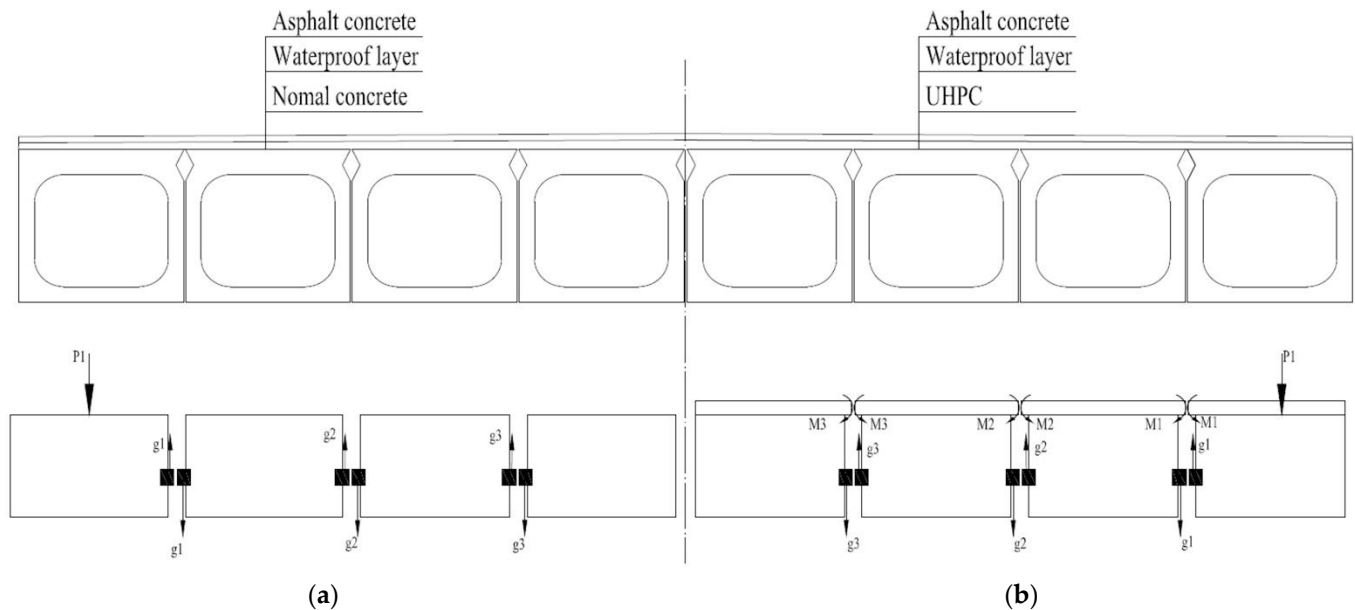
Figure 4. Different mechanics modes of hinge joints. (a) Mechanics mode of the common hinge for transmission of shear. (b) New mechanics mode of the hinge with a stronger pavement structure. Note: P1–load; g_i –shear effect by hinge; M_i –bending (moment) load effect by reinforced pavement.

This approach changes the original calculation assumptions for the plate girder because the recast pavement structure with bars creates a stronger structure above the adjacent plates, which can withstand bending moments (Figure 4b) [23]. With the change in the stiffness of the structural layer (effected by the thickness, rebar mesh, anchorage rebar between the pavement layer and the hollow plate), other factors will affect the distribution of the force of the adjacent hollow plate.

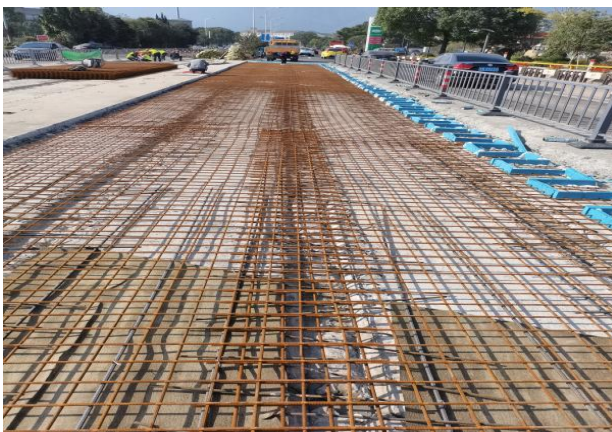
Figure 6. Preparation before UHPC construction.

The original undamaged hinged rebars were retained, and the corroded or broken rebars were removed. In addition to the reserved hinged rebars, $\Phi 12@200$ hinged rebars were added using a planting method. The down-bending of the rebar was performed in the factory in advance to ensure that the down-bending size met the specification requirements (Figure 6a). The rebar was implanted in the web, and it was not allowed to penetrate the roof to the slab girder. Another rebar mesh $\Phi 10@100$ was added.

(a) Bridge deck rebar tying

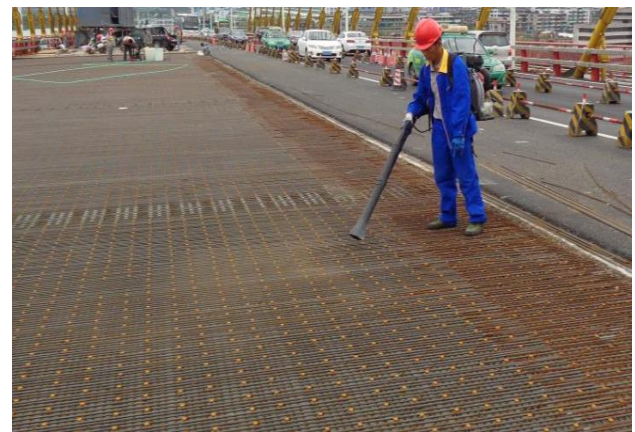
(b) Bridge deck cleaning

(5) The surface of the slab girder was cleaned completely and the debris and rubbish generated by the planting rebar were removed (Figure 6b).

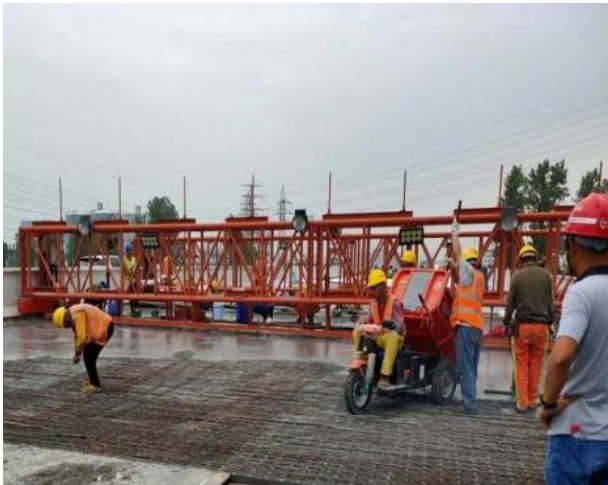
Figure 7. UHPC pavement construction.

After the rebars of the bridge deck pavement were inspected and accepted and the hinged joint rebars met all the requirements, the pouring of the hinged joints and the pavement layer began. The overall principle of pavement pouring is “mixing, pouring, leveling, and covering”. The UHPC mixture was immediately distributed; then the corresponding strips were immediately vibrated and leveled (Figure 7). After completing the preliminary distribution of 2–3 strips, the vibrating ruler was used for further smoothing and vibrating. The length of the vibrating ruler should be less than or equal to 1.5 m.

(a) Electric transport vehicle for pumping UHPC

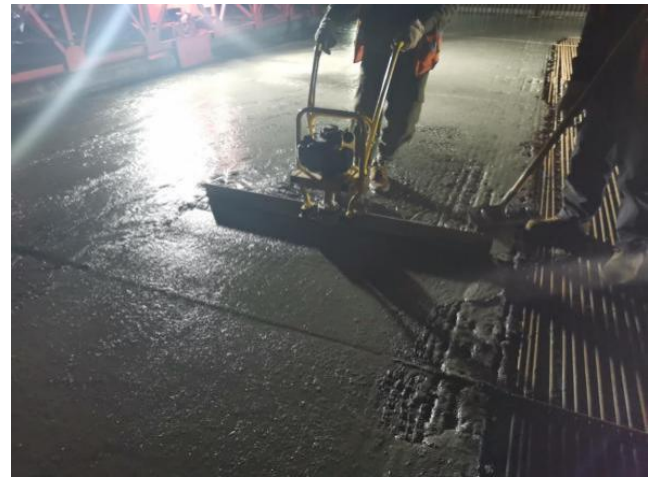
(b) Vibration construction with vibrating ruler

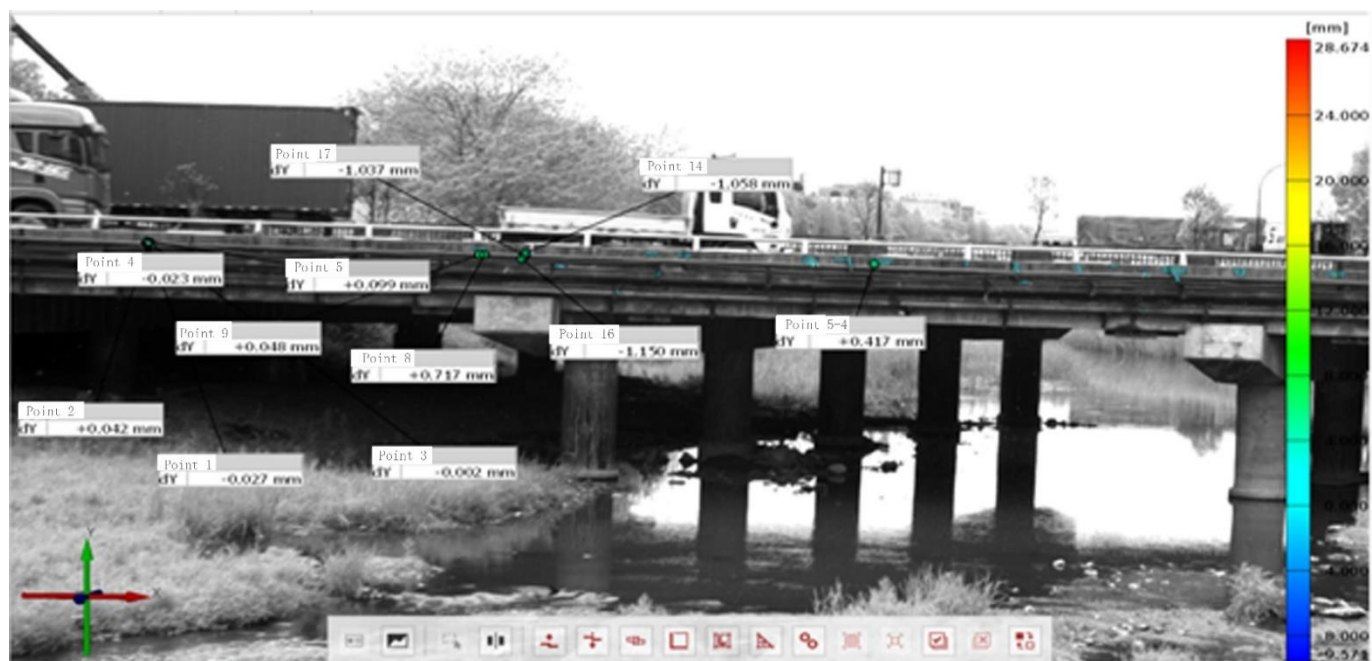
With the help of a non-contact optical deflection monitor, multiple monitoring points were placed on the left, middle, and right side of the bridge to measure the deflection of the span. We used the Germany-made “GOM” Optical 3D Deformation Analysis System (ARAMIS Professional), and the ARAMIS 3D 12M model. Figure 8 shows the side observation points that can be used for observation, while the actual observation was achieved through various points at the bottom of the bridge.

Figure 8. Interface of the monitoring system.

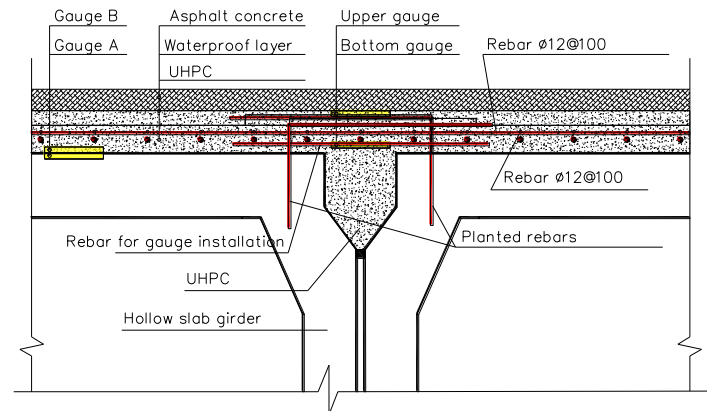
beams of the first span. There were a total of eight rebar strain gauges and eight concrete strain gauges on the left and right sides of the bridge. The strain gauges were numbered from the inside to the outside as No. 1 to No. 4 on the left, and No. 5 to No. 8 on the right.

Figure 9. Gauge arrangement plan.

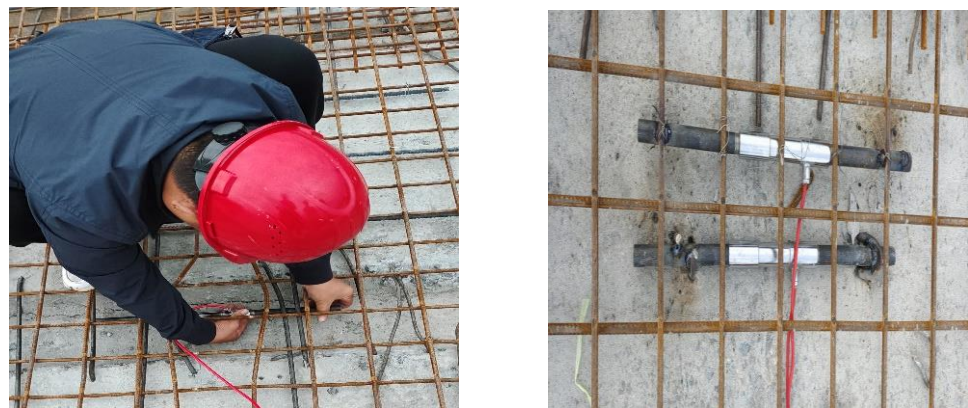
Theoretically, if the bond layer is not separated, the two gauges should have the same strain value when the girder is under moment. Based on the plane section assumption, it is considered that the concrete strain at the same height is consistent. Therefore, to keep the gauges at the same height in the girder section, before UHPC pouring, it was necessary to arrange strain gauge A on the upper surface of the hollow slab girder. The most feasible method was to chisel out the top rebar of the hollow beam and fix the strain gauge to the rebar to ensure that the center was in parallel with the hollow slab girder on the upper surface (see Figures 9 and 10).

Figure 10. Gauge installation in the adhesion layer.

Strain gauge B was fixed on the rebar in the UHPC layer, but the center of the strain gauge was located on the lower surface of the UHPC. Gauge B was placed in parallel with strain gauge A at the same location, and the distance between them was as close as possible. Figure 10 shows an image of gauge A and B located on the top of the girder.

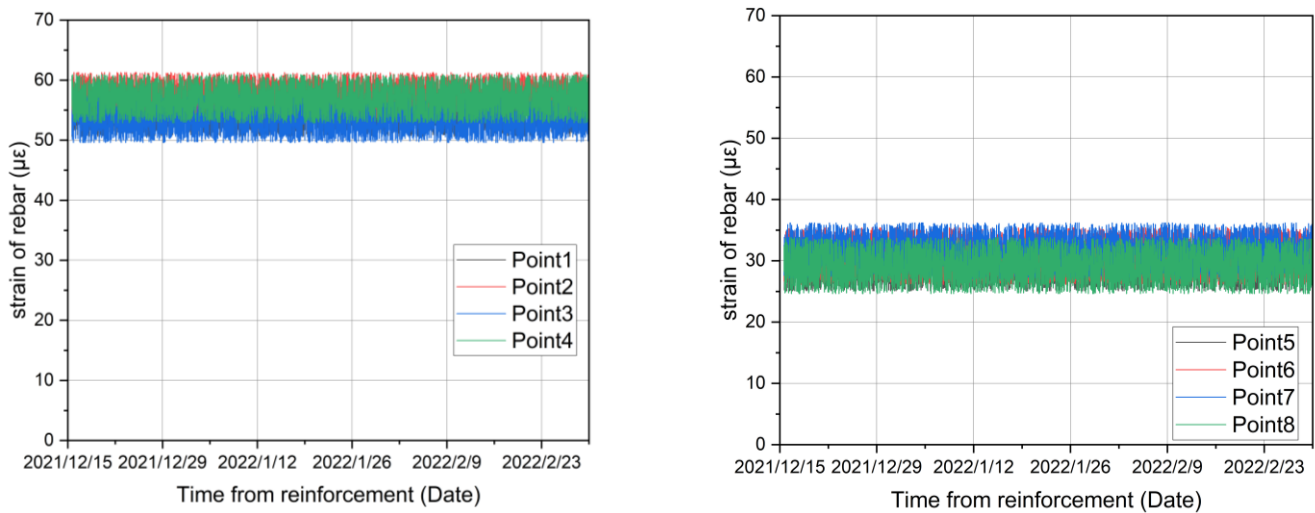
Figure 11 shows the results of monitoring the rebar strain in the three months after the completion of the construction. The strains recorded by rebar strain gauges 1 to 4 in the hinge joints on the left side of the bridge were in the range of 49~62 $\mu\epsilon$, and the strains of rebar strain gauges 5 to 8 in the hinge joints on the right side of bridge were in the range of 24~37 $\mu\epsilon$.

Figure 11. Rebar strain.

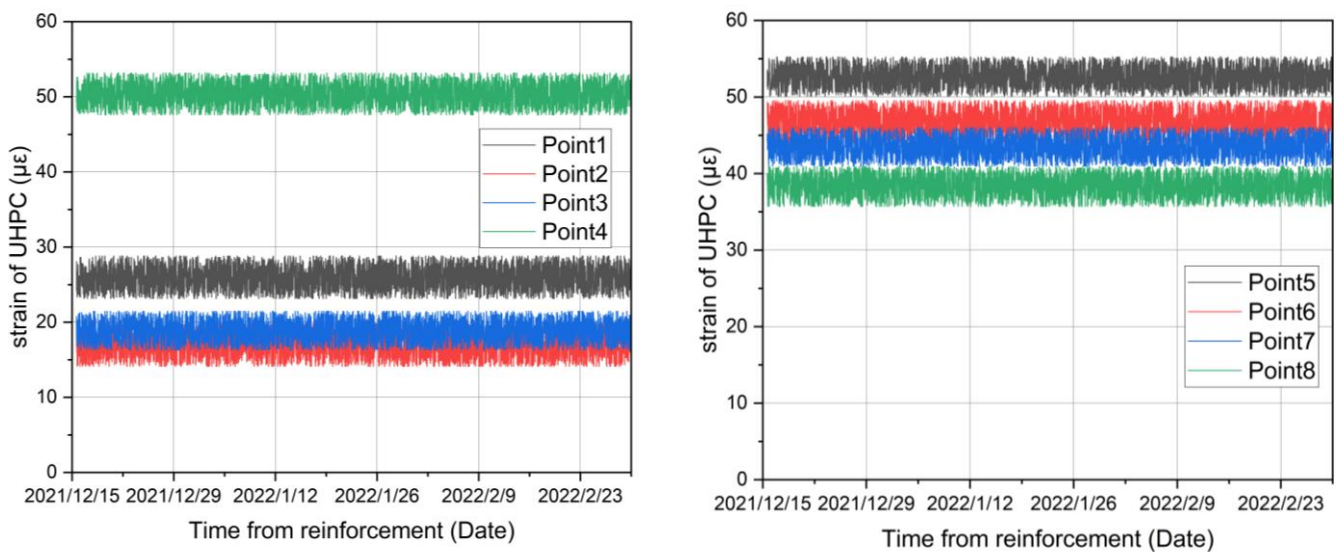
The strains recorded by gauges 1 to 4 in the UHPC layer on the left side of the bridge hinge all fluctuated within 10 $\mu\epsilon$. The strain range on the UHPC layer in the right side of the bridge hinge was relatively small, that is, between 35 and 55 $\mu\epsilon$, of which the maximum value of the No. 5 sensor was 55 $\mu\epsilon$, and the minimum value of the No. 8 sensor was 42 $\mu\epsilon$ (Figure 12).

Figure 12. UHPC strain.

According to the strain values of the beam and UHPC calculated by the adjacent strain gauges, it can be seen that the beam and the UHPC at the same position have basically the same strain characteristics, which fully proves that the UHPC and the beam have good

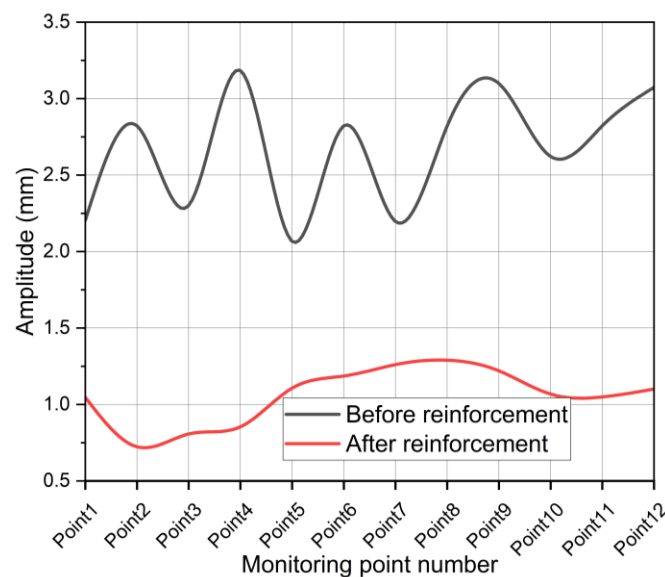
Figure 13 shows that the maximum amplitude of the bridge deck before reinforcement was greater than 2 mm, and the maximum amplitude of the bridge deck reached more than 3 mm. Among the 12 randomly selected monitoring points, the maximum amplitude of each point was different. The graph below shows obvious ups and downs, indicating that before the bridge deck was reinforced, the bridge deck had significant deflection under normal traffic conditions.

Figure 13. Maximum amplitude of bridge deck before and after reinforcement (unit: mm).

After the bridge deck was reinforced, the maximum values of the 12 selected monitoring points under normal traffic conditions were relatively small. It can be clearly seen from the graphs that the maximum values after reinforcement do not exceed 1.5 mm. The curve undulates smoothly, and there is no obvious undulation, which indicates that after the bridge deck was reinforced, the maximum amplitude of the bridge deck decreased compared to that before the reinforcement, and the UHPC reinforcement had a significant effect.

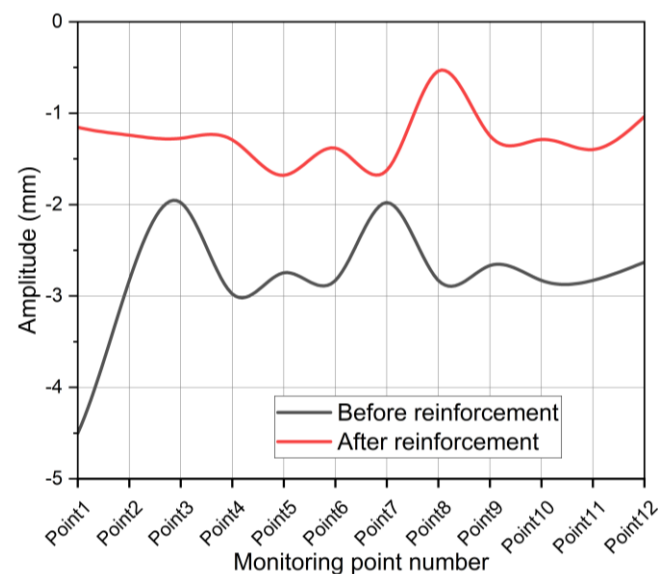
Figure 14 shows that the minimum amplitude of the bridge deck before the reinforcement reached -4.5 mm and stayed below -2 mm. Among the 12 randomly selected monitoring points, the minimum amplitude of each point was different. The associated curve has obvious ups and downs, indicating that before the bridge deck was reinforced, under normal traffic conditions, the bridge deck had significant deflection after being compressed. Similarly, after the bridge deck was reinforced, the minimum values of the 12 selected monitoring points under normal traffic conditions were relatively small. Except for point 8, the minimum values after reinforcement did not exceed -1.7 . The undulation of the curve is gentler than that before the reinforcement, which also indicates that the minimum amplitude of the bridge deck after the reinforcement decreased compared to that before the reinforcement, and the use of UHPC had a significant effect on the reinforcement.

Figure 14. Comparison of minimum amplitude before and after reinforcement.

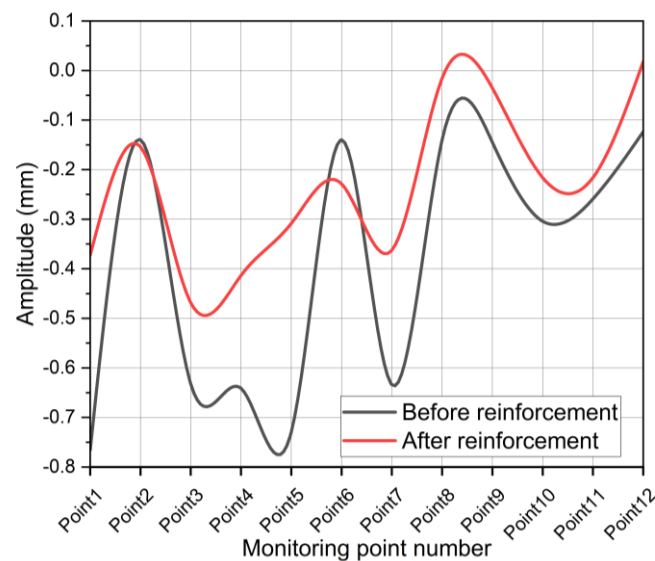
Figure 15 shows the comparison of the results of the average amplitude before and after the reinforcement of the bridge deck.

According to the average value of the 12 monitoring points, it can be clearly seen that the amplitude of each point is different before reinforcement, and the difference in the average values is also large. Therefore, the curves in the wave are relatively large, which indicates that the stability of the bridge deck was poor. After the bridge deck was strengthened, the amplitude of the curve was relatively large compared with that before the reinforcement. Although the beam located in the lane fluctuated more, the overall deflection was still relatively gentle, proving that the bridge deck had a better reinforcement effect.

Figure 15. Average amplitude before and after reinforcement.
