Technical Analysis of the Masonry of the Bargello' Palace, Florence (Italy)

Massimo Coli *

Featured Application: This paper establishes the assemblages, material and mechanical parameter of the Bargello' masonry; these data can be used for the seismic assessment of this historical building.

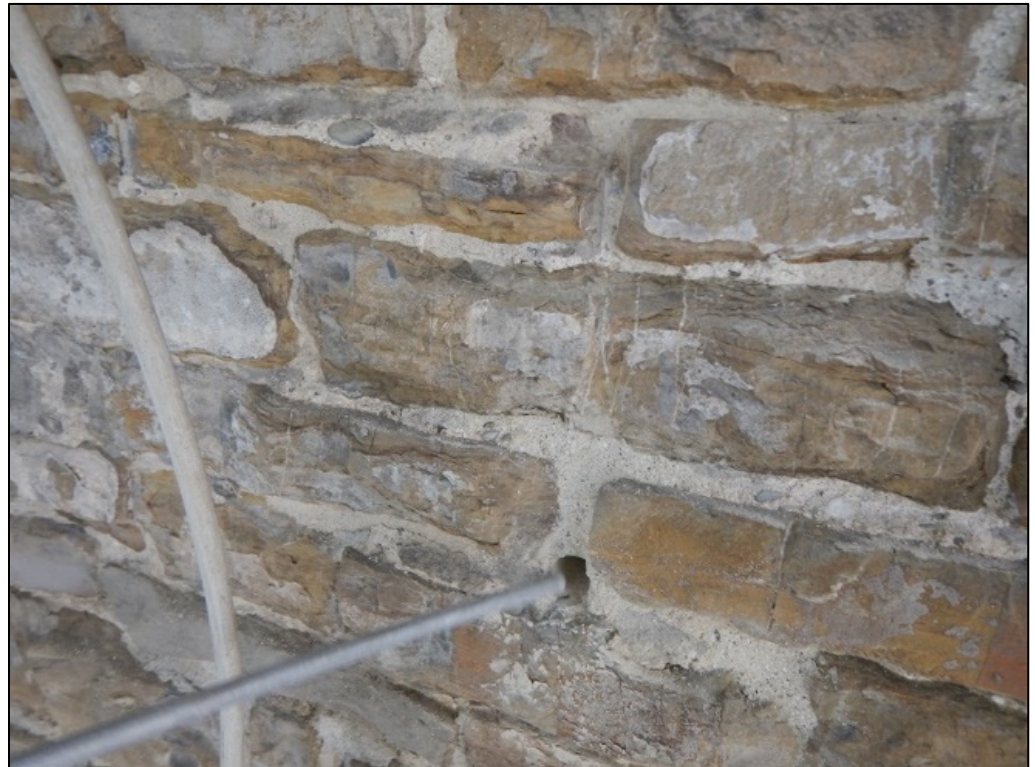
Figure 3. The Bargello palace at Florence (Italy), *facciavista* setting of the external facades, in regular rows of Pietraforte quoins and mortar layers of about 1 cm.

The walls of the Bargello appear well done, as is common for the Florentine buildings of that time [11]; they are thick, about two Florentine arms (about 130 cm), and are made with a double face of well-tightened quoins, with the external faces left *facciavista* at regular rows (Figure 3), and the internal plastered, window frames are marked by ashlar; the mortar layer's thickness is around 1 cm.

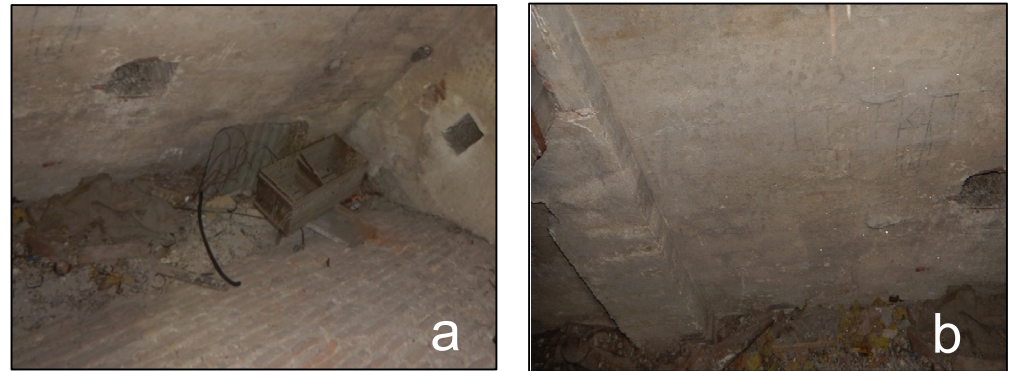
Figure 4. The Bargello palace at Florence (Italy): (a) the overvault of the Magdalena Chapel, the brick setting of the vault; (b) the plastered internal side of the walls, with the quoins setting visible in transparency.

The masonry of the vault of the Magdalena Chapel, is directly observable in the overvault, and, presumably, resembling that of all the vaults they built up at the same time; this vault is made of bricks of about $40 \times 5 \times 20$ cm set on a head (Figure 4).

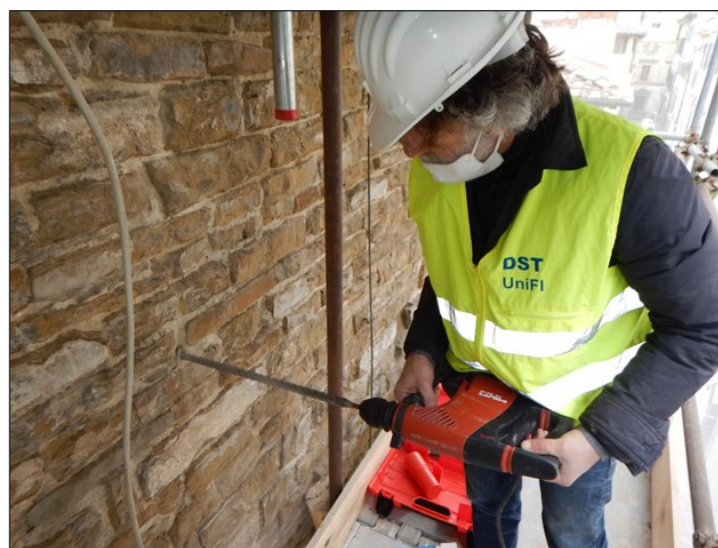
Figure 9. DAC-test execution by the scaffolding; drill-holes were made in the mortar to save the quoins' integrity.

Drill-holes were made using the scaffolding mounted on the external side of the walls (Figure 9); in order to avoid any possibly damage on the fresco on the inner sides, walls thickness (≈ 130 cm) was determined in the windows shafts and, therefore, drill-holes had been limited to 70 cm.
