Structural Health Monitoring and Management of Cultural Heritage Structures: A State-of-the-Art Review

Citation: Rossi, M.; Bournas, D. Structural Health Monitoring and Management of Cultural Heritage Structures: A State-of-the-Art Review. *Appl. Sci.* **2023**, *13*, 6450. <https://doi.org/10.3390/app13116450>

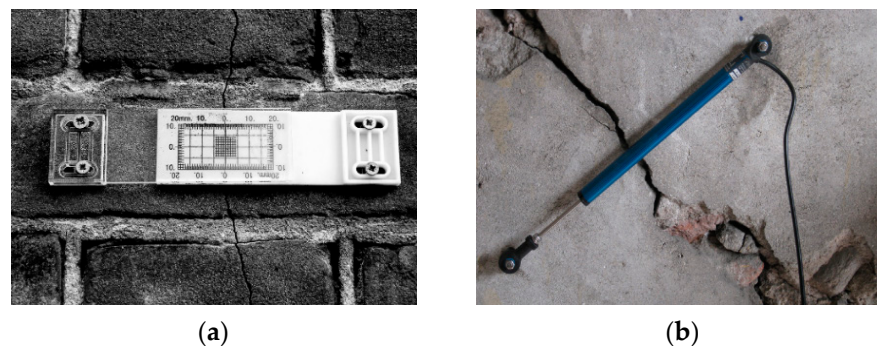
Figure 2. Monitoring of cracks employing: (a) plastic Tell-Tale crack meter, and (b) an LVDT sensor (from [48]).

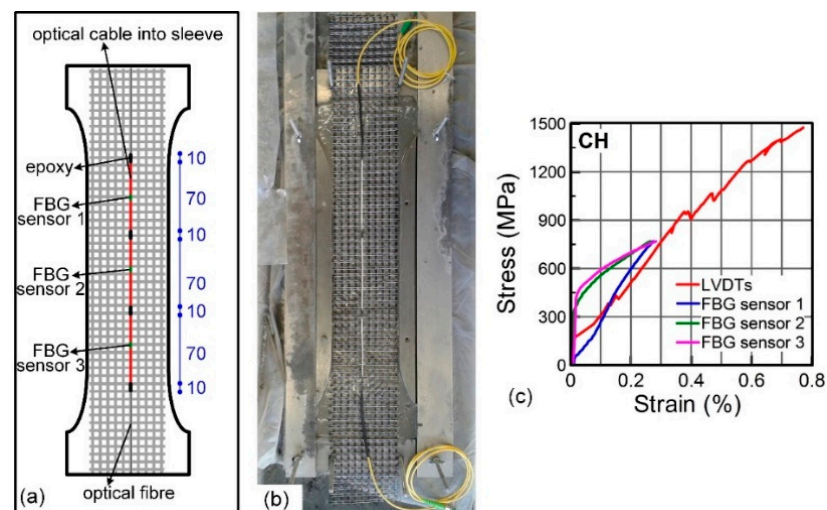
Figure 8. FBG sensors in a TRM coupon tested in tensile: configuration of FBG sensors (a); preparation of TRM coupon (b); stress versus strain curves (c) (from [129]).

The use of FBG sensors integrated with textile reinforced mortar (TRM) was also investigated by Tetta [129], exploiting the TRM composites developed by Tetta et al. [130] (Figure 8). Specifically, three optical FBG sensors were attached at the central roving point of the textile of a TRM coupon tested in tensile. The stress–strain curves of all three optical FBG sensors are presented and compared with the corresponding average response obtained by two LVDTs, showing a good agreement, mainly after the development of the cracking pattern of the TRM coupon. The authors concluded that using optical fibres for monitoring TRM jacketing externally applied to existing structures seems quite promising and worthy of further investigation in future research.

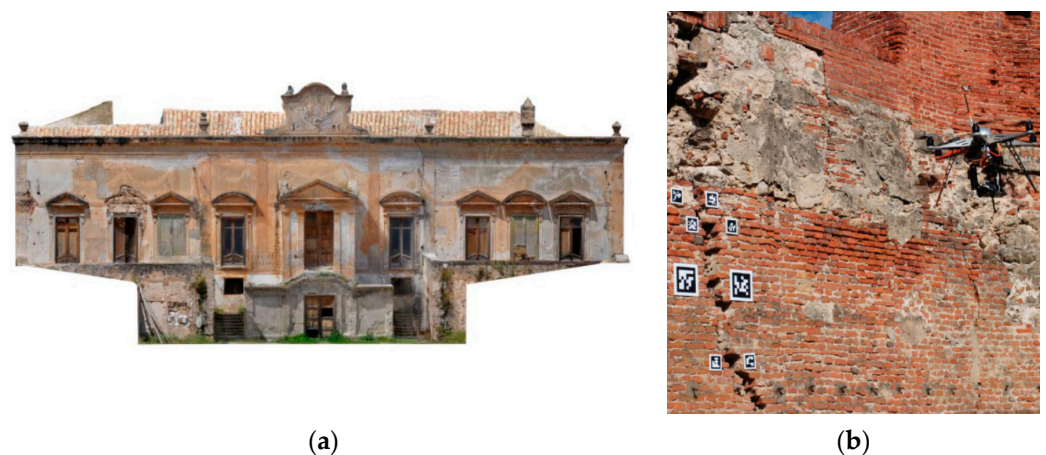
Figure 11. Orthophoto from close-range photogrammetry acquisition (a), from [155]; UAV image acquisition for marker-based structural defects monitoring (b), from [156].

Different photogrammetric approaches are available today, from terrestrial photogrammetry, which uses images from ground-based cameras (e.g., Figure 11a) to aerial photogrammetry, based on images acquired with airborne devices, such as aircrafts and satellites, and, more recently, unmanned aerial vehicles (UAVs) (e.g., Figure 11b) [151]. Several studies demonstrated the potential of combining data provided by UAV and terrestrial photogrammetry [152], as well as various terrestrial SHM methods [153,154]. Indeed, UAV photogrammetry easily reaches almost every part of the analysed structure, speeding up and optimizing subsequent work. On the other hand, the terrestrial survey allows for the use of high-performing optics and cameras, which currently cannot be easily installed on commercial drones because of their high weight [152].

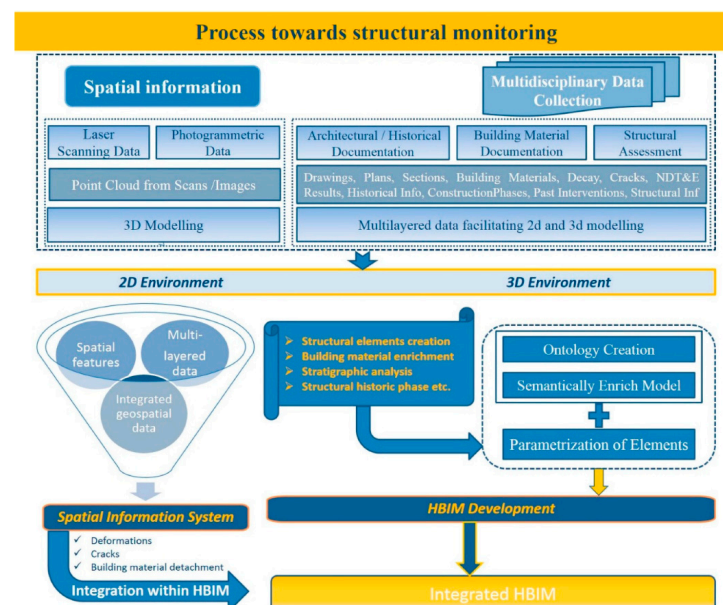
Figure 13. Workflow towards HBIM creation and integration proposed by [207]).
