Article

Post-Earthquake Dynamic Performance of Intact Masonry Building Based on Finite Element Model Updating

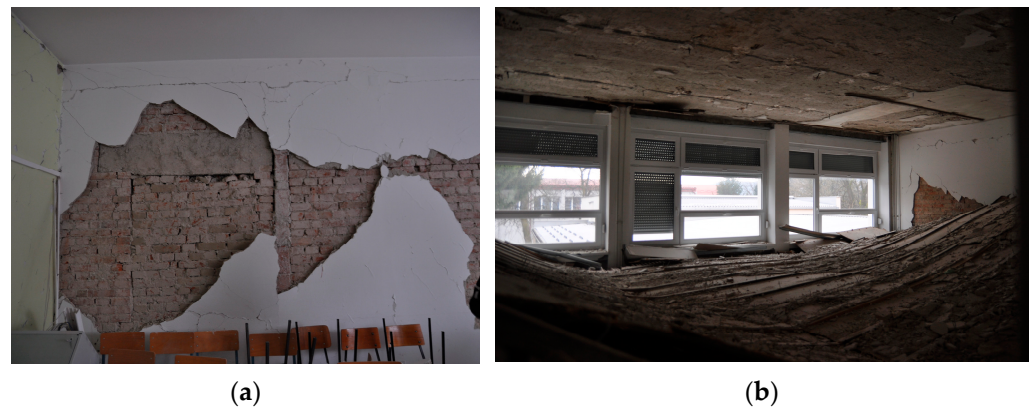
Figure 4. Observed damage on (a) the partition wall and (b) the ceiling.

A detailed visual inspection was performed to visually evaluate the structure. During the inspection, some guidelines of the RVS (Rapid Visual Screening) method were applied [36]. The building was inspected by a team of four engineers. The inspection lasted approximately six hours. During the inspection, damage on load bearing and partition walls was observed on the ground floor and first floor. Special attention was paid to crack widths on structural and non-structural elements, separation between structural elements, and displacement of structural components. The cracks were generally diagonal and occurred both in the mortar joints and in the masonry units themselves. Some characteristic and specific damage can be seen in Figure 3. There was frequent evidence of crushing and spalling on many non-structural elements, seen in Figure 4a. Extensive detachment of the surface layer was evident on some parts of the ceiling, seen in Figure 4b. Considering the observation during the visual inspection, the finite element model of the structure in the updating phase is adapted to the found state.

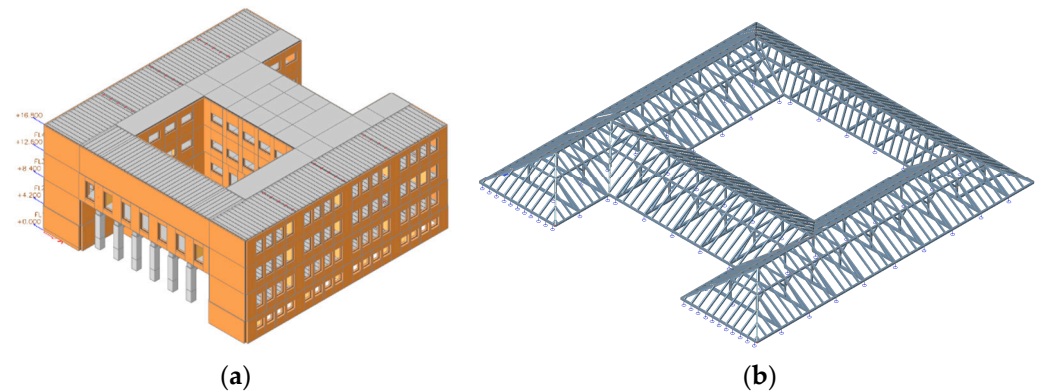
Figure 8. Numerical model of the case study: (a) 3D model and (b) 3D sub-model of the roof.

Experimentally obtained results were used to update the numerical model of the high school (Figure 8a). The model was developed in the commercial software SCIA Engineering 22 [19]. Considering the fact that the determination of the dynamic parameters is based on the ambient excitation in the vicinity of the real structure, with respect to a very low (hardly measurable) vibration level, it is sufficient for the comparison of the experimentally

To consider the effect of the roof, i.e., its weight, a sub-model was created (Figure 8b). The basic mechanical properties of the material are taken from the experimental investigation, while the dimensions are defined according to the available drawings. The elements of the roof are modelled using the beam elements. By calculating the sub-model of the roof,

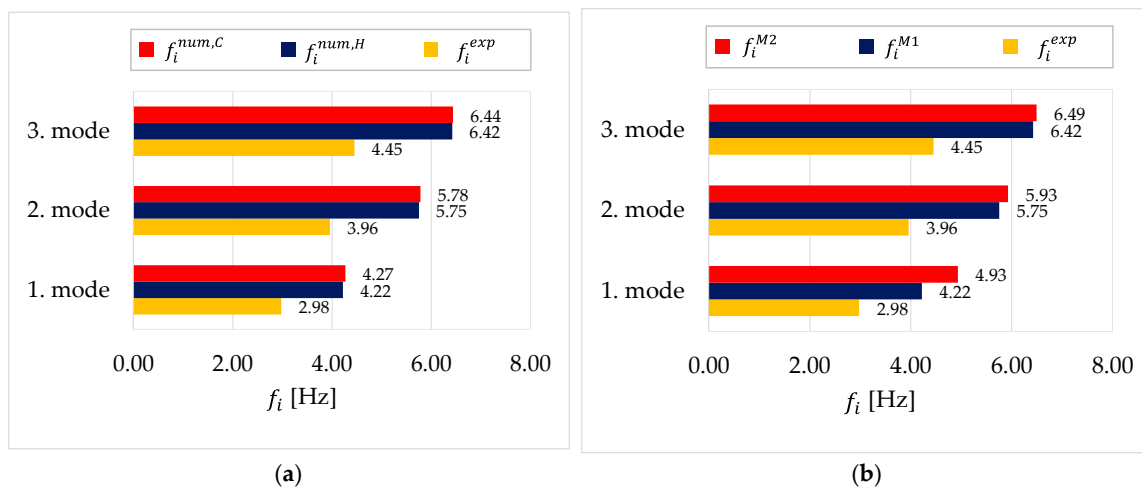
Figure 10. Graphical comparison of the experimentally obtained natural frequency values (f_1^{exp}) with the frequencies obtained for hinge ($f_1^{num,C}$) and clamped ($f_1^{num,H}$) boundary conditions for (a) Model 1 and (b) Model 2.

To determine the influence of the boundary conditions on the change in the value of the natural frequencies of the structure, a model with fixed and clamped boundary conditions was developed. In the numerical model, the values of the entered masses of partition walls, roofs, and staircases were retained. A graphical comparison of the experimentally obtained natural frequency values with the frequencies obtained for both clamped ($f_1^{num,C}$) and hinge ($f_1^{num,H}$) boundary conditions is given in the Figure 10.

Based on the analysis of the influence of the boundary conditions on the first natural frequency values, it can be seen and concluded from the graphical representation (Figure 10a) that there are no differences between the natural frequency values for the hinge ($f_1^{num,H}$) and clamped ($f_1^{num,C}$) boundary conditions, i.e., boundary conditions do not affect the natural frequency values. A clamped boundary condition, also known as fixed or fully restrained boundary condition, means that a structure is completely fixed or immobilized at a particular boundary. A hinge boundary condition, also referred to as a pinned or simply supported boundary condition, allows rotation at a specific boundary while preventing translation. Based on this observation and conclusion, for the further analysis and updating steps, the numerical model with hinge boundary conditions is considered. For the sake of simplicity, the selected model is referred to as M1 in the following text.
