Article

Real Stiffness and Fatigue Resistance of Stringer-to-Cross-Girder Connection of Riveted Steel Railway Bridges

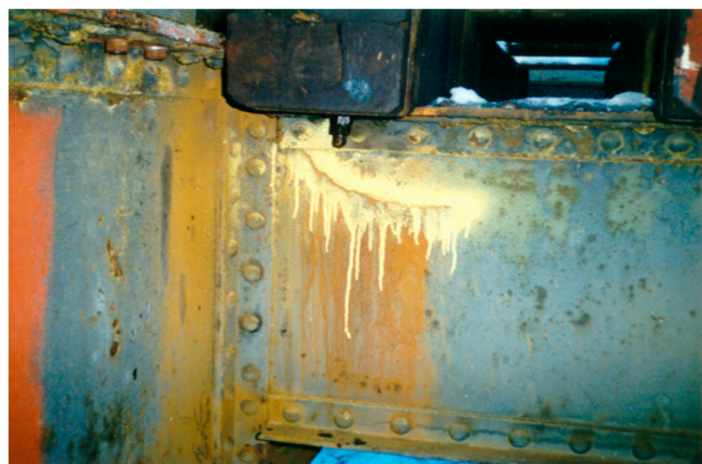
Figure 1. Illustrative picture of a fatigue crack occurrence in the web of the stringer.

One of the typical cases of fatigue damage on steel riveted bridges is a fatigue crack in the web of the stringer at the point of its connection to the cross girder (Figure 1), which is realised only by connecting the webs of the stringer and the cross girder to each other using connecting angles while the flanges of the adjacent stringers are not connected. At the time of the design of the mentioned types of bridges, such a connection was commonly considered to transmit only axial force and shear force in the plane of the web. Based on this simplifying assumption, no fatigue crack was expected to develop in this detail during the bridge service life. However, the relatively frequent occurrence of fatigue cracks indicates the incorrectness of this assumption. To explain this phenomenon, it is possible to consider that, although not great, a certain real bending stiffness of this connection has resulted in higher normal stresses in the web of the stringer at the upper edge, mainly tensile, due to hogging moment. Increased concentration of normal stresses usually in the place of the first rivet connecting the web plate and the flange angles, in combination with a large number of loading cycles, have led to the initiation and subsequent growth of a fatigue crack. The bending stiffness as well as the fatigue resistance of the stringer-to-cross-girder connection is the subject of several works, e.g., [13,14]. However, they are focused on fatigue cracks in the connecting angles as well as rivet failures, not on cracks in the stringer web as shown in Figure 1.

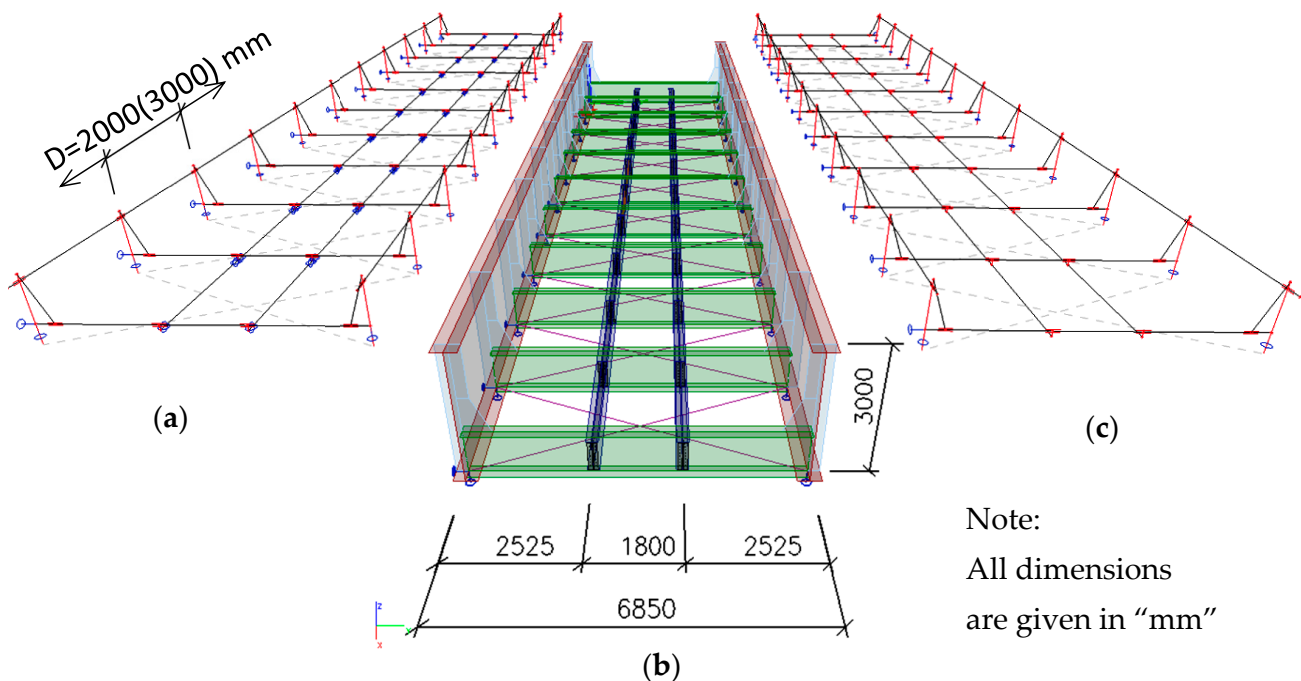
Figure 4. Three types of numerical models of the bridge superstructure: (a) beam FEM model with hinged stringers, (b) shell FEM model, (c) beam FEM model with continuous stringers.

Theoretical analysis of the behaviour of these three types of connections was carried out using three different types of finite element models (FEM models) of a fictitious superstructure of a plate girder bridge with a lower member deck. The numerical models were processed with SCIA Engineer software [15]. The two models represented a common way of modelling this type of bridge when all the structural members of the superstructure were modelled with beam elements (Figure 4a,c). The stringer-to-cross-girder connection was considered once as fully hinged and once as a perfectly rigid joint. In the third model, the whole superstructure was modelled using shell elements for all load-carrying structural members (Figure 4b). Such a model allowed for a better approximation of the behaviour of the analysed type of connection at the cost of a more demanding modelling process as well as the necessary computing time.

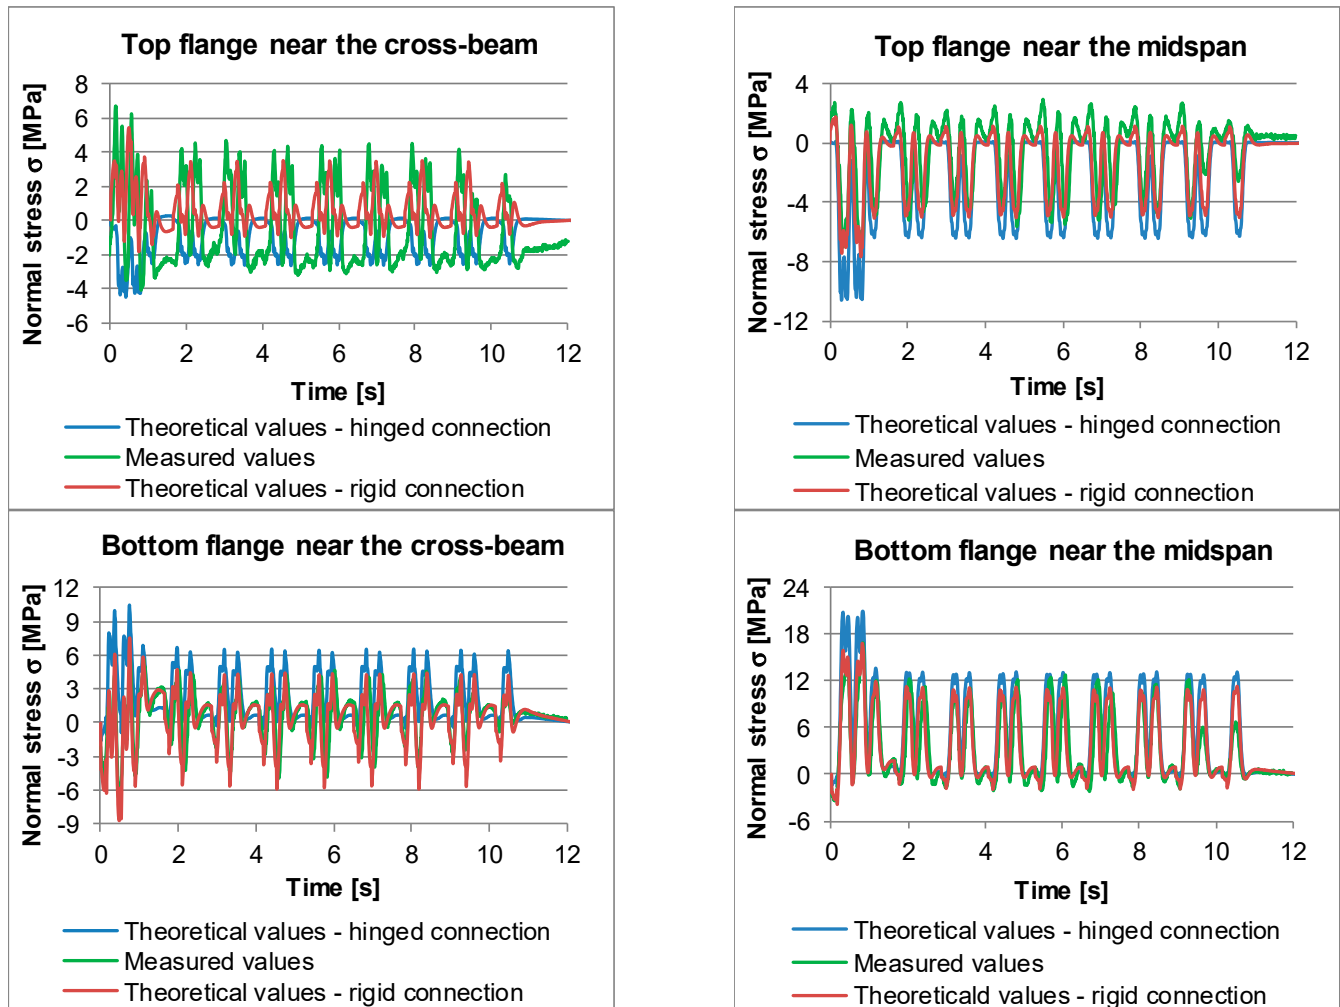
Figure 11. Courses of the stress response in the chosen locations of the stringer.

A comparison of the stress responses in the selected locations obtained from the experimental measurements as well as from the numerical simulations using the beam FEM model in Figure 8 is illustrated in the graphs in Figure 11, where the time courses of the stress response to the passing train set consisting of one electric locomotive of the 162 series and eight-passenger wagons are presented. The locomotive and each of the passenger wagons was characterised by axle forces 4×212.5 kN and 4×112.5 kN, respectively. In order to eliminate the horizontal effects of the real railway traffic load, the average values of the corresponding pairs of normal stresses recorded in the monitored locations of the bottom and top flange of the stringer were evaluated, i.e., (S0, S1) and (S2, S3) in the bottom and the top flange, respectively, in the middle of the stringer as well as (S4, S5) and (S6, S7) in the bottom and top flange, respectively, near the cross girder.

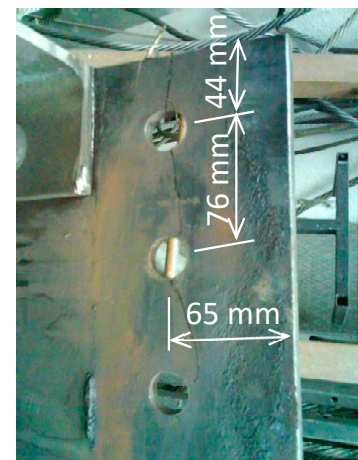
Figure 15. Fatigue cracks in the web of stringer.

The crack initiation was considered the failure criterion during the tests. Since the rivet holes were covered by the connecting angles, the initiation of the fatigue crack was difficult to follow. However, extensive plasticization around the rivet holes and subsequent crack initiation caused significant deformations of the free end of the monitored sample where the alternating force was acting. Then, it was a problem to ensure the set vibration mode of the sample, and the test had to be stopped. Thus, fatigue failure was defined indirectly as the inability of the specimen to sustain the applied load. Typical failures of the investigated detail are presented in Figure 15. The failures themselves were recorded only after the samples were disassembled when the tests were completed. The picture on the left side shows the out-of-roundness of the hole diameter due to material cyclic plasticity, after which, the global deflection of the beam increased rapidly. The right figure shows the

final failure of one sample induced by static loading only after finishing the fatigue test itself. Although a total of eleven fatigue tests were performed, we could finally use the results of only ten to determine the fatigue detail category, as in one case, the fatigue crack did not appear in the web of the stringer (Figure 15) but in the connecting angle (Figure 16). The shape of the growing fatigue crack is somewhat different from the shape that appears on real stringers (Figure 1). The difference is due to the different static scheme of the test specimens, which was chosen as a cantilever beam for both practical and economic reasons. The actual stringer with the connection to the cross girder according to Figure 1 can be considered at the beginning of its service life as a beam with a semirigid connection to the cross girder on both sides, albeit with relatively low bending stiffness. In the case of the fatigue crack origin, the bending stiffness of the cross-section at the connection point gradually decreased with the gradual crack growth, which made the static scheme of the stringer closer and closer to a double-hinged beam. The result is a gradual decrease in the bending moment in the connection and the related redistribution of stresses in the stringer. It is reflected by the gradual curvature of the shape of the crack growing in the direction perpendicular to the main tensile stresses, as well as by slowing down or even stopping the crack growth. On the other hand, in the case of the cantilever, which is a statically determinate structure regardless of the actual stiffness of the joint (higher than zero, of course), the bending moment at a constant loading force is constant even in the case of fatigue crack development, and the direction of the main tensile stresses does not change much. However, this discrepancy in the static schemes does not have a fundamental impact on the recorded design life of the investigated detail because the design life (in terms of fatigue) is generally related to the crack initiation, and it is reasonable to assume that the crack initiation period will be the same for both static schemes.

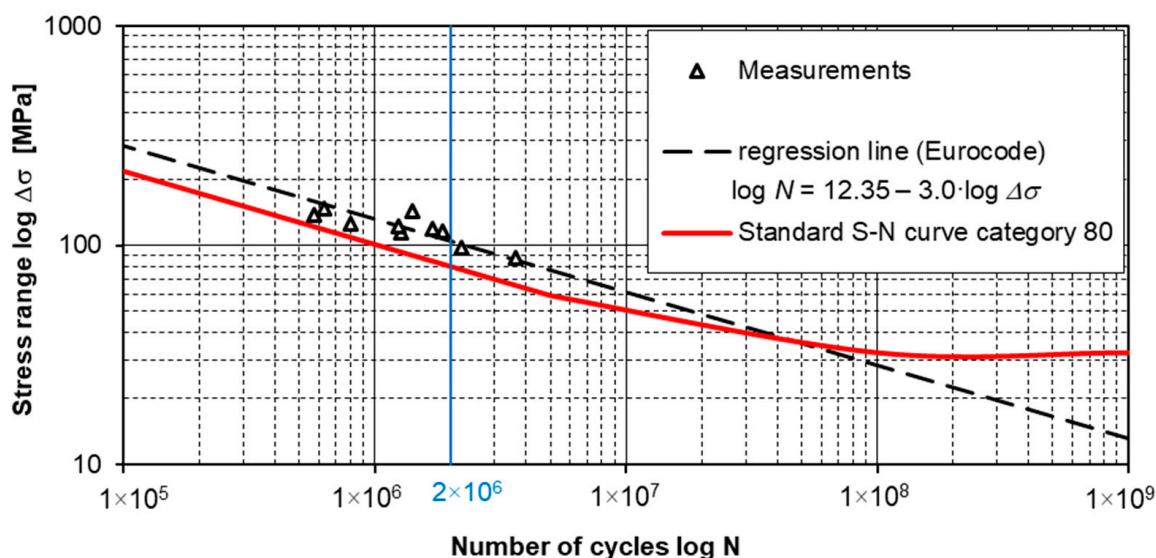
Figure 17. Results of fatigue tests and characteristic S-N curve for the stringer-to-cross-girder connection.

Applying this procedure with the value of factor $k_n = 1.92$ for a number of samples $n = 10$ and the unknown value of V_x from table D.1 in [33] and using the data in Table 1, the parameter $\log \hat{C}$ takes on a value 12.35, and the characteristic value of stress range is $\Delta\sigma_C = 85.6$ MPa. The graphic evaluation of the fatigue test results is shown in Figure 17.

Both the procedures for processing the fatigue test data provide very similar results, which is understandable since both are based on the same mathematical–statistical principles. However, the procedure according to the original Slovak standard [32] enables the determination of the slope of the S-N curve. The results of this procedure confirmed the validity of the assumption of the slope of the S-N curve obtained by the value $m = 3$ even for the investigated riveted detail. Based on the calculated characteristic values of the stress range $\Delta\sigma_C$ corresponding to 2×10^6 stress cycles, the investigated detail of the stringer-to-cross-girder connection can be classified, in accordance with [18], to the category 80 with characteristic fatigue strength $\Delta\sigma_C = 80$ MPa.
