# Applicability of Digital Image Photogrammetry to Rapid Displacement Measurements of Structures in Restricted-Access and Controlled Areas: Case Study in Korea

**Keywords:** restricted-access and controlled area; MSE wall; monitoring; digital image photogrammetry; displacement

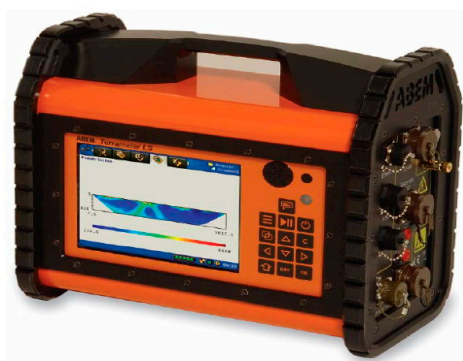
- Model: Terrameter LS (ABEM, Sweden)
- Output: 2500 mA
- Number of Channels: 12
- Up to 16,320 electrode connections
- USB port (2EA), LAN (PC connect)
- Electrode rod (T-shaped steel stick)
- Cable 21 takeout (2 sets)
- Resistivity analysis program
- Dipro for Windows Ver. 4.0

**Figure 3.** Electrical resistivity survey instrument specifications.

The electrical resistivity survey was conducted to determine the condition of the reinforced earth mass of the MSE wall. An electrical resistivity survey is a common non-destructive exploration technique used to determine the condition of the ground by measuring the potential difference caused by the difference in electrical resistivity among the differences in underground electrical properties. The electrical resistivity survey instrument supplies power to two current electrodes through an ammeter connected to a power source. It works on the principle that the potential difference is measured using an electrometer connected to two other potential electrodes through the supplied current. In this research, the electrode spacing of the electrical resistivity survey was installed at 5.0 m in order to consider the exploration depth and exploration extension of the ground. In addition, the ground condition was evaluated to identify leakage and problem areas distributed inside and around the MSE wall. The instrument used for the electrical resistivity survey is shown in Figure 3.

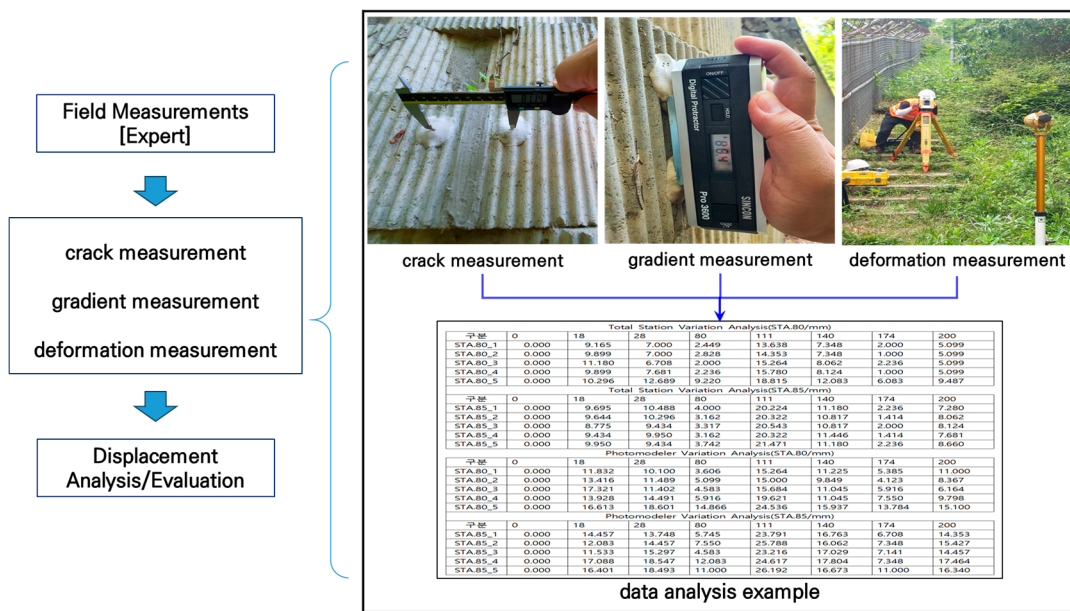
**Figure 5.** Comparison of monitoring methods for MSE walls: (a) traditional monitoring procedure; (b) digital image photogrammetry procedure based on commercial imaging devices.

In this study, a total station is used for the traditional monitoring method, and it is generally applied to the measurement of structural surface displacements. A total station is an electronic device that can measure three-dimensional positions in space using light waves such as lasers. It requires a reflective target for the accurate measurement of a specific position and has high mechanical reliability. However, experts are required for measurement, and the reliability of the measurement results may vary depending on the expert. Digital image photogrammetry applied in this research can acquire images using imaging devices such as digital cameras and cellphone cameras, and it can measure the displacement of a required position in the image using a 3D analysis program.

The digital image photogrammetry procedure based on commercial imaging devices is summarized as follows. First, the surface of the MSE wall is photographed using a digital camera or cellphone camera and sent to a remote expert. The expert then uses a 3D image

conversion program (PhotoModeler) to check the wall displacement of the MSE wall. In comparison with the traditional monitoring method, this approach has advantages, such as time-saving qualities and high applicability, as the image can be taken by laypersons. In other words, it is a very simple monitoring method that allows laypersons in restricted-access and controlled areas to take multiple images of the target structure using commercial imaging devices, and they can send them to experts at a remote location.

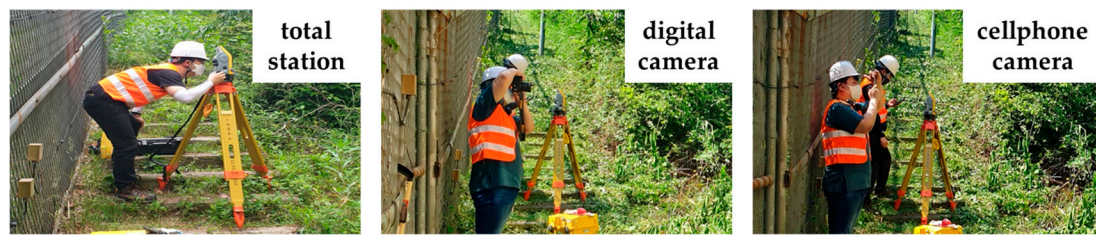
**Figure 7.** Field experiments with the traditional monitoring method (total station) and digital image photogrammetry (commercial imaging devices, digital camera, and cellphone camera).

The traditional monitoring method using total stations utilizes a reflection target on a specific surface of the MSE wall corresponding to the measurement location. Then, internal office work on the analysis of position changes is performed in the office, after obtaining 3D coordinates through the measurement of the reflection target by an expert. Digital image photogrammetry uses digital cameras and cellphone cameras, and it acquires two or more MSE wall images of the measurement target from each device. The acquired images are immediately transmitted to the PhotoModeler operator in the office via wireless Internet, and the operator performs image alignment, camera calibration, and 3D position information analyses. Since the use of PhotoModeler requires images, it is only used for digital image photogrammetry. In digital image photogrammetry, the image acquisition location can affect the error in the results of two or more image registrations. Therefore, the digital camera and cellphone camera locations were maintained at  $\pm 45^\circ$  from the front of the measurement location, and they were placed within approximately 10 to 15 m from the measurement location. Figure 7 displays the field experiment.

The field experiment employed a C3 total station manufactured by Trimble Inc., (Westminster, CO, USA). The specifications of Trimble C3 were 800 m and 3.0 mm + 2 ppm for the measurement distance and accuracy without reflective targets, respectively. With the prism, the measurement distance and accuracy were 5000 m and 2.0 mm + 2 ppm, respectively. The digital camera used was D7100, which has a CMOS sensor manufactured by Nikon (Tokyo, Japan). The D7100 has 24,710,000 pixels. The cellphone camera was a Galaxy S21 model from Samsung Electronics (Seoul, Republic of Korea) with 12 million pixels.

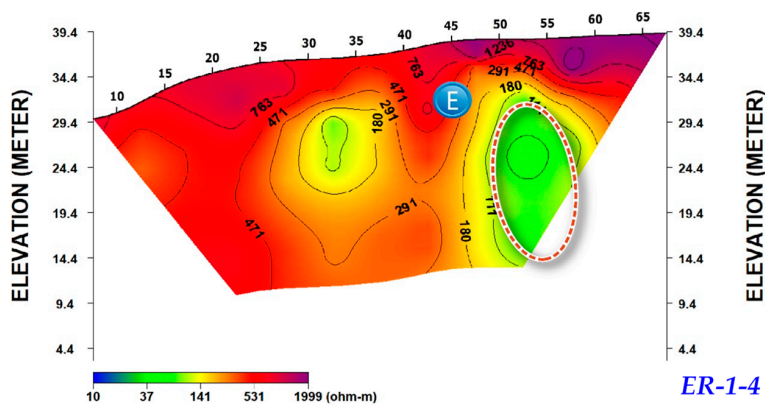
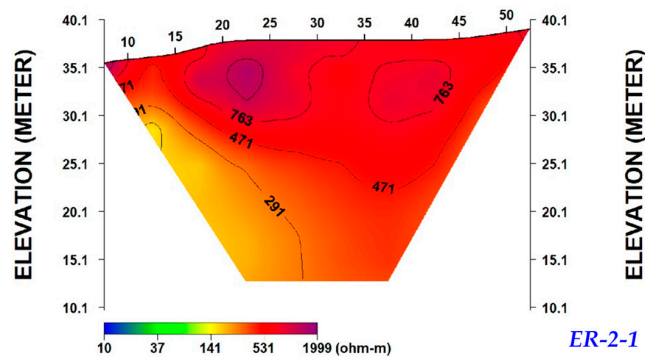
Figure 8. Electrical resistivity survey results: (a) ER-1-1 and ER-1-2; (b) ER-1-3; (c) ER-1-4; (d) ER-2-1; (e) ER-2-2 and ER-2-3.

Figure 8 shows the results of the electrical resistivity survey of the MSE wall.

Figure 8a to Figure 8c show the results of the original ground exploration focused on the front of the MSE wall. There were no abnormal areas in ER-1-1 and ER-1-2 (Figure 8a). However, four abnormal areas were identified as a result of the ER-1-3 exploration. Based on the past construction history of the MSE wall, areas A and D were among the abnormal areas evaluated due to the drainage pipes in the original ground in front of the MSE wall. Moreover, area C was identified as being affected by a collector well, which is a reinforced concrete structure. Area B, which is the exploration result for the ground where the corner of the MSE wall is located, was analyzed to be an abnormal area caused by low ground stiffness since there was no history of underground construction structures. This means that it had a great influence on the occurrence of longitudinal cracks in the facing of the MSE wall. Area E, which can be seen in the exploration results of ER-1-4, was also identified as being affected by underground structures. Therefore, it was analyzed that the low ground stiffness of the original ground in the structurally vulnerable corner induced the displacement of the MSE wall due to subsidence, based on the exploration results of the original ground in the front of the MSE wall.

Figure 8d to Figure 8e show the exploration results of the reinforced earth mass in the MSE wall. It was found that there was no abnormal area in ER-2-1, but two abnormal areas were confirmed in ER-2-2 and ER-2-3. Areas F and G correspond to the corners of the MSE wall, and the abnormal areas are connected. In addition, these areas have similar longitudinal cross-section locations to area B. In other words, it was found that the problems (such as groundwater infiltration) in areas F and G, which extended to area B, caused the continuous deformation of the corner on the MSE wall.

Therefore, the risk area for the MSE wall of the case site was determined to be the corner based on the results of the electrical resistivity survey. In other words, this area was evaluated as requiring continuous monitoring. The longitudinal crack status of the corner is shown in Figure 9.

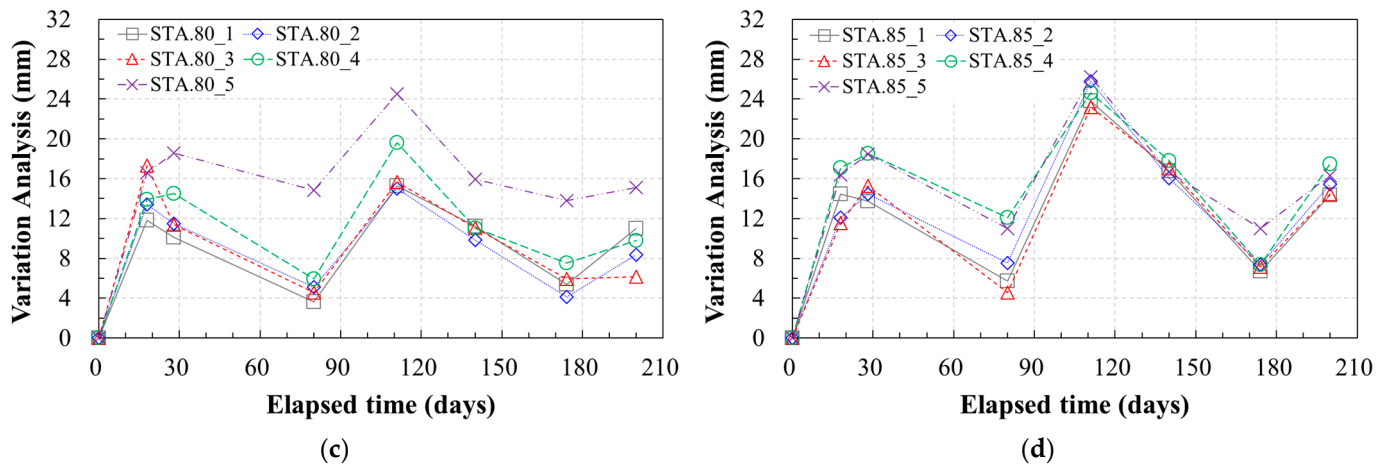
**Figure 10.** Elapsed time–displacement relationship depending on the position of the wall facing (monitoring for 7 months): (a) total station value [STA.80]; (b) total station value [STA.85]; (c) digital camera value [STA.80]; (d) digital camera value [STA.85].

Based on the measurement results, the elapsed time–displacement relationship according to the position of the wall facing was plotted, as shown in Figure 10.

First, the total station measurements were analyzed. It was found that the displacement at STA.80 ranged from a minimum of 1 mm (STA.80\_2, STA.80\_4) to a maximum of 18.815 mm (STA.80\_5). The change in displacement over time showed similar shapes for STA.80\_1–STA.80\_5, but the displacement at STA.80\_5 was larger than that at the other points. The height of the measurement point STA.80\_5 was 5.2 m from the bottom of the MSE wall, which was approximately 37% of the total height of the MSE wall (14.1 m). It is typical for the wall facing deformation of an MSE wall to have the largest deformation in the first one-third segment of the total height (approximately 33% of the total height). This implies that STA.80\_5 had a larger deformation at the corner. The displacements at STA.85 were found to range from a minimum of 1.414 mm (STA.85\_2, STA.85\_4) to a maximum of 21.471 mm (STA.85\_5). The evolution of the displacement over time and quantitative displacement values were found to be almost similar for all points, and the displacement at STA.85 was slightly larger than that at STA.80 for less than one-third of the total height. This agreed with the analysis of the cause of the displacement at STA.80.

The digital image photogrammetry results, obtained using a digital camera, were analyzed. The displacement at the corner of STA.80 was found to be a minimum of 3.606 mm (STA.80\_1) and a maximum of 24.536 mm (STA.80\_5). The temporal changes in the displacement were similar for STA.80\_1 to STA.80\_5. However, the quantitative displacement values were somewhat larger than the displacement values for the total station, and some were irregular. In particular, the displacements at STA.80\_4 and STA.80\_5 were found to be large. The displacements at the corner of STA.85 were found to range from a minimum of 4.583 mm (STA.85\_3) to a maximum of 26.192 mm (STA.85\_5). This was similar to the observation for STA.80, and it was much larger than the displacement value obtained from the traditional monitoring method (total station).

The measurement and monitoring results of the traditional monitoring method and digital camera-based digital image photogrammetry revealed significant wall facing displacements at 18, 28, and 111 days. These were attributed to a large amount of rainfall that occurred just before the elapsed time due to the seasonal characteristics of South Korea; the rainfall penetrated the anomalous area found in the electrical resistivity survey's results, causing the wall facing's displacement.

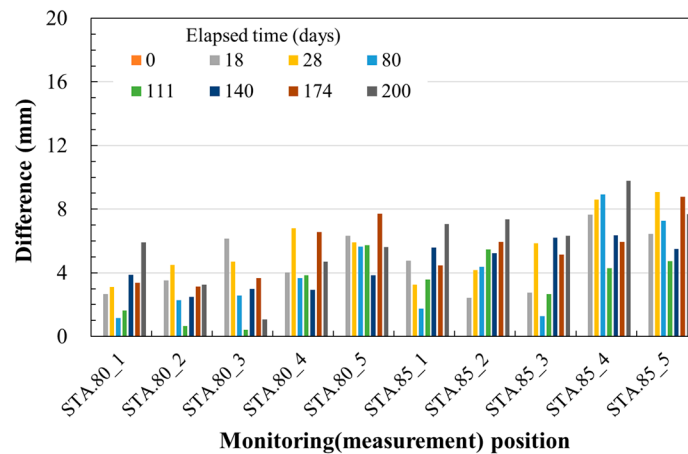
**Figure 11.** Difference between displacements obtained using the traditional monitoring method and digital camera-based digital image photogrammetry.

For STA.80, the two highest error levels occurred at 80 days and 174 days from the initial measurement date. STA.85 showed similar results. The largest errors occurred at positions STA.80\_4–STA.80\_5 and STA.85\_4–STA.85\_5, which means that the error was larger when the displacement was relatively large.

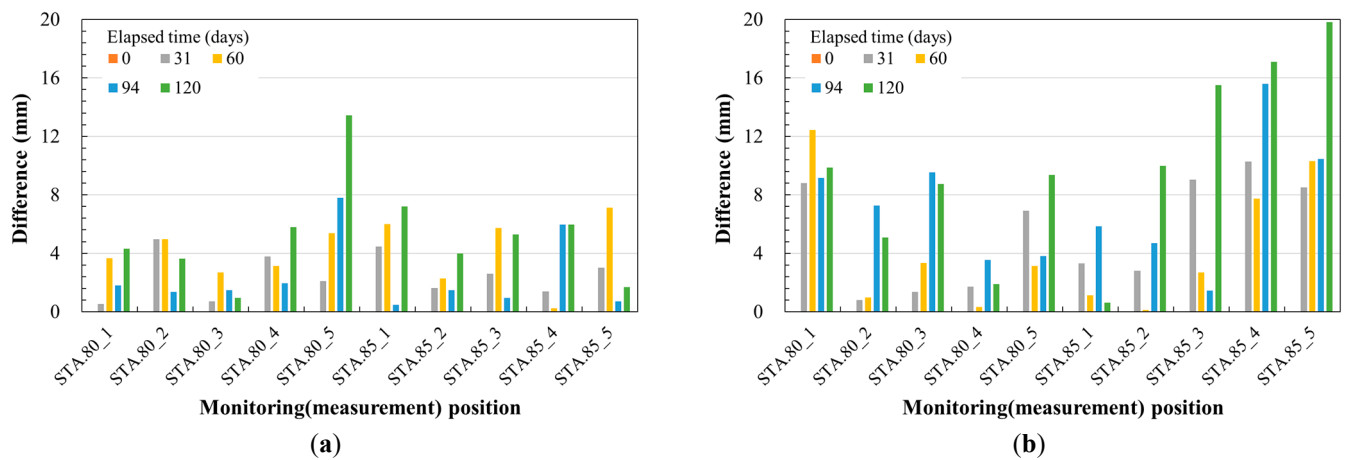
**Figure 13.** Difference in displacement between total station and digital camera and cellphone camera results: (a) total station–digital camera; (b) total station–cellphone camera.

Figure 13 shows the evaluation results of the digital image photogrammetry error based on each commercial imaging device against the traditional monitoring method using the measurement results.

The results of digital camera-based digital image photogrammetry show that the measurement values for low-level displacements were less different from those of the traditional monitoring method. However, the errors between the two methods were shown to be large when displacements were large. In addition, the measurement errors of cellphone camera-based digital image photogrammetry were evaluated to be at a level that was not meaningful for analysis compared to the measurement results of other methods; thus, they were excluded from discussion in this study.
