Article

Damage Index Calibration of Frame-Supported Concealed Multi-Ribbed Wall Panels with Energy-Efficient Blocks

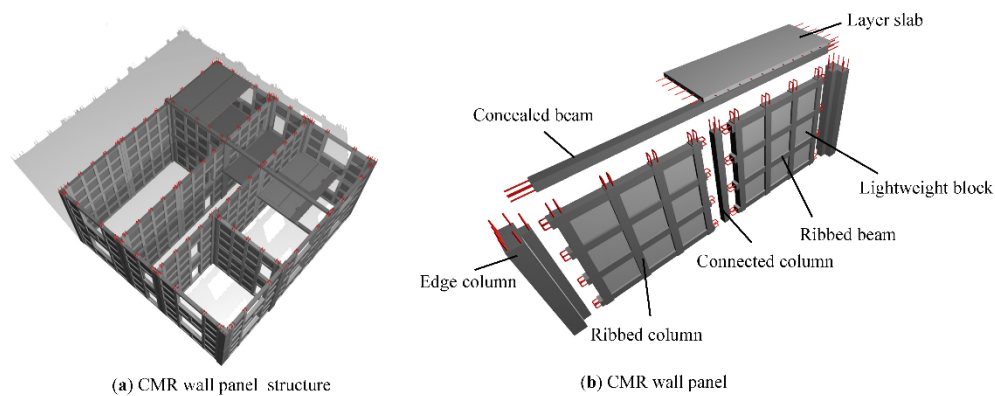
Figure 1. Diagram for CMR wall panel structure with energy-efficient blocks.

With a layer-by-layer embedded design, a CMR wall panel structure is composed of a cast-in-situ edge frame, layer slabs, and a prefabricated CMR panel. The latter, as a newly-proposed composite panel, uses lightweight blocks with a low elasticity modulus embedded in the CMR frame, manufactured by densely arranged reinforced-concrete beams and columns. The edge frame (constructed from concrete edge columns, connected columns, and concealed beams) both bonds and simultaneously restrains the CMR panel [10]. Thereby, the above-mentioned parts comprise the major force-bearing members of the structure, namely the CMR wall panel (see Figure 1). Floor slab of cast-in-situ reinforced concrete shall be applied as layer slab, the steel bars of which shall be well connected with the concrete beams, the edge columns and the connected columns. The force bearing calculation and construction procedures of layer slab shall follow the rules set out in the National Standard for People's Republic of China (GB50011-2010 and GB50010-2010) [11,12].

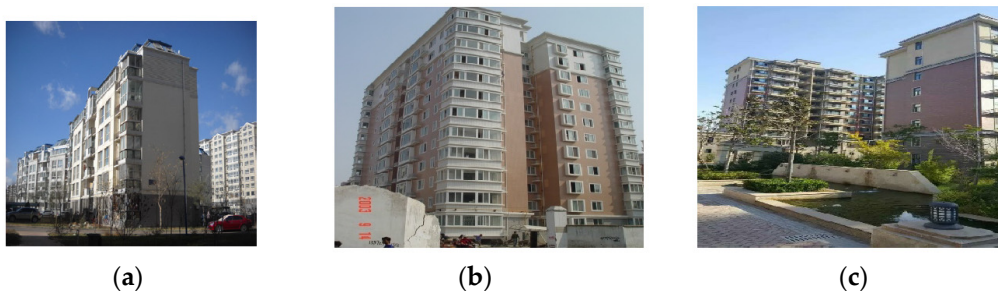
Figure 2. Residence pilot projects using CMR wall panel structure with energy-efficient blocks. (a) Xing-Guang Hua District in Yin Chuan, the Ningxia Hui Autonomous Region; (b) Geng-xin-street District in Xi'an, Shanxi Province; (c) Zhong-zhou-yu-fu project, in Lankao, Henan Province.

Because the residence pilot projects have taken place in Yinchuan, Shanxi, Henan, and many other provinces, the CMR wall panel structure has reached into to every aspect of social production and practice (see Figure 2), and efforts of the country toward this end have yielded both economic and social results [15–17]. Under such circumstances, the Ministry of Housing and Urban Development, P.R. China, has issued an industrial standard, *The Directive Rules for Concealed Multi-Ribbed Wall Panel Structures with Energy-efficient Blocks*, which became effective 1 June 2014 [13].

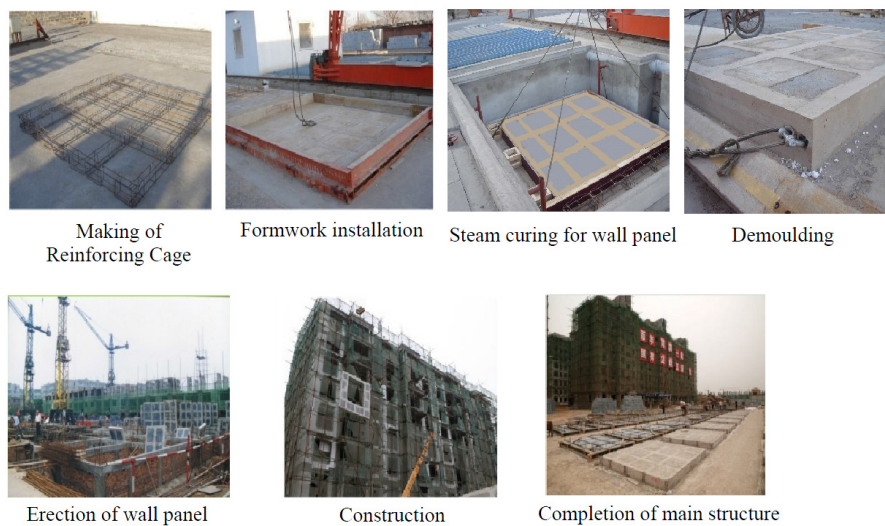
Figure 4. Production and assembly of CMR wall panel structure with energy-efficient blocks.

See Figure 3 for the arrangement and configuration of multiple seismic lines of defence for the CMR wall panel structure with energy-efficient blocks, while Figure 4 shows the manufacture and assembly of a CMR wall panel structure with energy-efficient blocks.

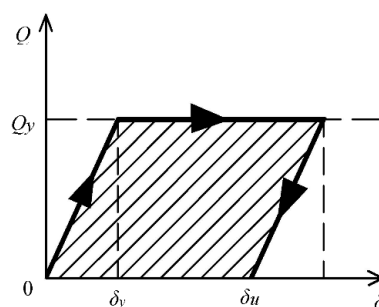
Figure 6. Calculation diagram for plastic energy consumption.

The simplified recoverability model for an elastic-plastic structure under ideal conditions is applied to calculate the plastic capacity of energy consumption under monotone loading, which, as Figure 6 shows, equals the envelope area.

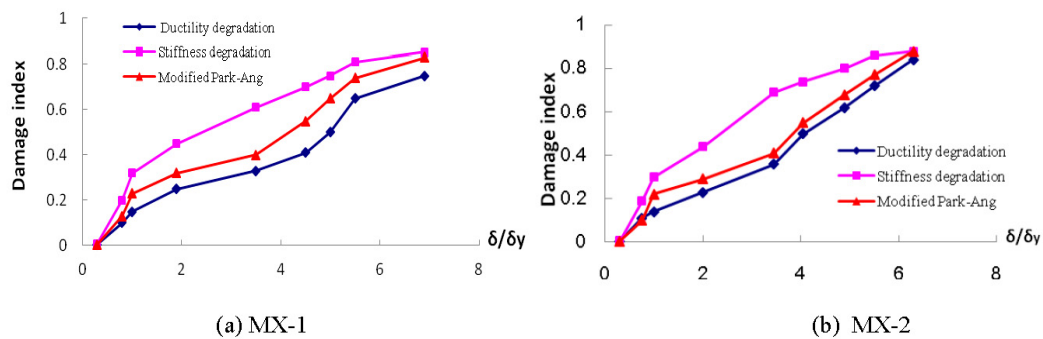
Figure 7. Relationship curves of damage index and δ/δ_y .

After the data from all three damage models are collected, the relationship between the damage index and the displacement ratio (or δ/δ_y) can be determined (see Figure 7).

As shown in the figure above, the damage indices calculated by the modified Park–Ang model tend to fall between those of the other two models, which is consistent with the experimental results of the paper. Comparatively, it better depicts the failure processes and damage patterns of FSCMR wall panel structures. Figure 8 shows damage indices for the two specimens.

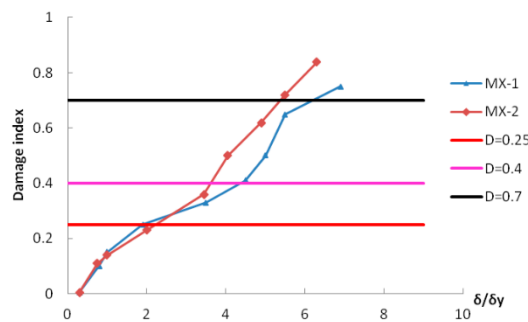
Figure 8. Comparative diagram of damage indexes between two FSCMR wall panel structures.

Figure 8 shows that the two specimens share a relatively similar variation pattern. As δ/δ_y fluctuates between 0 and 2, the specimens maintain fairly good conditions, with no visible damage on the surface. At this point, the damage index varies between 0 and 0.25. As δ/δ_y increases to a range of 2 to 4.5, the specimens begin to crack slightly. At this stage of mid-term development, the damage index falls between 0.25 and 0.4. At the next stage (that is, the stage of rapid development), aggravated damage begins to occur. Here, δ/δ_y tends to stay between 4.5 and 6, while the damage index fluctuates within a range of 0.4 to 0.7. As the experiments continue, the specimens are completely destroyed and have no bearing capacity. Here, the corresponding damage index varies between 0.7 and 1.0.

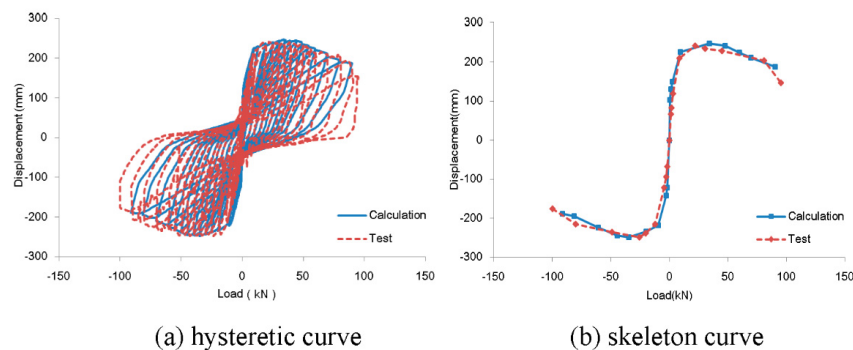
Figure 9. Comparison between calculated values and experimental data (hysteretic curve and skeleton curve).

The study, with the help of OpenSees, simulates the hysteresis of an FSCMR wall panel structure under cyclic loading. The simulated results are then compared with collected experimental data (see Figure 9). The accuracy of the model can be verified by examining whether or not the hysteretic curve and skeleton curve coincide. Here, MX-1 is used to specify the procedure. The research team introduces OpenSees in its simulation of specimen physical performance (see Figure 10), using the material-specialized model Concrete02, in which the strength and linear emollescence in tension of concrete is applied in the study of the constitutive relationship of concrete. In contrast, in the uniaxial material model, a hysteretic material is chosen for the simulation of reinforced concrete, as the model does not eliminate stiffness degradation upon the lift of force impulsion and is fully able to reflect the pinching effect. The beam-column unit makes use of the nonlinear fibre model provided in the OpenSees simulation. In accordance with the equivalent principle of compressive stiffness and bending stiffness, the paper simulates the reinforced concrete plate in the ShellMITC4 unit, which is defined as a multi-layered shell element. It can be concluded that the simulated results of both hysteretic curves and skeleton curves with the help of OpenSees stay consistent with the corresponding data collected from the experiment.

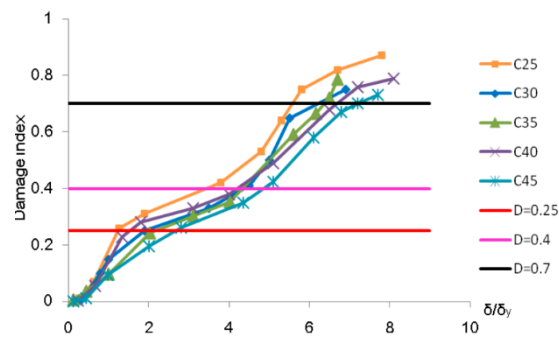
Figure 10. The MX-1 variation diagram of damage indices for different concrete compositions.

The study simulates the cyclic loading test by altering concrete strength, calculating the displacement item δ_m/δ_u and energy item $\int dE/Q_y (\delta_u - \delta_y)$ accordingly. From these results, Equation (5) is used to obtain the damage indices at each stage of force impulsion, which are then compared with the experimental data for MX-1 (of concrete C30).

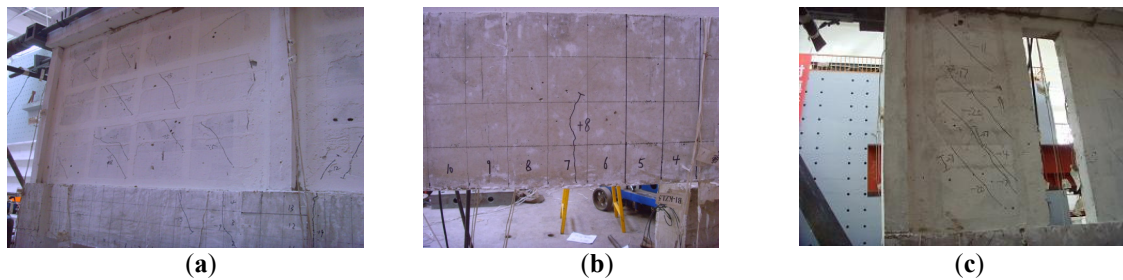
Figure 11. Preliminary development stage of FSCMR wall panel. (a) Minor cracks on block surface tend to close up under girder restraint. (b) Minor cracks at frame-supported beams. (c) Oblique cracks at either side of the hole along the direction of force impulsion.

Few tensile cracks are observed at the hole portal and at block joints, which then tend to close up under reversed loading. As the loading continues, minor cracks reach the FS columns, the FS beams, and the structural columns at the portal. These cracks then increase in quantity. In the process, the loading-displacement curve follows a linear variation pattern. In addition, it must be noted that the reinforced embedded steel bears little strain, while the blocks, ribbed beams, and ribbed columns at the upper structure work cooperatively (see Figure 11).

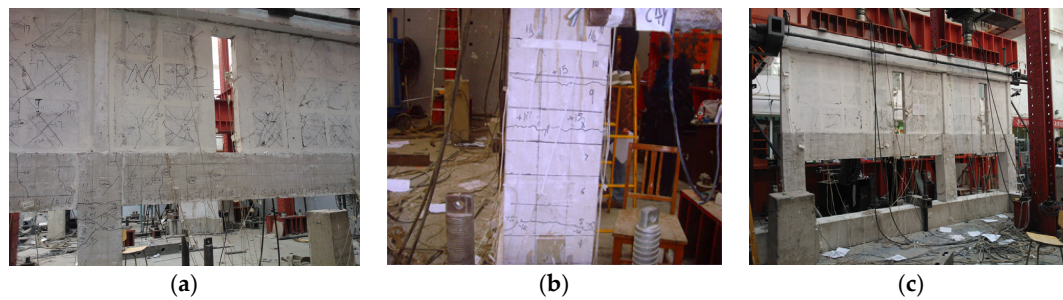
Figure 12. Mid-term development stage of FSCMR wall panel. (a) As cracks spread out over the specimens, the edge frame is deteriorated in the process. (b) Horizontal cracks intersect on FS column. (c) Block Exfoliation (The upper structure performs fairly well overall thanks to the grid restraint, while cracks on the lower FS structure continue to increase in quantity).

At this stage, visible cracks are apparent in the blocks as tensions are imposed. As the applied loading is transformed into pressure, cracks increase in quantity and then tend to extend across the blocks. In other words, oblique cracks intersect under cyclic loading. As the loading continues, existing cracks begin to extend in length, while oblique cracks continue to be apparent, accompanied by a slight cracking noise. As the blocks exfoliate, a considerable number of oblique cracks stretch further out to the edges of the ribbed beams and ribbed columns. In spite of the damage described above, the overall performance of the blocks remains extraordinary because of the restraint of the grid. New cracks continue to climb towards the FS beams and FS columns, with through-cracks occurring horizontally on the FS columns (see Figure 12). At this point, the hysteretic curve, which begins as a spindle-like

curve, then approaches the original point. A pinching effect then occurs. Simultaneously, the stiffness of the specimen continues to deteriorate.

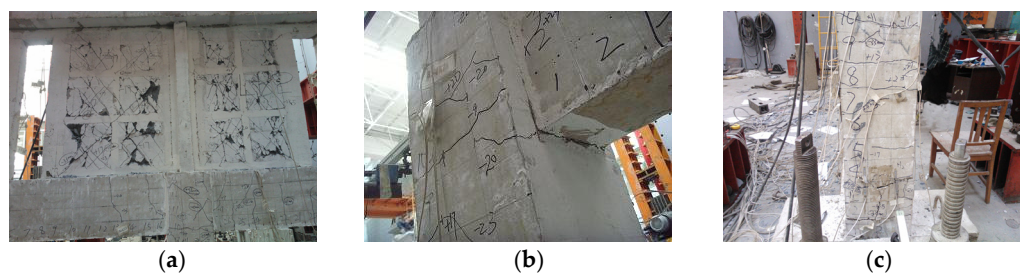
Figure 13. Rapid development stage of FSCMR wall panel. (a) Visible block exfoliation. Sliding at block-grid interface. (b) Visible cracks at the joints of FS beams and FS columns. (c) Flexural cracks increase at FS columns. Concrete crushing at column base.

Severe damage largely deteriorates adhesion at the block-grid interface, which results in visible sliding and exfoliation. The majority of cracks, located at the edges of ribbed beams, cut through the cross-sections of the beams. The concrete at the FS column base cracks, and flexural cracks increase in quantity. Visible cracks develop in the beam-column joints (see Figure 13). At this point, the hysteretic curve envelopes increase in size, which can be interpreted as an increase in energy consumption.

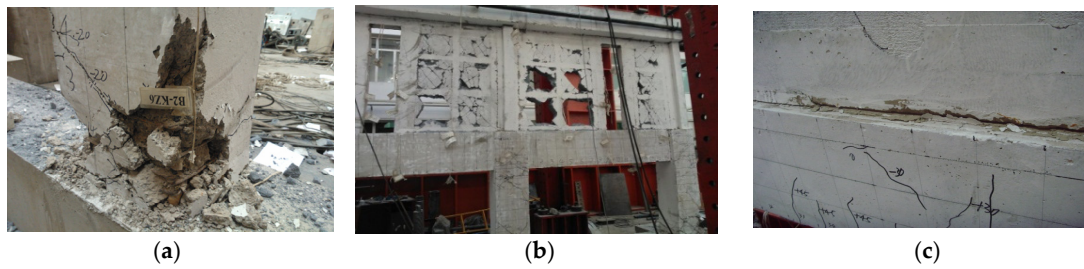
Figure 14. Failure stage of the FSCMR wall panel. (a) Convex reinforced steel at the bottom of the FS column Concrete exfoliation; (b) Block crushing due to exfoliation. Deformation of the structural columns at both sides of the hole; (c) Mortar crack and layer sliding.

The experiment now reaches an enduring stage, as the paper tightens displacement control. As the displacement amplitude increases, the force bearing capacity of the wall panels decreases. In the meantime, more cracks can be observed at the block-grid interface, and exfoliation occurs on a large scale, which results in a hole opening at the upper wall panel. As loading proceeds, the structural columns at the hole portal bend, while concrete at the edge columns, connected columns, and joint of FS beams and FS columns begins to peel off. At this point, the reinforced steel at the FS column bases begins to buckle, accompanied by a large cracking sound, while sliding takes place at the interface of the upper and lower layer, which then tends to become aggravated. The structure, which has an embedded layer-by-layer design and multiple lines of defence, promises impressive force-bearing performance and the collapse resistance of the edge frame and grid, in spite of the severe exfoliation (see Figure 14). The hysteretic curve shows evident pinching effects. However, the envelope dimensions are still considerably large. Therefore, a conclusion is reached, the structure displays extraordinary performance in terms of energy consumption.
