Article

Lock-In Thermography and Ultrasonic Testing of Impacted Basalt Fibers Reinforced Thermoplastic Matrix Composites

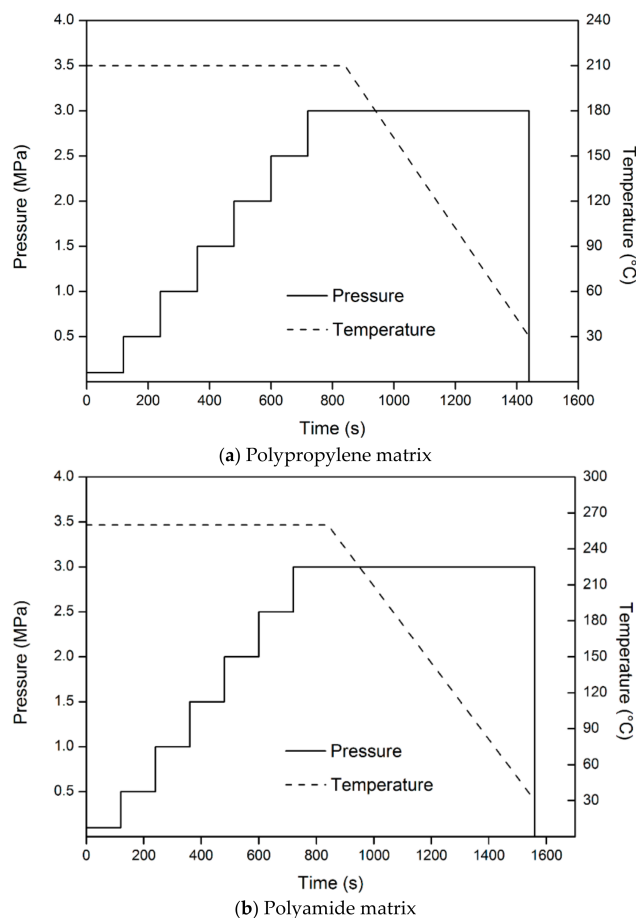
Figure 1. Molding compression pressure and temperature against time for polypropylene (PP) based (a) and polyamide (PA6B) based (b) matrices.

Each specimen includes 18 balanced basalt fabric layers 0°/90° symmetrically arranged with respect to the middle plane of the laminate ((0/90)₉)_s configuration), with a basalt fiber content of 50% by volume (the actual relative percentages of fiber and matrix evaluated according to ASTM D 3171-04, Test Method II). The percentage of 50% has been chosen as an optimal value through preliminary tests. Laminates are obtained by alternating layers of matrix films (PP, PC2, PA6) with basalt fibers fabric by the hand lay-up film-stacking technique and compacted with the aid of a compression molding machine (model P400E, Collin GmbH, Germany) under pre-optimized molding conditions (Figure 1). Each specimen is 300 mm × 300 mm with a target thickness of 3 mm.

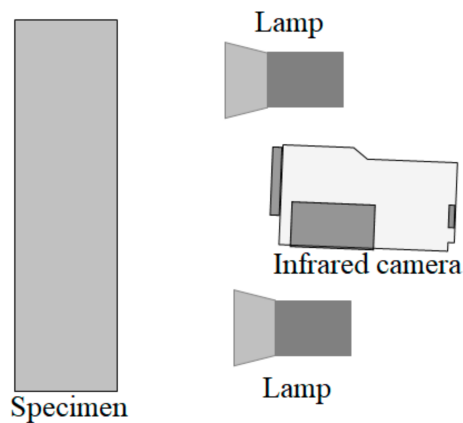
Figure 2. Scheme of the lock-in thermography setup.

Lock-in thermography is a well-known technology and will not be herein described in detail; only a sketch of the test setup (Figure 2) and some basics are recalled for easy reading. The thermal wave, delivered to the specimen surface, propagates inside the material and gets reflected when it reaches parts where the heat propagation parameters change (in-homogeneities). The reflected wave interacts with the surface wave producing an oscillating interference pattern, which can be measured in terms of either temperature amplitude, or phase angle φ , and represented as an amplitude, or phase, image, respectively. The basic link of the thermal diffusion length μ to the heating frequency f and to the mean material thermal diffusivity coefficient α is via the relationship:

The depth range for the amplitude image is given by μ , while the maximum depth p , which can be reached for the phase image, corresponds to 1.8μ [9–12]. In general, it is preferable to reduce data in terms of phase image because of its insensitivity to either non-uniform heating or local variations of emissivity over the monitored surface. The material thickness, which can be inspected, depends on the wave period (the longer the period, the deeper the penetration) and on the material thermal diffusivity.

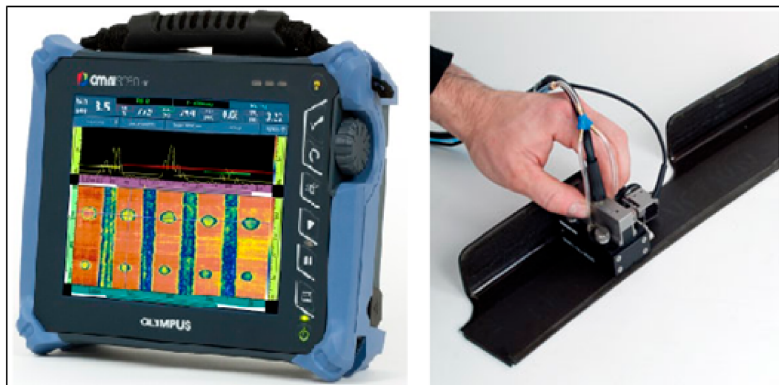
Figure 3. Some details of the ultrasonic (UT) testing setup.

Ultrasonic non-destructive inspection is performed with an ultrasonic flaw detector Olympus OmniScan SX with phased array unit (Figure 3). The Omniscan detector is equipped with a phased array 16:64PR probe and with an ultrasonic (UT) conventional channel allowing for pulse-echo (PE), pitch-catch, or time-of-flight diffraction (TOFD) methods of inspection [13]. To perform the inspection the phased array probe elements are pulsed simultaneously, or with a time lag, in order to promote ultrasonic beamforming that is the constructive interference of multiple-beam components into a single wavefront traveling in the desired direction. Correspondingly, in the acquiring mode, the receiver is able to combine the signals (echoes) coming from multiple elements (reflectors) into a single representation. Exploiting the phasing technology that allows beam shaping and steering, it is possible to generate a wide variety of ultrasonic beam profiles with a single probe assembly, and, at the same time, to dynamically set the beam steering to perform electronic scans.

In the present work, tests are performed by means of an encoded 5 MHz, phased array transducer with 64 active elements arranged in a linear array with a pitch of 1 mm and a straight wedge. The system calibration is performed by considering the specimen thickness as a reference, so no calibration blocks are used.

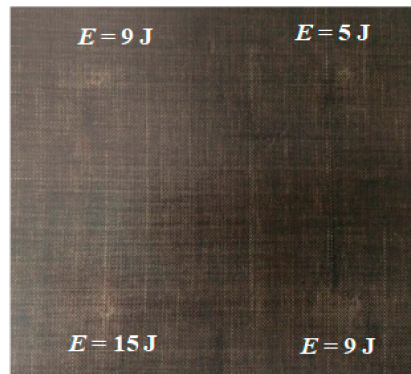
Figure 4. Photo of the polypropylene added with 2% maleic anhydride (PA6B) specimen with indicated energy and location of the impacts.

Firstly, a photo of the PA6 specimen taken after impact is reported in Figure 4. As indicated, the specimen was subjected to four impacts with energies: 5, 9, and 15 J and with two impacts at the same $E = 9$ J. The location of each impact is also recognizable from the light local surface discoloration.

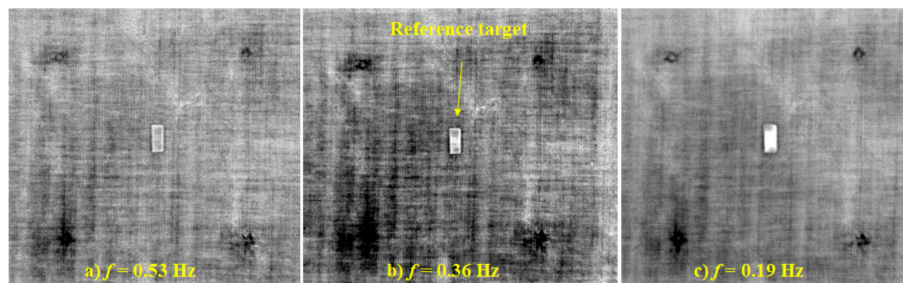
Figure 5. Phase images taken on the impacted side of the PA6B specimen at three heating frequencies; (a) $f = 0.53$ Hz; (b) $f = 0.36$ Hz; (c) $f = 0.19$ Hz (see Figure 2 for impact energies location).

Three phase images taken from the impacted side (shown in Figure 4) are reported in Figure 5; a reference target of 19 mm \times 8 mm, clearly visible on each image, allows for fast estimation of the damage size. From these phase images it is possible to see that:

- There are dark stains in correspondence of the four impacts.
- The size of dark stains increases with the impact energy.
- Going in-depth, the stains first expand by decreasing f from 0.53 Hz (Figure 5a) to 0.36 Hz (Figure 5b), and after contracting to their initial size to a further reduction of f to 0.19 Hz (Figure 5c).

In particular, the dark zone centered at the impact point of $E = 15$ J (Figure 5a) assumes for $f = 0.36$ Hz (Figure 5b) a well H shaped configuration being representative of the delamination evolution along the vertical fiber's direction. Such a vertical displacement may be explicable owing to the fact that, during the impact, the specimen was positioned inside the lodge with the vertical direction of the fibers (as shown in Figure 5b) along the longer side of the lodge's window ($12.5 \text{ cm} \times 7.5 \text{ cm}$). In addition, it is possible to see threadlike structures resembling cracks in the matrix which are most pronounced around the impact point of 9 J on the bottom (Figure 5b). However, apart from the clearly visible impact coupled stains, there are other dark zones mostly present on the phase image taken at $f = 0.36$ Hz (Figure 5b), which are distributed away from the impact points and which may indicate that material in-homogeneities likely occurred during the manufacturing process. All of these dark structures fade going more in-depth; they remain clearly evident for $f = 0.19$ Hz (Figure 5c) mostly around the impact points.

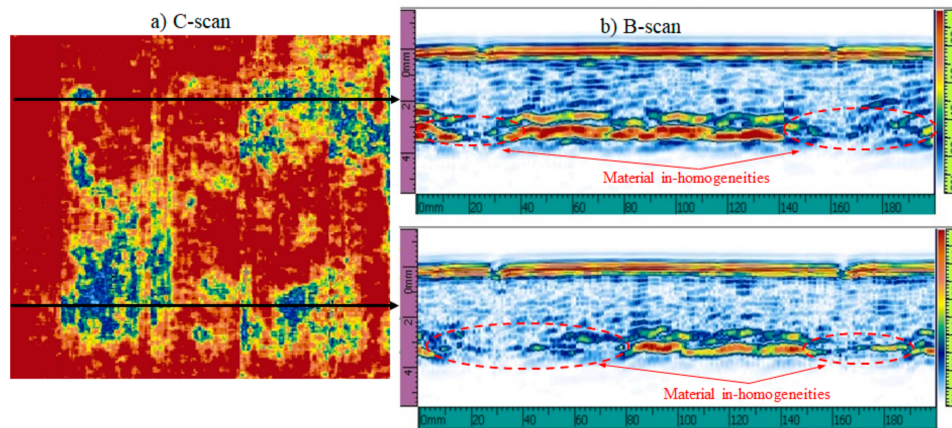
Figure 6. C-scan (a) and B-scan (b) images taken on the impacted side of the PA6B specimen (see Figure 4 for impact energies location).

What is observed in Figure 5b is practically confirmed by the C-scan image of Figure 6a. In fact, the black color of Figure 5b is replaced by the dark blue color of Figure 6a to highlight the indentation of each impact and the most important damage.

In particular, it is confirmed the presence of delamination along the direction of the vertical fibers and it is also confirmed the presence of material in-homogeneity around impacts at 15 J, 9 J (on the right bottom), and 5 J and far away from the impact points. In addition, the dark structures around the impact at 5 J of Figure 5 are better depicted as blue-green structures in Figure 6. The comparison between Figures 5 and 6 helps to classify such structures as material in-homogeneities rather than impact-induced damage. As already evidenced, such in-homogeneities display their best contrast for $f = 0.36$ Hz (Figure 5b) meaning that they are mostly located in the second half of the specimen thickness towards the bottom. It is worth noting that around the impact points in-homogeneities are present for lower f (Figure 5c) and so extend to the entire thickness. This set of evidence, probably

exacerbated by impact effects, are confirmed in the ultrasonic B-scan sections (Figure 6b), where it is possible to see wide porosity areas through the stratification close to the opposite surface of the impacted side.

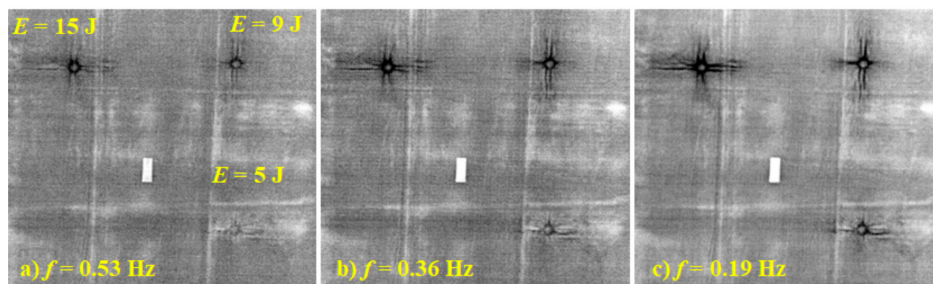
Figure 7. Phase images taken on the impacted side of the pure polypropylene (PPB) specimen at three heating frequencies; (a) $f = 0.53$ Hz; (b) $f = 0.36$ Hz; (c) $f = 0.19$ Hz.

The Figures 7 and 8 show phase images, taken from the impacted side, of the two specimens PPB (Figure 7) and PC2B (Figure 8), which were subjected to three impacts at 5 J, 9 J, and 15 J as indicated on the first image (a) of both Figures 8 and 9. Figure 9 shows a comparison between phase images taken at $f = 0.19$ Hz from the rear side (opposite to impact) of the three specimens PA6B (Figure 9a), PPB (Figure 9b), and PC2B (Figure 9c).

As a general observation, the occurred damage appears in the form of a cross-shaped structure with a central ring. The cross's branches indicate the main deformation directions while the ring may be assumed to coincide with the imprint of the impactor. The cross is more accentuated for the highest impact energy of 15 J and achieves its best contrast at $f = 0.19$ Hz (Figure 7c Figure 8c). As a main difference between the two specimens, the cross is depicted by fan-like branches in the PPB specimen (Figure 7) and by almost straight lines in the PC2B one (Figure 8). Such a difference is a symptom of different behavior of the two materials under the impact. It is worth noting that the superimposed layers of the PPB specimen are not fully rigidly connected at their interface but are free to somehow mutually slide. Instead, the stronger bond entailed by the grafting agent in the PC2B specimen prevents slipping effects of layers and allows for bending and deformation through the entire thickness. This may entail wrinkling in the layers furthest from the impact point as shown in Figure 9c.

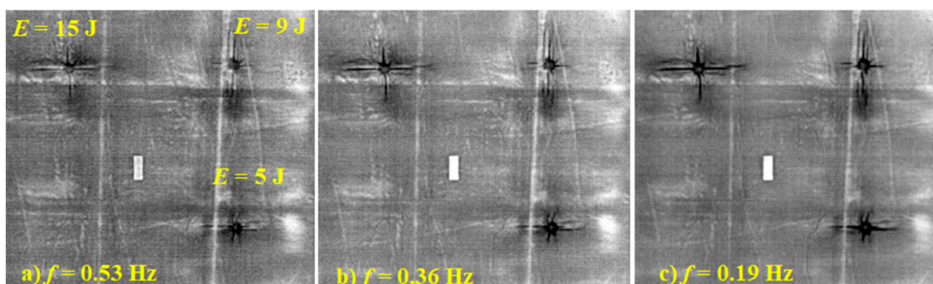
Figure 8. Phase images taken on the impacted side of the PC2B specimen at three heating frequencies; (a) $f = 0.53$ Hz; (b) $f = 0.36$ Hz; (c) $f = 0.19$ Hz.

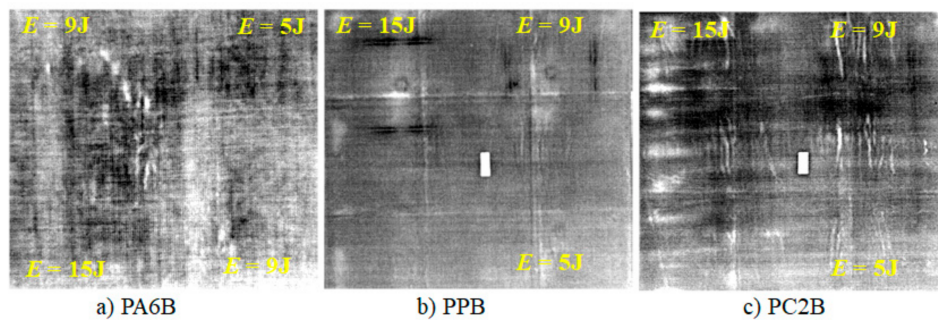
Figure 9. Phase images taken at $f = 0.19$ Hz on the rear side of the three specimens; (a) PA6B; (b) PPB; (c) PC2B.

- The presence of the coupling (compatibilizing) agent has no significant effects on the extension of the impact damage with regards to the branches length on the superficial layer but mostly affects the deformation way of the underlying layers. More specifically, a stronger interface adhesion entails a crumple effect with stretching of the bottom layer. This effect is evident looking at the phase images taken from the rear of specimens PA6B (Figure 9a) and PC2B (Figure 9c) in comparison with the phase image of the specimen PPB (Figure 9b), which appear almost flat.

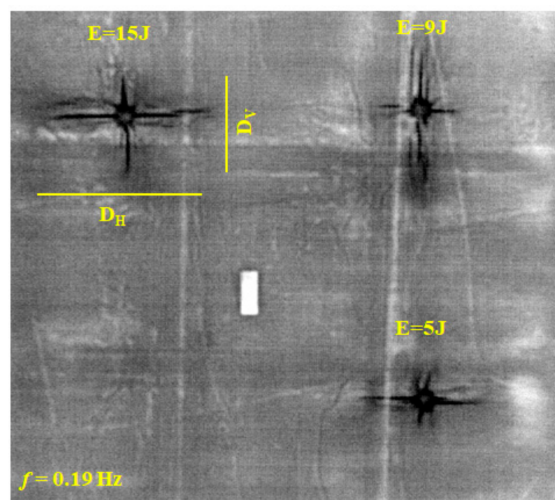
Figure 10. Indication of D_H and D_V over a phase image.

The extension of the occurred impact damage is evaluated by considering its elongation along horizontal (D_H) and vertical (D_V) directions as represented in Figure 10. These values are extracted from the phase images through a correspondence pixels/mm by considering the reference target.
