Remote-Sensing Measurements of Wave Breaking at Two Pacific Northwest Jettied Inlets

Rob Holman ^{1,*}, Hans Rod Moritz ² and James McMillan ²

Citation: Holman, R.; Moritz, H.R.; McMillan, J. Remote-Sensing Measurements of Wave Breaking at Two Pacific Northwest Jettied Inlets. *J. Mar. Sci. Eng.* **2022**, *10*, 1037. <https://doi.org/10.3390/jmse10081037>

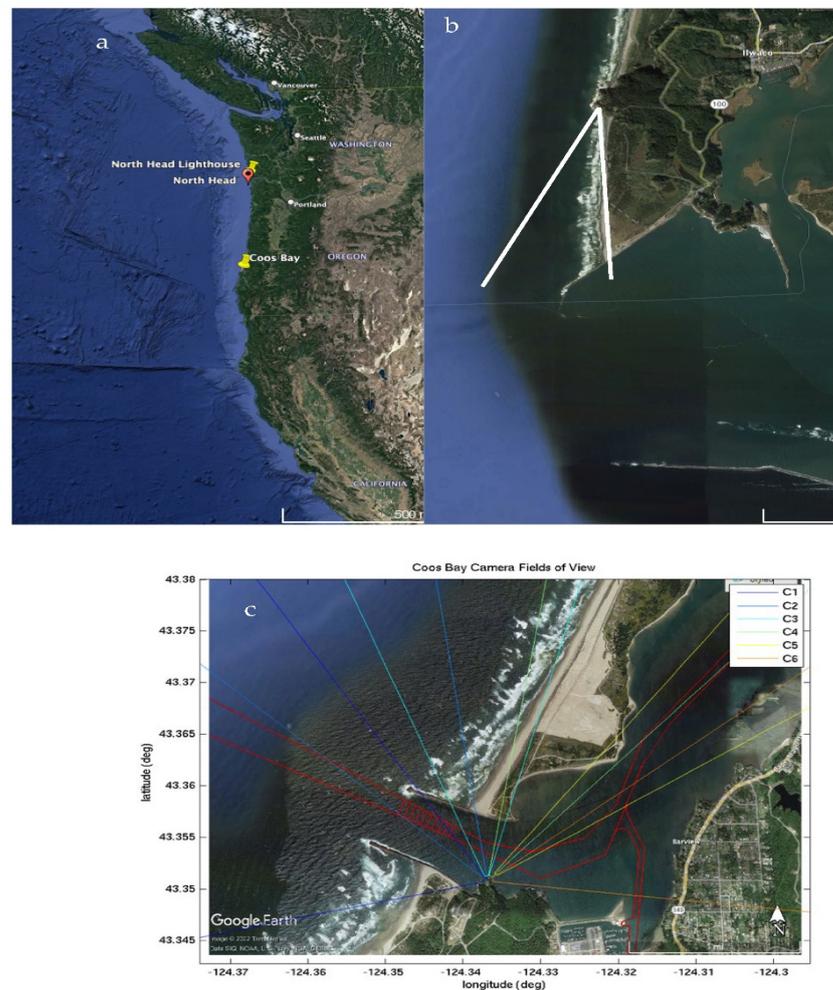
Figure 1. Map views of the two field sites. (a) Shows the entire Pacific Northwest region and the locations of both North Head and Coos Bay. (b) Zooms in to the North Head region showing the imaged field of view to the south (white lines) spanning Benson Beach which lies between the Head and the north jetty of the Columbia River. (c) Shows a magnified view of Coos Bay including the two jetties, the navigation channels (in red), and the fields of view of the six Argus cameras (paired colored lines).

The two camera installations are at the North Head lighthouse, Washington State, and the coast guard watch station at Coos Bay, Oregon, both in the region of large wave energy in the Pacific Northwest (Figure 1a). The North Head Argus station is located 3.3 km north of the north jetty of the Columbia River and overlooks Benson Beach, a low sloping, dissipative, west-facing beach with open wave exposure to the Pacific Ocean (Figure 1b). The Coos Bay Argus station is 325 km to the south and includes an estuary opening to the WNW that connects to the long estuary of Coos Bay that winds north and then turns south (Figure 1c).

Most of the sampling for Coos Bay is similar to that for North Head. As seen in Figure 1c, six cameras were used to span almost 180° of viewing, including views back into the estuary. For this paper, we will only consider seaward looking views, so cameras 1 to 3. Figure 6 shows an example of “brightest” panorama from 20 May 2019, showing some wave breaking on both the north and south jetties as well as on the ocean beaches to the north and south. The boundaries of the two dredge disposal areas are shown offshore with dotted lines (site E is to the south or left, site F is to the north or right).

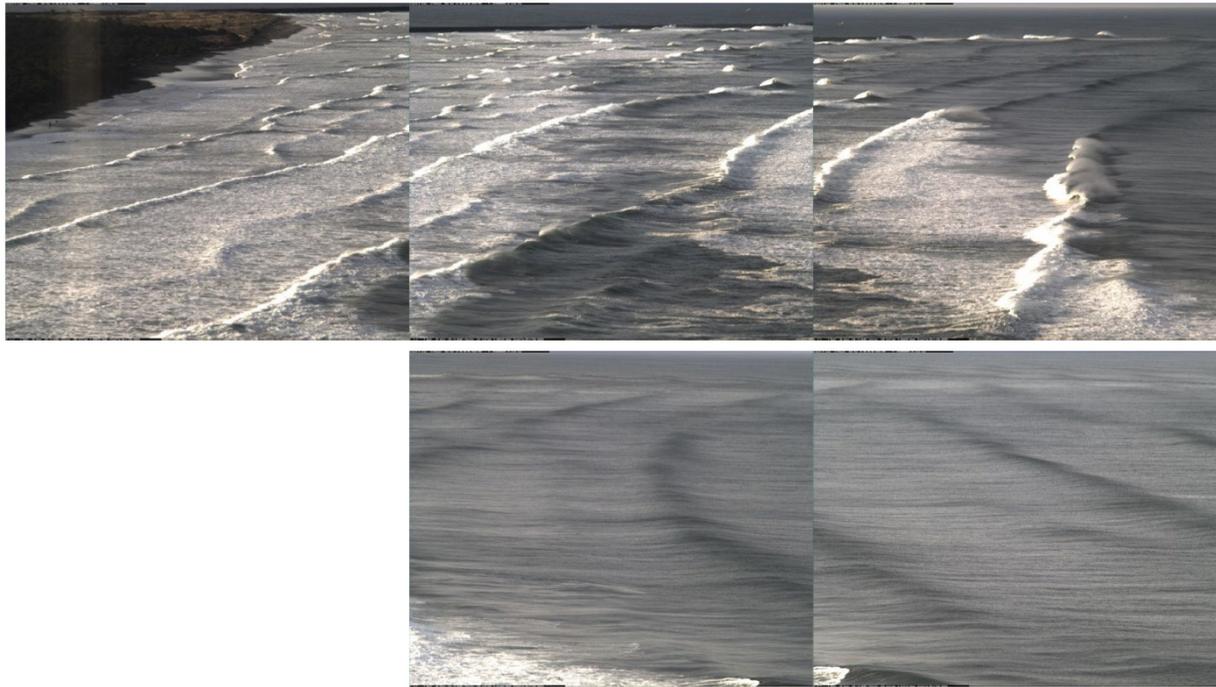
Figure 2. Example snapshots from each of the five cameras from North Head for 12 March 2018, 1530 GMT.

For North Head, there was a requirement to sample with sufficient resolution out to a range of 4.5 km, the distance of the SWS disposal site from the North Head lighthouse. Due to the extreme range, five cameras were required to span the 40° field of view (Figure 1b) to allow sampling from Benson Beach on the left of the camera view out to the SWS location on the right. Each camera had a field of view of only 9.3° (50 mm lens) with a 5% overlap between adjacent images. Figure 2 shows example snapshot images from each camera.

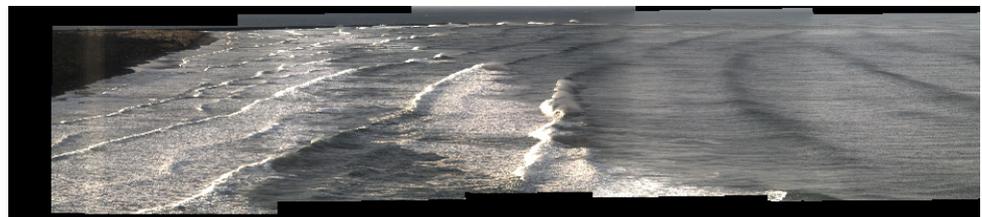
Figure 3. Panoramic view merging the five snapshots in Figure 2.

With photogrammetry accurately corrected, images from the five cameras could be merged into composite images in which world locations are accurately known. Figure 3 shows a merged panorama (pan for short) computed from the snapshot images in Figure 2. The pan axes are vertical and horizontal angles (tilt and azimuth) and world locations such as the SWS disposal site boundary can be accurately mapped in the composite image.

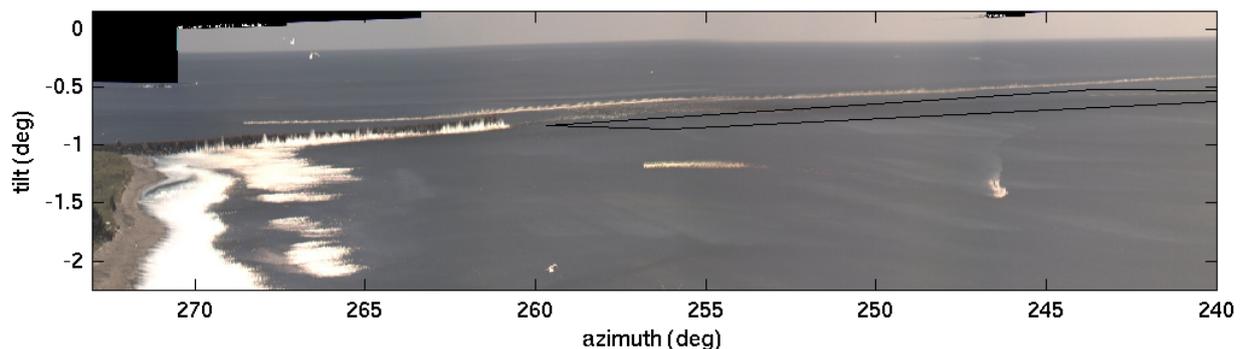
Figure 4. Example of merged pan “brightest” image from 16 July 2017 showing regions of wave breaking during the ten minutes of data collection, for example, over the shoreline and sand bar and against the jetty. Anomalous streaks correspond to boat wakes. The SWS boundaries are shown offshore as a black line. The figure is shown with a vertical exaggeration of 4:1 to improve interpretation.

as a “brightest” image. Figure 4 shows an example of “brightest” panorama for 16 July 2017, a day with relatively low wave conditions. White areas indicate locations where wave breaking occurred at least once during the ten-minute collection, for example, along the shoreline and over a nearshore sand bar, as well as along the sides of the jetty. There are also some streak features due to boat wakes, for example, the long trail of a small boat entering the estuary just beyond the north jetty. The image shows azimuth and tilt angles for illustration. Images are shown with a vertical exaggeration of 4:1 to make features more visible. This has the effect of making breaking on the jetty look more extreme than it is. The boundaries of the SWS disposal site are included as a black line. The “brightest” images will be used to detect wave breaking on the north jetty and over the SWS disposal site.

The brightest pans in Figures 4, 5 and 7 all show evidence of wave breaking on the north jetty (this is vivid in Figure 4 but more averaged out in Figures 5 and 7). Since wave breaking is a primary stress on jetty structure, it was decided to use these images to quantify the extent and environmental dependencies of this breaking. The jetty region was digitized using the bin-averaged pan with the lowest tide and wave heights, $z_t < 0$ m, $H_s < 1$ m, of which there was only one case (Figure 9, the blue dashed line defines the jetty region). For each of the remaining 35 bin-averaged pans, the fraction of this region that was obscured by breaking waves (brightness exceeding a threshold intensity selected manually by viewing intensity histograms) was recorded. Figure 10 shows the resulting bulk breaking fractions as a function of wave height and tide elevation. Not surprisingly, higher tides yield more breaking over the jetty. Increasing wave heights also increases the breaking fraction substantially until it reaches essentially 100% for storms at mid to high tides.

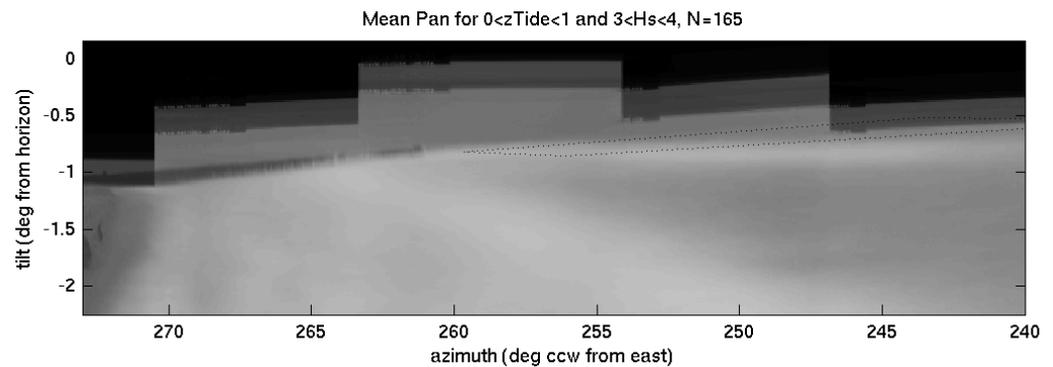
Figure 5. Example of averaged pan “brightest” image for North Head for the 165 images for which the tide elevation was between 0 and 1 m and the wave height was between 3 and 4 m. The SWS disposal site is shown by the black dotted lines extending from the end of the jetty.

Both Figures 5 and 7 also show the boundaries of the SWS disposal site as a dotted line. After close examination, it was clear that for all bin-averaged brightest pans, the region of enhanced breaking was oriented and located northward of the SWS boundary (closer to the camera). This is more evident if the pan image from Figure 5 is reprojected to a map view; Figure 8a. The band of white breaking is seen to extend mostly to the west northwest, not following the SWS boundaries shown in blue. Instead, the region of enhanced breaking appears to be following the flank of a shoal called Peacock Spit, shown in the nautical chart in Figure 8b and repeated as a white dashed line in the map view in Figure 8a. There is no evidence from any of the brightest images that the SWS disposal site was causing enhanced breaking or a hazard to navigation.

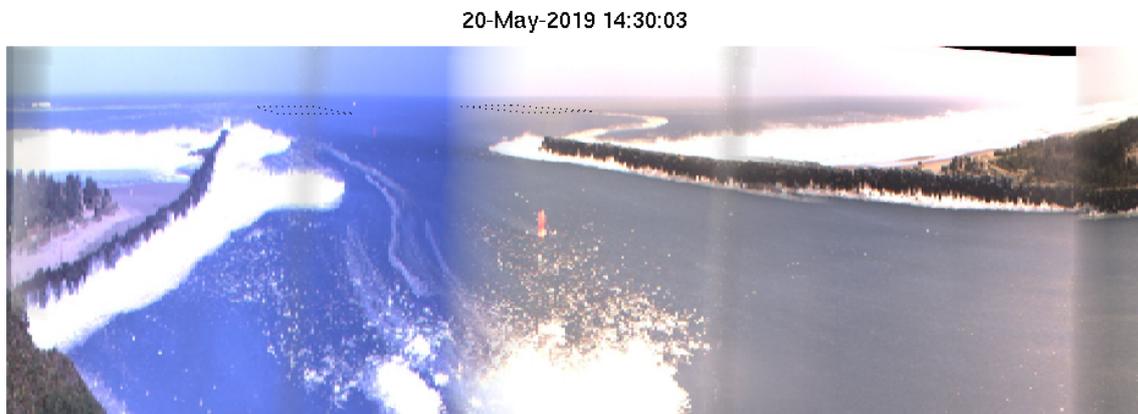
Figure 6. Example of pan “brightest” image of the seaward region of interest (ROI) for Coos Bay for 20 May 2019, 1430 GMT. The wave height was 2.35 m, period was 11.0 s, tide level was -1.63 m and the wave direction was 252° . The Site E and Site F dredge disposal sites are marked offshore of the inlet with lightly dotted lines. A red channel marker is visible near the inlet center. The white region at the bottom of the image corresponds to wave breaking over Guano Rock, a submerged feature (the main channel lies to the right of this location).

The Coos Bay jetties' constructions began in 1890. Both jetties are visible in the Argus data, allowing measurement of wave breaking on both sides of the inlet. Coos Bay has two disposal sites: site E to the south of the offshore channel and site F to the north. Both locations are shown in Figures 6 and 12.

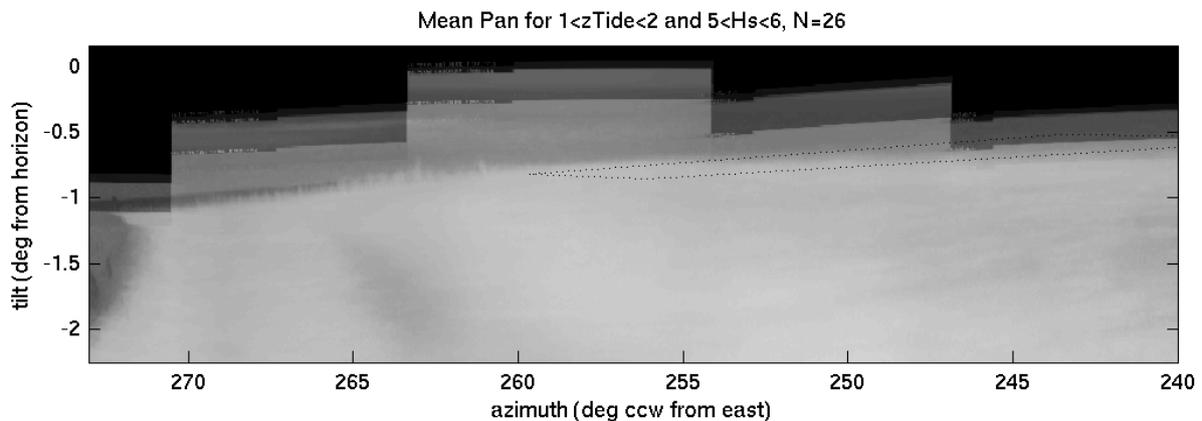
Figure 7. Example of averaged pan “brightest” image for the 26 images for which the tide elevation was between 1 and 2 m and the wave height was between 5 and 6 m. Breaking for very large wave heights appears to saturate across the full surf zone.

One of the main purposes of the North Head sampling was to determine if the SWS dredge disposal site caused enhanced wave breaking that would be a hazard to navigation. Thus, “brightest” images were an excellent tool to assess this problem. Figure 5 shows an example of bin-averaged “brightest” pan for tide elevations between 0 and 1 m and wave heights between 3 and 4 m, averaging a total of 165 images within this bin. There is a clear concentration of breaking seaward of the jetty in a white band that extends offshore from the jetty tip. An examination of the full set of bin-average pans showed that this anomalous band was not visible for wave heights of less than 2.0 m but was then a consistent feature up to wave height around 5 m after which surf zone breaking appeared to be broadly saturated (Figure 7). Little dependence on tide elevation was seen.

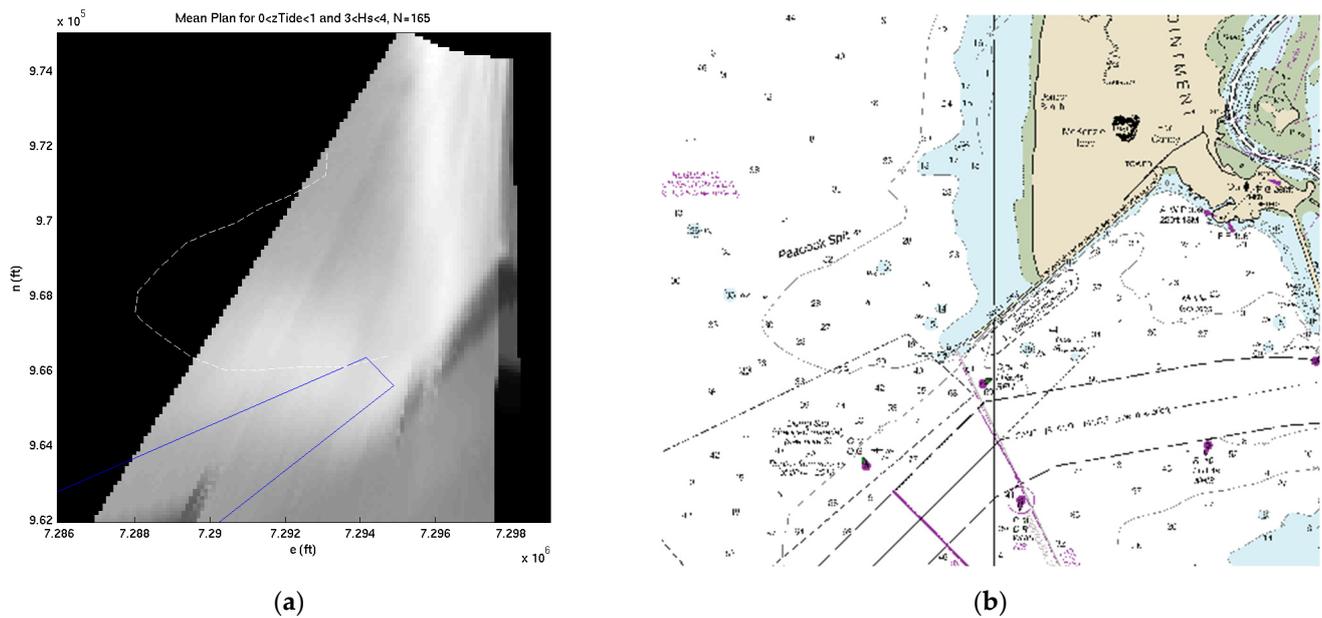
Figure 8. (a) Rectified (map) North Head re-projection of the panoramic view in Figure 5 onto Oregon state plane coordinates. The jetty is visible angling to the southwest. The SWS boundary is shown by the blue line and lies to the southwest of the band of enhanced wave breaking. (b) Nautical chart of the same region showing Peacock Spit on the north side of the jetty. The Peacock Spit boundary is reproduced in (a) and corresponds to the region of enhanced breaking.

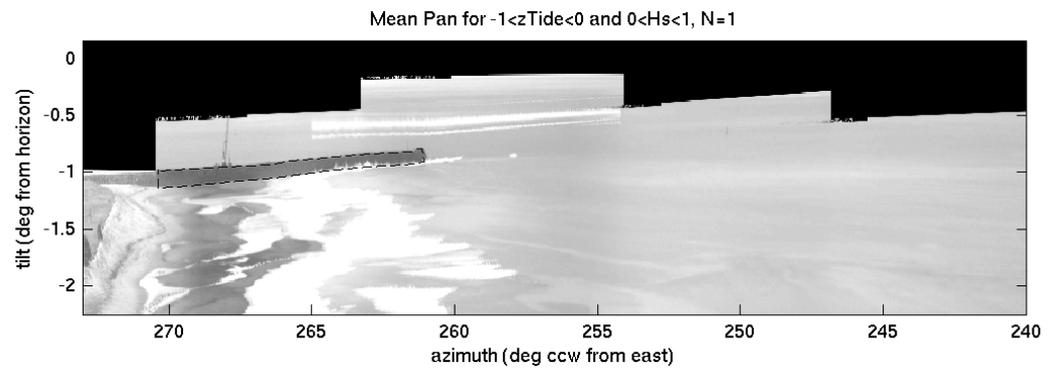
Figure 9. Averaged pan image for the lowest tides and lowest waves (only one image fit this condition). The jetty was manually digitized (dashed blue line) to define the region of interest for breaking detection. This region was then applied to pan images for all tide and wave height bins to detect the fraction that was obscured by breaking waves.

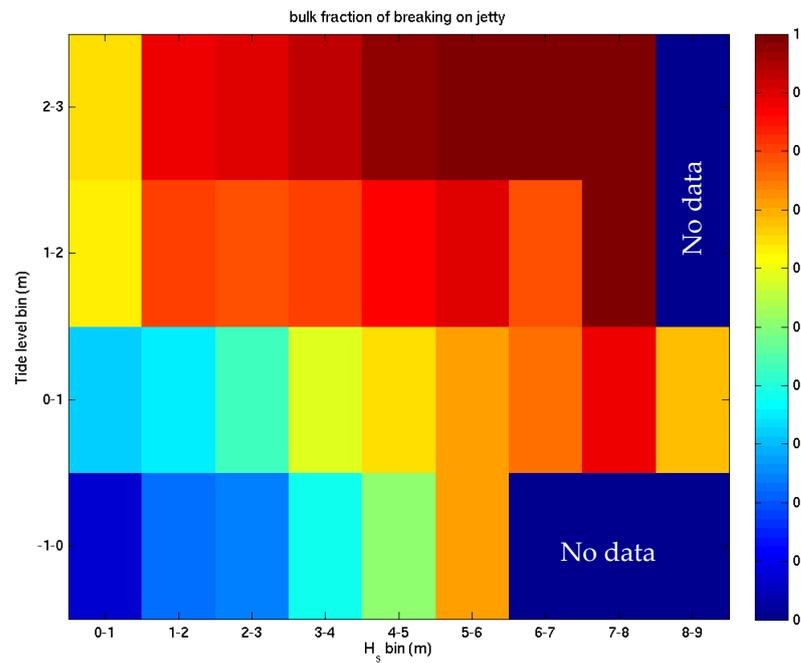
Figure 10. Bulk fraction of breaking over the jetty region as a function of significant wave height (x-axis) and tide elevation (y-axis). Blue regions at very large wave heights are due to there being no examples in these bins.

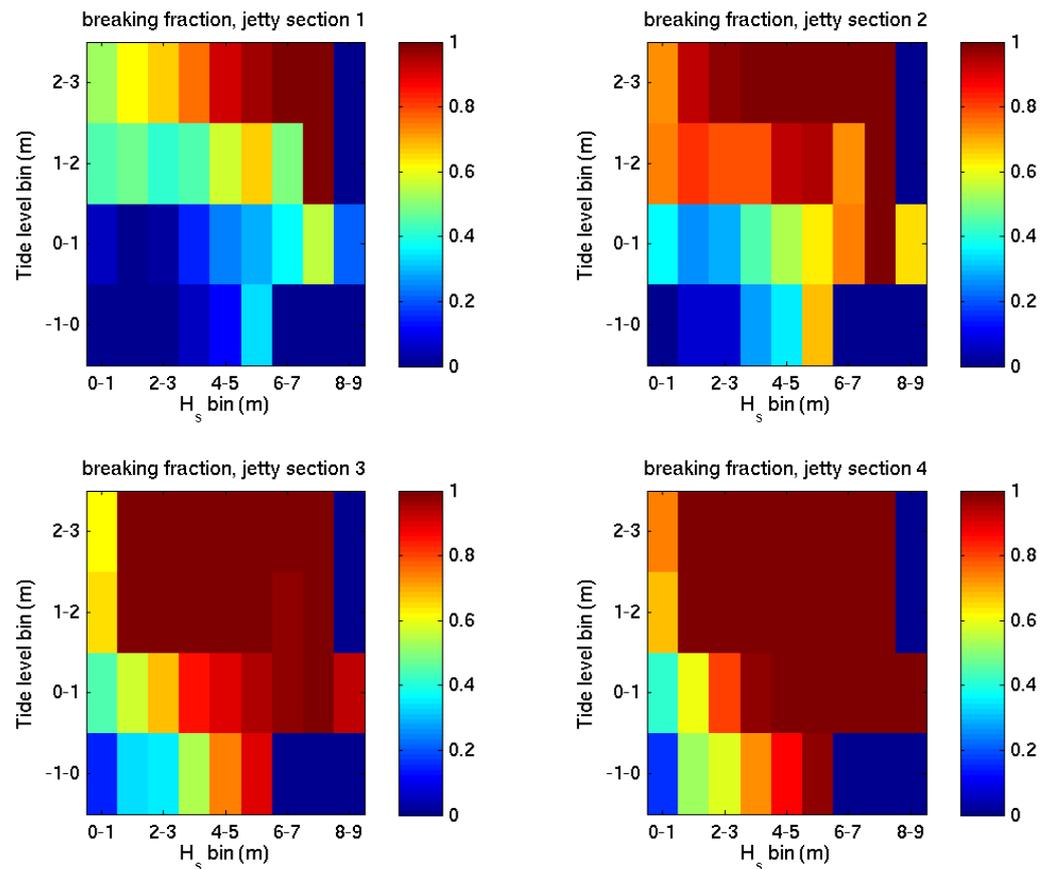
Figure 11. Fraction of breaking on the jetty, partitioned by jetty section from Section 1 (most landward, top left) to Section 4 (most seaward, bottom right). Zero values at large wave height correspond to there being no cases at those conditions.

Breaking percentage varies with distance along the jetty. To quantify this, the jetty region was broken up into four quarters, from landward to seaward, and the fraction of breaking was found in each section (Figure 11). It is clear that the outer half of the jetty experiences significant breaking regularly for wave heights > 1 m and mid to high tides. The inner half of the jetty is better protected, except during high tides.

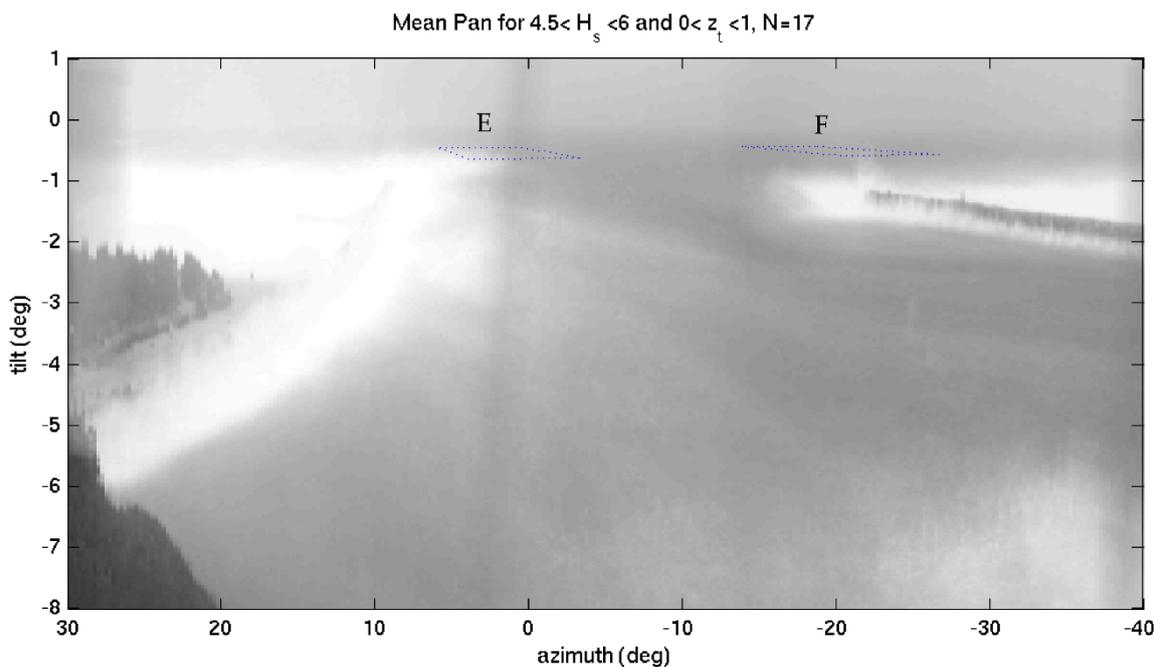
Figure 12. Bin-averaged “brightest” pan for wave heights greater than 4.5 m and mid to high tides. A total of 17 individual pans were included in this average. The E and F dredge disposal sites are shown with dotted lines.

Mean pan images were computed for bins comparing H_s , the significant wave height, with z_t , the tide elevation (this was a four-by-four suite of panBars). Figure 12 shows an example for the largest wave heights, $H_s > 4.5$ m, and mid to high tides (an average of 17 cases, the best example for the largest waves). As can be seen from the dotted lines outlining the two dredge disposal regions, there is no breaking in Site F, to the north, and only a tiny overlap of breaking with Site E, to the south. In fact, this minor overlap is only due to the overlay problem, whereby the tops of waves breaking at landward locations are mapped to a further offshore location in the rectification process (the same effect that causes the north jetty to stretch north in Figure 8). To ensure this conclusion, every “brightest” pan for which wave heights were greater than 4.0 m was examined manually. A total of 90% showed no overlap at all of breaking with Site E, while 10% showed slight overlap of the southeastern tip of the disposal site due to the overlay problem. It can be safely concluded that these two disposal sites had no impact on wave breaking for the 202 days that were sampled and do not cause enhanced wave breaking that could be a hazard to navigation.

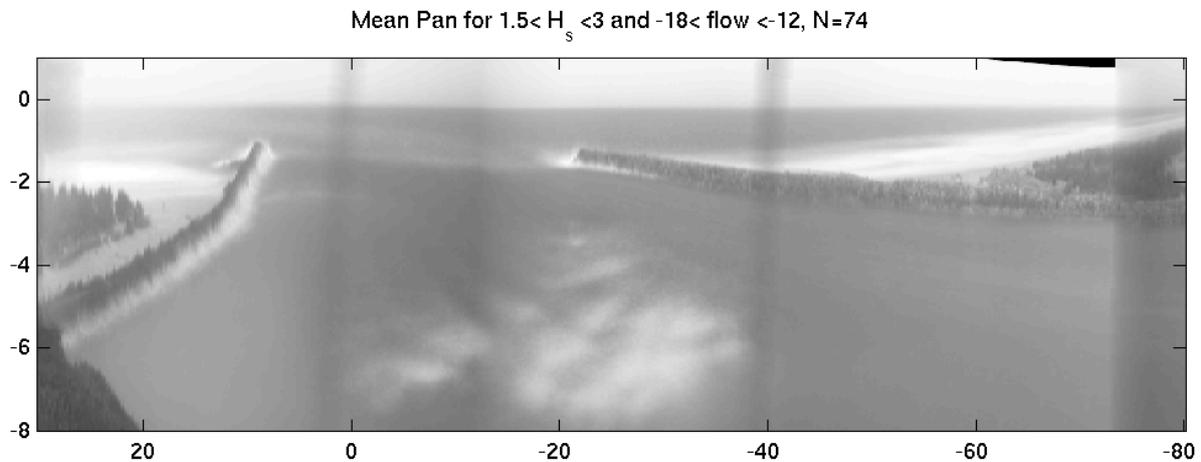
Figure 13. Bin-averaged “brightest” pan for wave heights between 1.5 and 3.0 m and spring ebb flows. The strong ebb flows cause breaking over Guano Rock (lower center of the image), as well as a slight increase in breaking at the mouth of the inlet.

Figure 13 shows an example of breaking over Guano Rock, in the south center of the jettied channel, for low-to-moderate wave heights and spring ebb flows. There is a clear region of wave breaking near the camera, due to the strong ebb flows causing breaking over Guano Rock (note that this is well south of the main channel, which is on the right

looking out). There is also a slight increase in breaking at the mouth of the inlet (between and seaward of the jetty tips) as incoming waves encounter the opposing ebb flows.

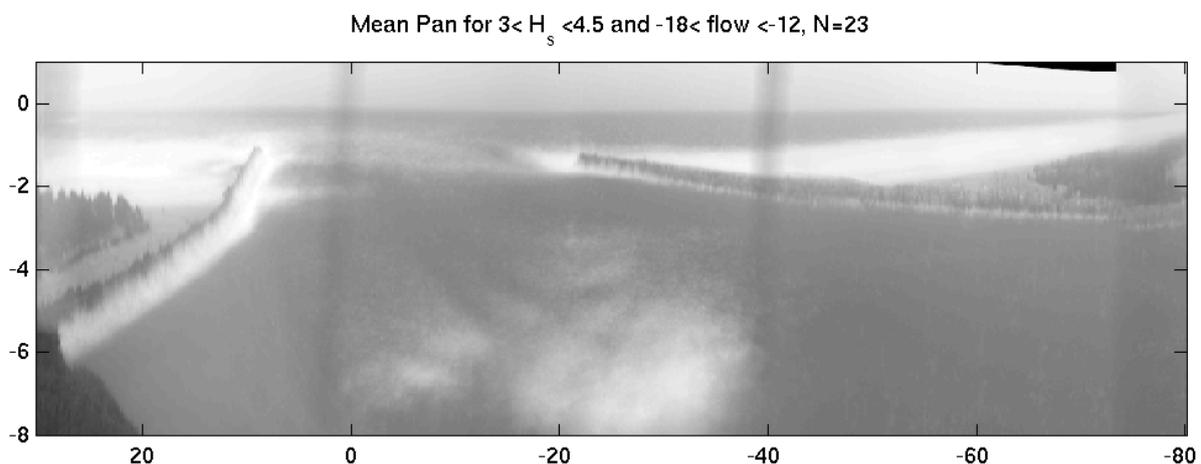
Figure 14. Bin-averaged “brightest” pan for wave heights between 3.0 and 4.5 m and spring ebb flows. The enhanced breaking over Guano Rock continues but the breaking at the mouth of the inlet is more evident.

Figure 14 shows the same pattern, but a bit exaggerated, for larger waves between 3.0 and 4.5 m in height. In this case, the inlet breaking is more obvious. It is surprising how well the details of breaking over the Guano Rock region are replicated. Finally, Figure 15 shows the mean “brightest” image for moderate-to-large wave height and maximum flood flows. There is no longer enhanced breaking at the mouth of the inlet. The breaking over Guano Rock is now shifted landward by the flood flows and is much more linear in an across-channel direction.

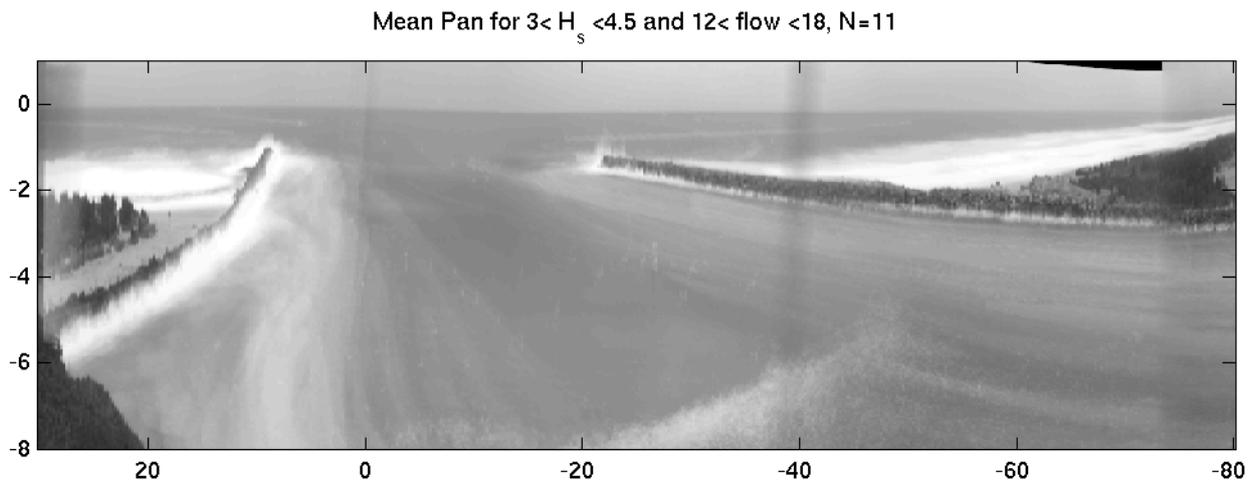
Figure 15. Bin-averaged “brightest” pan for wave heights between 3.0 and 4.5 m and spring flood flows. There is no longer any enhanced breaking in the inlet mouth and the breaking over Guano Rock is shifted landward by the flood flow in a more cross-channel linear direction.

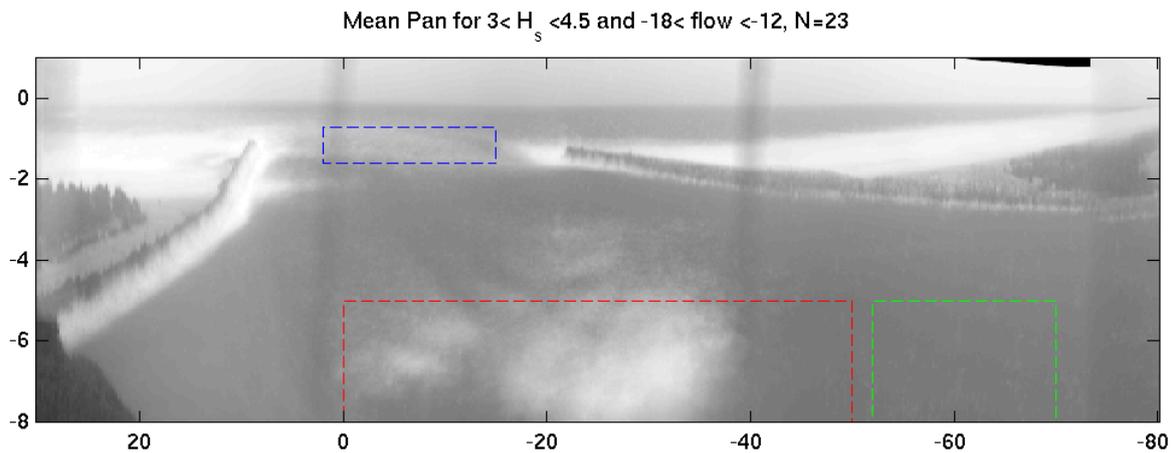
Figure 16. Mean intensity sampling regions. Red is the region of Guano Rock, blue shows the Offshore region, and green shows the intensity normalization region.

Both wave height and tidal flow seem to play a role in these breaking patterns. To explore this more systematically, the 24 bin-averaged pan images (six flow bins by four wave height bins) were computed and the mean intensities were measured in three regions, Guano Rock, the mouth of the inlet between the jetties (called Offshore), and a mid-channel region away from Guano Rock that could act as an intensity normalization (Figure 16).

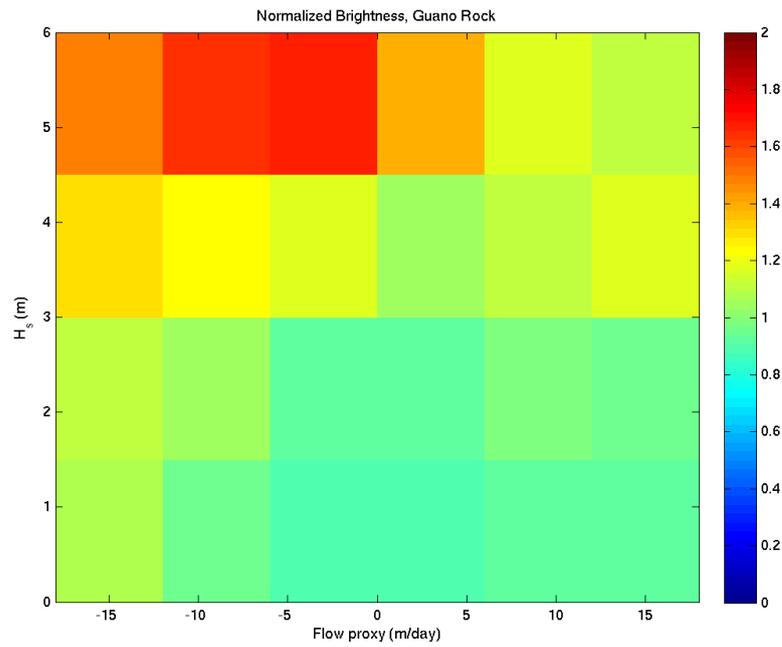
Figure 17. Normalized brightness of Guano Rock sampling region as a function of wave height and tidal flow (proxy).

Mean intensities were found for each H_s -flow combination for the Guano Rock and offshore regions, and were then normalized by the intensity from the normalization region. The results for Guano Rock are shown in Figure 17. Breaking over this feature increases with wave height, with some breaking for most cases of wave heights greater than 3 m. However, breaking is also clearly dependent on tidal flow, being weakest at low flows and stronger in ebb flows (negative) than in floods. For the largest waves, breaking is persistent, although much less during flood flows. Note that for the highest wave bin, there are only one and two cases for the extreme flows, so statistics are expected to be noisy.

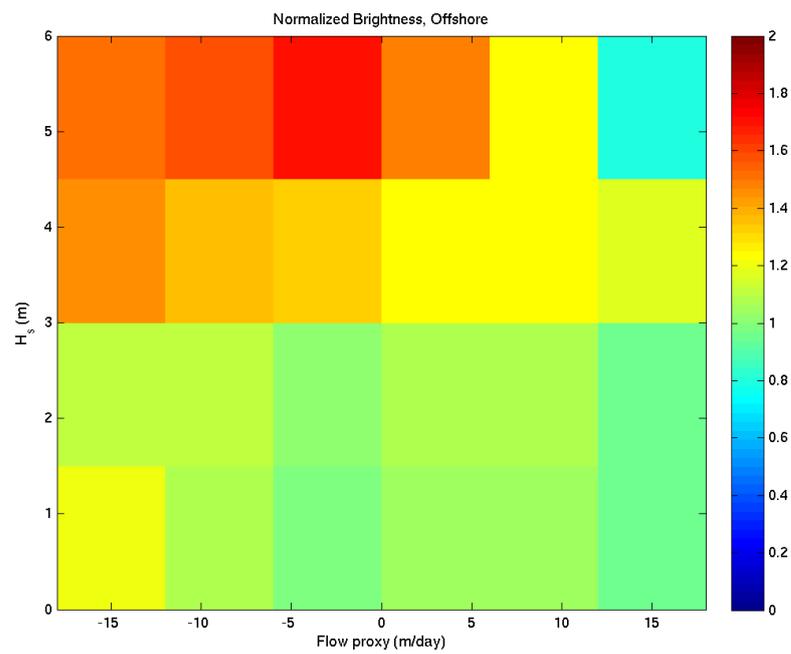
Figure 18. Normalized brightness of offshore sampling region as a function of wave height and tidal flow (proxy).

Figure 18 shows a companion figure for the offshore sampling region. Again, breaking between the jetties increases with wave height, but it also shows the weak but expected asymmetry with enhanced signals for strong ebb flows and no enhancement during floods.

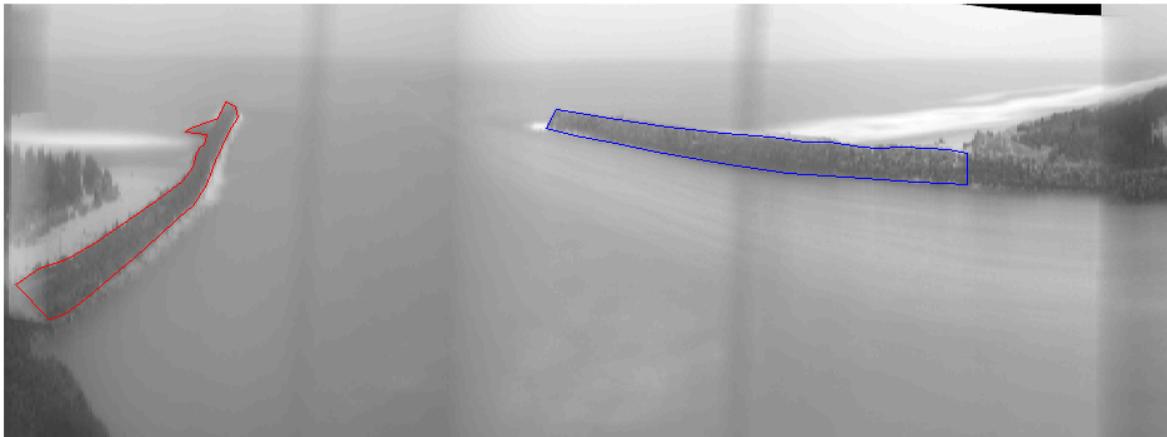
Figure 19. Regions of interest (ROIs) for wave breaking over the Coos Bay jetties with the north jetty ROI marked in blue and the south in red. The regions were manually delineated using this bin-averaged pan for the smallest wave height and lowest tide bin that averages 96 cases.

As with North Head, the “brightest” pan images have clear signatures of wave breaking around and over the jetties (e.g., Figure 12). The regions of interest (ROIs) were defined for both the north (blue line) and south (red line) jetties by manual digitization of the breaker footprint in a bin-average “brightest” pan that had the lowest wave heights and the lowest tides (Figure 19, which averaged 96 individual pans). Thereafter, for each wave-height tide bin, the fraction of pixels within each ROI whose brightness exceeded a breaking brightness threshold were determined as the breaking fraction for that bin.

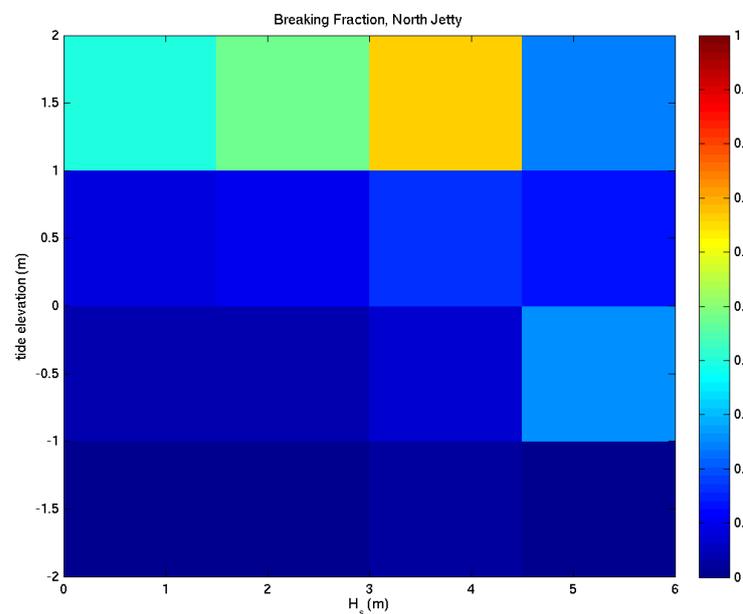
Figure 20. Breaking fraction statistics for the north jetty as a function of wave height and tide elevation.

Figure 20 shows the breaking fraction statistics for the north jetty. Only one bin shows breaking fractions greater than 0.5 with a mean over all bins of 0.17. These low values likely reflect the fact that we are seeing the inner, protected face of the jetty and that the south jetty extends further seaward, perhaps providing extra protection. In contrast, breaking fractions for the south jetty are much larger (Figure 21). Just over half of the bins had breaking fractions that exceed 0.5, and the mean value over all bins was 0.53. The viewing angle of the south jetty is primarily from the top rather than from the protected inner side. Despite this geometric aspect, it is clear that the south jetty experiences much greater wave breaking energy than the north.

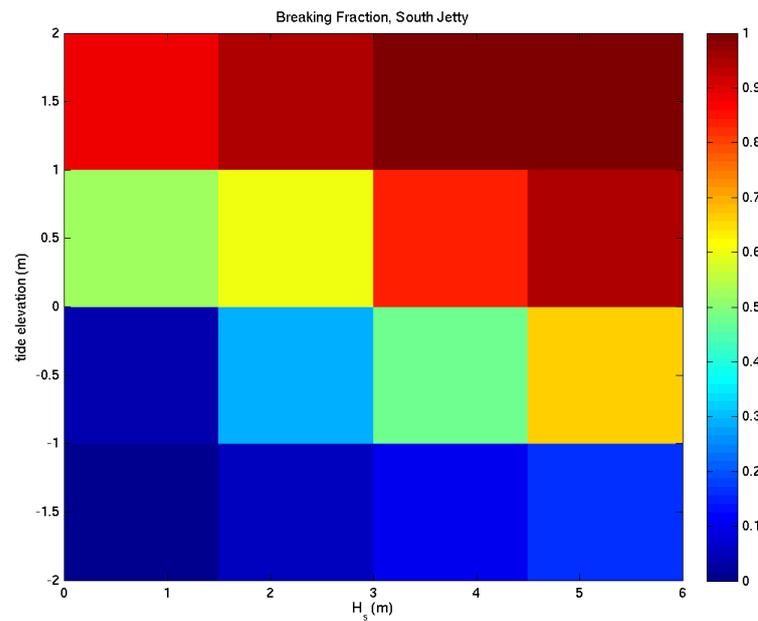
Figure 21. Breaking fraction statistics for the south jetty as a function of wave height and tide elevation.

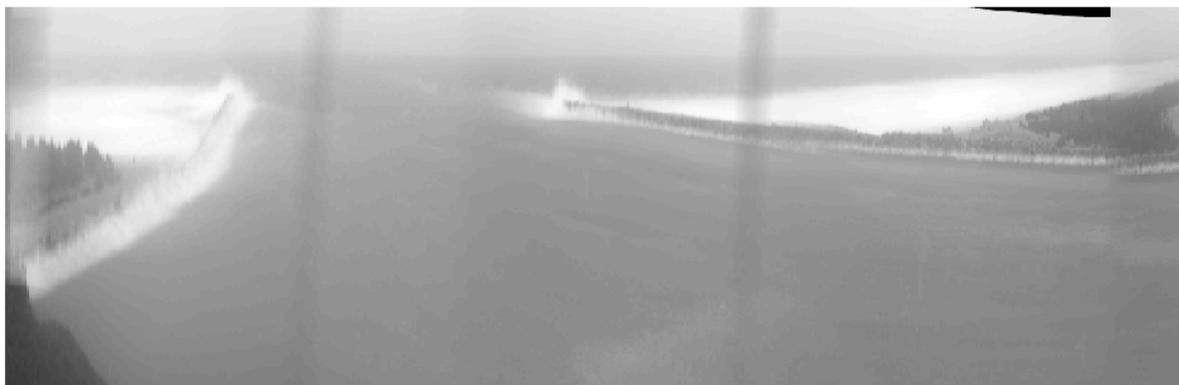
Bin-averaged Pan, $3.0 < H_s < 4.5$, $1.5 < z_t < 2.0$

Figure 22. Bin-averaged “brightest” pan showing that large breaking occurs anomalously near the tip of the north jetty, usually within the seaward-most 100 m. In this example, the splash height is about 3.28 times the jetty height.

Several other interesting features can be observed in the brightest images. While the north jetty does not show much breaking, breaking at the jetty tip can be dramatic, especially for high tides. Figure 22 shows breaking at the tip of the north jetty for the bin-averaged pan for medium to high waves ($3.0 < H_s < 4.5$) and high tides ($1.5 < z_t < 2.0$). The height of the jetty top and splash were roughly digitized, and the splash was found to be roughly 3.28 times as high as the jetty (2.28 exceedance of jetty top height). A scan of the top several hundred individual pan images with higher tide and at least 2.0 m of wave height showed that most of the intense breaking on the north jetty is focused on the seaward 100 m.

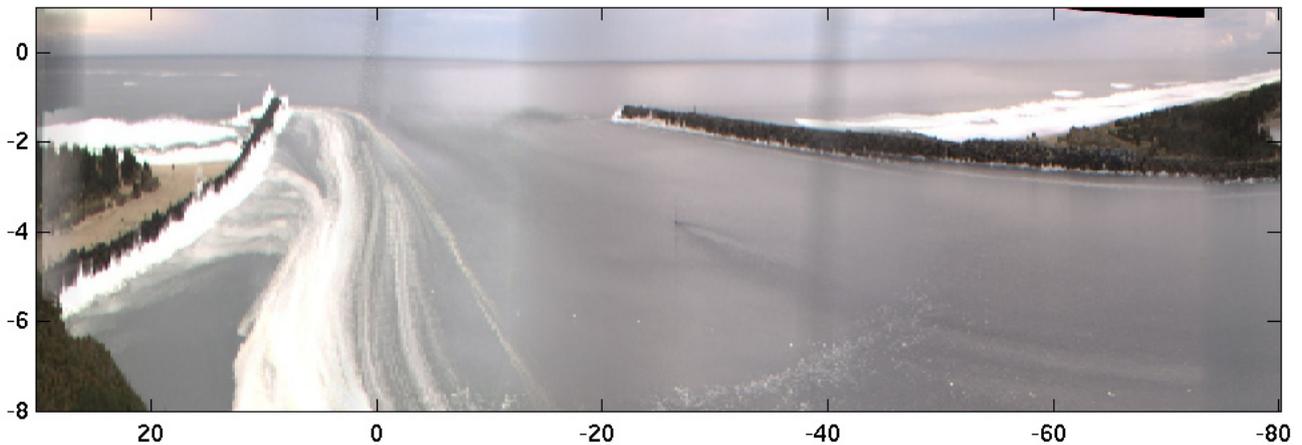
Hs = 3.55, zt = -0.03, dir = 207.45

Figure 23. Individual “brightest” pan for 05/18/29, 1730 GMT showing foam being carried landward from the south jetty tip by the flood tide but also a source of foam occurring mid-jetty, near the region of anomalous wave breaking in many pans.

Finally, anomalous behavior was sometimes noted along the south jetty when wave energy was strong from the south. In Figure 14 and in many others, we noticed an apparent wave dissipation feature on the north side of the south jetty, roughly aligned with the south beach shoreline. Looking over pans, we noticed that the south jetty looked “leaky” at this location at times, perhaps allowing sediment to pass through under conditions of strong southerly waves. Figure 23 shows one example with medium to large waves ($H_s = 3.55$ m)

arrived from the south (wave direction 207° , shore normal is 300°). Foam is being carried from the tip of the south jetty into the inlet by the flood tide. However, there is also a source of foam midway along the north side of the south jetty, in the region of the breaking anomaly that was referred to above. This is at low tide and the jetty is not being overtopped.

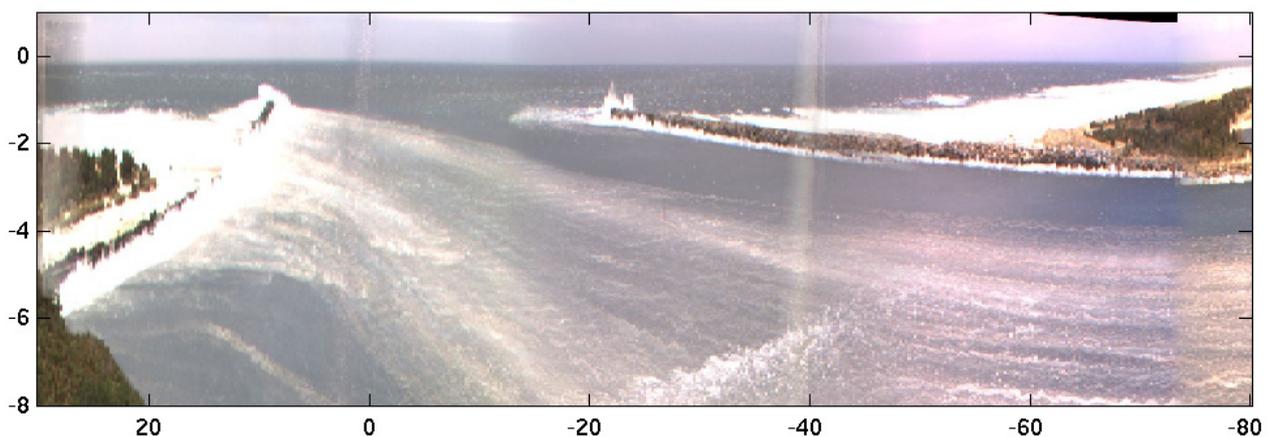
Hs = 2.75, zt = 0.41, dir = 229.30

Figure 24. Pan “brightest” image of wave overtopping of the south jetty near the beach but not overtopping further offshore. Foam and perhaps sediment are being carried into the inlet by the flooding tide. Note the signature of breaking over Guano Rock.

Figure 24 provides another example. In this case, the jetty appears to be overtopping in the near beach region (but not further seaward). We are not sure if this is a low point in the jetty. Again, the waves are approaching from the south (direction = 229° , shore normal of 300°) and foam is being carried landward by the flooding tide. It should be noted that these observations of potential jetty leaking of the south jetty are very preliminary.
