Article

How Effective Were the Beach Nourishments at Cancun?

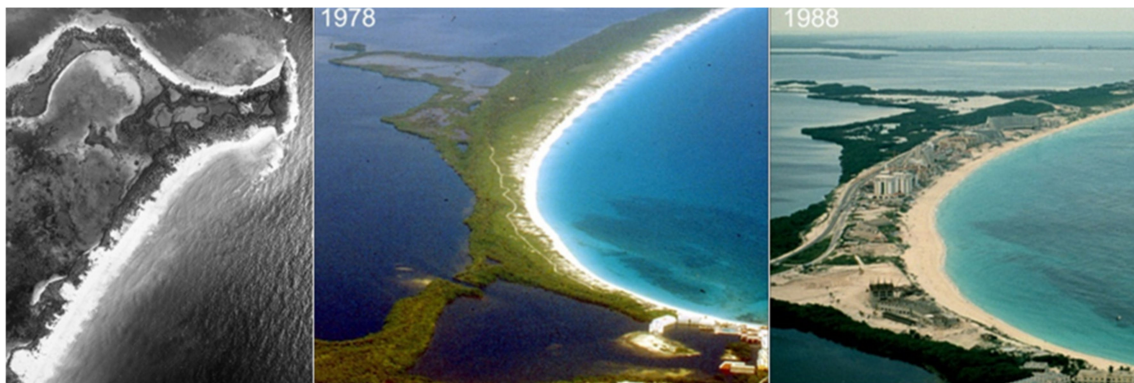
Figure 2. Historical aerial images of Cancun. Punta Cancun in 1947 (left panel) and Punta Nizuc in 1978 and 1988 (center and right panels, respectively).

The main anthropic alteration to the Cancun coast has been the construction of very dense infrastructure (hotels, roads, gardens, golf courses, etc.) on the dunes. The inlets were also rigidized, causing modifications to the natural breaching of the sandbar during storms, and thus limiting the interaction between the sea and lagoon. These changes, together with a decline in the amount of natural sediment availability, brought about intense erosion. Beach loss was estimated at an annual rate of 1.8 m for 1967–2005 [29]. Figure 2 shows Cancun in 1947, and the slow, but continuous urbanization of the beach between 1978 and 1988.

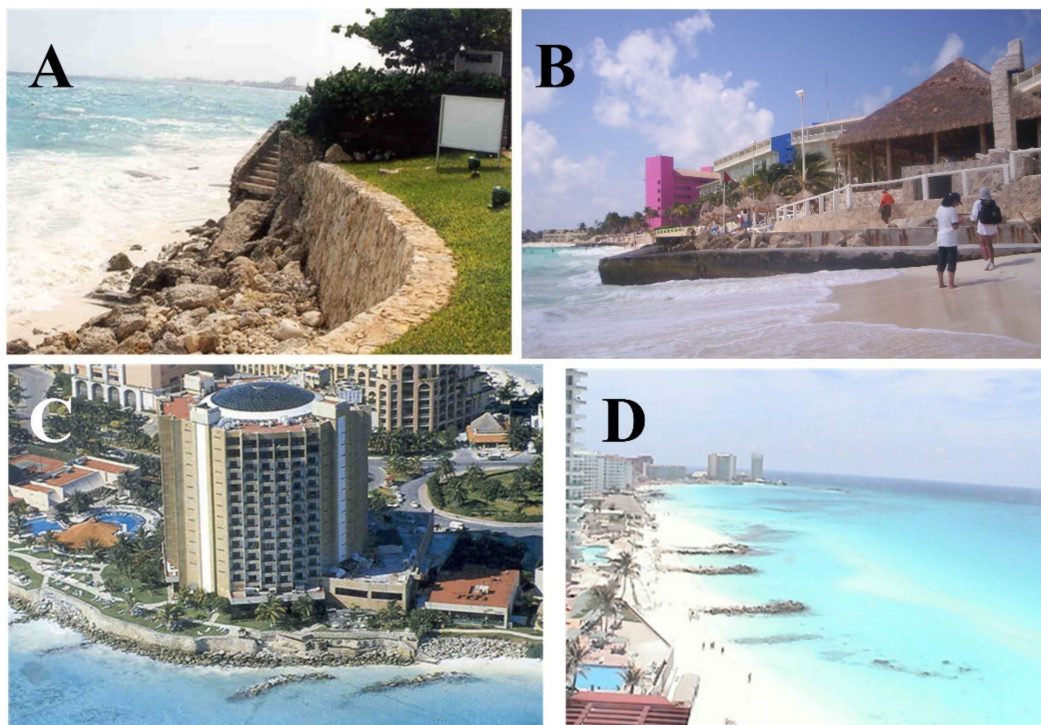
Figure 3. Examples of inadequate solutions implemented 1988–2004. Vertical walls (panels A and B); detached structures (panel C) and groins (panel D).

As documented by [30] and [31], until 1988 the urban planning of Cancun did not take into consideration the natural dynamics of the coast. In September 1988, Cancun received the full force of hurricane Gilbert. The waves and storm surge moved massive quantities of sand and, for the first time, the hoteliers there experienced the effects of substantial erosion on the beach. Several studies were carried out, but no action was taken to recover the beach. The individual hotel owners implemented uncoordinated, inadequate coastal protection schemes (e.g., vertical walls, detached breakwaters, and groins), accelerating the problem and transferring the effects to neighboring beach segments (see Figure 3). Even so, the beach partially recovered until hurricanes Ivan (2004) and Emily (2005) hit the coast [32]. Then, in October 2005, Hurricane Wilma hit Cancun, removing 8 million m³ of sand [33]; almost all of the beach was left without sediment (Figure 4).

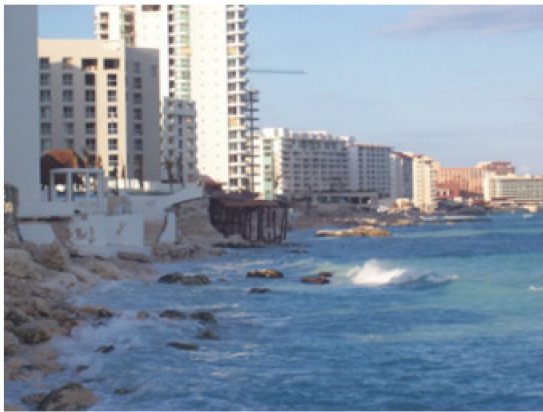
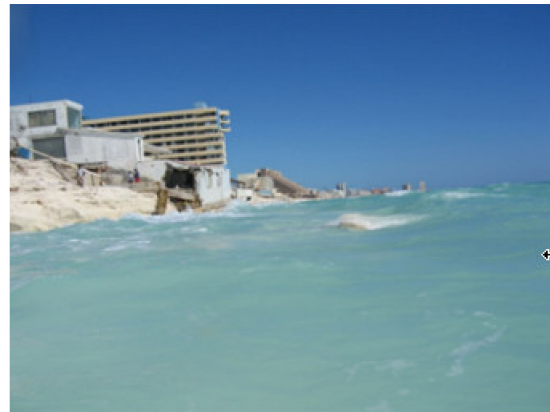
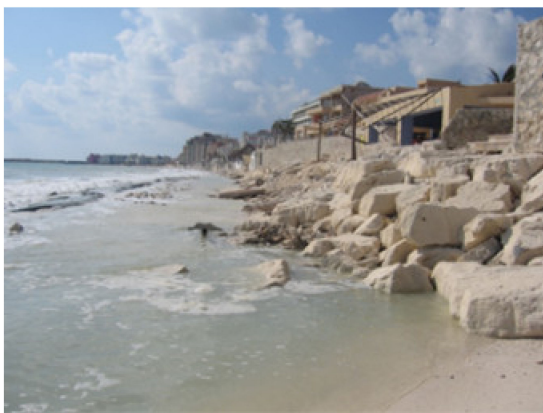
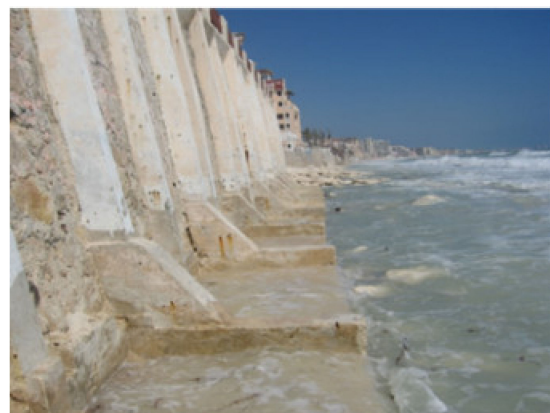
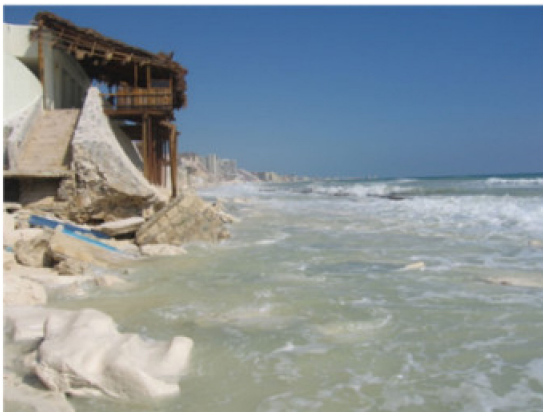
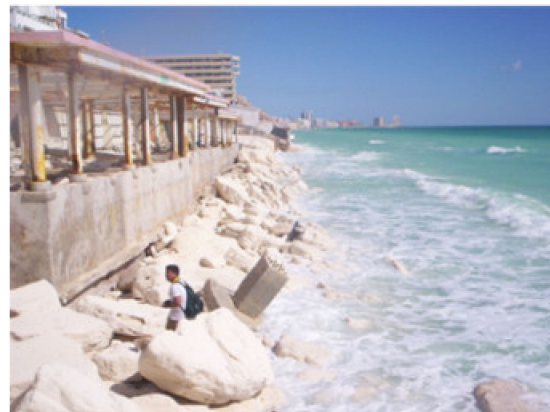
Figure 4. Examples of damage caused by Hurricane Wilma to the beach of Cancun in 2005. It can be seen that in front of many hotels the beach totally disappeared; only rocks were left behind (panels (a), (c) and (f)), while in other places, waves were hitting the hotels walls and facilities directly (panels (b), (d) and (e)).

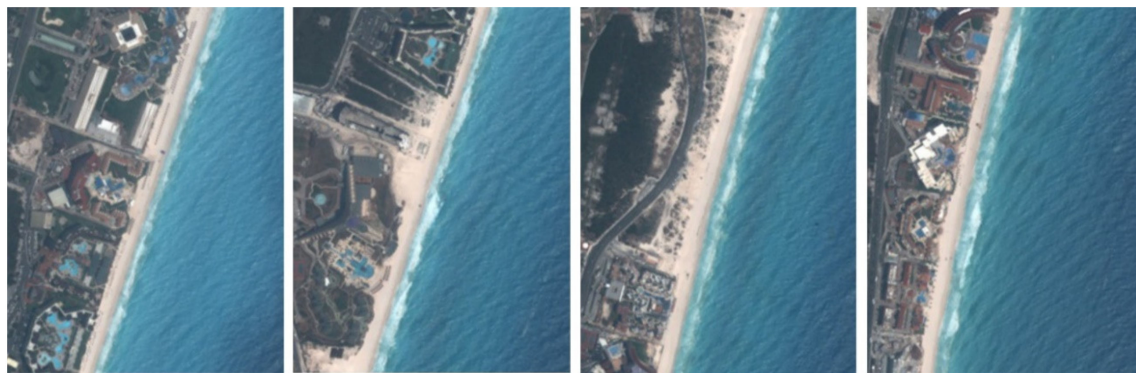
Figure 5. Aerial views (from north to south) of various segments of the central part of Cancun beach in May 2006; the immediate result obtained from the nourishment is evident.

Immediately after the sand nourishment, the beach had an average width of 60 m (Figure 5). However, the beach rapidly began to narrow, losing an average 8 m in width, from May to September 2006, and even more, 29 m, from September 2006 to September 2007 [34]. In the same period, the sand on the beach formed a dramatic, pronounced scarp, making it very difficult for tourists to enjoy the beach (see upper panels of Figure 6). These scarps remained, due to the lack of sediment in the submerged part of the beach profile. The beach was dramatically damaged by hurricane Dean in August 2007.

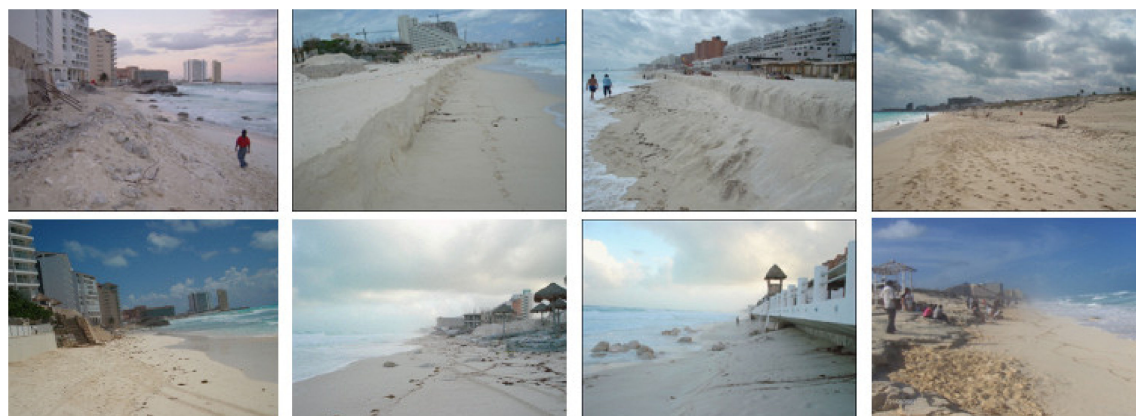
Figure 6. Examples of damage caused by Hurricane Dean to the beach of Cancun. Upper panels: August 15, 2007 (a few days before Hurricane Dean hit land), and lower panels: August 25, 2007 (a few days after Hurricane Dean had landed). Each photograph corresponds to approximately the same place in the upper and lower panel.

On 21 August 2007, Hurricane Dean hit Cancun, generating very intense waves that removed significant volumes of sand; the dry beach was reduced in width and the scarps disappeared (Figure 4). After Hurricane Dean, the erosion on the beach continued, with a recorded loss of 10 m of dry beach, from September 2007 to August 2008, and a further 1 m between August 2008 and January 2009 [36]. Although the rate of the erosion diminished, by January 2009 the waves were lapping only 14.5 m from the sea walls of the hotels [37]. The erosion continued, bringing a shoreline recession in the central and northern sections of the beach to a position similar to the post-Wilma conditions of 2005.

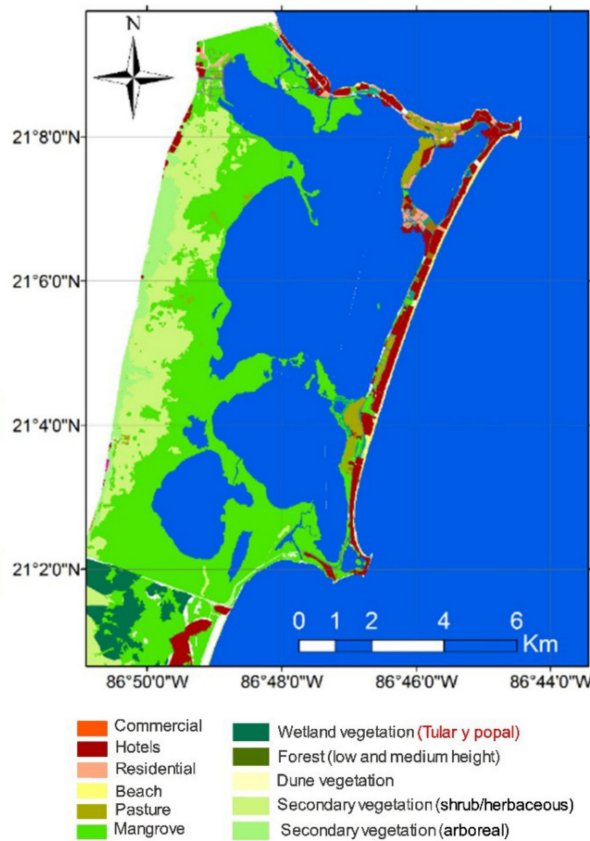
Figure 7. Land use, Cancun 2007 [35]. Intense urbanization all along the barrier rigidized the coast and facilitated the loss of beach sediment.

By 2007 the level of anthropization of the barrier island was over 95%, with commercial centers, hotels, houses, gardens, and a wide boulevard covering almost all the areas that had originally been dunes, coastal vegetation, and mangrove (Figure 7 [35]).

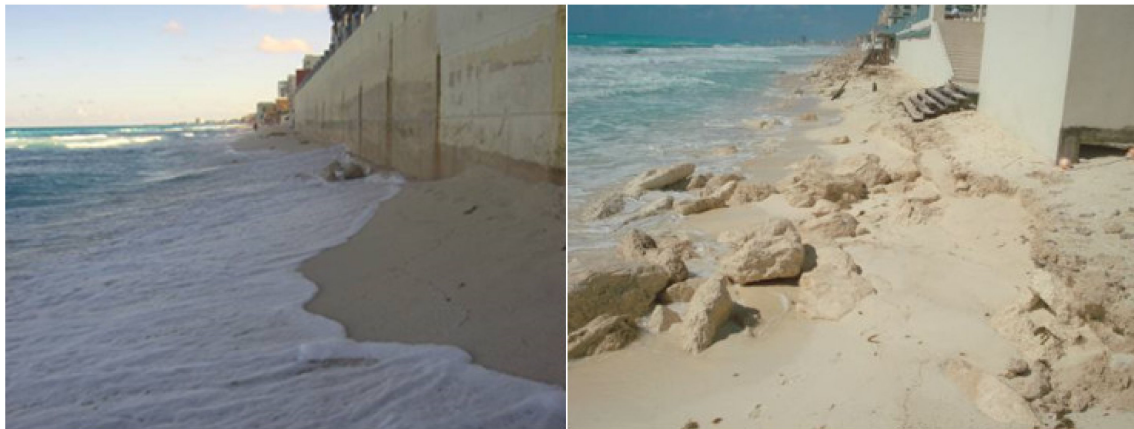
Figure 8. View of the beach at Cancun in 2009, before the second nourishment. Waves attacking the hotel facings (left) and rocks left behind after erosion (right).

Given that the beach had not reached a dynamic equilibrium, it continued eroding and consequently was not attractive for tourists (Figure 8). A second beach nourishment was therefore performed, from December 2009 to January 2010. The methodology was similar to that of 2006. However, this time the amount of sand used to replenish the beach was almost twice that of 2006 (5.2 million cubic meters). The width of the beach at the end of the process was 80 m and the thickness of the sand layer in the beach profile was substantially higher than that of 2006 (Figure 9). Additionally, a 305 m

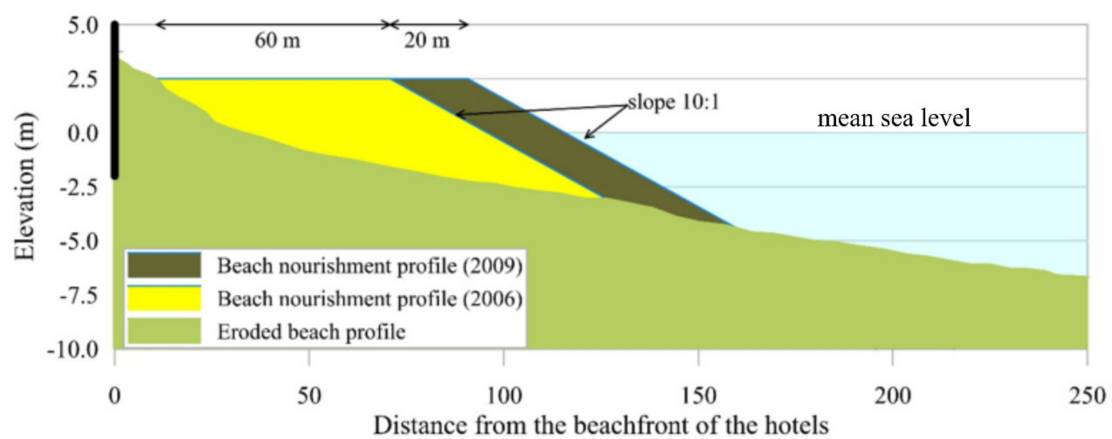
Figure 9. Projected profiles for the 2006 and 2009 beach nourishments.

long breakwater crowned 2.5 m above the mean sea level was built on Punta Cancun, to prevent the transport of the sediment to the north.

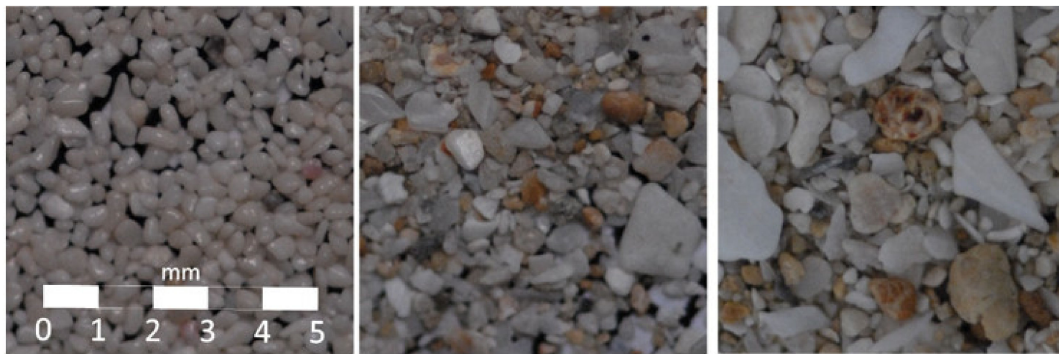
Figure 10. Left panel shows the native sand, 2004. Central and right panels, sand from the emerged and submerged beach fill, respectively.

For the second nourishment project, 2.5 million cubic meters of sand were extracted from La Ollita II sand bank, next to the sand bank used in 2006. The sand was extracted from an average depth of 25 m. The remaining 2.8 million cubic meters of sediment were taken from the sandbank at Punta Norte, in the shallow waters north of the island of Cozumel, 48 km away, at a depth of 12–29 m [33]. While all the borrowed sand was of marine biogenic origin, the sand used had different mechanical characteristics from the sand native to Cancun beach (see Figure 10). The differences in the sand characteristics may explain the unpredictable behavior of sand transport on the beach and therefore the beach evolution after the second nourishment.

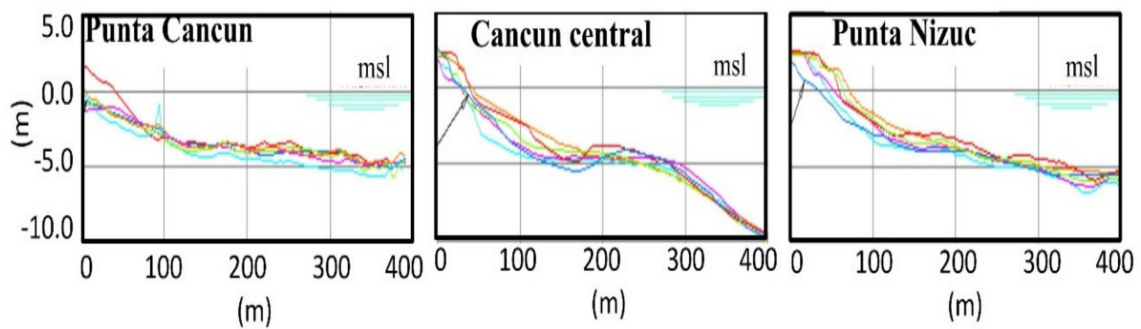
Figure 11. Beach profiles at northern (P. Cancun); central, and southern (P. Nizuc) Cancun, showing the beach growth due to the first beach fill (early 2006), and a return to erosion conditions by 2008, when the need for a 2nd nourishment was evident: Nov-2005 (—), May-2006 (—), Aug-2006 (—), Apr-2007 (—), Sep-2007 (—) and Aug-2008 (—).

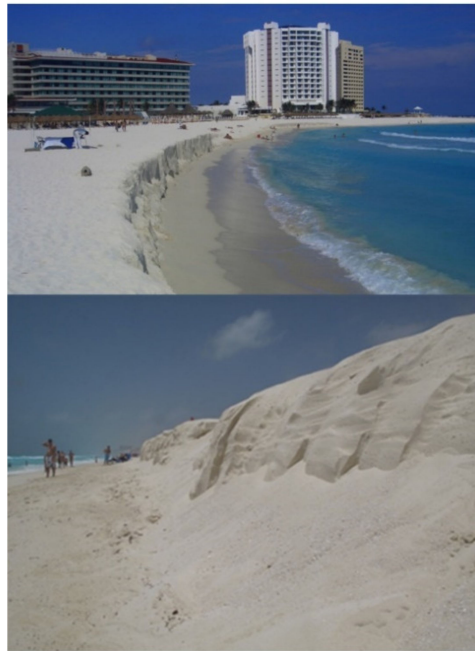
Figure 12. The second beach nourishment was carried out in June 2010. By October 2010 the beach had developed a scarp of almost 2 m height as seen in both photographs.

5. Beach scarps are unsuitable for tourism. The design and techniques employed for beach nourishment has to be different, since for long periods the beach profile had a 2 m scarp.

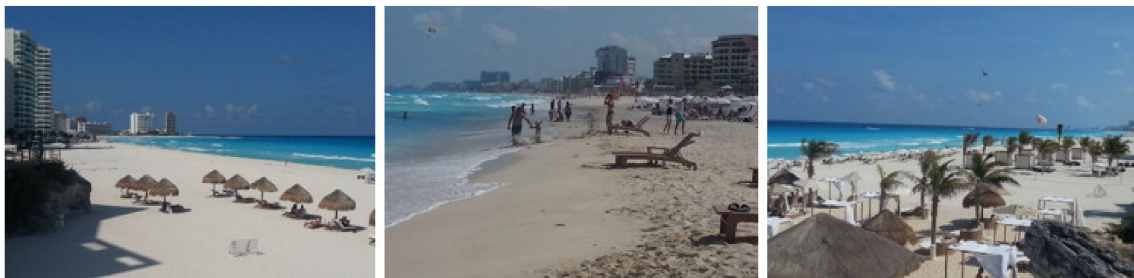
Figure 13. Aspect of the beach of Cancun in 2013. All the scarps have disappeared and the beach seems to be in a sound state.

In 2013 all the scarps had disappeared (Figure 13) and, 10 years after the second nourishment, the beach at Cancun has managed to conserve a nearly stable width of approximately 30 m (Figures 14 and 15). Therefore, no further beach nourishments have been required.

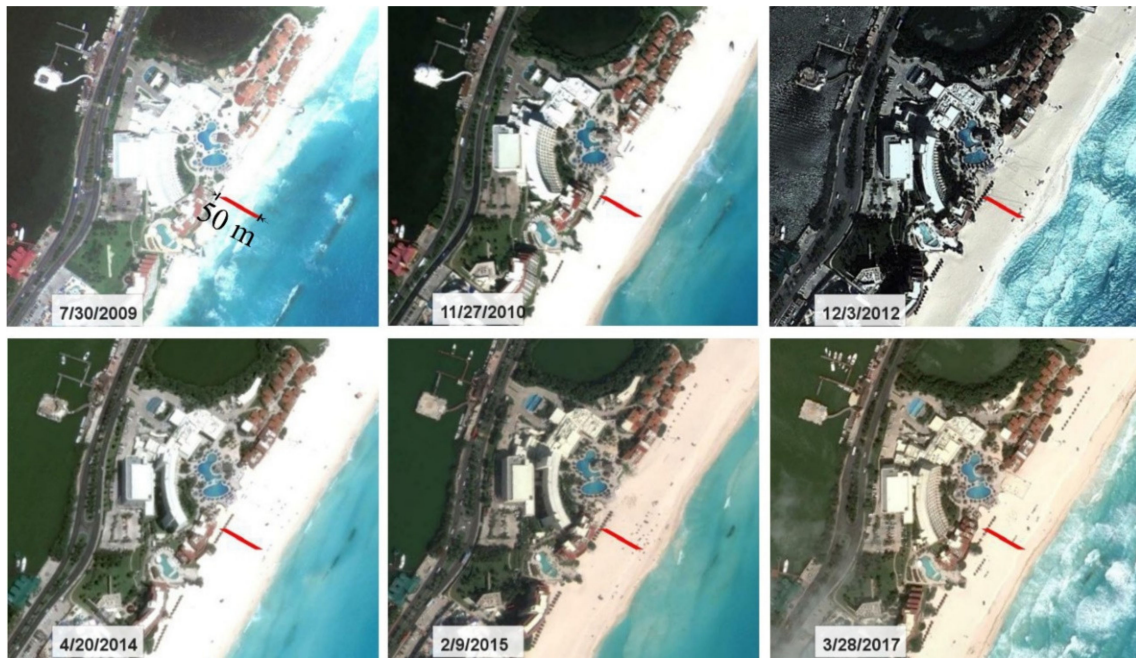
Figure 14. Satellite images, 2009 to 2017, of the beach in front of the Grand Park Royal Cancun, located in the central-north part of the beach (source: Google Earth Pro, version: 7.3.2.5776). The red line, 50 m long, shows the dynamic stability being reached.

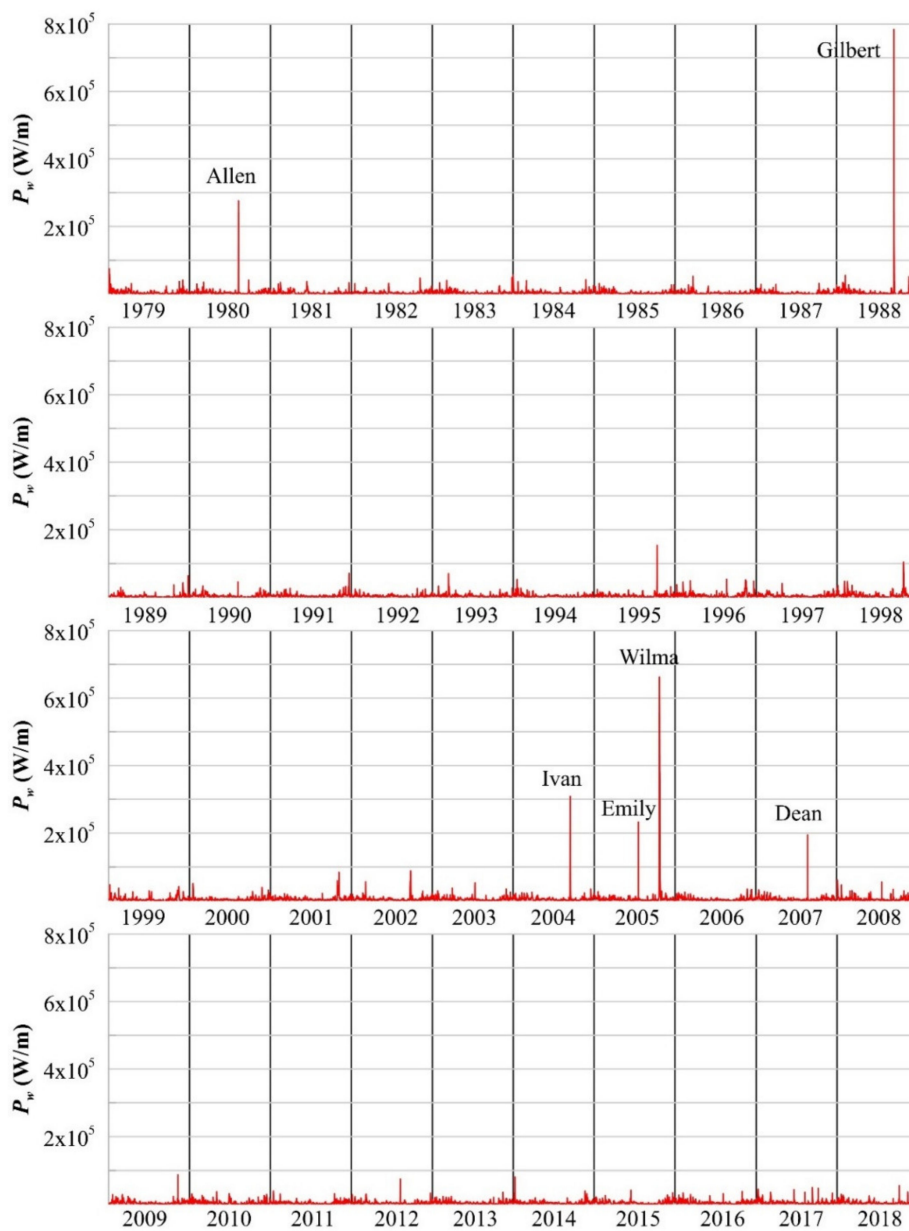
Figure 17. Hourly wave power at 21.0 °N and 86.5 °W.

For the study of the wave power, a time series was calculated using the formula for irregular waves (Equation (1)), see Figure 17:

From 1979 to 2018, six events reached or exceeded a maximum wave power of 2×10^5 W/m (see Figure 17); this threshold was selected, being the greatest erosion reported (general knowledge).
