Article

Damage Mechanism Based Approach to the Structural Health Monitoring of Wind Turbine Blades

Malcolm McGugan and Leon Mishnaevsky, Jr. *

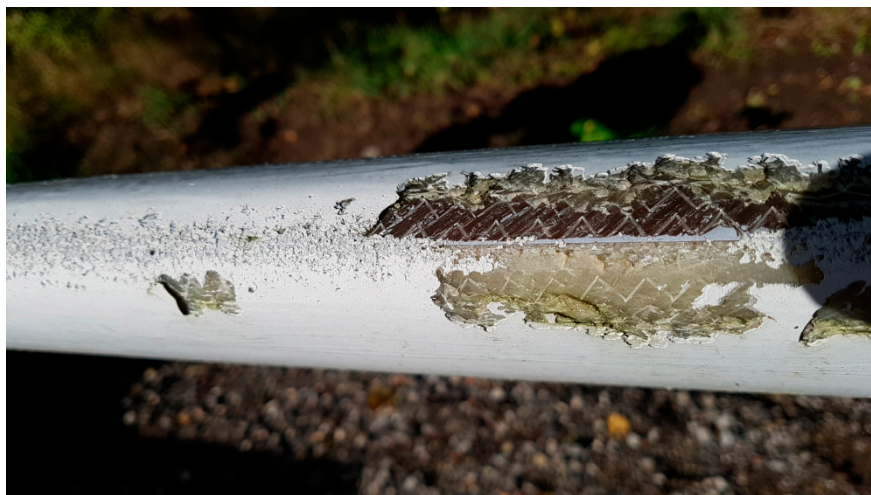
Figure 3. Eroded blade and mechanism of blade erosion (photo Jakob I. Bech).

With a view on repair procedures, wind turbine blade damage is classified as: (a) surface erosion, (b) non-structural damage, and delaminations (b) and (c) structural damage, with fiber failure [61,62,70]. The surface erosion is caused by fatigue from repeated rain drop and hail impacts, causing surface microcracks, leading to pits, gouges, delaminations, and surface roughness, which in turn reduces the energy production of the wind turbine [71,72]. The surface roughening has also an effect on the wind turbine noise [73,74]. Eroded blades increase dramatically the noise generation [75]. Figure 3 shows a photo of an eroded blade.

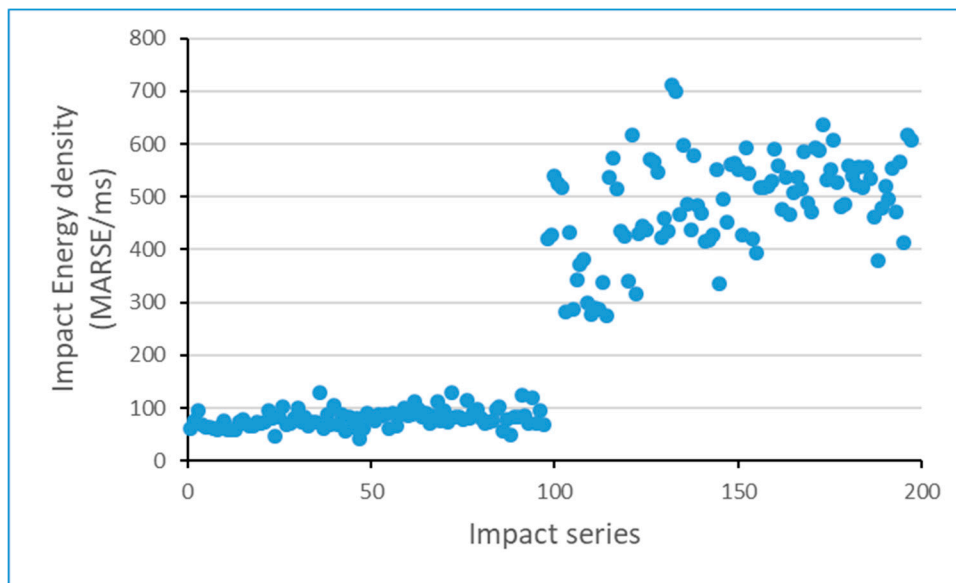
Figure 4. Sensor readout showing the energy density for each impact in a single point impact fatigue tester (SPIFT) series.

Figure 4 shows a typical output reading with each point corresponding to a single pellet impact. The y -axis shows a value corresponding to the energy density index for each impact, being calculated from the area under the stress waveform (MARSE—measure of the area under the envelope of the rectified linear voltage time signal) detected by the sensor in the underlying laminate divided by the duration of that waveform (in milliseconds). The change in this value indicates the point at which local failure of the leading edge protection capability at the impact point occurs.

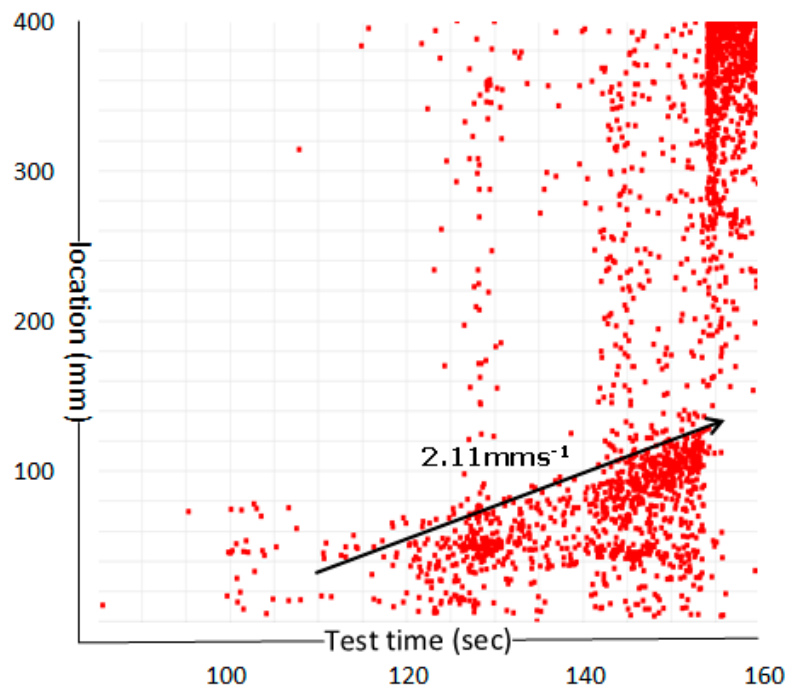
Figure 6. Acoustic emission localization during plydrop specimen static loading.

Figure 6 shows the localization output from the AE linear array during static load to failure. The vertical axis is the distance between the top and bottom sensors, and the horizontal axis shows test time. After initiating damage at the first two plydrops near the bottom of the specimen, the delamination propagated linearly until it approached the third plydrop at which point it became unstable and propagated rapidly. From the linear portion of the data, these measurements provided confirmation of the propagation rate as the crack front moves along the specimen, in this case 2.11 mms^{-1} .

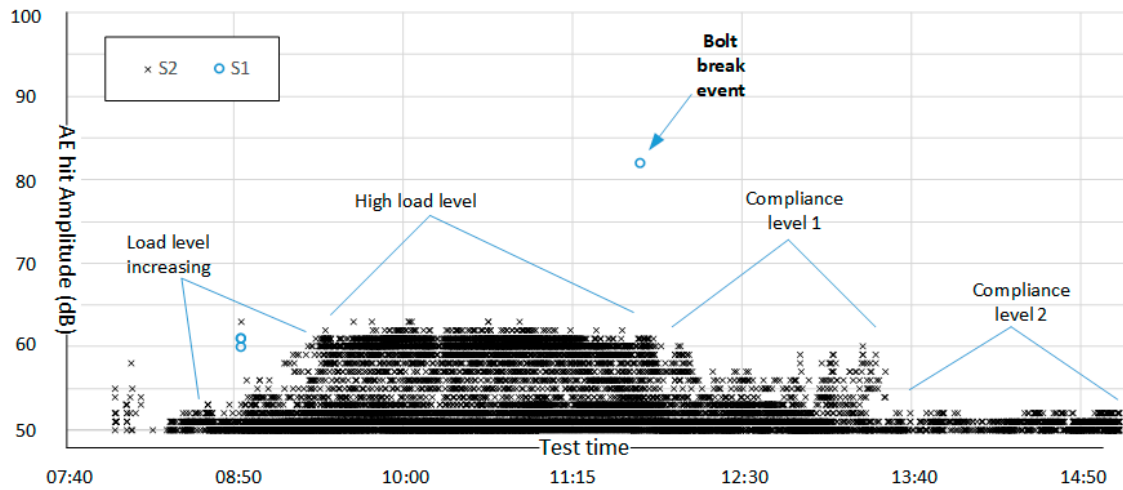
Figure 9. AE amplitude distribution for blade test during bolt failure incident.

Details about the testing for the duration of the day are reflected in the acoustic emission sensor output shown. At around 0800 on December 2nd, the blade was being prepared for the days testing. At about 0830 dynamic loading began; low magnitude to begin with but increasing gradually until the

high levels intended to propagate the induced damage were achieved. By 0930 the high load level target was reached and the loading saddle displacements being applied to the blade in order to achieve this were maintained for the rest of the day.

At 1145 the bolt failure event occurred and was detected by the S1 sensor closest to the root; sensor 1 was almost entirely silent during the test up until this point. This AE hit detected by S1 was the single highest amplitude and highest energy hit of the day.

Shortly after this, the AE profile of the active S2 sensor began to change with lower amplitude activity being detected. This is due to compliance in the system as a result of the bolt failure at the root attachment to the loading block. At about 1330 the amplitude profile from S2 drops further as a more extensive compliance effect began.

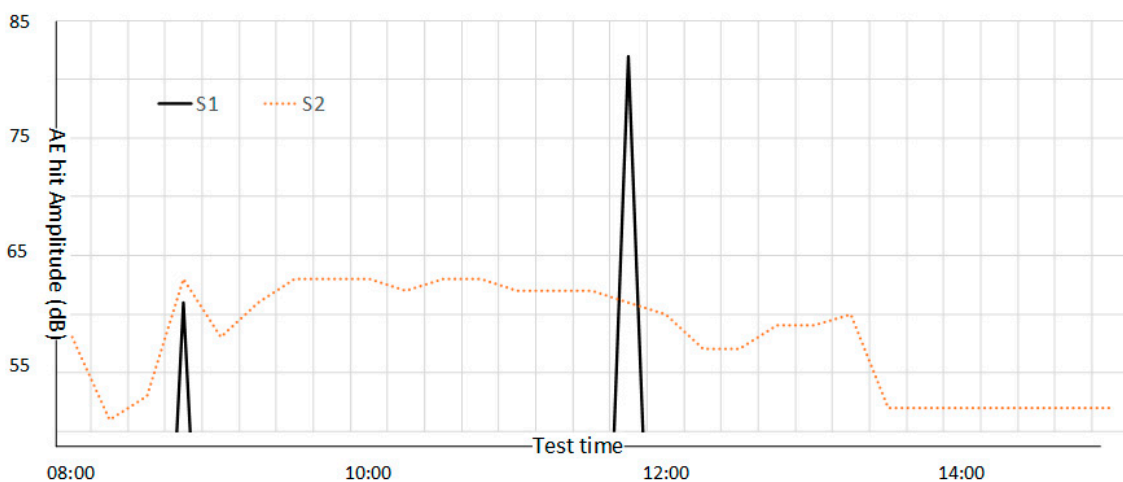
Figure 10. Maximum amplitude AE detected (15 min block period) during blade test bolt failure.

One often highlighted drawback of passive AE monitoring for operational structures is the volume of data generated if all characteristics of every hit detected is to be recorded in order to permit a detailed analysis. However, as Figure 10 shows, even when the system only supplies a compiled report every 15 min (suitable for integration with SCADA) the occurrence of a unique event at the root section (S1) and a measure of the change in the structural behavior (S2) resulting can be flagged by automated surveillance programs.

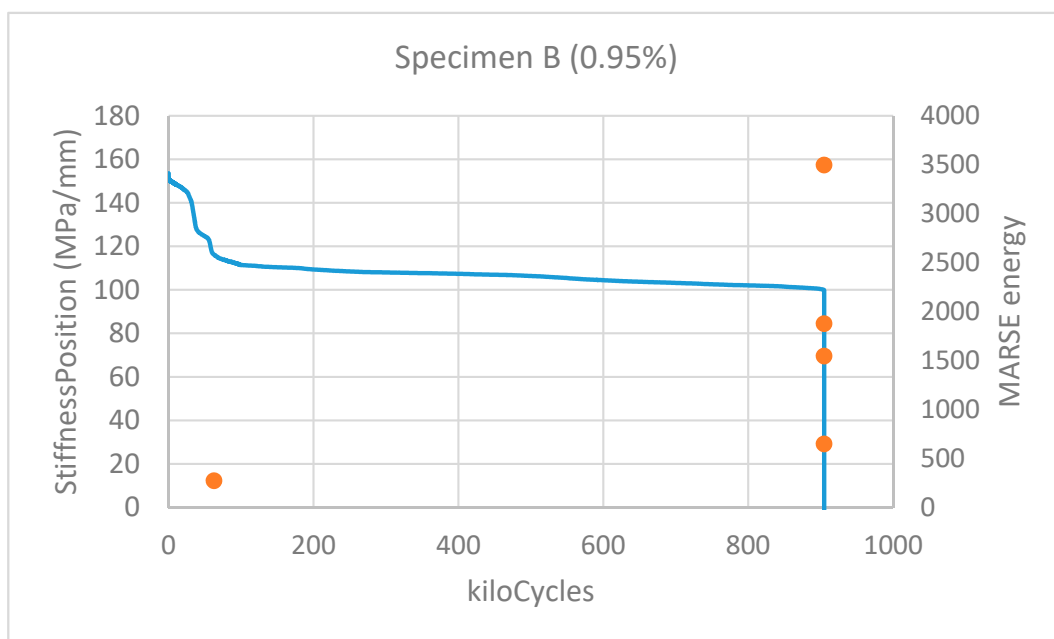
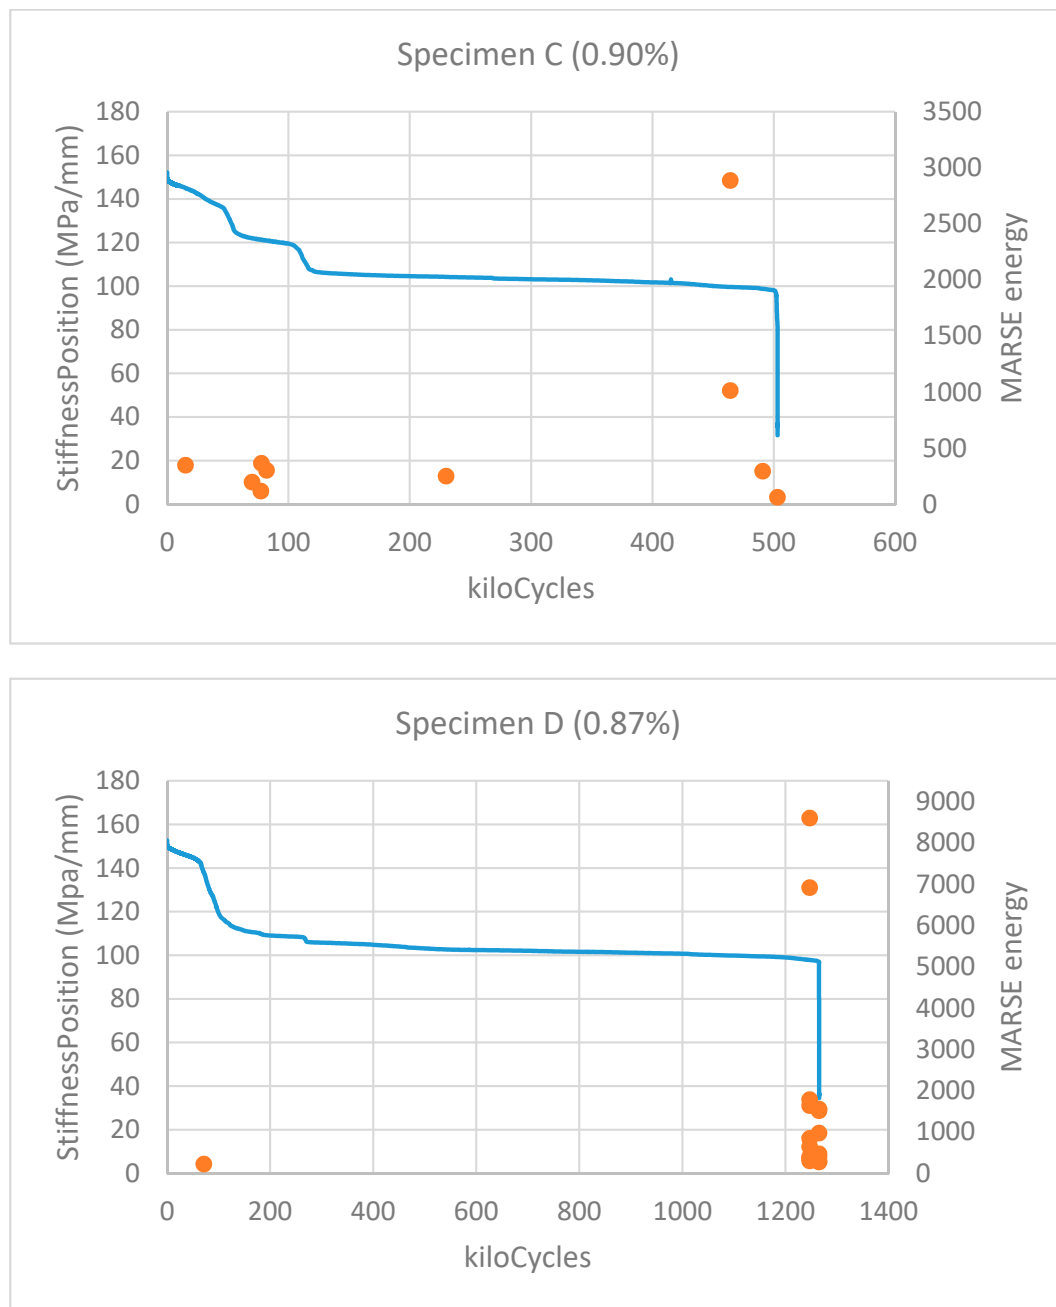
Figure 12. Stiffness response for the tested specimens B, C, and D (MPa/mm) illustrating the standard phase I, II, and III of the tensile fatigue test. Additionally, shown on the same time axis is the occurrence of high amplitude AE hits during phase I and II, and in the case of the prematurely failed specimen C, also in phase II.

Of interest here is the possibility of detecting the suboptimal performance of specimen C early in its simulated life cycle. By looking at the AE data from these tests we saw a general response where high amplitude, high energy hits were detected briefly near the start of the testing (phase I), followed by a long period of fatigue loading where there was no high energy hits. The length of this middle phase (phase II) depended on the level of strain being applied and there was considerable lower amplitude activity as the material was affected by the dynamic strains and a distributed microdamage develops throughout the gauge length. Then, at the very end of the test (phase III), AE activity levels increased once more as the laminate material damage became macroscale failure and the integrity of the specimen broke down. This stiffness and AE response during the three phases of fatigue testing can be seen in Figure 12.

Figure 12 shows the stiffness response for the test specimens B, C, and D during fatigue testing overlaid with the high amplitude and high energy acoustic emission activity (all hits below 90 dB in amplitude were excluded). Note that test specimen C was the only one that emitted high amplitude hits during phase II, and that the highest energy hits occurred some 40,000 cycles prior to specimen failure rather than immediately at the failure point as with the others.
