# Wear Study of Coated Mills during Circumferential Milling of Carbon Fiber-Reinforced Composites and Their Influence on the Sustainable Quality of the Machined Surface

**Keywords:** milling; composite systems; carbon fibers; tool wear; tool parameters

**Citation:** Knápek, T.; Dvořáčková, Š.; Knap, A. Wear Study of Coated Mills during Circumferential Milling of Carbon Fiber-Reinforced Composites and Their Influence on the Sustainable Quality of the Machined Surface. *Coatings* **2022**, *12*, 1379.

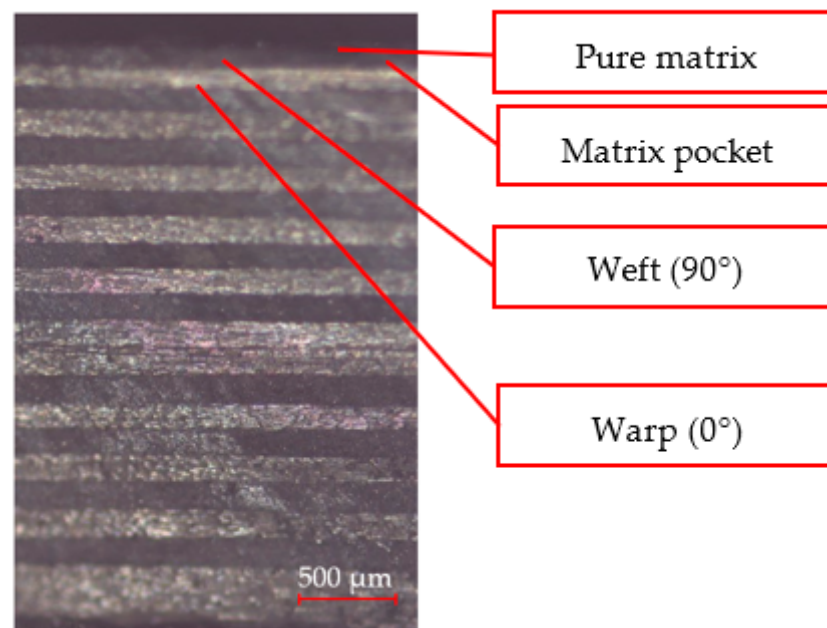
**Figure 1.** Cut through 3 mm thick laminate.

The surface of the laminate consists of a thin layer of pure resin with a thickness of 10–15  $\mu\text{m}$ . The thickness of the resin layer changes as the warp and weft yarns are placed. Next comes the weft yarn. Then, there is the warp yarn below and again the weft yarn. The undulation path of the warp and weft yarns in a twill weave can be approximately described by a sine function. A grouping of matrix material is visible between the warp and weft yarns.

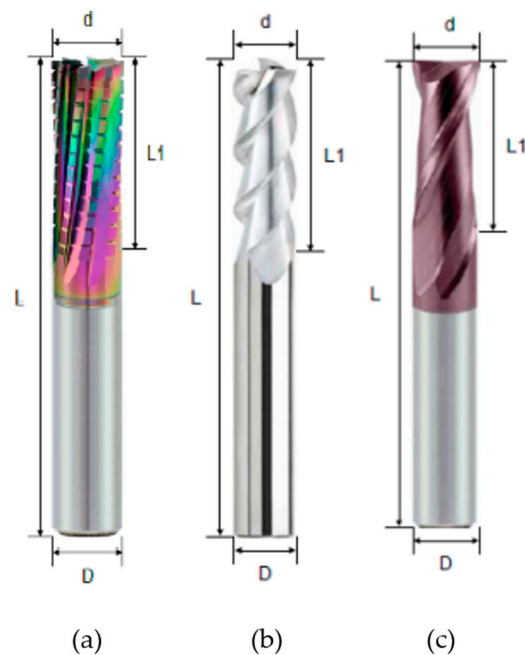
**Figure 2.** Tools used for the study. (a) ECSSF milling cutter; (b) A100 milling cutter; (c) G550 milling cutter.

The ECSSF finishing cutter is designed for CFRP/GFRP laminate composite materials, the microhardness of DLC surfaces is between 3300 HV0.05 and 4200 HV0.05. The carbide cutter A100 is intended for machining non-ferrous metals, aluminum, and aluminum alloys, the microhardness of the CrN coating is between 1200 HV0.25 and 2900 HV0.25. The universal milling cutter G550 is suitable for steel, stainless steel, cast iron, and hardened material up to 55 HRC, the hardness of the UNICO surface layer is 2800 HV0.05 and 3100 HV0.05.

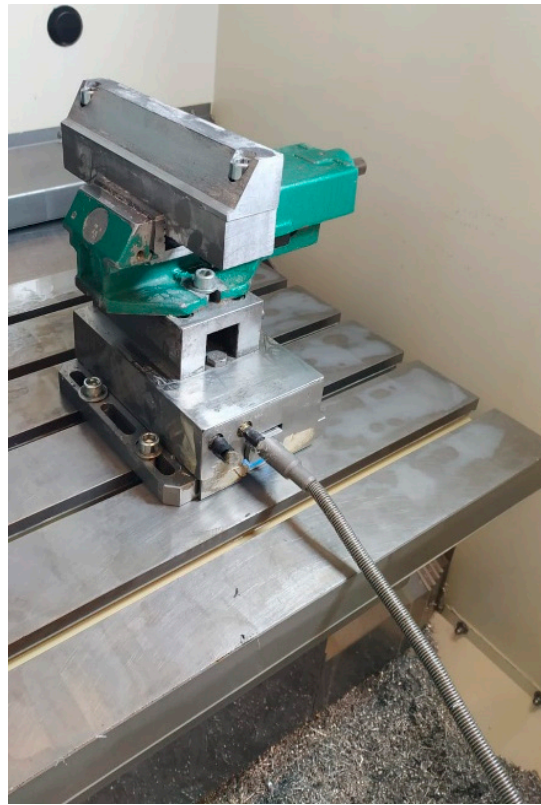
Milling was carried out on a 3-axis DMG MORI CMX 600 (DMG Mori Seiki, Nagoja, Japan) milling center with a spindle power of 13 kW and a maximum rotation speed of 12,000 rpm. The instruments were clamped using a heat clamp. To minimize the influence of vibrations, the samples were fixed over a large area to the clamping device and the clamping device to the KISTLER 9265 B (Kistler Instrument Corp, Amherst, NY, USA) dynamometer, see Figure 3. To reduce the dust particles of the chips, an auxiliary air extraction was installed at the cutting site using an industrial vacuum cleaner.

**Figure 3.** Fixture for mounting CFRP sample on the experimental device—piezoelectric dynamometer KISTLER 9265 B.

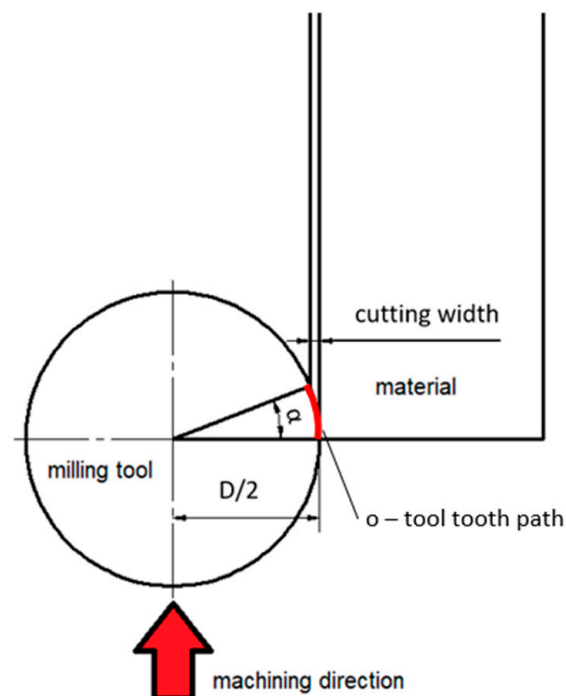
As part of the study, circumferential down milling without process fluid was implemented. A 200 mm long board edge was milled. The length of the tool tooth path was determined according to Equations (1) and (2), Figure 4, and Table 4.

**Figure 4.** Scheme for calculating the tool tooth path.

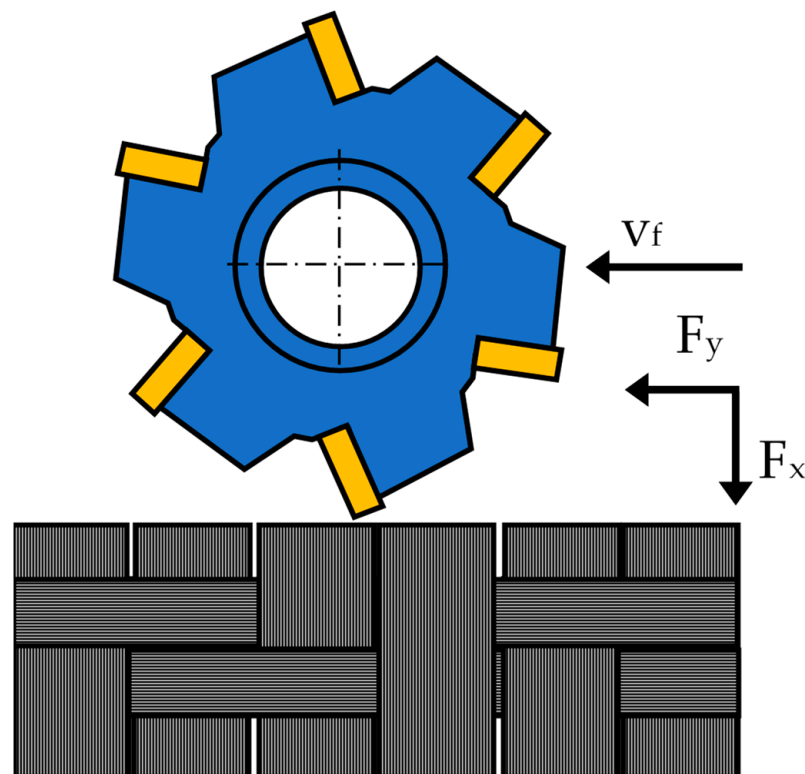
According to [25], delamination is induced at the point of initial contact of the fiber with the tool, where the first cut of the fiber occurs. It follows that the maximum length of the protruding fiber is the distance between the initial contact and the edge of the machined (milled) surface in the longitudinal direction of the fiber. The milling path was oriented at a 90° angle to the weft yarn, Figures 5 and 6.

Figure 5. Orientation of the milling tool to the warp yarn.

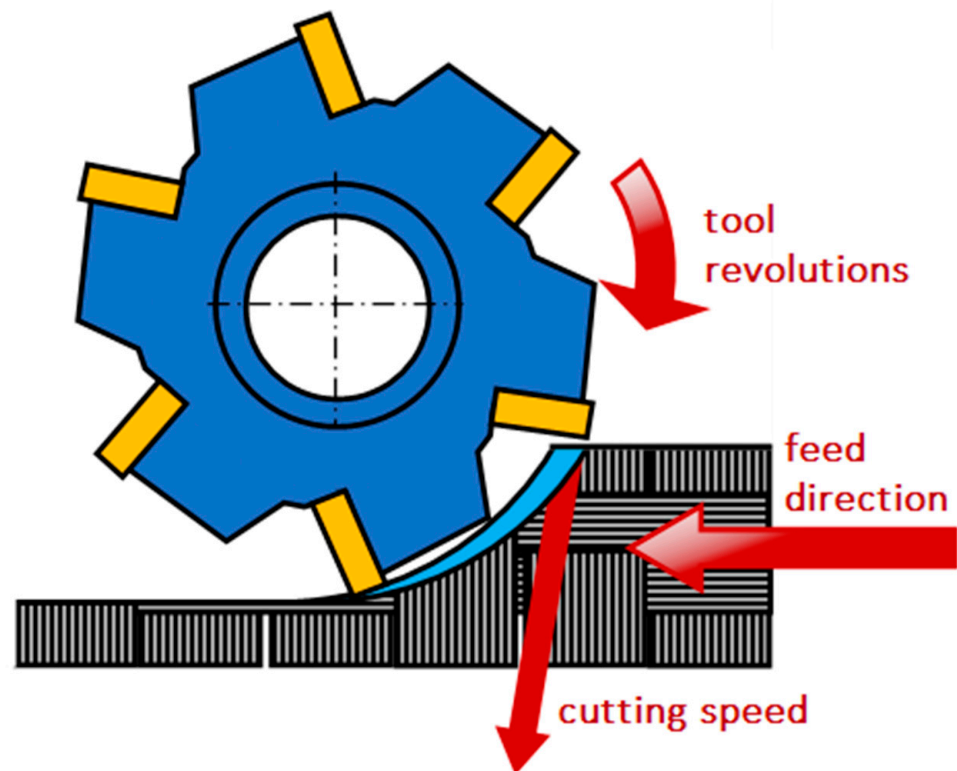
**Figure 6.** The arrangement of warp and weft yarns from the point of view of delamination during down milling.

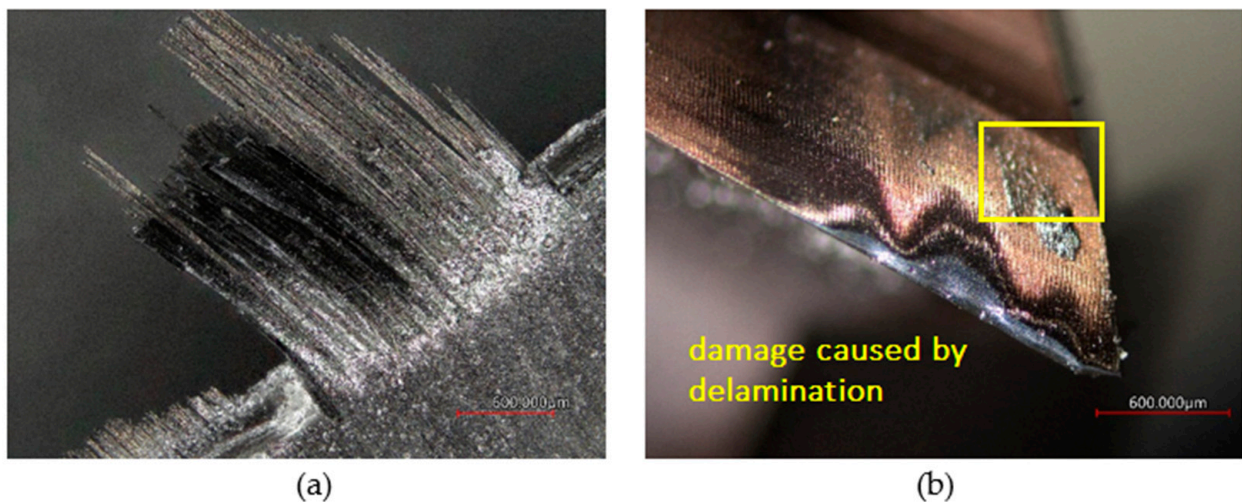
Figure 7a shows the machined laminate surface with several protruding (approx. 0.5–2 mm) cut weft fibers. This is type II delamination. The protruding weft fibers are unevenly distributed over the entire machined surface. The machined surface does not have a clear cut, the edge is frayed. The image of tool Figure 7b indicates abrasive damage to the tool. The amount of wear is  $187.60 \pm 0.20 \mu\text{m}$ . The number of corrugations corresponds to the number of fabric layers in the laminate. Next, in Figure 7b, the yellow frame, abrasive damage to the tool is visible, due to protruding fibers.

**Figure 7.** Capture after a tool tooth path of  $15 \times 165 \text{ m}$ . (a) Laminate thickness 1 mm; (b) G550 milling tool.

This tool was the only tool used to show wear in the form of nicks and scratches extending into the base material of the tool outside the cutting area, see Figures 7b and 8b. This phenomenon was caused by the abrasive effects of uncut fibers and the influence of the helix rising angle of the cutter, which was the largest of all geometries used. The high rate of tool wear had a significant effect on the monitored roughness parameters. In most cases, the examined roughness parameters reached the highest values in the control sections ( $5 \times$ ,  $10 \times$ ,  $15 \times$ , and  $20 \times 165$  m) with the G550 tool. The length of the protruding weft fibers reached slightly lower values compared to the CrN tool, in the order of 0.5–3 mm.

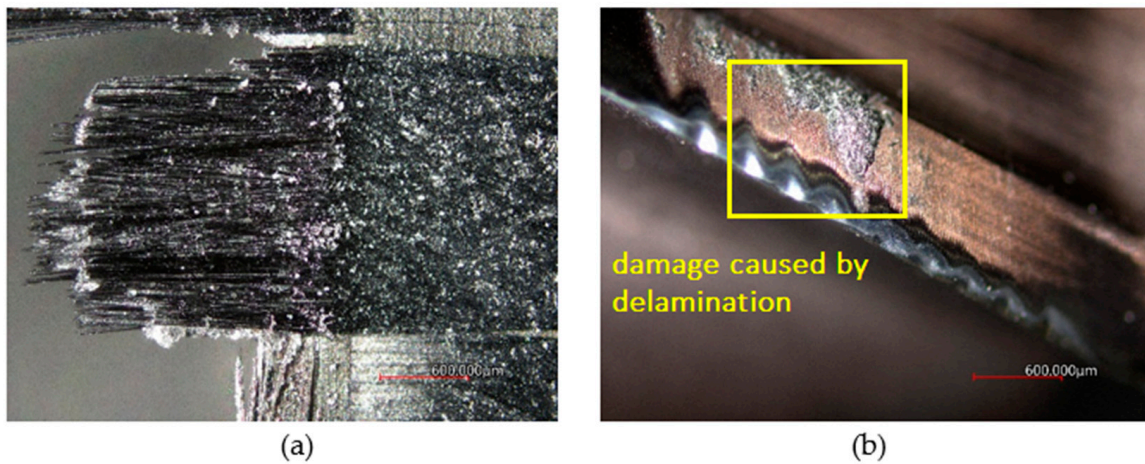
Figure 8a shows a distinct layer of crushed resin on the fibers and many protruding (approx. 1.5 mm and more) cut weft fibers. Again, this is type II delamination. The protruding weft fibers are unevenly distributed over the entire machined surface. The machined surface does not have a clear cut, the edge is frayed. Furthermore, broken/separated bundles of warp yarn fibers also protrude from the machined surface. The image of tool Figure 8b shows significant abrasive damage to the tool. The size of the wear is  $254.50 \pm 0.28 \mu\text{m}$  (the shape of the wear can be compared to a sine function). The number of corrugations corresponds to the number of fabric layers in the laminate. Next, in Figure 8b, there is a yellow frame, where the abrasive damage of the tool due to the protruding fibers is again visible.

**Figure 8.** Capture after a tool tooth path of  $15 \times 165 \text{ m}$ . (a) Laminate thickness 3 mm; (b) G550 milling tool.

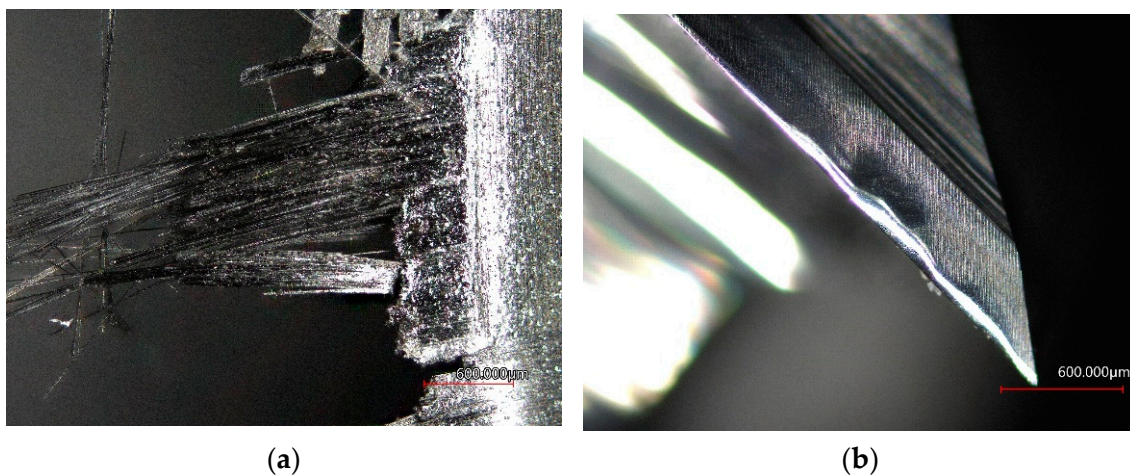
Figure 9a shows significant surface damage after milling with many protruding and pulled cut weft fibers (approx. 3 mm and more). Again, this is type II delamination. Protruding and broken weft fibers are unevenly distributed over the entire machined surface. The machined surface does not have a clear cut, the edge is significantly frayed to wavy and damaged. Broken/separated bundles of warp yarn fibers also protrude from the machined surface. Abrasive damage to the tool is visible in the image of tool Figure 9b. The amount of wear is  $108.80 \pm 0.20 \mu\text{m}$ . The number of corrugations corresponds to the number of fabric layers in the laminate.

**Figure 9.** Capture after a tool tooth path of  $15 \times 165 \text{ m}$ . (a) Laminate thickness 1 mm; (b) A100 milling tool.

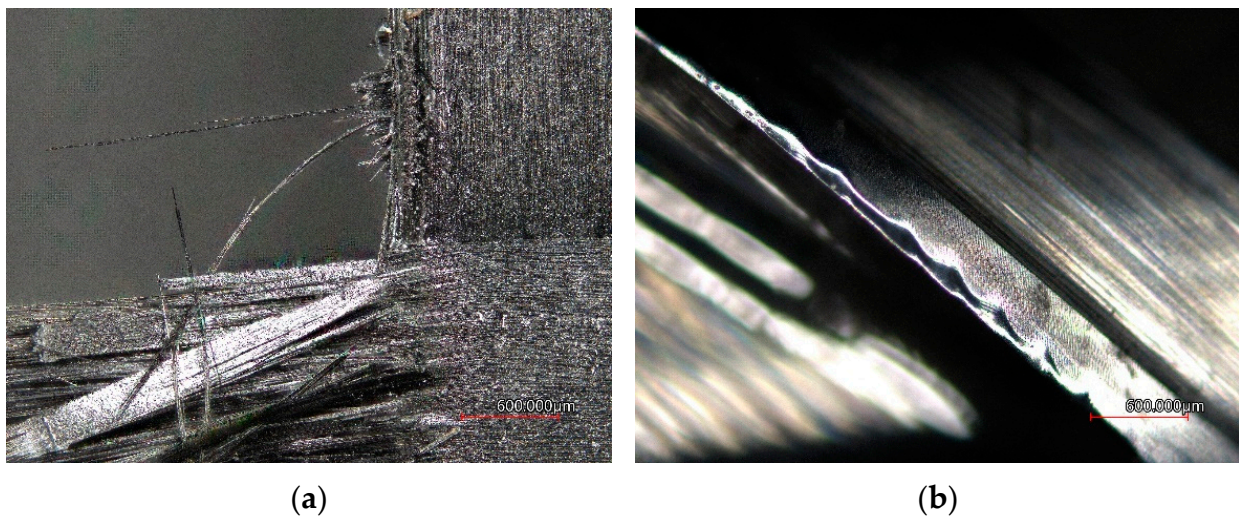
Figure 10a shows a surface with many protruding fibers (approx. 3 mm and more) of cut weft fibers. Again, type II delamination. The protruding weft fibers are unevenly distributed over the entire machined surface. The machined surface does not have a clear cut, the edge is frayed, and slightly bent bundles of warp yarn fibers protrude from the machined surface. The image of tool Figure 10b shows abrasive damage to the tool. The amount of wear is  $182.40 \pm 0.20 \mu\text{m}$ . The number of corrugations corresponds to the number of fabric layers in the laminate.

**Figure 10.** Capture after a tool tooth path of  $15 \times 165 \text{ m}$ . (a) Laminate thickness 3 mm; (b) A100 milling tool.

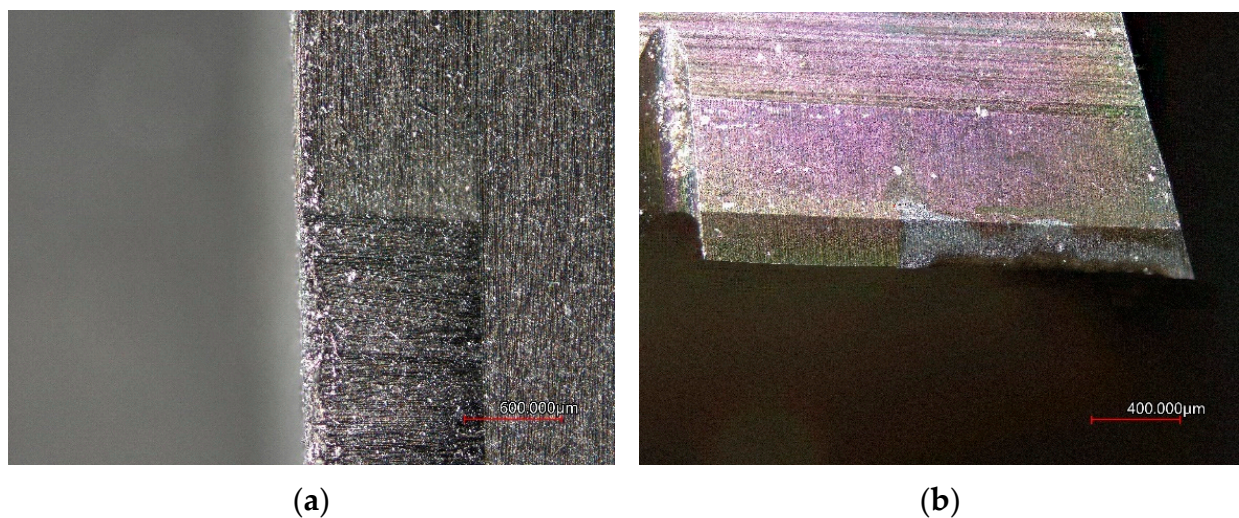
In Figure 11a, a very fine layer of destroyed (broken) resin on the laminate is observed. The machined surface has a clear cut, and the edge is solid, without burrs and protruding fibers. In some places of the machined surface, slightly protruding bent bundles of warp yarn fibers were rarely seen. In Figure 11b, the measured value of the tool coating wear can be observed, which is  $284.550 \mu\text{m}$  due to the abrasive effects of the carbon fiber. Figure 11b of the tool indicates abrasive damage to the tool. The resulting wear rate of the tool base material was  $74.70 \pm 0.16 \mu\text{m}$  after the tool tooth path  $15 \times 165 \text{ m}$ .

**Figure 11.** Capture after a tool tooth path of  $15 \times 165 \text{ m}$ . (a) Laminate thickness 1 mm; (b) ECSSF milling tool.

The geometry of the cutting edge and the orientation of the fibers at contact play a critical role in tool wear and the final roughness of the machined surfaces. Tool flank face wears affected the machined surface structure, roughness, and topography. The more the tool was worn, the more the laminate surface was devastated. When the weft fibers were oriented perpendicular to the tool cut, the A100, CrN coated and G550, UNICO coated cutters caused a strong bending of the weft fibers, which resulted in a poor-quality cut of the fibers, which was manifested in the form of ragged protruding fibers, Figures 8a and 9a. There was serious damage to the surface with the carbon fibers being crushed or chopped and pulled out. The opposite was the case with the ECSSF cutter, and DLC coating, Figures 11a and 12a.

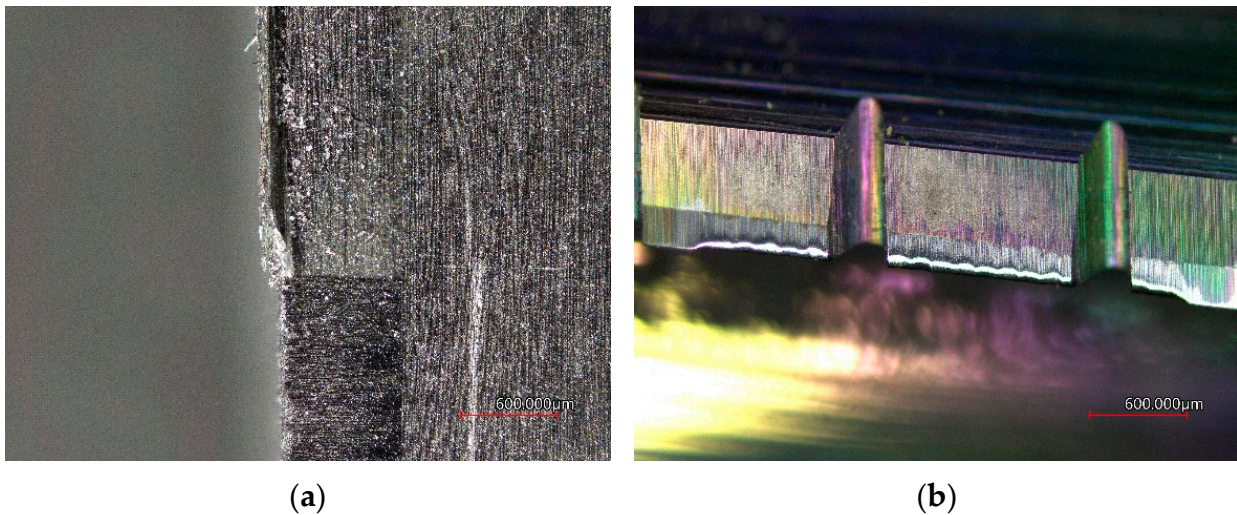
In Figure 12a, a slight layer of destroyed (broken) resin on the fibers and a finely separated warp yarn bundle can be seen. The weft fibers are cut evenly, without protruding fibers. This is type I delamination, which occurs only in the plane of the first layer. The machined surface has a clear cut, but with slightly separated warp yarn bundles. The image of tool Figure 12b again points to the abrasive damage of the tool, the size of which is  $98.40 \pm 0.18 \mu\text{m}$ . The number of corrugations corresponds to the number of fabric layers in the laminate.

**Figure 12.** Capture after a tool tooth path of  $15 \times 165 \text{ m}$ . (a) Laminate thickness 3 mm; (b) ECSSF milling tool.

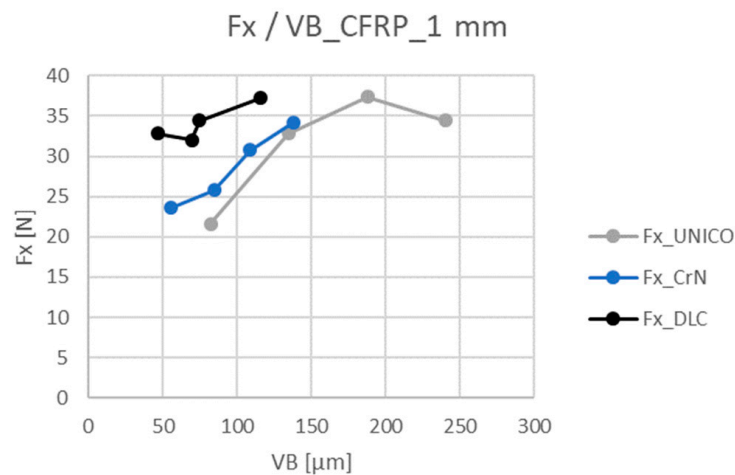
The highest measured values of the  $F_x$  component of the cutting force at the beginning and at the end of the experiment were measured at the ECSSF stand, see Figure 13. The lowest measured value of the parameter  $VB = 46.57 \pm 0.14 \mu\text{m}$  corresponds to the size of the cutting force  $F_x = 32.80 \pm 0.14 \text{ N}$ . These values were observed after traveling the tool path  $5 \times 165 \text{ m}$  when machining a plate with a thickness of 1 mm.

**Figure 13.** Dependence of the cutting force component  $F_x$  on wear, laminate thickness 1 mm.  $F_x$ —cutting force in x direction.  $VB$ —flank wear.

The size of the VB wear produced on the A100 tool ( $137.16 \pm 0.20 \mu\text{m}$ ) is similar to the VB wear size of the DLC-coated tool ( $115.43 \pm 0.20 \mu\text{m}$ ). However, the course and measured values differ significantly. The A100 tool can be characterized by a linear development of the increase in the applied force  $F_x$ . A similar trend can be observed with the UNICO-coated tool.

Figure 13 shows the highest achieved tool wear of  $240.05 \pm 0.28 \mu\text{m}$  at the applied force  $F_x = 34.40 \pm 0.14 \text{ N}$ . This value was measured with the G550 tool after traveling the tool path  $20 \times 165 \text{ m}$  and is 1.75–2.1 $\times$  greater than the other tools used, while the force  $F_x$  achieves similar values. When using the tool with UNICO coating, the lowest force value  $F_x = 21.60 \pm 0.14 \text{ N}$  was measured.

From Figures 13 and 14, similarities in the course can be observed for tools with CrN and UNICO coating due to the similarity of tool geometries, see Table 2.

According to Figures 13 and 14, there are noticeable differences in the amount of wear of individual tools at the end of individual control sections. The lowest measured wear size values were achieved across all parameters and control sections by the ECSSF tool.

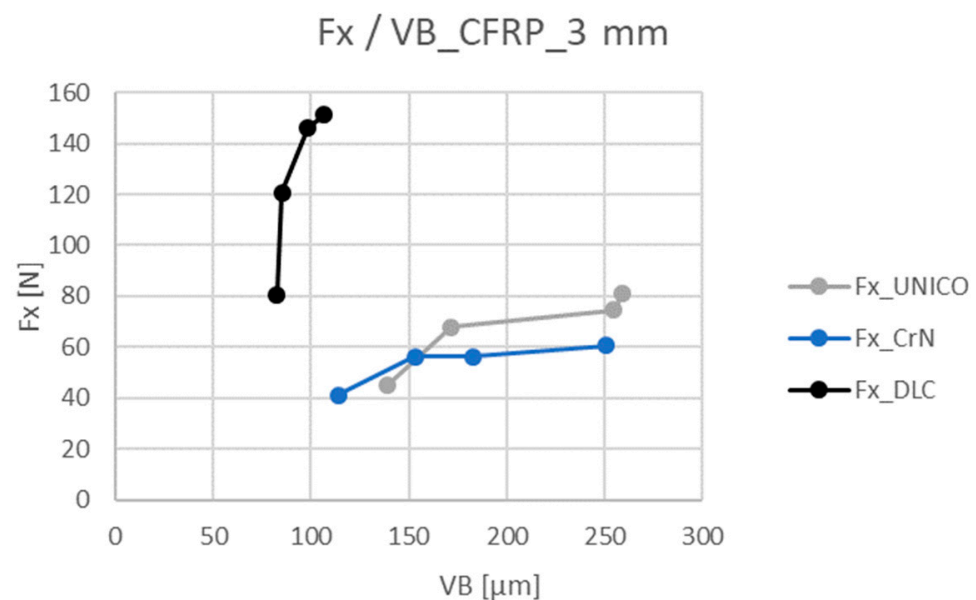
When machining a sample with a thickness of 3 mm according to the conditions, see Table 4, the results were measured and processed in Figure 14. The graph shows a similarity with Figure 13. Tools A100 and G550 show a similar course of applied forces, the ECSSF tool is characterized by the smallest measured amount of wear and the largest measured value of the applied force  $F_x$ . For both measured parameters, there was an approximately twofold increase in the measured values in the individual reading intervals for the A100 and G550 tools.

**Figure 14.** Dependence of the cutting force component  $F_x$  on wear, laminate thickness 3 mm.  $F_x$ —cutting force in x direction. VB—flank wear.

The exception is the ECSSF tool. The size of the tool wear remained relatively the same, a significant change is an increase in the force  $F_x$ , where a 2.4–4 times increase in values can be observed.

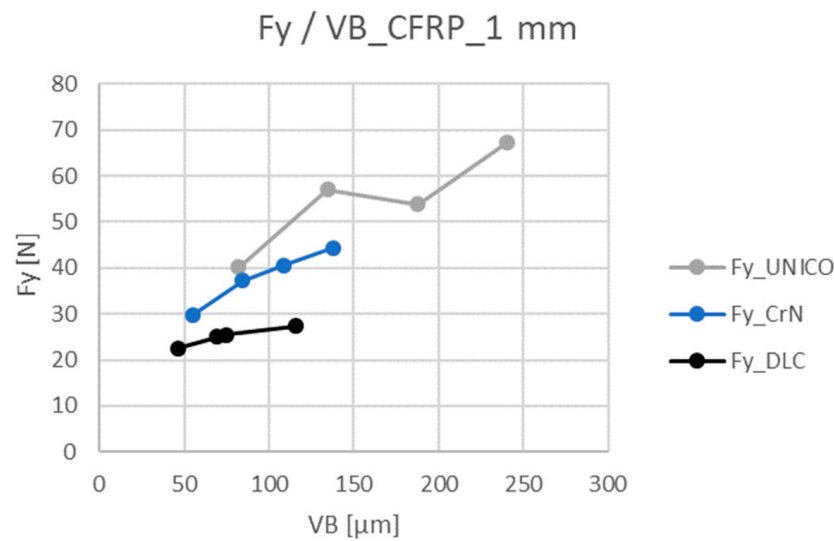
**Figure 15.** Dependence of the cutting force component  $F_y$  on wear, laminate thickness 1 mm.  $F_x$ —cutting force in x direction. VB—flank wear.

From Figure 15, it is possible to observe an increase in the acting forces with increasing helix pitch angle. The individual curves of the dependences of the acting component of the cutting force  $F_y$  depending on VB during the machining of a sample with a thickness of 3 mm show a similar course as that of the component  $F_x$  for the same machined thickness.

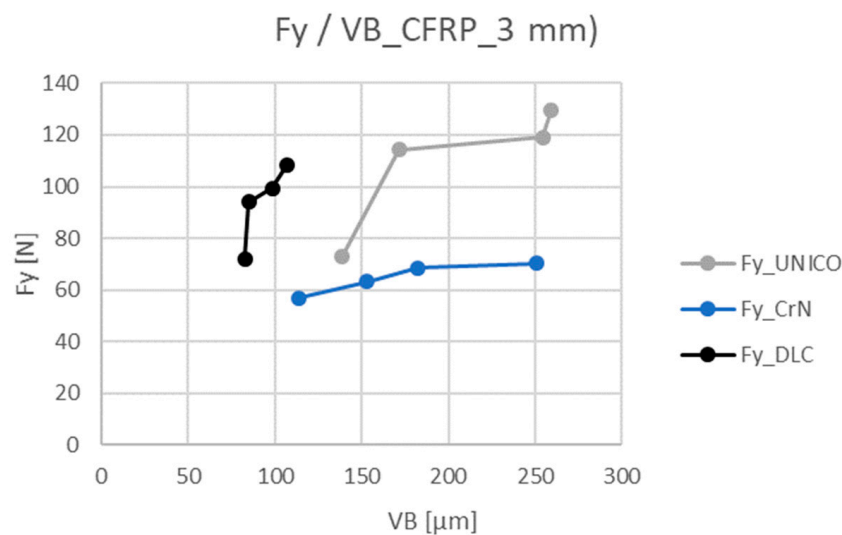
**Figure 16.** Dependence of the cutting force component  $F_y$  on wear, laminate thickness 3 mm.  $F_x$ —cutting force in x direction. VB—flank wear.

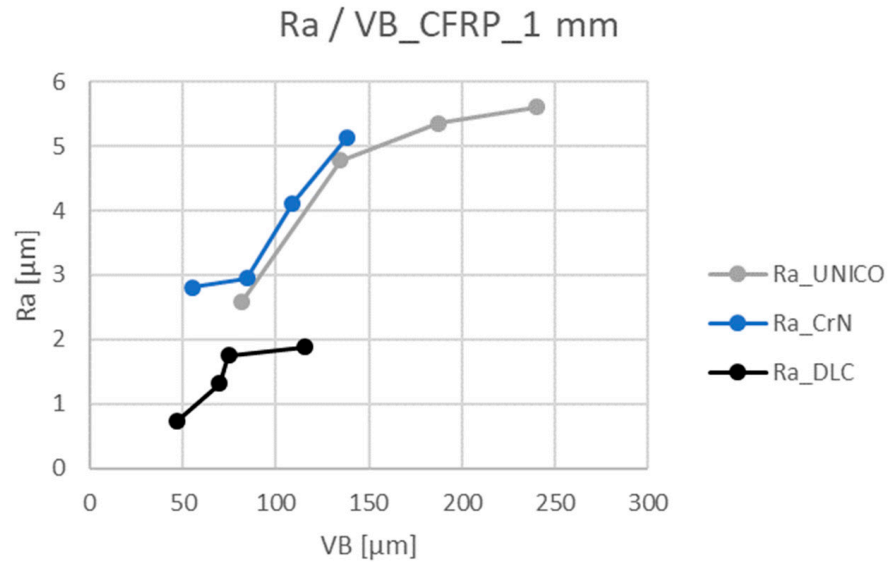
The parameters  $R_a$ ,  $R_z$  and  $R_t$  were determined as roughness evaluation parameters due to their frequent use in the technical practice of European countries. According to Figure 17, an increase in the values of the parameter  $R_a$  can be observed for all the curves with increasing wear of the VB. Figures 11a and 17 show the achieved surface quality when using the ECSSF tool supported by the measured values. The difference between the measured values at the beginning and end of the measurement is 1.16  $\mu\text{m}$ . After driving

the 20 × 165 m track, the G550 tool shows an increase in the value of the  $R_a$  parameter by 3.02  $\mu\text{m}$  and the A100 tool an increase by 2.55  $\mu\text{m}$ . A more pronounced increase in the values of the  $R_a$  parameters was measured for the A100 and G550 tools. The G550 tool shows an asymptotic growth to a value of 6  $\mu\text{m}$  after traveling a tool path of 20 × 165 m. The A100 tool shows tendencies towards a further increase in the values of the  $R_a$  parameter.

**Figure 17.** Dependence of the surface roughness parameter  $R_a$  on wear, laminate thickness 1 mm.  $R_a$ —arithmetical mean high. VB—flank wear.

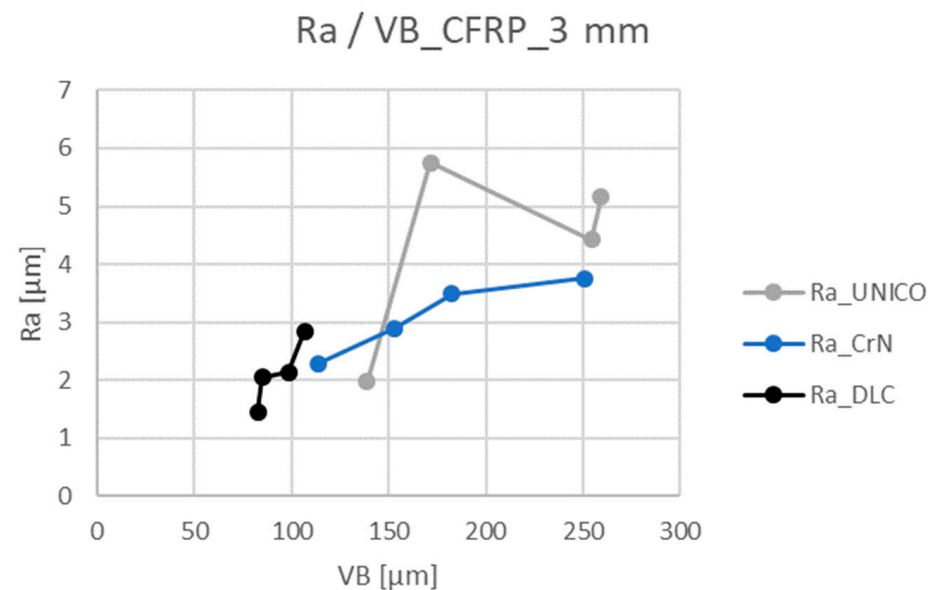
From the measured values when machining a sample with a thickness of 3 mm, see Figure 18, a significant change in the course of the individual graphs can again be observed. The most significant change is seen before  $VB = 150 \mu\text{m}$ . This is where the graphs for the A100 and G550 intersect. The G550 tool shows a steep increase in the values of the parameter  $R_a$  to the value  $R_a = 6 \mu\text{m}$  at  $VB = 171.56 \pm 0.20 \mu\text{m}$ . The course of the graph for the A100 tool shows a smoother course and asymptotically approaches the value of  $R_a = 4 \mu\text{m}$ .

**Figure 18.** Dependence of the surface roughness parameter  $R_a$  on wear, laminate thickness 3 mm.  $R_a$ —arithmetical mean high. VB—flank wear.

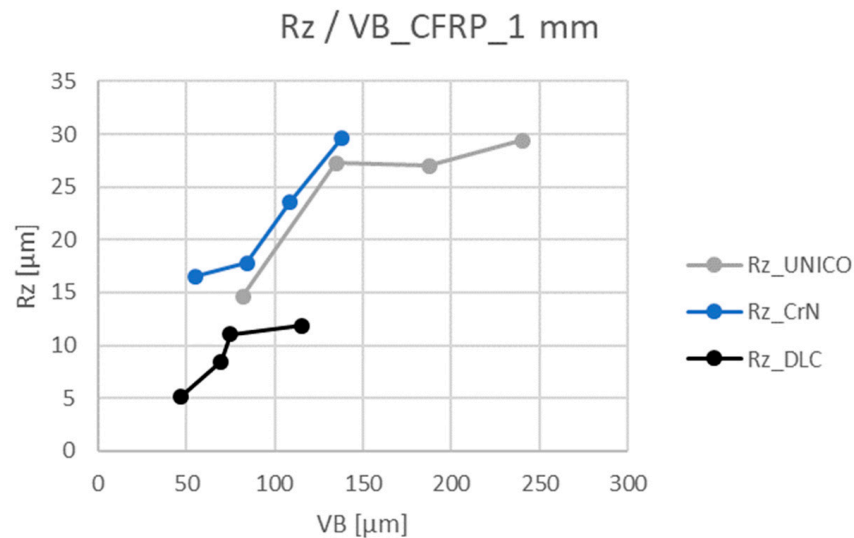
When comparing Figures 19 and 20, a decrease in the measured values of the  $R_z$  parameter can be observed as the wear of the VB tool increases and the machined thickness of the sample increases. A decrease can be observed in the A100 and G550 tools. With the ECSSF instrument, the increase in measured values is noticeable mainly by 50%.

**Figure 19.** Dependence of the surface roughness parameter  $R_z$  on wear, laminate thickness 1 mm.  $R_z$ —maximum height of profile. VB—flank wear.

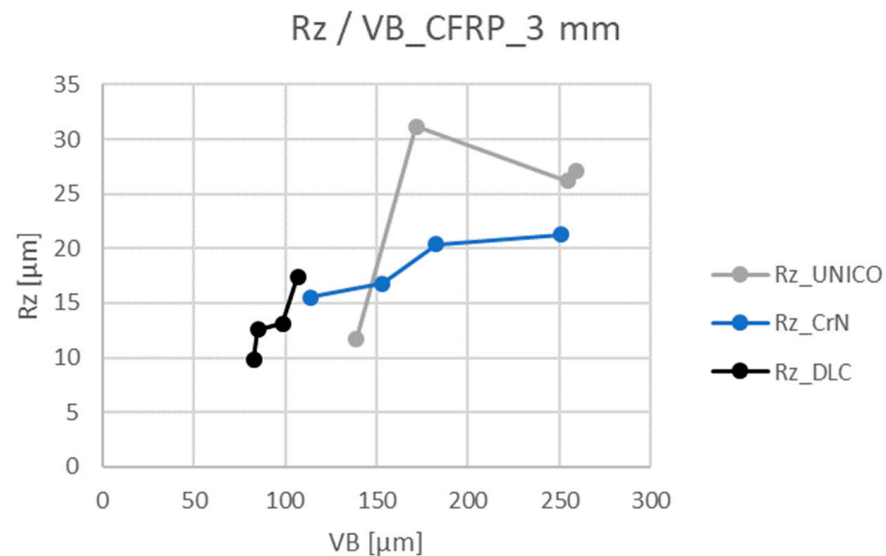
**Figure 20.** Dependence of the surface roughness parameter  $R_z$  on wear, laminate thickness 3 mm.  $R_z$ —maximum height of profile. VB—flank wear.

A similar course of the increase in values is also visible in a sample with a thickness of 3 mm, Figure 22. Here, individual tools show a difference in  $R_t$  parameter values of 4–10  $\mu\text{m}$  compared to the  $R_z$  parameter, see Figures 20 and 22.

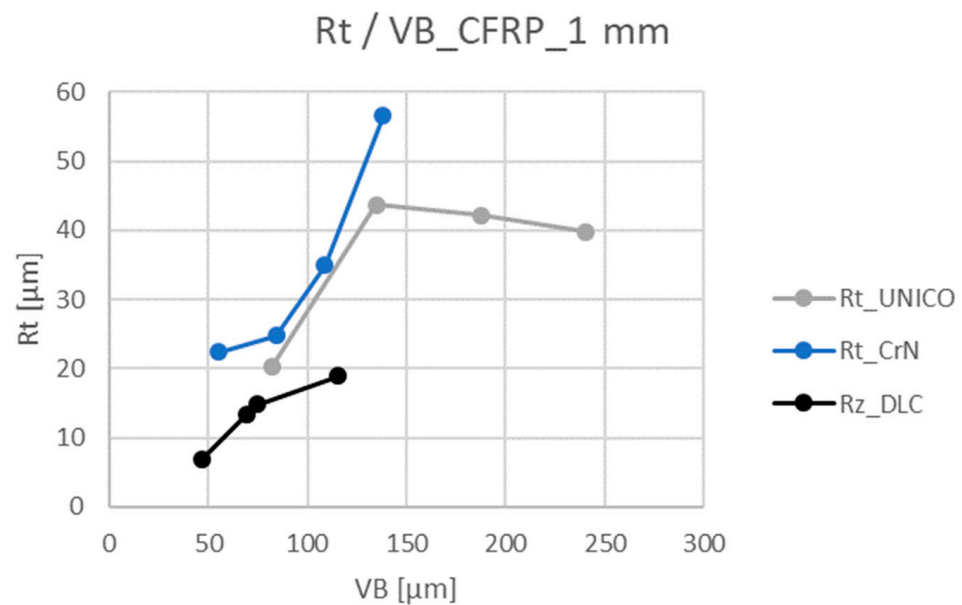
The depth of roughness  $R_t$ , which is the sum of the highest peak of the profile and the depth of the deepest depression of the R profile inside the measured path for a plate thickness of 1 mm, reaches up to  $10\times$  greater values compared to the  $R_a$  parameter, see Figures 17 and 19. Another noticeable increase in the measured values is compared to the  $R_z$  parameter, Figure 21. Measured the values for the tool with DLC coating show an

increase in values of about 5  $\mu\text{m}$ , for tools with CrN and UNICO coatings the increase is about up to 20  $\mu\text{m}$ .

**Figure 21.** Dependence of the surface roughness parameter  $R_t$  on wear, laminate thickness 1 mm.  $R_t$ —total height of profile. VB—flank wear.

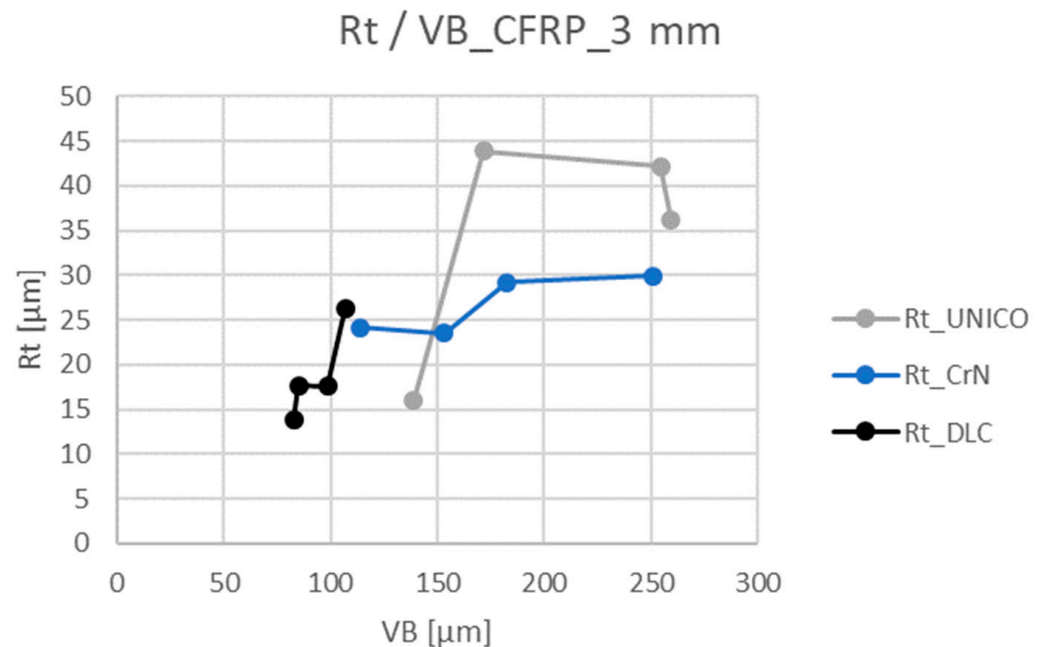
**Figure 22.** Dependence of the surface roughness parameter  $R_t$  on wear, laminate thickness 3 mm.  $R_t$ —total height of profile. VB—flank wear.

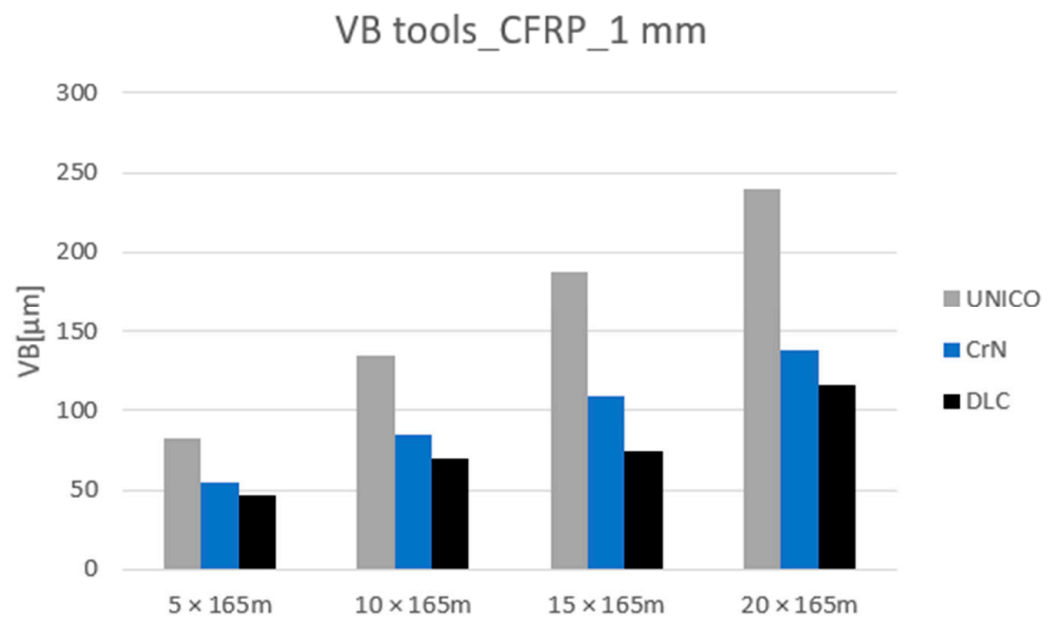
Across the experiments, after evaluating the VB tool wear parameter over a tool path of  $5 \times 165 \text{ m}$ ,  $10 \times 165 \text{ m}$ ,  $15 \times 165 \text{ m}$ , and  $20 \times 165 \text{ m}$ , when machining 1 mm and 3 mm thick samples, the highest wear values were achieved with the UNICO coated tool in all controlled sections, see Figures 23–30.

Figure 23. Tool wear, laminate thickness 1 mm.

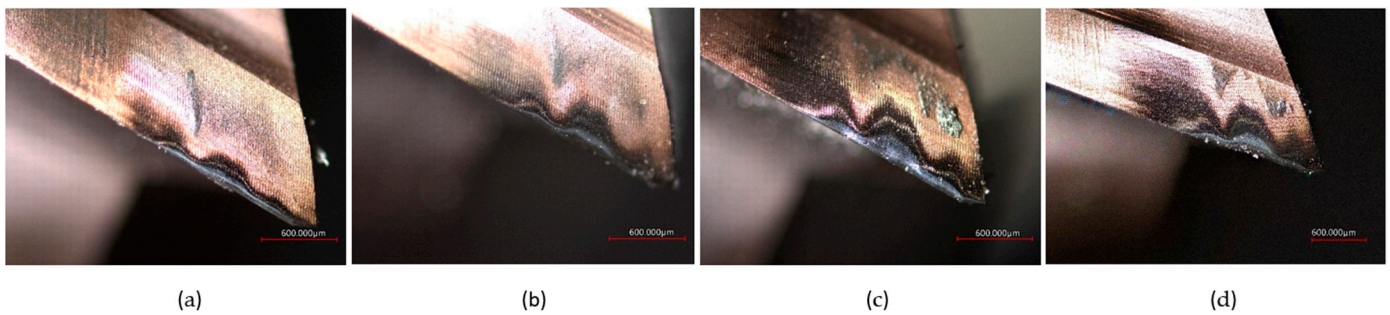
Figure 24. Tool wear of the G550 milling tool, laminate thickness 1 mm. (a) Tool tooth path 5 × 165 m; (b) tool tooth path 10 × 165 m; (c) tool tooth path 15 × 165 m; (d) tool tooth path 20 × 165 m.

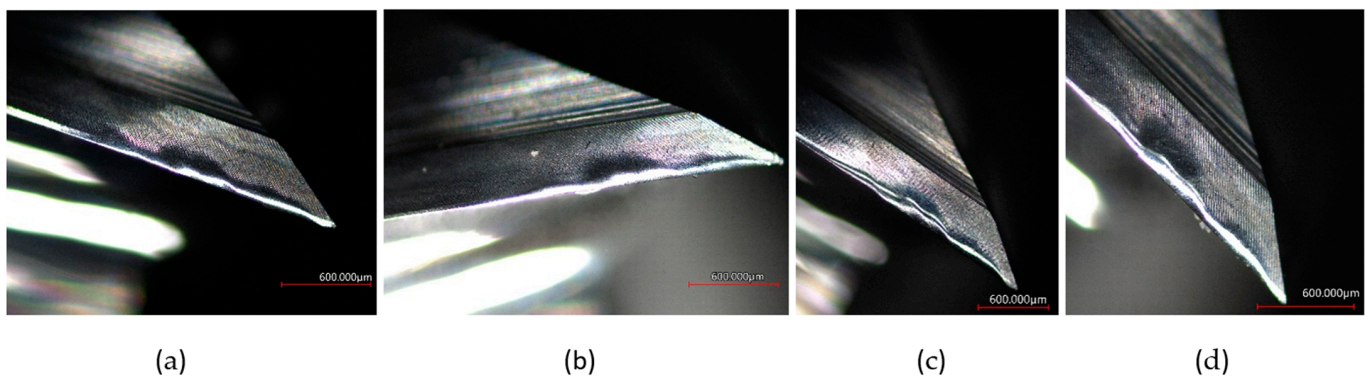
Figure 25. Tool wear of the A100 milling tool, laminate thickness 1 mm. (a) Tool tooth path 5 × 165 m; (b) tool tooth path 10 × 165 m; (c) tool tooth path 15 × 165 m; (d) tool tooth path 20 × 165 m.

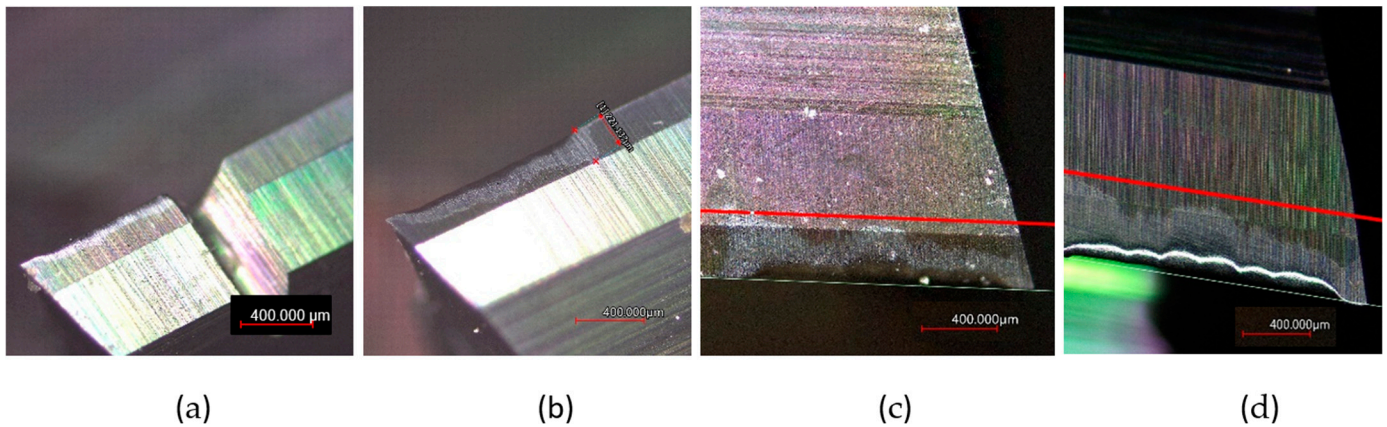
**Figure 26.** Tool wear of the ECSSF milling tool, laminate thickness 1 mm. (a) Tool tooth path  $5 \times 165$  m; (b) tool tooth path  $10 \times 165$  m; (c) tool tooth path  $15 \times 165$  m; (d) tool tooth path  $20 \times 165$  m.

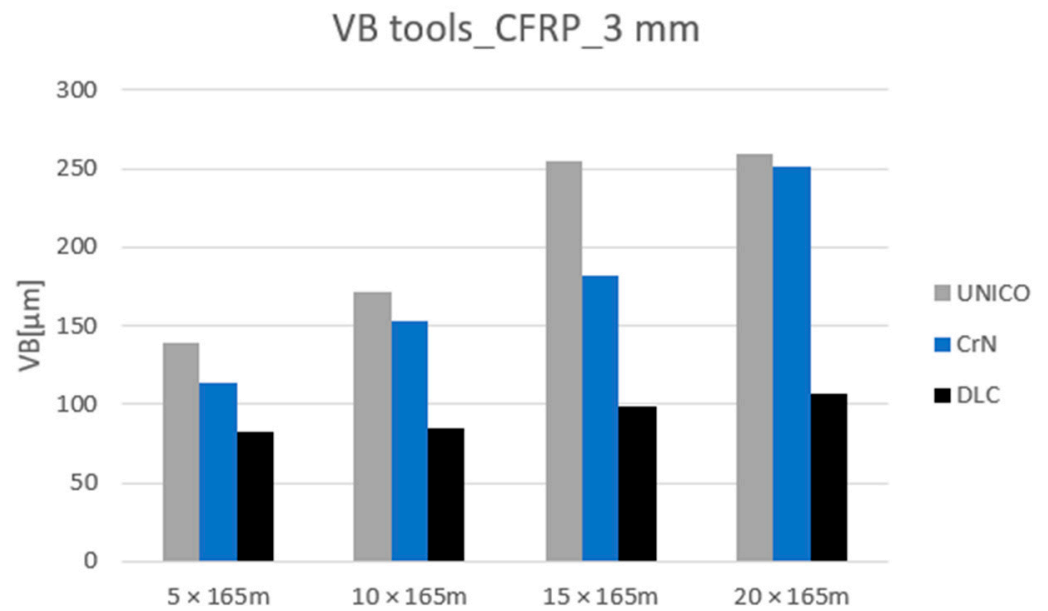
**Figure 27.** Tool wear, laminate thickness 3 mm.

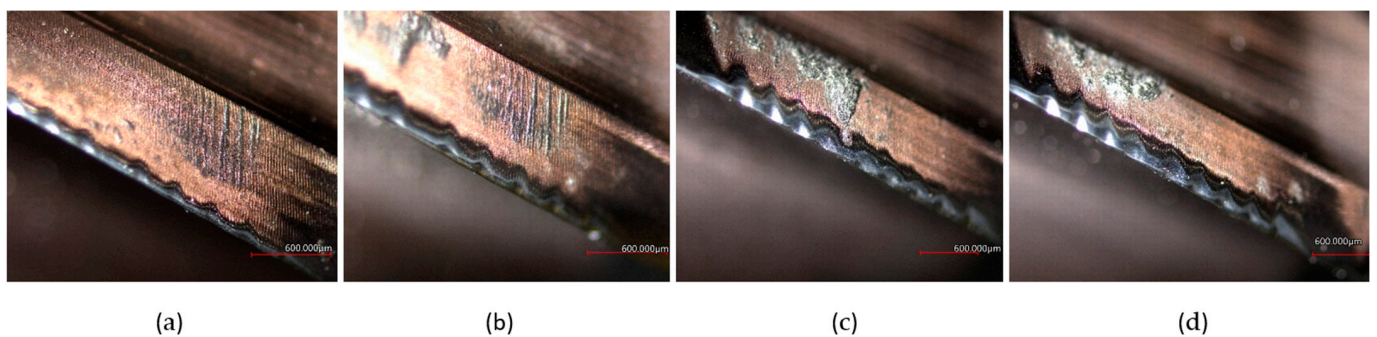
**Figure 28.** Tool wear of the G550 milling tool, laminate thickness 3 mm. (a) Tool tooth path  $5 \times 165$  m; (b) tool tooth path  $10 \times 165$  m; (c) tool tooth path  $15 \times 165$  m; (d) tool tooth path  $20 \times 165$  m.

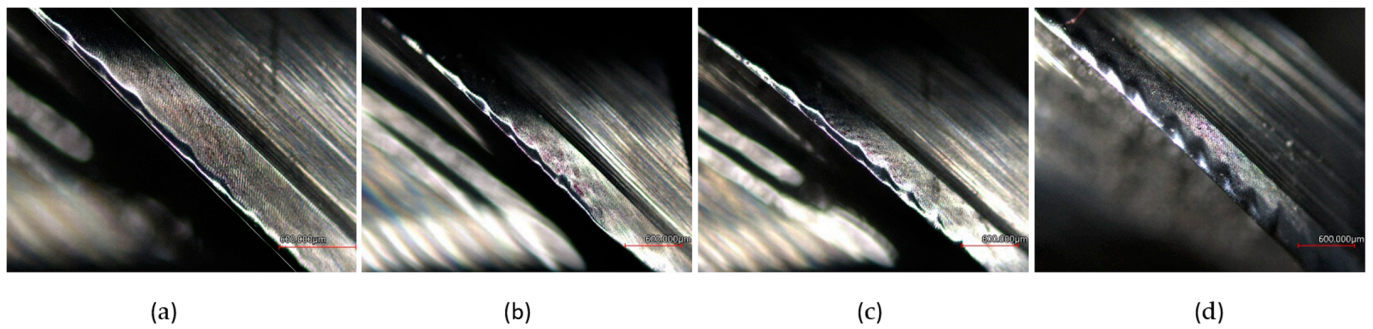
**Figure 29.** Tool wear of the A100 milling tool, laminate thickness 3 mm. (a) Tool tooth path  $5 \times 165$  m; (b) tool tooth path  $10 \times 165$  m; (c) tool tooth path  $15 \times 165$  m; (d) tool tooth path  $20 \times 165$  m.

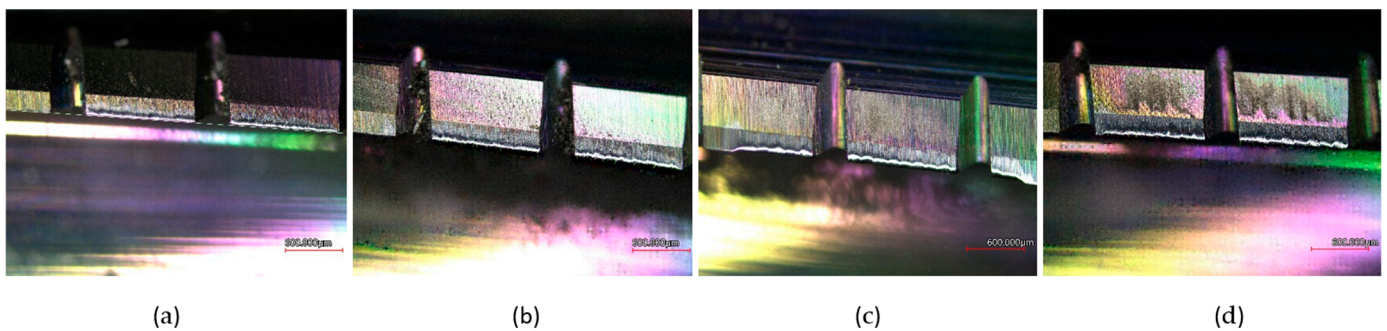
**Figure 30.** Tool wear of the ECSSF milling tool, laminate thickness 1 mm. (a) Tool tooth path  $5 \times 165$  m; (b) tool tooth path  $10 \times 165$  m; (c) tool tooth path  $15 \times 165$  m; (d) tool tooth path  $20 \times 165$  m.
