Blast Resistance of a Masonry Wall Coated with a Polyurea Elastomer

Abstract: The coating of polyurea elastomers on walls is a hotspot in the protection field. This work combines a numerical simulation with experimental validation to examine the blast resistance after coating a polyurea elastomer on a 370 mm wall under a contact explosion. Firstly, the failure limit, failure mode, and failure mechanism of the 370 mm unreinforced wall under different strength loads are studied. In the case of the contact explosion, the increase in size of the 370 mm wall blasting pit gradually stops after the dose is increased to more than 1 kg. Thereafter, the energy of the explosive load was released by splashing wall fragments as well as by the deflection and movement of the wall. Spraying double-sided polyurea reinforcement on the wall can effectively improve the resistance to damages caused by exposure to explosive loads and can inhibit the damage to the surrounding personnel and equipment caused by flying structural debris. When the polyurea thickness on the front surface is 6 mm, the optimal thickness of the back surface should be 2 mm.

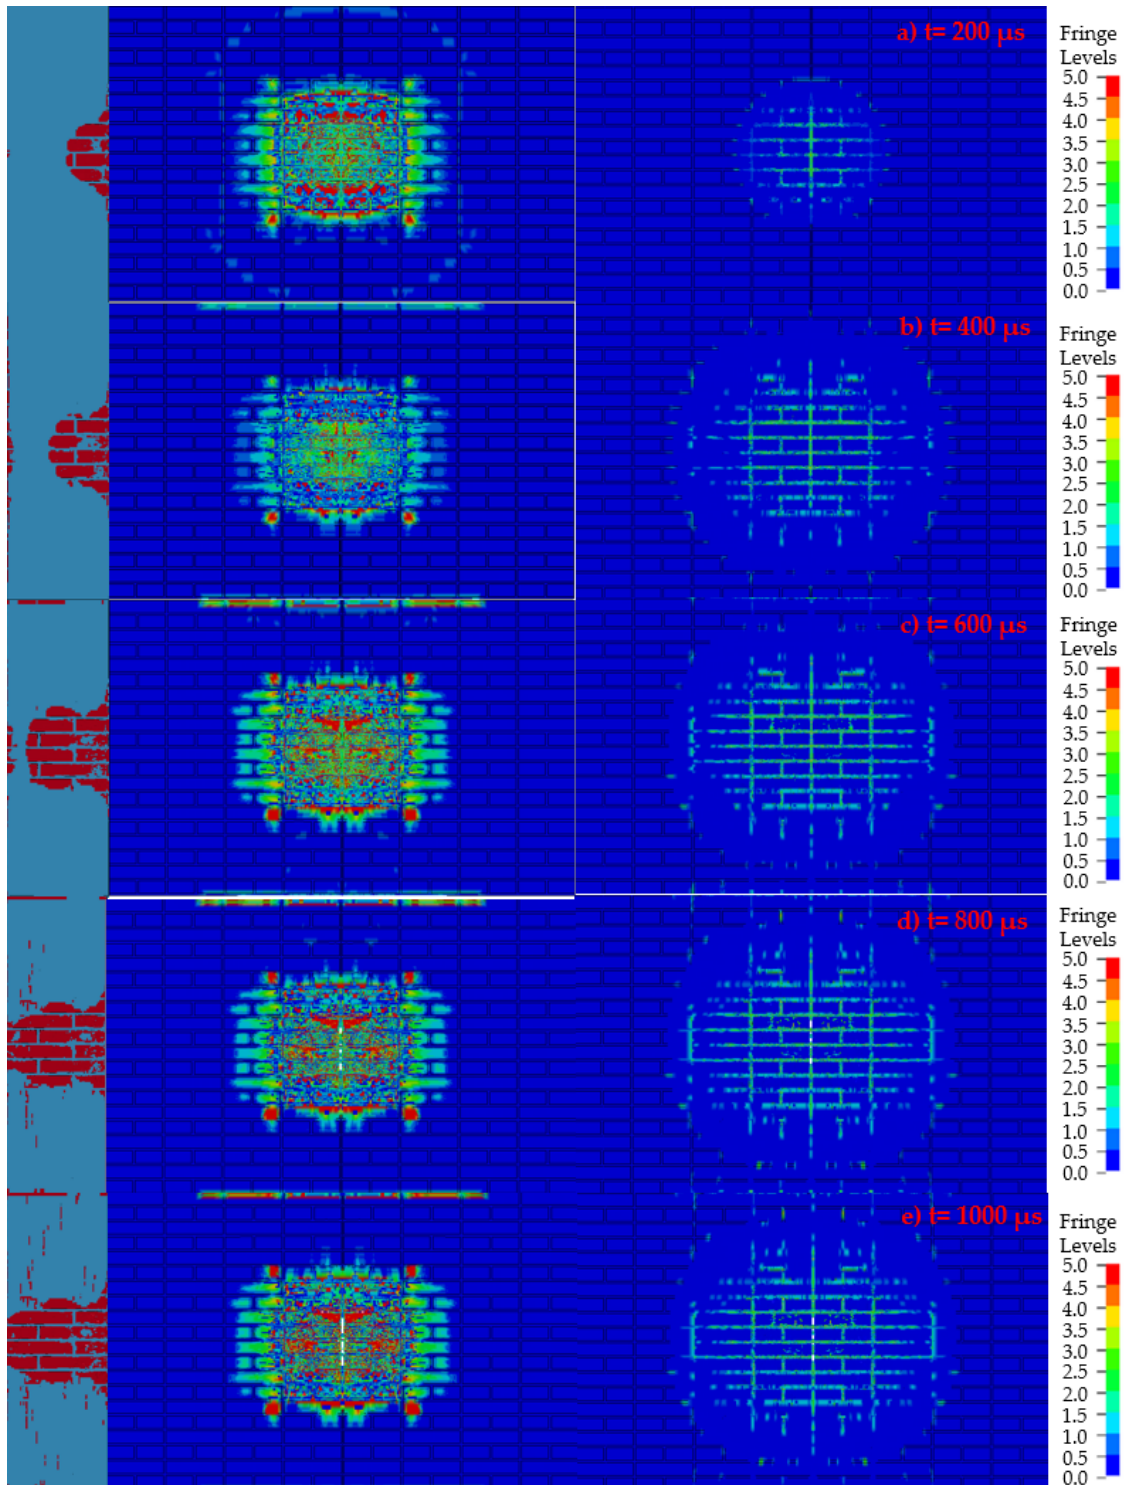
Figure 2 depicts the damage to the wall over time when the TNT was 1 kg. The left and middle figures show that the explosion load first caused a central blasting pit and longitudinal cracks on the blast front surface of the masonry wall and gradually formed divergent cracks along the mortar joint around the blasting pit at about 400 μ s. The longitudinal cracks expanded and thickened. The figure on the right suggests that the blast back surface first formed a longitudinal crack, and the central mortar joint of the wall began to crack at 400 μ s. As shown in Figure 2c–e, the cracks on the blast back surface show a divergent shape as a whole (except the rib plate).

Figure 2. Damage to the 370 mm wall at different times. (a) $200 \mu s$; (b) $400 \mu s$; (c) $600 \mu s$; (d) $800 \mu s$; (e) $1000 \mu s$.

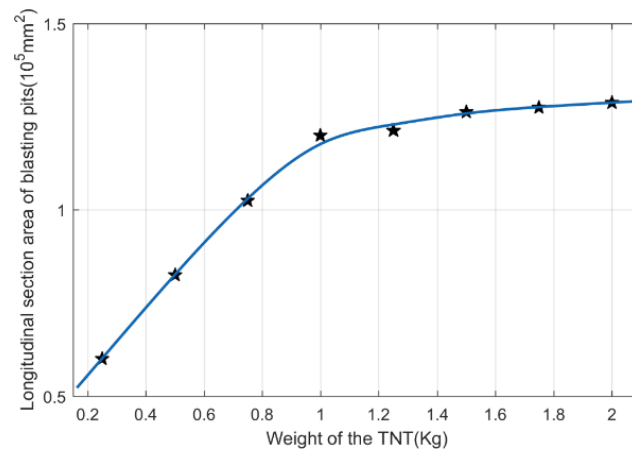
Figure 4a–c illustrate the linear increases in the area, depth, and radius of the blast pit when the explosive weights increase from 0.25 kg to 1 kg. However, with the increase in

mass of the charge, when the charge is greater than 1 kg, the area, depth, and radius of the explosive pit increase slowly and tend to be horizontal. This means that the charge mass of 1 kg is a critical state, and the damage form changes when it exceeds 1 kg.

Figure 4. Statistics for the longitudinal section size of the 370 mm wall under different weights of TNT: (a) longitudinal section area of the blasting pits; (b) diameter of the blasting pits; (c) depth of the blasting pits.

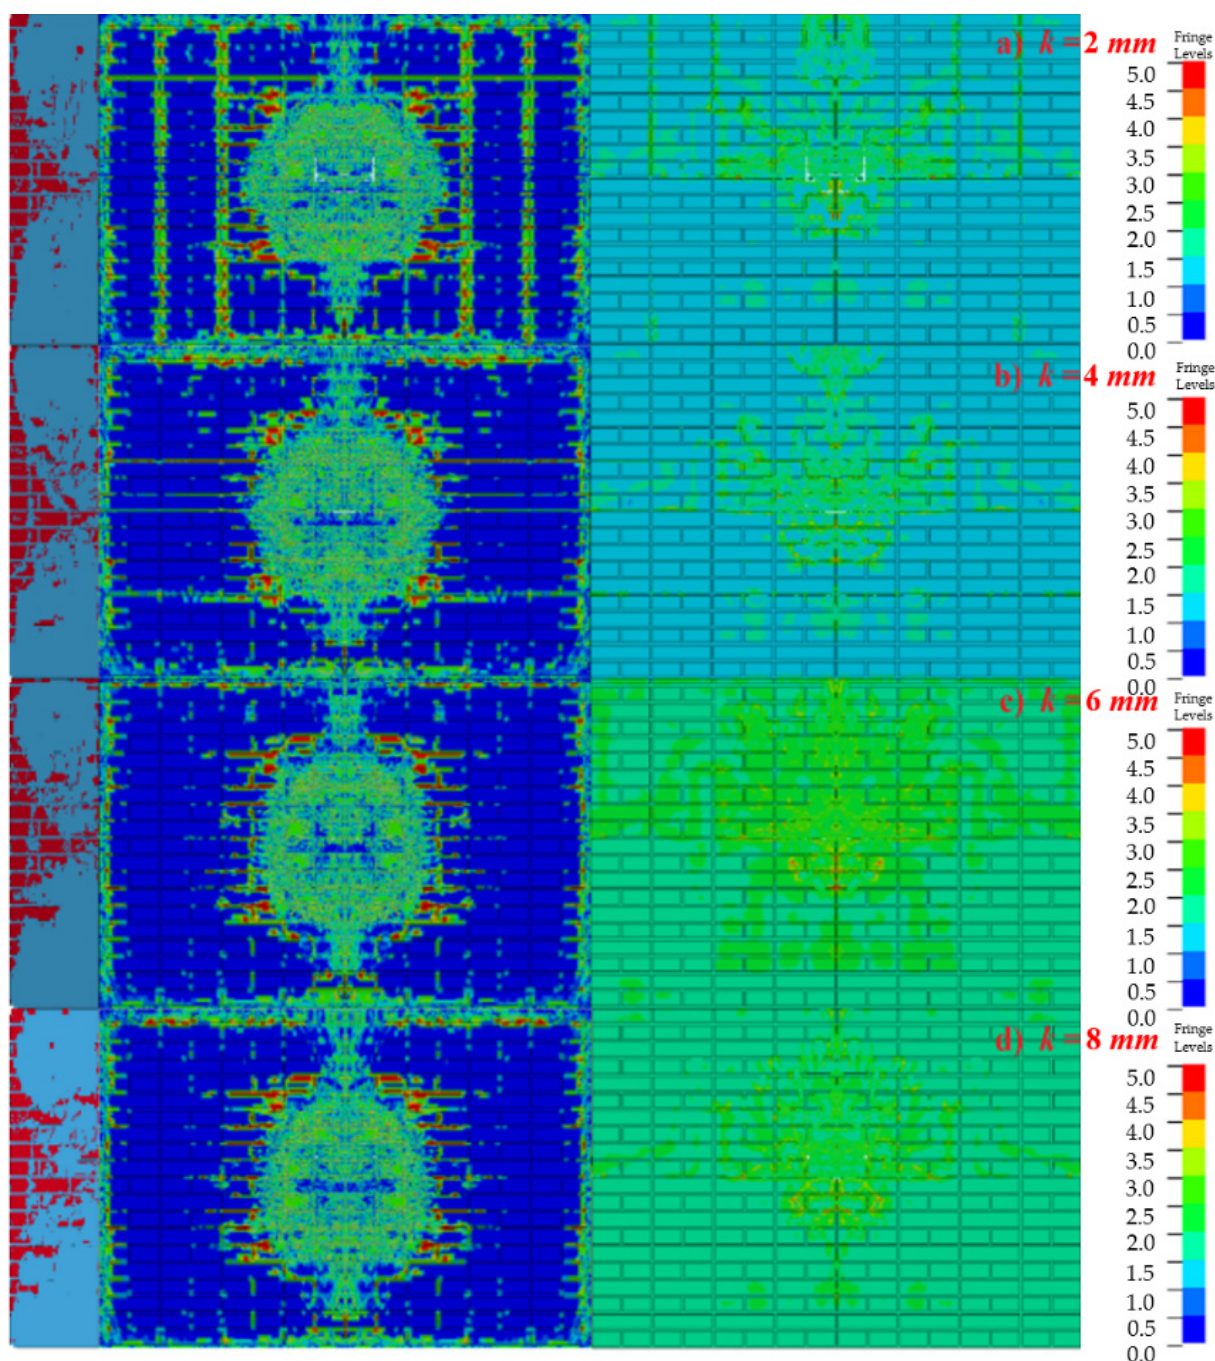
To more clearly see the damage to the reinforced masonry wall under contact explosions, Figure 8 was created without the polyurea reinforcement layers on each side. Only the damage to the bricks and mortar under the four working conditions in Table 4 is depicted in the image. The reinforced masonry wall's longitudinal section or symmetrical plane, blast front surface, and blast back surface are all destroyed on the figure's left, middle, and right sides, respectively.

Figure 8. Damage to the reinforced 370 mm wall under contact explosion at 1000 μ s with different k values (thickness of back face: (a) $k = 2$ mm; (b) $k = 4$ mm; (c) $k = 6$ mm; (d) $k = 8$ mm).

As shown in the longitudinal section on the left, when the thickness of the polyurea reinforcement layer on the front surface remained unchanged, the depth of the central blasting pit of the masonry wall did not change much with the increasing thickness of the back surface reinforcement layer, and the cracks were densely distributed inside the masonry wall. The damage to the front surface in the middle shows that the areas of the central blasting pit (circled in the figure) under the four working conditions were different. When the back surface was thin (i.e., in conditions 1 and 2, as shown in Figure 8a,b), the area of the blasting pit was larger. When the polyurea reinforcement layer was thicker (i.e., in conditions 3 and 4, as shown in Figure 8c,d), the area of the blasting pit was smaller; the spalling and cracking of the explosion-proof surface of the wall under the four working

conditions were also different. Compared with conditions 3 and 4, the damage phenomena, such as the spalling and cracks on the blast front surface of the masonry wall concentrated in the mortar joint in conditions 1 and 2, were more obvious. The damage to the back surface on the right shows that under the four working conditions, the mortar joints were all weak links, and the collapse and spalling developed along the joints, with an overall radial trend (except for the rib plate). Compared with working conditions 3 and 4, where the polyurea reinforcement layer on the back surface was thicker, the strain on the back surface of the masonry wall in working conditions 1 and 2 was smaller.

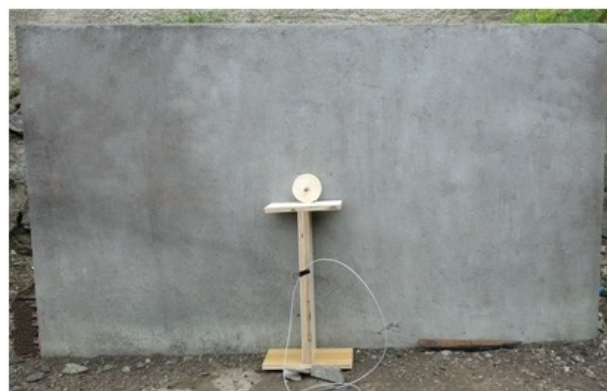
The test wall size was 2000 mm × 1200 mm × 370 mm, and a pair of ribs were symmetrically arranged on both sides of the wall to simulate the supporting effect of the surrounding walls on the actual building. The wall surface was smoothed with about 2 mm of mortar. The explosive used in the test was a TNT cylindrical compressed explosive with a charge density of 1.63 g/cm³. Two charge specifications were used, i.e., 0.50 kg (test 1) and 1.00 kg (test 2). The basic dimensions were Φ100 mm × 39 mm and Φ100 mm × 78 mm. The wall was larger than the explosive to ensure that the explosive would not destroy the entire wall and to avoid the influence of the masonry wall and the size effect of the charge. Tests 1 and 2 correspond to the b and d working conditions in the numerical simulation, respectively. The test layout is shown in Figure 9.

Figure 9. Test layout.

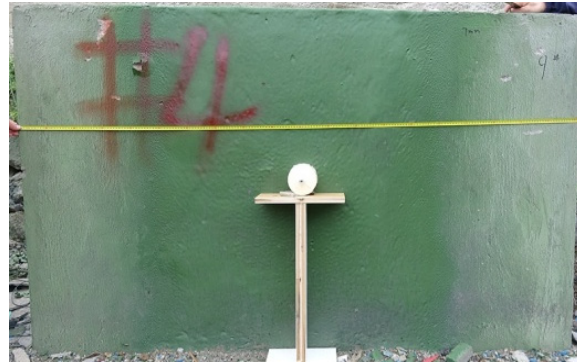
dimensions of 100 mm × 78 mm was employed in the test. The reinforced 370 mm wall was sprayed with a 6-mm-thick polyurea reinforcement coating on the blast front surface and 2-mm- and 4-mm-thick polyurea reinforcement layers on the rear surface, respectively. Tests 1 and 2 correspond to working conditions 1 and 2 in the simulation, respectively, and the layout of the test site is shown in Figure 11.

Figure 11. Test site layout.

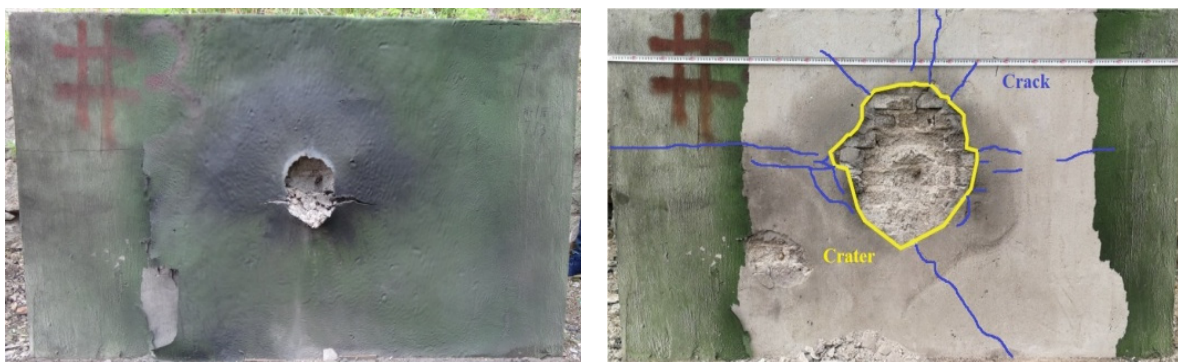
Figure 12 displays the damage to the reinforced wall during the test. The polyurea elastomer reinforcement layer coated on the surface was removed while maintaining the damaged state of the wall as much as possible. The right side of the figure demonstrates the damage to the wall when the reinforcing layer was removed. In tests 1 and 2, the center of the front surface in Figure 12a,b produced a hole with a small diameter, and on both sides of the hole there were several short tears. The area between the polyurea reinforcement layer and the brick wall “caught” some of the wall fragments, trash, and dust, which was visible through the hole in the reinforcement layer. Large blasting pits with shallow edges were formed in the center of the internal masonry wall, but the depth of the pits became larger in the part corresponding to explosive position. A large number of large radial cracks were distributed around the blast pit, with horizontal and vertical cracks penetrating the brick wall. In test 2, around the center blasting hole of the interior masonry wall, numerous little spidery fractures and spalls appeared along the mortar joints. Based on Figure 12c, the large cracks in the wall center of test 2 extended to the back surface, and the back surface of the internal masonry wall had cracks diverging from the center to the surroundings, where the horizontal and vertical cracks were the coarsest. The polyurea elastomer reinforcing layer on the blast back surface was not torn by massive fractures though. The reinforcing layer, which experienced a minor uplift under the displacement of the internal brick wall, blocked the huge fractures on top, as seen in the left half of Figure 12c.

Figure 12. Damage to the reinforced 370 mm wall in the test. (a) Test 1 blast front surface; (b) Test 2 blast front surface; (c) Test 2 blast back surface.
