Article

Evaluation of the Long-Term Performance of Marine and Offshore Coatings System Exposed on a Traditional Stationary Site and an Operating Ship and Its Correlation to Accelerated Test

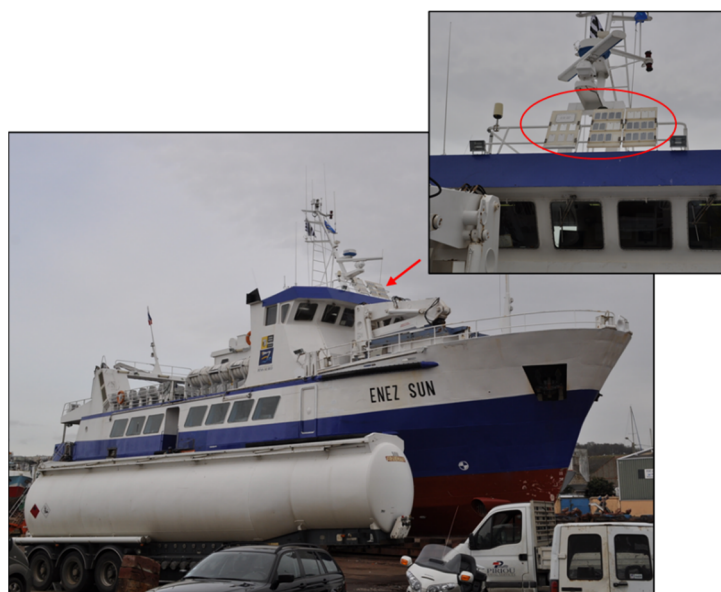
The exposure on the real structure was realized on an operating ship (Enez Sun) doing a daily routine (July–August: 6 h/day—rest of the year: 2–4 h/day) between Audierne and Sein Island in Brittany (France). The distance between Audierne and Sein Island was 23 km. The coated materials were exposed on an area with no disturbance from passengers and where they could be exposed correctly to the climatic conditions, as illustrated in Figure 1.

Figure 1. Photography of the coated samples exposed on the Enez Sun.

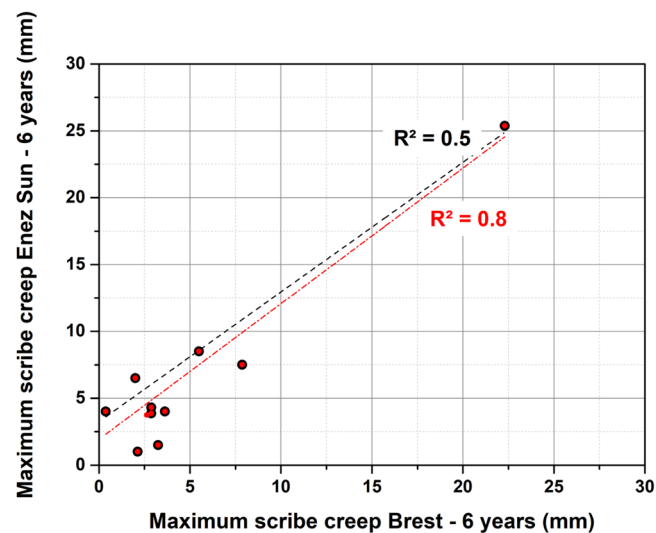
Simple linear regression was applied to evaluate the linear relationship between the two sites. According to the previous results, it is not surprising that no good linear correlation could be found between the stationary site and the operating ship, as exemplified in Figure 9. When the paint system S7 (epoxy aluminium) was excluded from the calculation, the coefficient of correlation, R^2 , was improved to 0.8. However, the satisfying correlation obtained was only due to the contribution of paint system S8 (epoxy glass flakes), which was the most degraded system. It was also observed by Knudsen et al. that a better correlation was obtained for coating systems with a poor performance, when comparing various combinations of coating systems between field exposures (5 years) and several accelerated tests [17,34]. The Spearman's rank correlation coefficient was also calculated, and no strong relationship was found between the two sites. The Spearman correlation allows for estimating the degree of relationship between two sets of data, as well as how each set of data will influence the other (negative or positive influence).

Figure 9. Linear regression plot between the maximum scribe creep before coating removal (M1) for Brest and Enez Sun. The red plot is the linear regression plot, with S7 excluded.
