# Experimental Study on the Bending Resistance of Hollow Slab Beams Strengthened with Prestressed Steel Strand Polyurethane Cement Composite

**Abstract:** In order to explore the toughening performance and failure mechanism of hollow slab beams strengthened with prestressed steel strand polyurethane cement composite, three test beams (L1–L3) were strengthened and one test beam (L0) was used as a comparison. The influence of different tensile stresses of steel strand and fiber additions on the flexural bearing capacity of the hollow slab beams, was studied. The cracking characteristics, load deflection relationship, ductility and strain of each test beam were compared and analyzed. The test results showed that the toughened material was well bonded to the hollow slab beam and the steel strand, which effectively inhibited the development of cracks in the test beams. The flexural bearing capacity of the strengthened test beams was significantly improved. The use of prestressed steel strand polyurethane cement composite material effectively improved the flexural bearing capacity of the test beams, and this reinforcement process can be further extended to engineering applications.

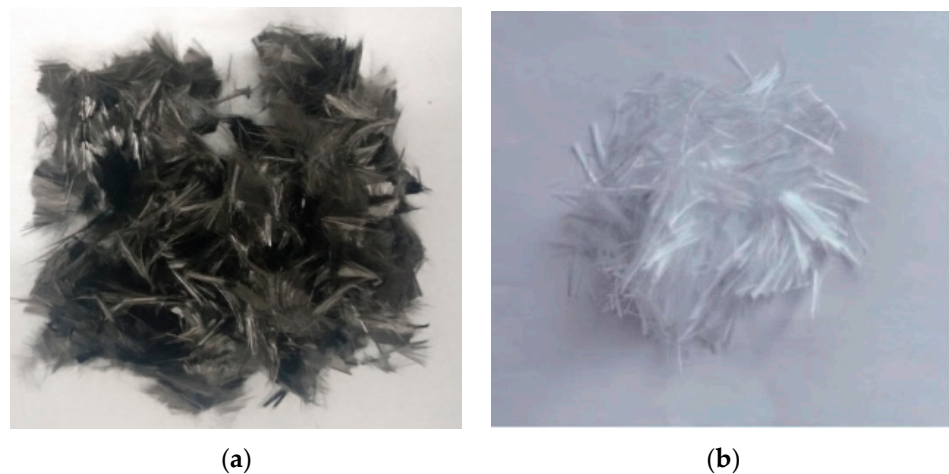
Figure 1. Test fibers: (a) carbon fiber, (b) glass fiber.

Polyurethane toughening test with carbon fiber and glass fiber: see Figure 1. Performance indexes are shown in Table 2.

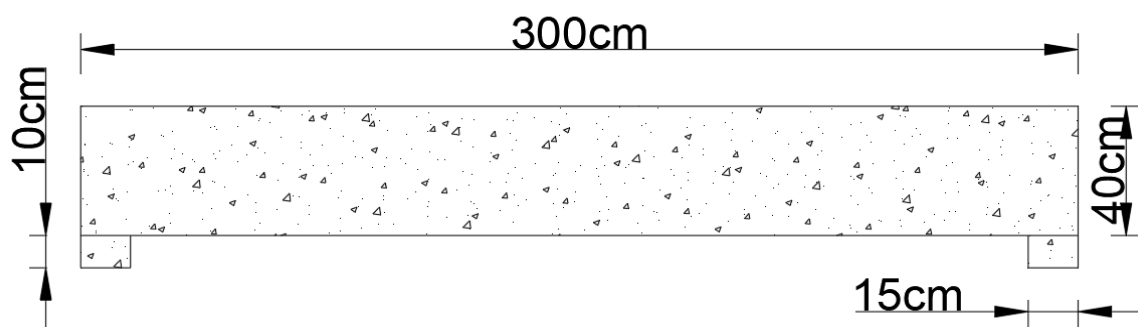
Figure 2. Longitudinal section of the test beam.

A total of 4 test beams, numbered L0–L3, were formed in this test. The control beam L0 was not strengthened, and the test beams L1–L3 were toughened in different ways. The length, width and height of the test beams were 300, 50 and 40 cm, respectively. Circular channels with a diameter of 25 cm were arranged in the cross section of the hollow slab beam. Hollow slab beams at both ends of the pouring support measured a support size length, width, and height of 50, 15, and 10 cm, respectively; in the test beams L0–L3, reserved tension channels were supported for the insertion of steel strands. The specific test beam sizes are shown in Figures 2 and 3.

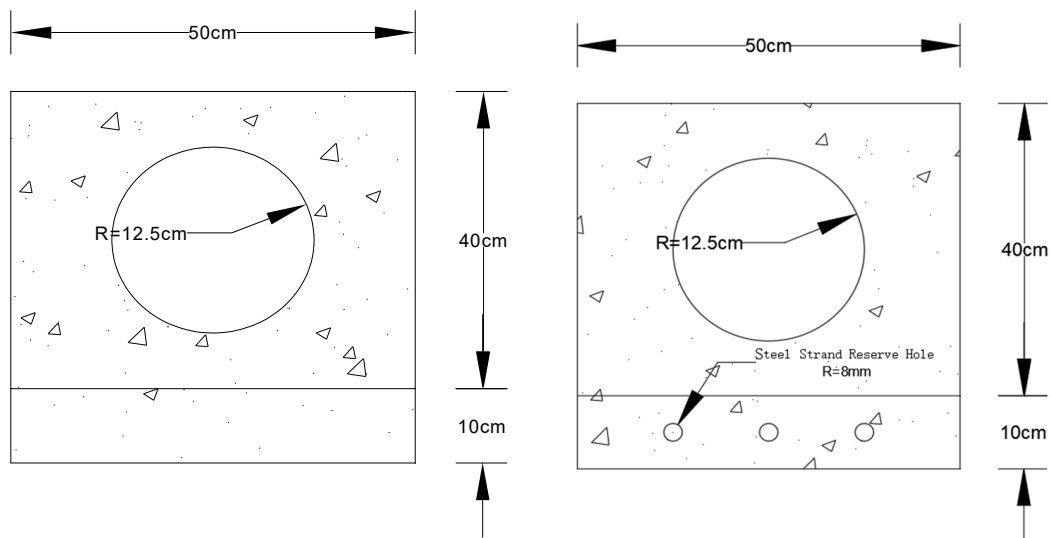
**Figure 3.** Cross section of the test beam.

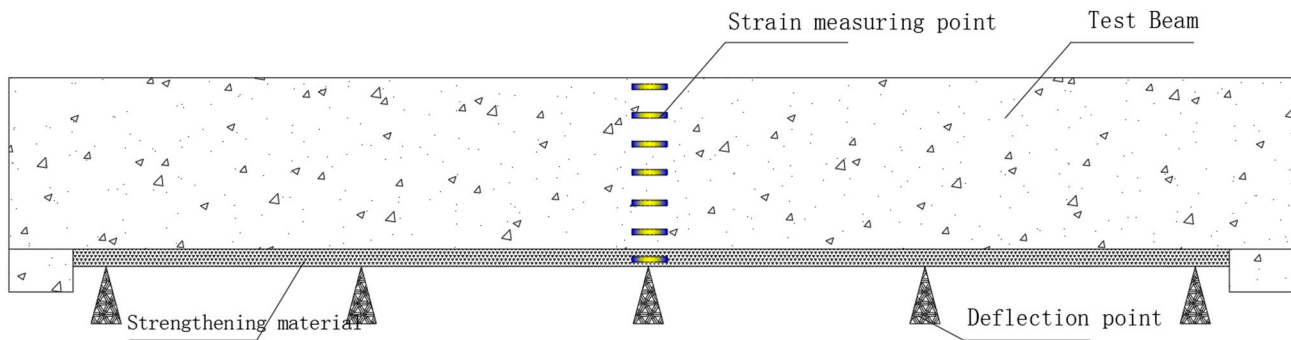
**Figure 4.** Layout diagram of strain and deflection measurement points.

In order to better reflect the strain situation along the beam height in the middle of the test beam span under all levels of load, a strain measuring point was set up on the middle side of the test beam span, with an interval of 6.6 cm between two adjacent measuring points. A total of 6 measuring points were set up on test beam L0, and 7 measuring points

were set up on test beams L1–L3. In order to observe the tensile changes of the beam bottom under various loads, two strain measuring points were arranged at the bottom of the mid-span beam.

In order to more clearly reflect the displacement changes of the test beam at the key section under all levels of load, deflection measurement points were placed at the bottom support, at 1/4 of the test beam and at the middle of the span. A total of 5 deflection measurement points were arranged for each test beam. See Figure 4 for the layout of the strain and deflection measurement points.

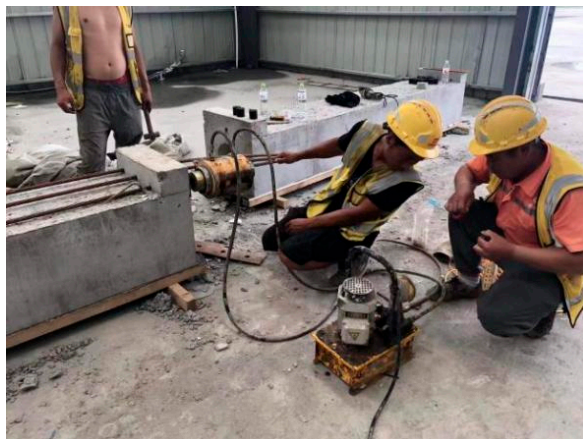
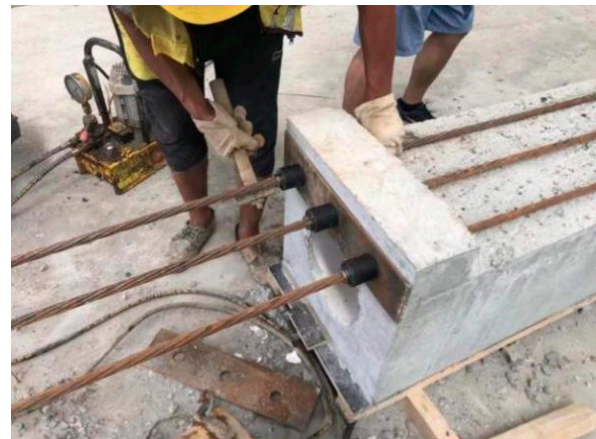
**Figure 5.** Field photograph of steel strands: (a) tensioning, (b) anchorage.

In total, 12 steel strands of 4 m length were cut. One end of the reserved channel was anchored with a single anchor head, and the other end was laid with an anchor plate and tensioning jack. The tensioning stress was controlled through the tensioning stress table and elongation. See Figure 5 for tension and anchorage of the steel strands.

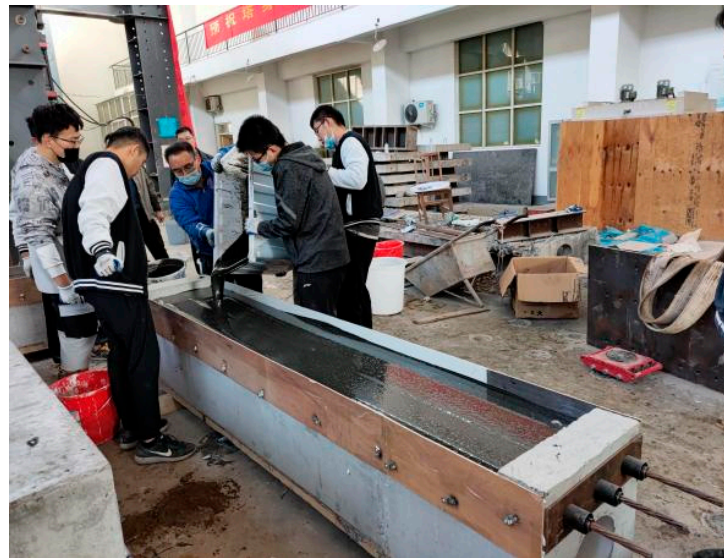
Figure 6. Site pouring.

The toughening material was weighed and mixed according to the ratio and then poured into the mixing bucket for full stirring with a hand-held agitator. After the materials were mixed evenly, the mixture was poured directly onto the beam surface. Due to the fast condensation of the reinforcement material, it was stirred continuously in the process of mixing and pouring to prevent consolidation of the material. After demolding and curing at 20 °C for 14 days, flexural capacity testing of the hollow slab beam was carried out. The site pouring and loading are shown in Figures 6 and 7.

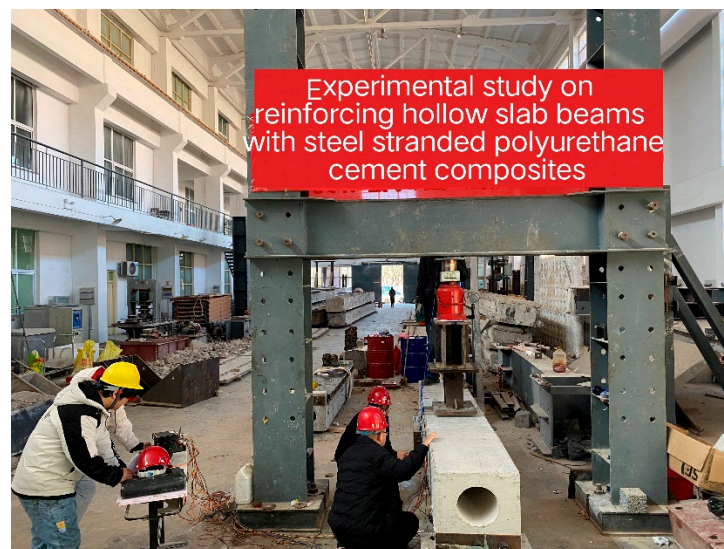
Figure 7. Field loading.

The test used a reaction frame to load through the jack, and the load was applied to the test beam through the steel plate, the pressure sensor, the distribution beam and so on. The distribution beam interval was 25 cm. Before the test, an initial load of 10 KN was applied to observe whether the strain gauge, displacement sensor and pressure sensor were working normally through the static acquisition system. After the inspection, the jack was unloaded, the data of the static acquisition system was cleared, and the formal loading began, with 15 KN loading per level. During the loading process, the phenomena of the test beam under each load were recorded, and a crack width meter was used to observe and record the crack development on the test beams at all times. Additionally, attention was paid to cracking sounds.

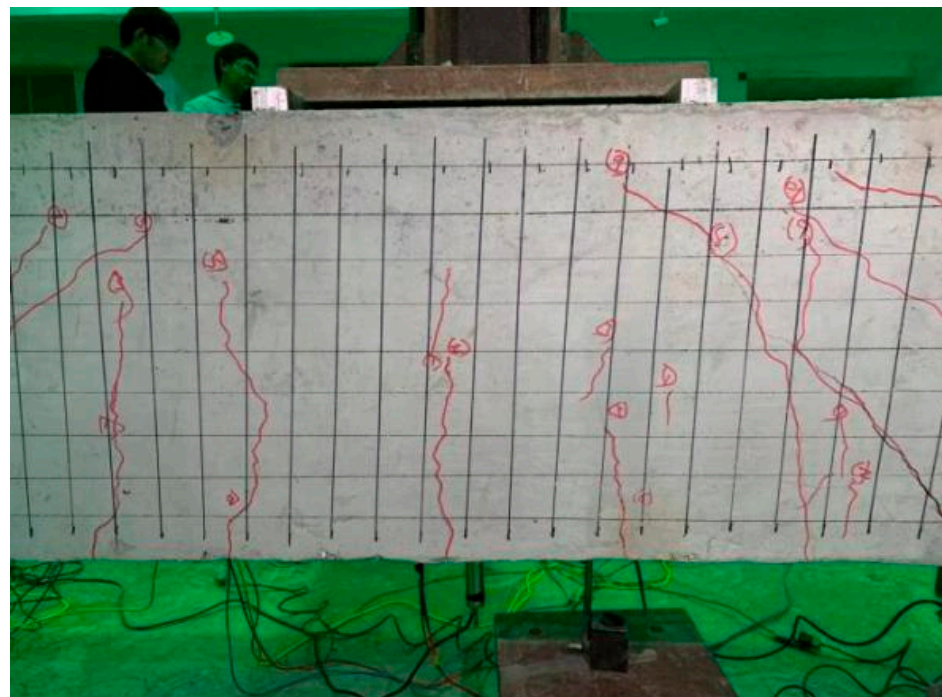
Figure 8. Crack pattern of L0 beam.

During loading, cracks appeared in all beams, and multiple cracks appeared with the acceleration of deflection growth, rapid crack extension, and crack spread to the top of the beams. Before cracks appeared in L1–L3 reinforced beams, the deflection and strain increased regularly with the increase in load. The deflection of the midspan section increased weakly, and the strain changes at different heights of beams were not obvious. When the crack spread to the top of the beam, it was accompanied by the fracture of the polyurethane-reinforced material. The concentrated forces, corresponding to the midspan sections of L0 and L1–L3 of the reinforced beam at each state, are shown in Table 5. The cracks and fractures of each beam are shown in Figures 8–11.

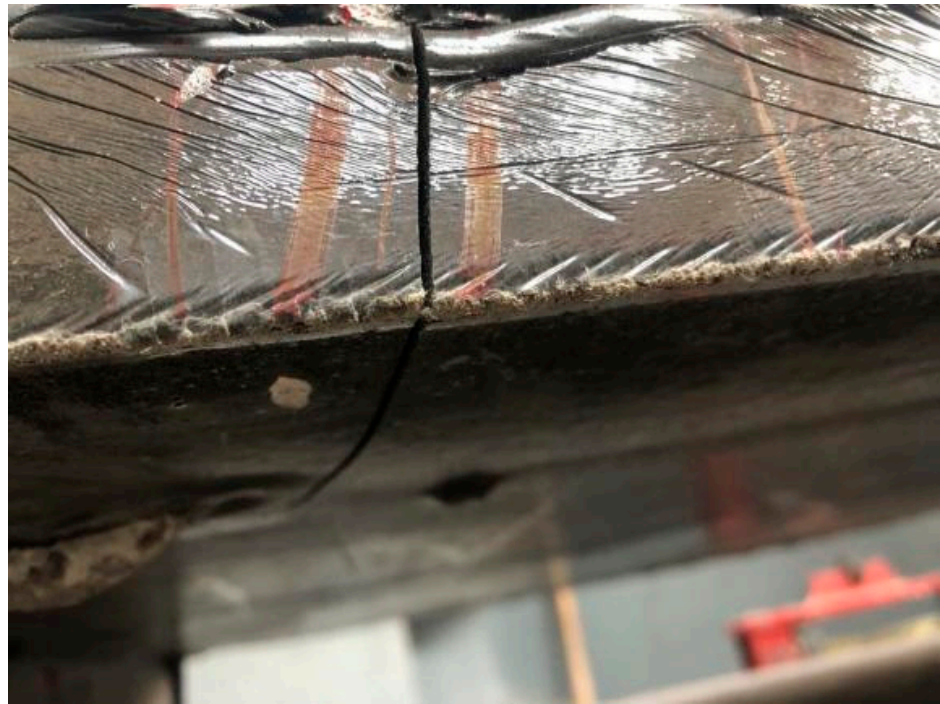
Figure 9. Fracture of L1 polyurethane.

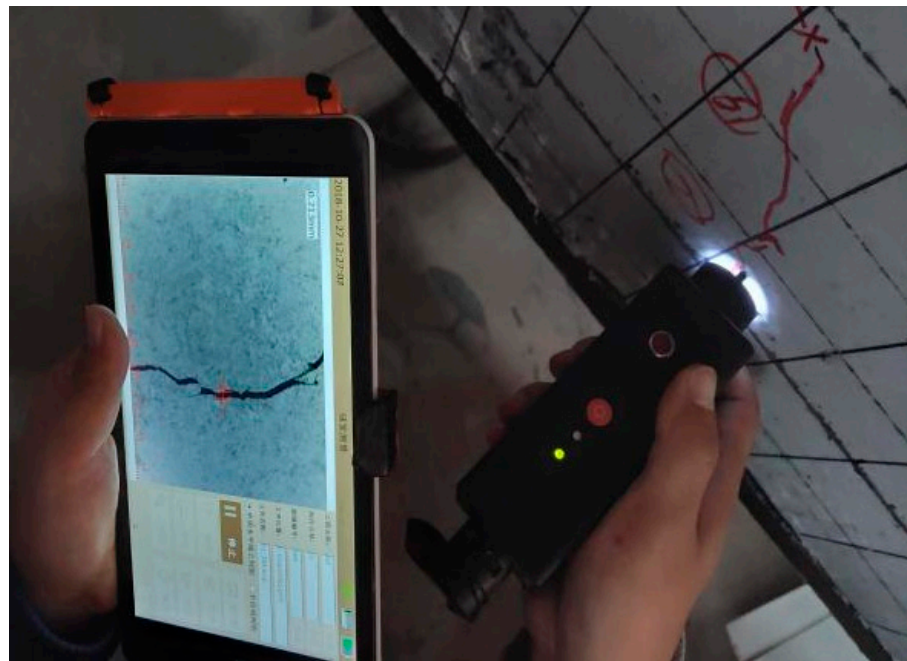
Figure 10. Crack opening assessment for L2 beam body.

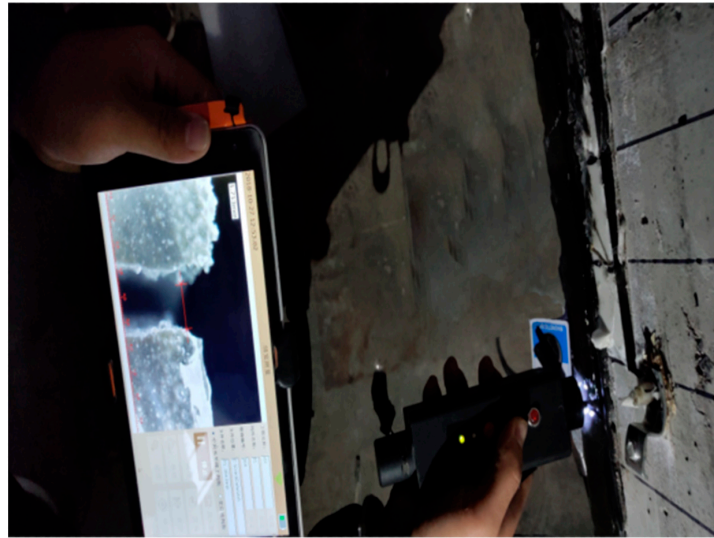
**Figure 11.** L3 crack penetration.

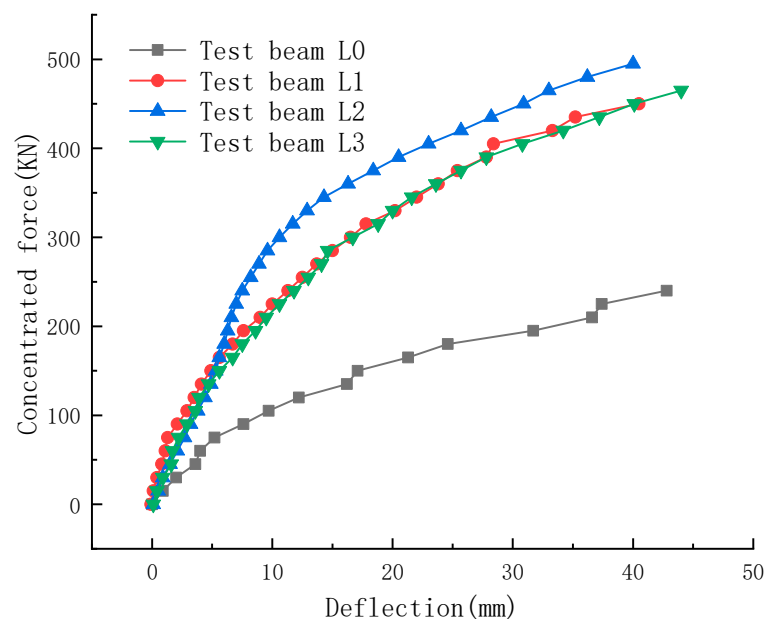
**Figure 12.** Load–deflection curve (crack development yield limit).

The whole process of stressing and deformation of the test beams L0–L3 under load was experienced as follows: no cracks in the concrete, initial crack appearance and development, and finally, failure. When there was no crack in the test beam, the applied concentrated force was lower than the cracking load, the load–deflection curve was basically linear, and the test beam was in the state of elastic force. After cracking, the slope of the load–deflection curve gradually decreased, showing a nonlinear trend. When the bending moment reached a certain value under the load, the deformation of the beam was limited under the constraint of the steel strand, and the crack width and deflection of the test beam increased slowly with the increase in the load. When the test beam was damaged, the deflection increased rapidly, the cracks developed rapidly and spread above the neutral axis, the concrete compressive strain at the edge of the compression zone reached the ultimate compressive strain, the concrete was crushed, the reinforcement layer broke, and the beam side in the middle of the span appeared through cracks. The load–deflection curve is shown in Figure 12.

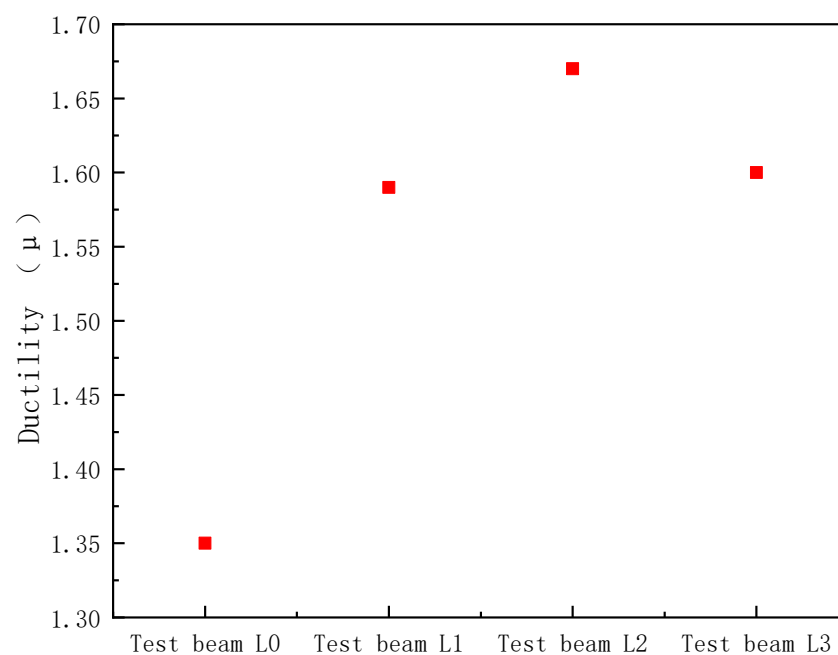
**Figure 13.** Ductility of each test beam.

The displacement ductility coefficient  $\mu$  was calculated by the ratio of the mid-span ultimate deflection  $\delta_u$  of the test beam to the yield deflection  $\delta_y$ . The results of the ductility of the test beams L0–L3 are shown in Table 6, and the scatter distributions of the ductility of each test beam are shown in Figure 13.

According to the distribution of ductility scatter in Figure 13, compared with the test beam L0, the ductility levels of the test beams L1–L3 significantly increased, by 17.8%, 23.7% and 18.5%, respectively. This indicated that the combined reinforcement of prestressed steel hinge lines and polyurethane cement composite could effectively improve the ductility of hollow slab beams and provide a greater safety reserve for structural applications. Compared with test beam L1, test beam L2 improved structural ductility by 5% by increasing the tensile stress of each strand by 100 MPa, and the steel strand tensile stress had some effect on the structural ductility. Meanwhile, test beam L3 improved ductility slightly, by mixing 0.04% carbon fiber and 0.04% glass fiber. Therefore, it was speculated that the toughened fiber and polyurethane materials were not fully mixed evenly during mixing, or the density of the toughened fiber was greater than that of the polyurethane cement

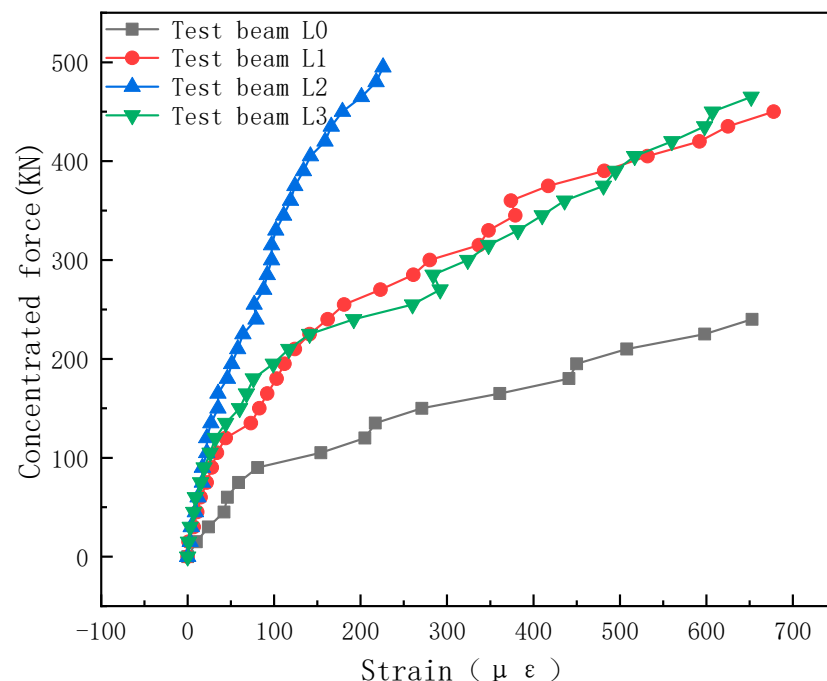
**Figure 14.** Load and strain at the bottom of the test beams.

The variation trend of the strain at the bottom of the test beam was roughly the same as that of the load–deflection curve, and the three stages of stress and deformation of the test beam under load were also verified. As shown in Figure 14, load–beam bottom strain, the test beam was in the elastic stress stage before cracks appeared, and the load–beam bottom strain at this stage was basically linear—that is, with continuous increase in load, the beam bottom strain did not greatly change. At this stage, the ground strand and polyurethane cement composite materials played a small role, mainly in beam force. When the concentrated force reached the cracking load of the test beam, the test beam immediately entered the elastic–plastic stage. At this stage, the load–beam bottom strain curve showed a nonlinear relationship. At this stage, the strain increased significantly with the incremental increase in load. At this stage, steel strand and polyurethane cement composite materials played a major role. When the load reached the yield load, the test beam entered the failure stage. At this stage, the steel bar reached the yield state, and the concrete of the test beam could be crushed or the polyurethane cement composite could be pulled off. The variation trends of L1 and L3 of the test beams were close to that of the load–deflection, which had similar characteristics. The load–beam bottom strain curve could, thus, effectively verify the variation trend of the load–deflection curve and the performance characteristics of the test beam under load, and more scientifically and accurately describe the mechanical properties of the test beam.

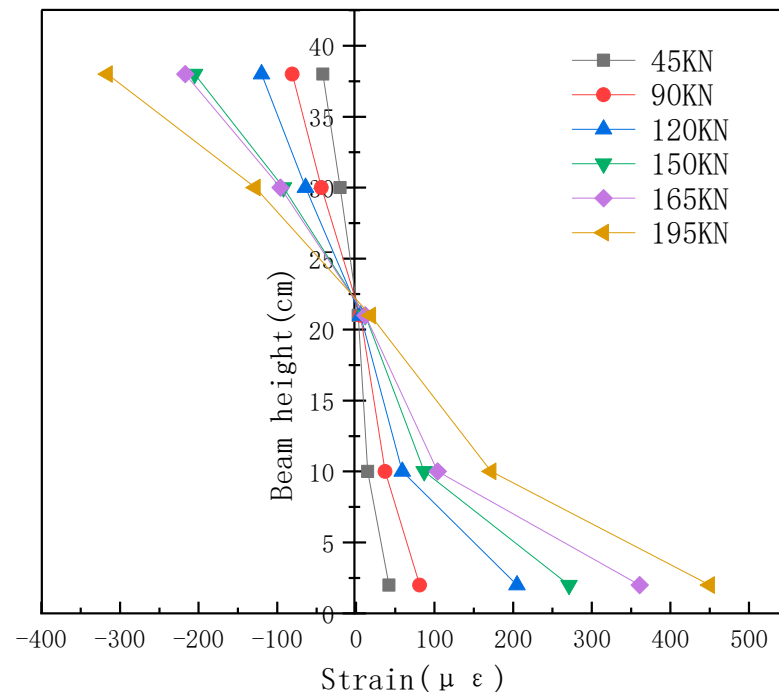
Figure 15. Strain of test beam L0 along beam height.

Through the flexural capacity test of the normal section of the test beam, the concentrated force was applied incrementally in the middle of the span. The concrete strain values of different sections of the beam height under different loads were obtained using the static strain collection instrument, and a distribution map of the measured average strain was drawn. As shown in Figures 15–18, when the test beam was in the elastic stress stage, there was no damage to the concrete beam, and the neutral axis of the section gradually moved to the compression zone as the load increased. At this time, the applied load was small, the concrete below the neutral axis was under tensile stress, and the concrete above the neutral axis was under compressive stress. At this time, the strain was an inclined straight line, and the strain distribution along the high section of the beam under the load was a triangle, with the top and bottom opposite. The concrete test beam at this stage fully conformed to the assumption of the plane section. When the test beams in the elastic–plastic stress test (L1–L3) reached the cracking load, below the neutral axis of the concrete cracks, reinforcement with the surrounding concrete occurred, producing relative displacement. However, at this stage, the prestressed steel hinge line and polyurethane cement composite began to undertake the main external load, offsetting part of the tensile stress. Under the action of load, the strain distribution along the high section of the beam was approximately triangular from top to top, and the average strain distribution of other sections of the beam across the crack was still consistent with the assumption of plane section. When the test beam was in the failure stage, the crack width in the tensile zone of the test beams L0–L3 increased sharply and the steel bar yield in the tensile zone occurred in a finite length range. The concrete in the compression zone was crushed within a certain length range, and the polyurethane cement composite did not peel or fracture. The section deformation at this stage was still approximately consistent with the assumption of the plane section.

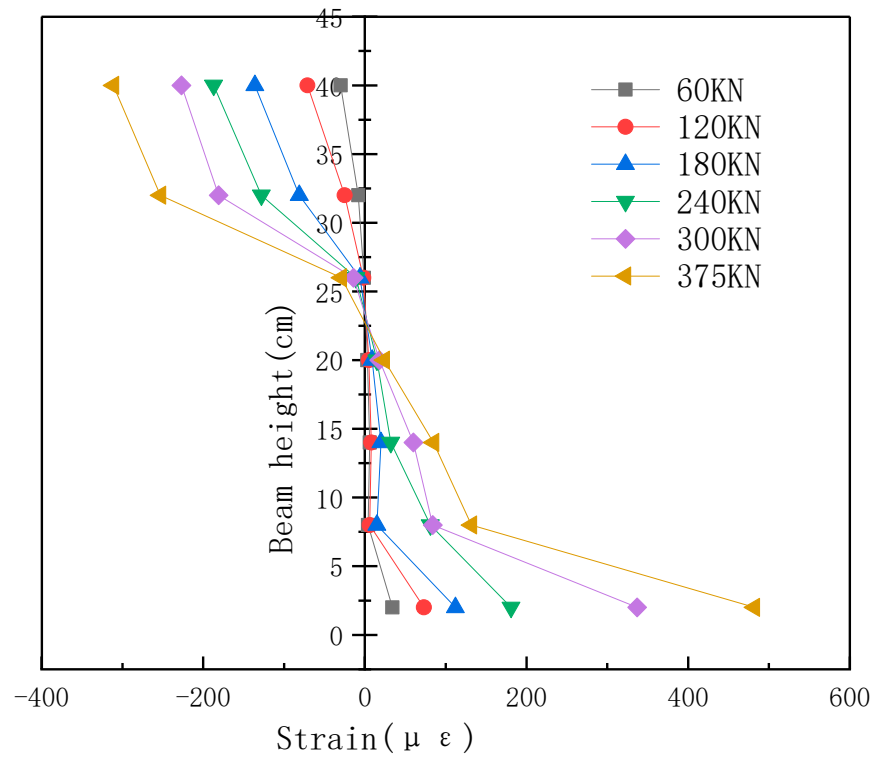
Figure 16. Strain of test beam L1 along beam height.

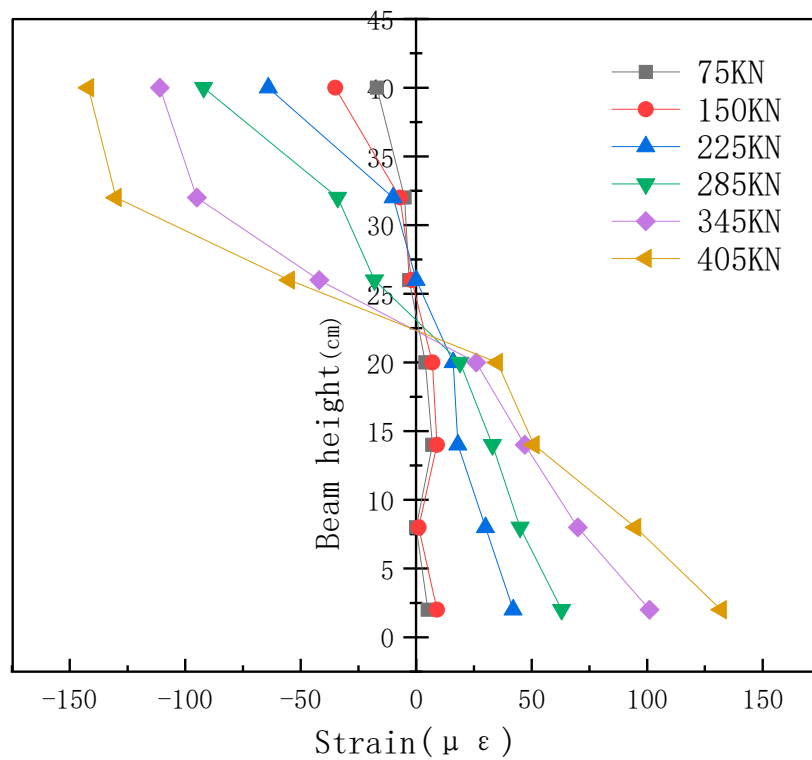
Figure 17. Strain of test beam L2 along beam height.

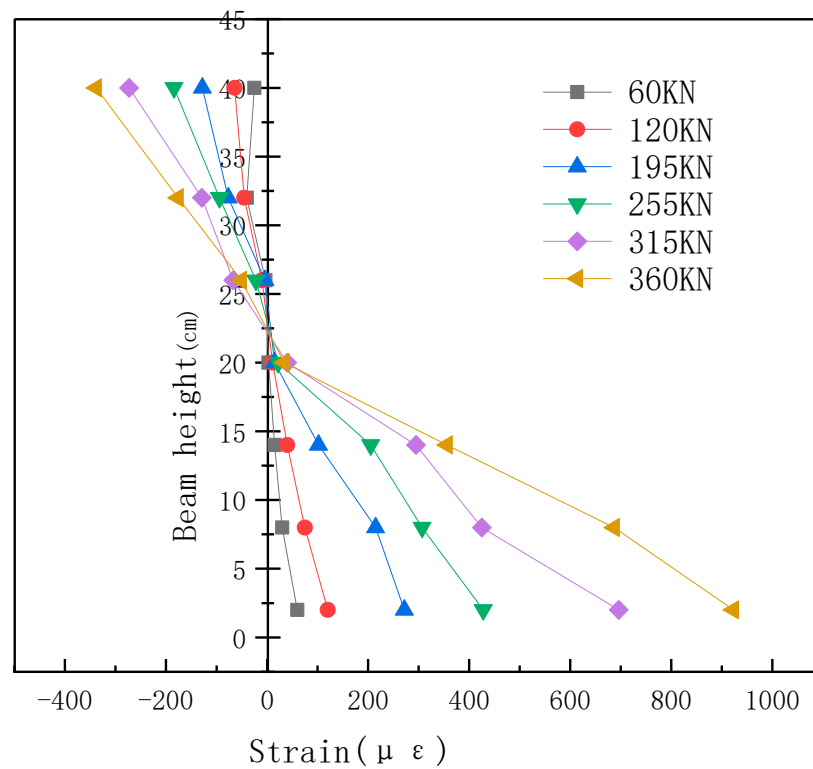
Figure 18. Strain of test beam L3 along beam height.

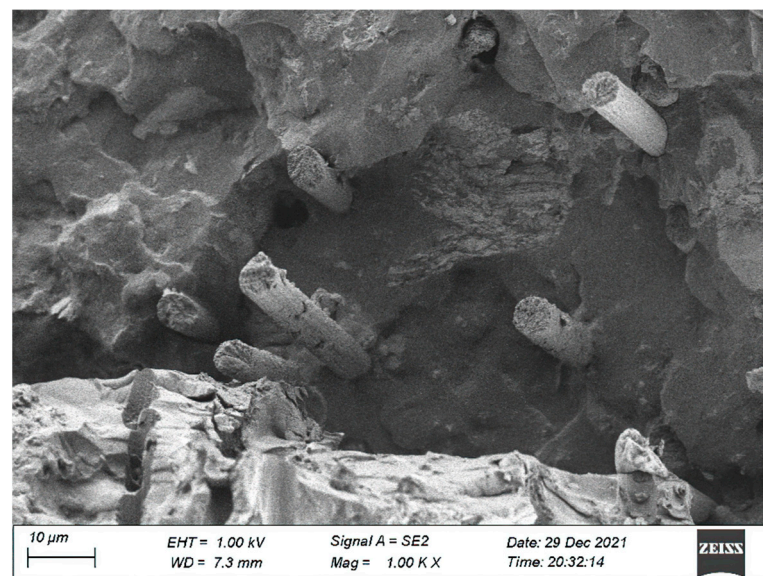
Figure 19. A 10 μm SEM micrograph.

The good adhesion of polyurethane cement composite could be clearly observed by SEM. There was no gap or crack between the fiber and the polyurethane cement composite, as shown in the figures below. As shown in Figures 19 and 20. It can be seen that the fiber played a positive reinforcement role [14].

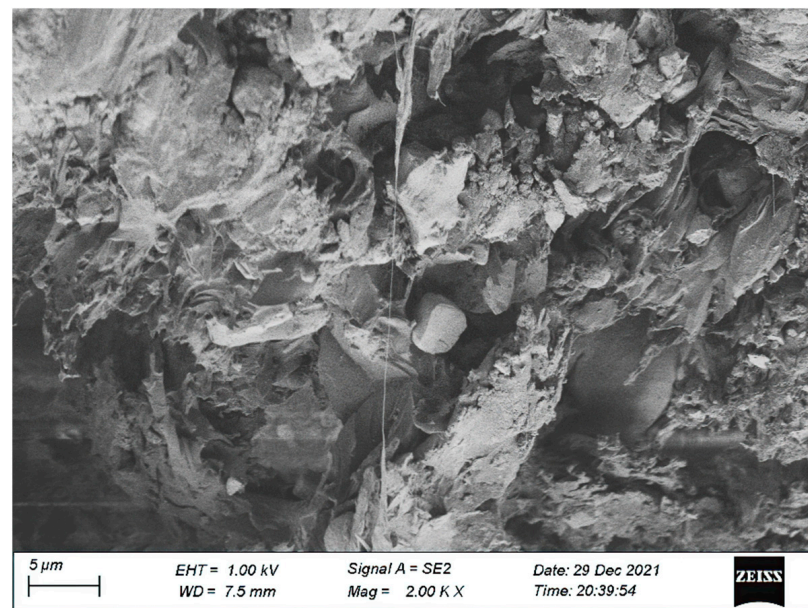
**Figure 20.** A 5  $\mu\text{m}$  SEM micrograph.
