Article

Effect of High-Temperature-Assisted Ultrasonic Deep Rolling on Microstructure and Tribological Properties of Ni-WC Coatings

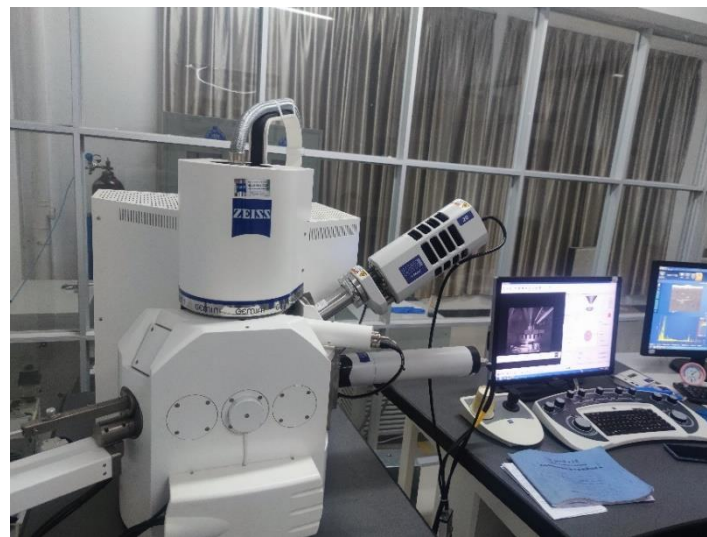
Figure 2. Electron microscope (ZEISS Sigma) with spectrometer.

The microstructure of the cermet coating was observed by electron microscopy (ZEISS Sigma, Jena, Germany), and the surface elements of the coating were analyzed by energy dispersive spectrometry (EDS), as shown in Figure 2. The JB-6C inductive surface roughness tester was used to randomly measure the surface roughness of the coating in three regions of the sample, and the average value was taken to reduce the error. The gradient microhardness of the cermet coating was tested by a CHV-1000A microhardness tester with an experimental load of 100 g and an application time of 15 s. Ten regions were selected for each position, and the average value was taken. The residual stress test of the coating surface was carried out by an X-350A X-ray stress analyzer, and the Cu target $K\alpha$ line was selected and measured by the roll fixed ψ method. The principle is that the residual stress changes the crystal structure of the material, the diffraction peak is displaced, the diffraction line displacement is used as the original data, and the measured result is the residual strain. Then, the residual stress was calculated by Hooke's law, as shown in Formula (1):

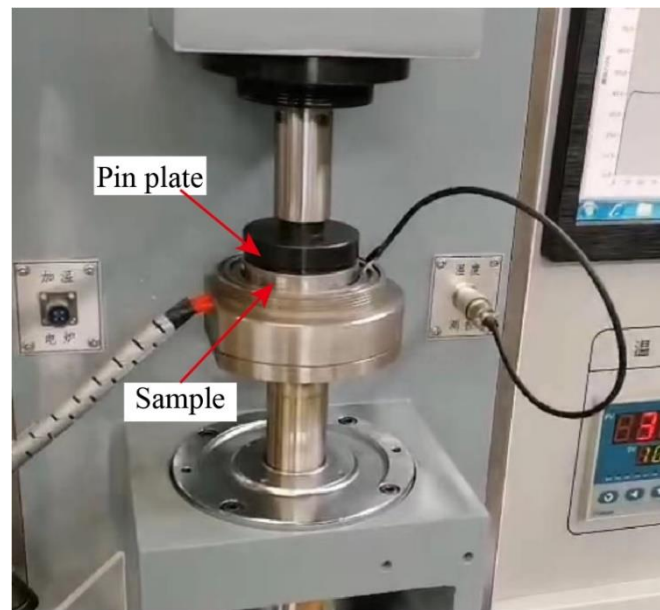
Figure 3. MMW-1A friction and wear testing machine.

A large pin plate wear test on the surface of the sample was performed at room temperature using an MMW-1A friction and wear testing machine (Jinan Chenda Testing Machine Manufacturing Co., Ltd., Jinan, China). As shown in Figure 3. The friction pair material was 45 steel with φ 4 mm \times 12 mm, and the hardness was HRC40-HRC45. The friction and wear test parameters are listed in Table 4.

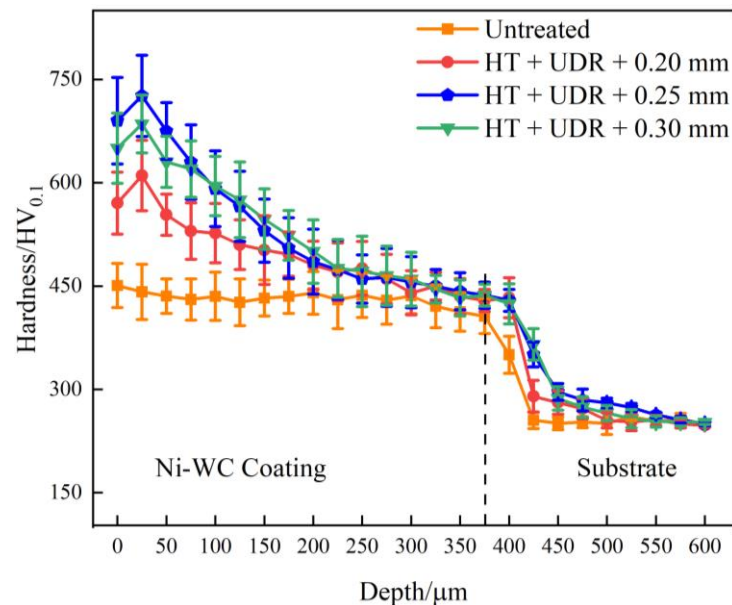
Figure 8. Distribution of hardness along with depth under different preloading depths.

According to the formula, with the decrease in the mean free path of dislocations and the increase in dislocation density, the grain size decreased, and the microhardness increased. The hardness of the Untreated coating varied with different preloading depths, which was less than that of HT + UDR. However, the hardness did not increase with increasing preloading depth, it increased between 0.20 mm and 0.25 mm and then decreased from 0.25 mm to 0.30 mm. Combined with the analysis of the microstructure of the coating, the impact stress on the surface of the cermet coating was more significant when the preloading depth was too high, resulting in wrinkling and micro-cracks on the surface of

the coating, and the surface roughness will increase, which had a particular influence on the uniformity of the microhardness. With the increase in the preloading depth, the plastic change layer and work hardening layer of the coating were improved. When the depth was more than 0.25 mm, the maximum microhardness no longer increased, the depth of strengthening also gradually became slow, and the hardness tended to be consistent after reaching the substrate.

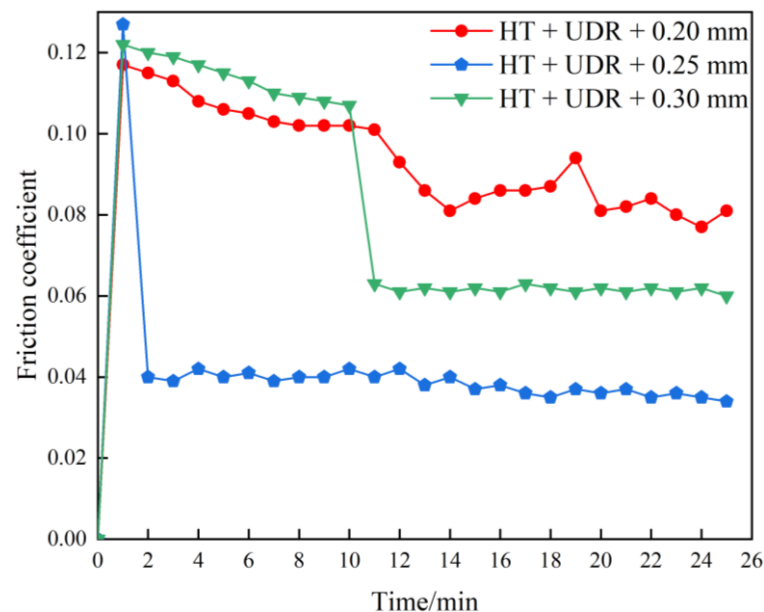
Figure 10 shows the friction coefficient curves of the samples after different preloading depth treatments. In the initial stage of friction and wear, the friction coefficients showed a sharp rise trend and then gradually decreased to a stable stage. In the initial stage, the soft base was first worn off by the surface of the friction pair to produce scratches, furrows, or fragments, and the remaining hard points formed a prominent surface to rub against the surface of the friction pair, leading to a large friction coefficient. As the friction and

wear entered the second stage, the wear contact part of the coating began to peel off, and oxidation continued to increase. At this time, the wear contact interface was micro peak and chip layer, and the friction coefficient decreased. When the wear entered the third stage, the friction coefficient gradually stabilized. Mechanical meshing and molecular attraction were involved in the coating wear process. According to the tribology principle, the calculation formula of the friction coefficient is as follows:

Figure 10. Friction coefficient of the coating under different preloading depths.

The initial friction coefficient of HT + UDR + 0.20 mm was the smallest, and it fluctuated more. The initial friction coefficient of HT + UDR + 0.25 mm was the largest, but it quickly reached the stable stage. The initial friction coefficient of HT + UDR + 0.30 mm was in the middle, then gradually decreased, then dropped sharply at 10 min, and gradually fluctuated steadily. The surface quality under the 0.20 mm preloading depth was relatively poor with pits and grooves, which resulted in contact stress concentration, local friction heat, high adhesion, and oxide, promoting the friction coefficient to fluctuate in an unstable way. Tribology mentioned in molecular mechanical theory that there were many tiny bumps on the smooth surface from the atomic scale. When the normal pressure was more than the elastic limit of the material, the bump at the top of the plastic deformation happened, crushed into a flat, and then touched each other. The distance between two objects decreased, with small molecular attraction to the scope of work, and atomic bonding occurred between two compressed surfaces. Therefore, the initial friction coefficient was the largest under 0.25 mm. After the preloading depth HT + UDR + 0.30 mm treatment, microcracks and pits appeared on the surface of the coating, which needed a long period of wear in the first and second stages before entering the stable wear stage.

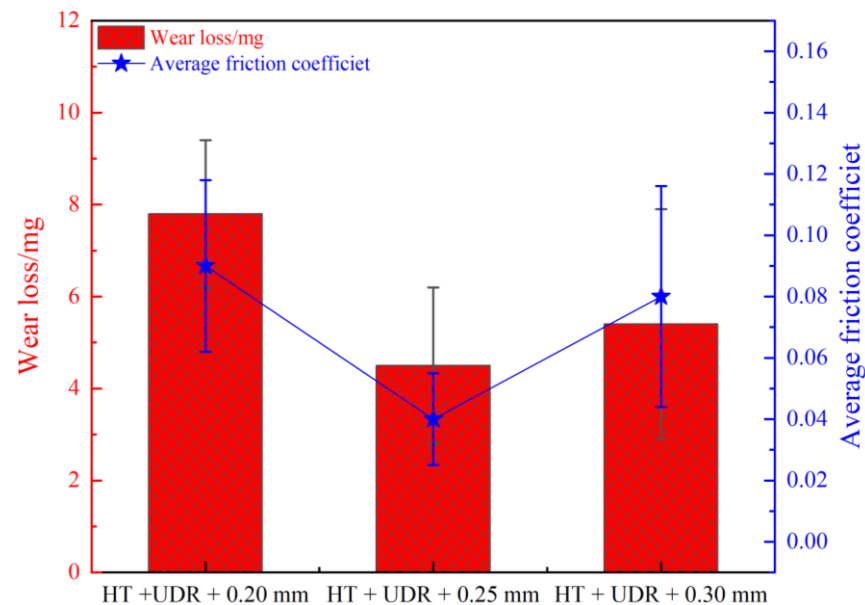
As shown in Figure 11, the average friction coefficients of the coatings under different preloading depths of 0.20 mm, 0.25 mm, and 0.30 mm were 0.09, 0.04, and 0.08, respectively, with the wear amounts of 7.8 mg, 4.5 mg, and 5.4 mg, respectively. In addition, the friction coefficient is related to the hardness and residual stress of the material. The residual compressive stress generated on the surface can offset the contact stress suffered by some samples. The microhardness and residual compressive stress of the coatings increased with

increasing preloading depth. When the preloading depth reached 0.30 mm, microcracks appeared on the coating surface and the residual compressive stress was reduced.

Figure 11. Average friction coefficient and wear of the coating under different preloading depths.
