Article

Investigating the Surface Damage to Fuzhou's Ancient Houses (Gu-Cuo) Using a Non-Destructive Testing Method Constructed via Machine Learning

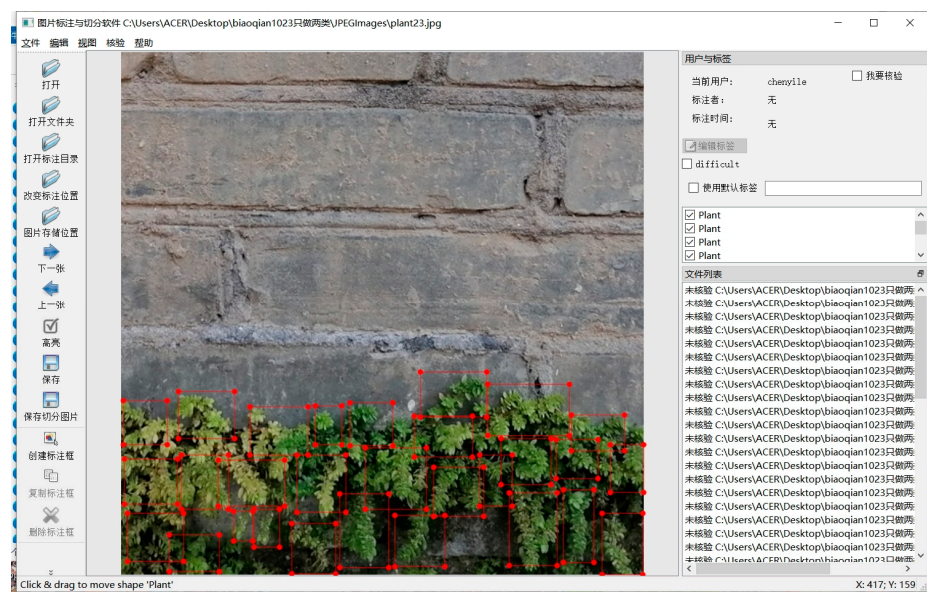
(3) Data labeling: This study used the LabelImg tool to label the collected images [45,46] (Figure 4). The LabelImg tool is installed in the created computer operating environment through the prompt command. At the same time, the LabelImg tool allows for viewing created annotations, correcting existing annotations, and even creating new annotations. Researchers can also delete the most incorrect annotations as needed, create new annotations, or adjust annotations with minor errors. The labeled gray brick damage types included efflorescence and plant growth. The quality of the annotations on the dataset directly influences the machine learning. Errors in the annotations will lead to poor machine learning. This is because the ability of the neural network to detect a given object depends on what it has learned. If we annotated something incorrectly or ambiguously, i.e., taught it the wrong object, the neural network would reflect this. In order to improve the accuracy of the model training, this research team not only used multiple rounds of verification and modification on the labeled data but also used model-assisted labeling (MAL). This method can improve the efficiency of labeling, reduce human labeling errors, and optimize the labeling results through continuous iteration of the model, thereby further improving the accuracy and robustness of the model. These labeled data involved a total of 49 images, ensuring the learning effect of the model under different damage scenarios.

Figure 4. We used the LabelImg tool to label the collected images. Since the author uses the simplified Chinese version of the software, the Chinese displayed in the screenshot is that which comes with the LabelImg tool. The red box in the figure represents the marked range. (image source: screenshot from LabelImg tool).

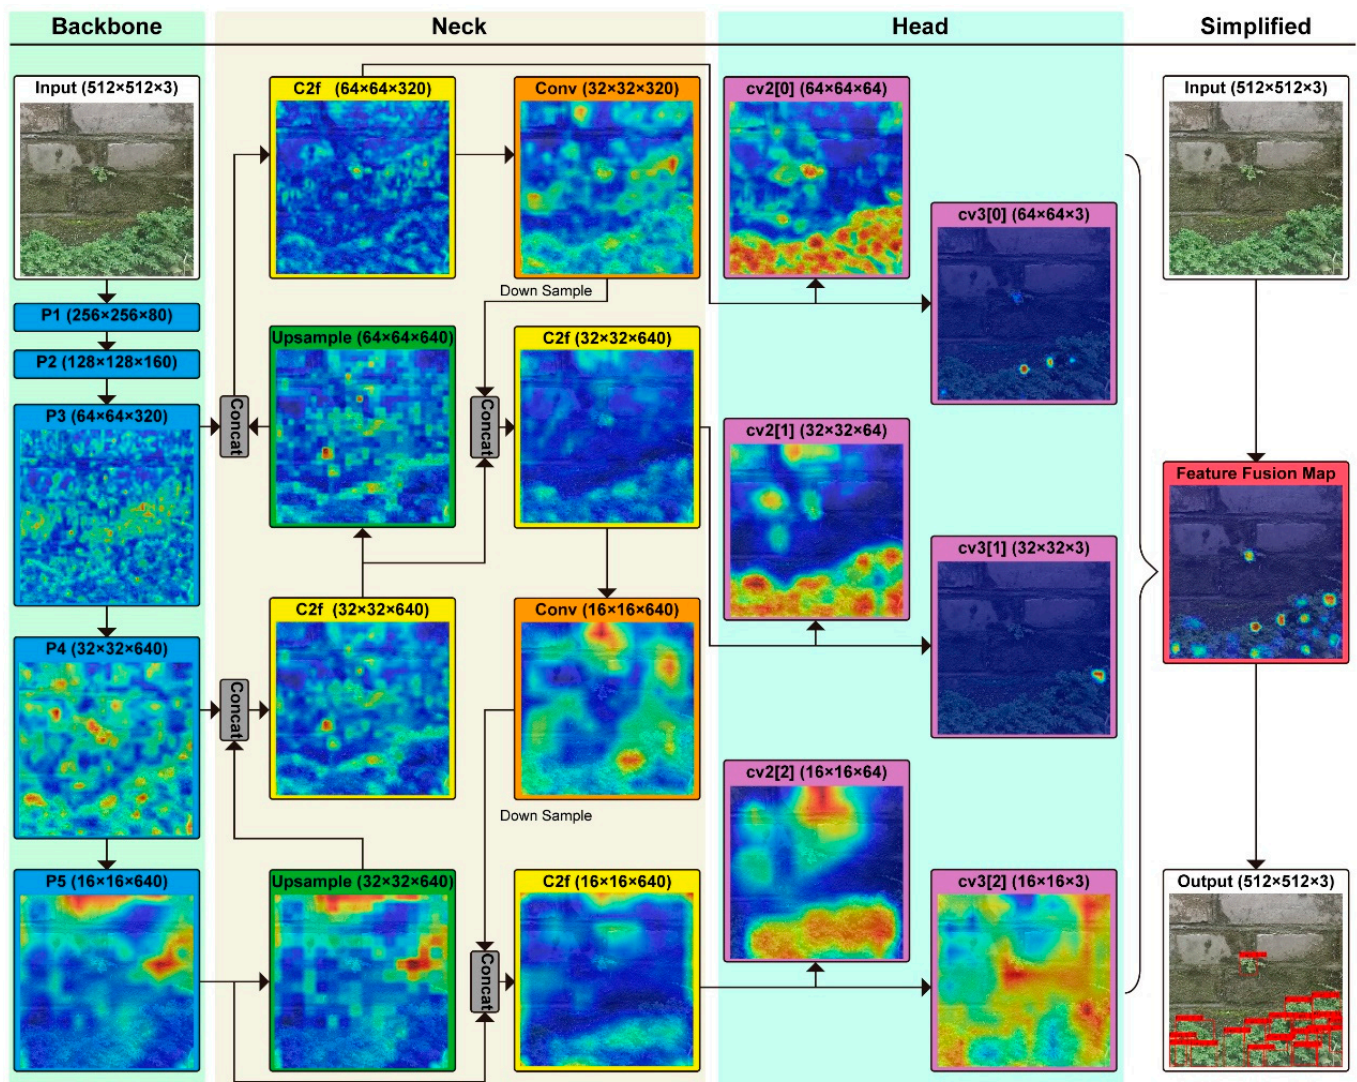
more low-level features, such as edges and textures, while the deeper layers (such as P4 and P5) extract more abstract, high-level features. These features can help the model better identify complex damage types on the gray brick surface.

Figure 5. Design of the YOLOv8 architecture used in this study (image source: drawn by the author).

(2) Neck: The role of the neck is to fuse features from different scales so that the model can better handle multi-scale targets. The neck part of YOLOv8 uses a feature pyramid network (FPN) and a path aggregation network (PANet) to fuse features through upsampling and downsampling operations. In this study, the neck part integrates feature maps of various resolutions, ranging from P3 to P5, to enable the model to detect both subtle damage to the gray brick and changes in the overall structure. For example, when the C2f module (for example, $64 \times 64 \times 640$) and the convolution (Conv) module (for example, $32 \times 32 \times 320$) work together, the model can accurately show the efflorescence of gray bricks and the features of plant growth at different sizes.

(3) Head: The head is used for the final target detection and classification. Multiple convolutional layers in the YOLOv8 head generate the final prediction box and classification results. In this study, the cv2 and cv3 modules of the head part are particularly important for extracting gray brick damage features. The feature map size of cv2 is $(64 \times 64 \times 64)$, while the feature map size of cv3 is $(32 \times 32 \times 3)$. By analyzing these feature maps, we can see the model’s ability to recognize different types of damage. For example, the cv2 module extracts relatively medium-scale features, while the cv3 module extracts details

(4) Simplification and fusion: After the feature extraction of the backbone, neck, and head, the multi-scale feature maps are finally fused to generate a feature fusion map, which is used for the final output prediction. In this study, this feature fusion map effectively integrates the feature information of various types of damage on the gray brick surface, helping the model to accurately locate the areas of efflorescence and plant growth. The final output prediction result is a $512 \times 512 \times 3$ image, in which the plant area is marked with red and the efflorescence area is marked with the fluorescent blue.

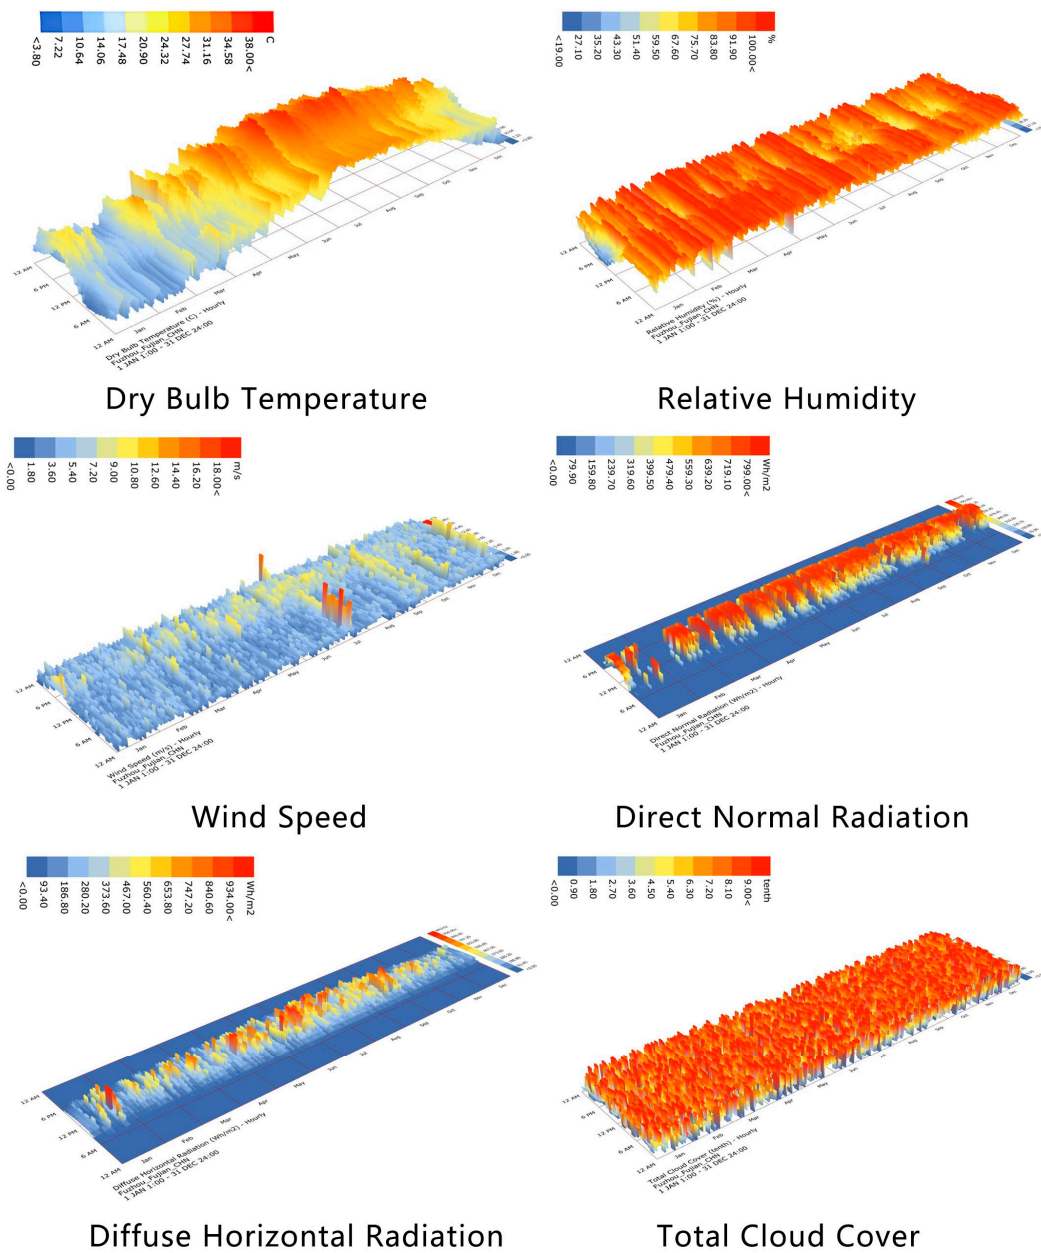
Figure 6. Climate analysis of Fuzhou City (image source: drawn by the author via Ladybug).

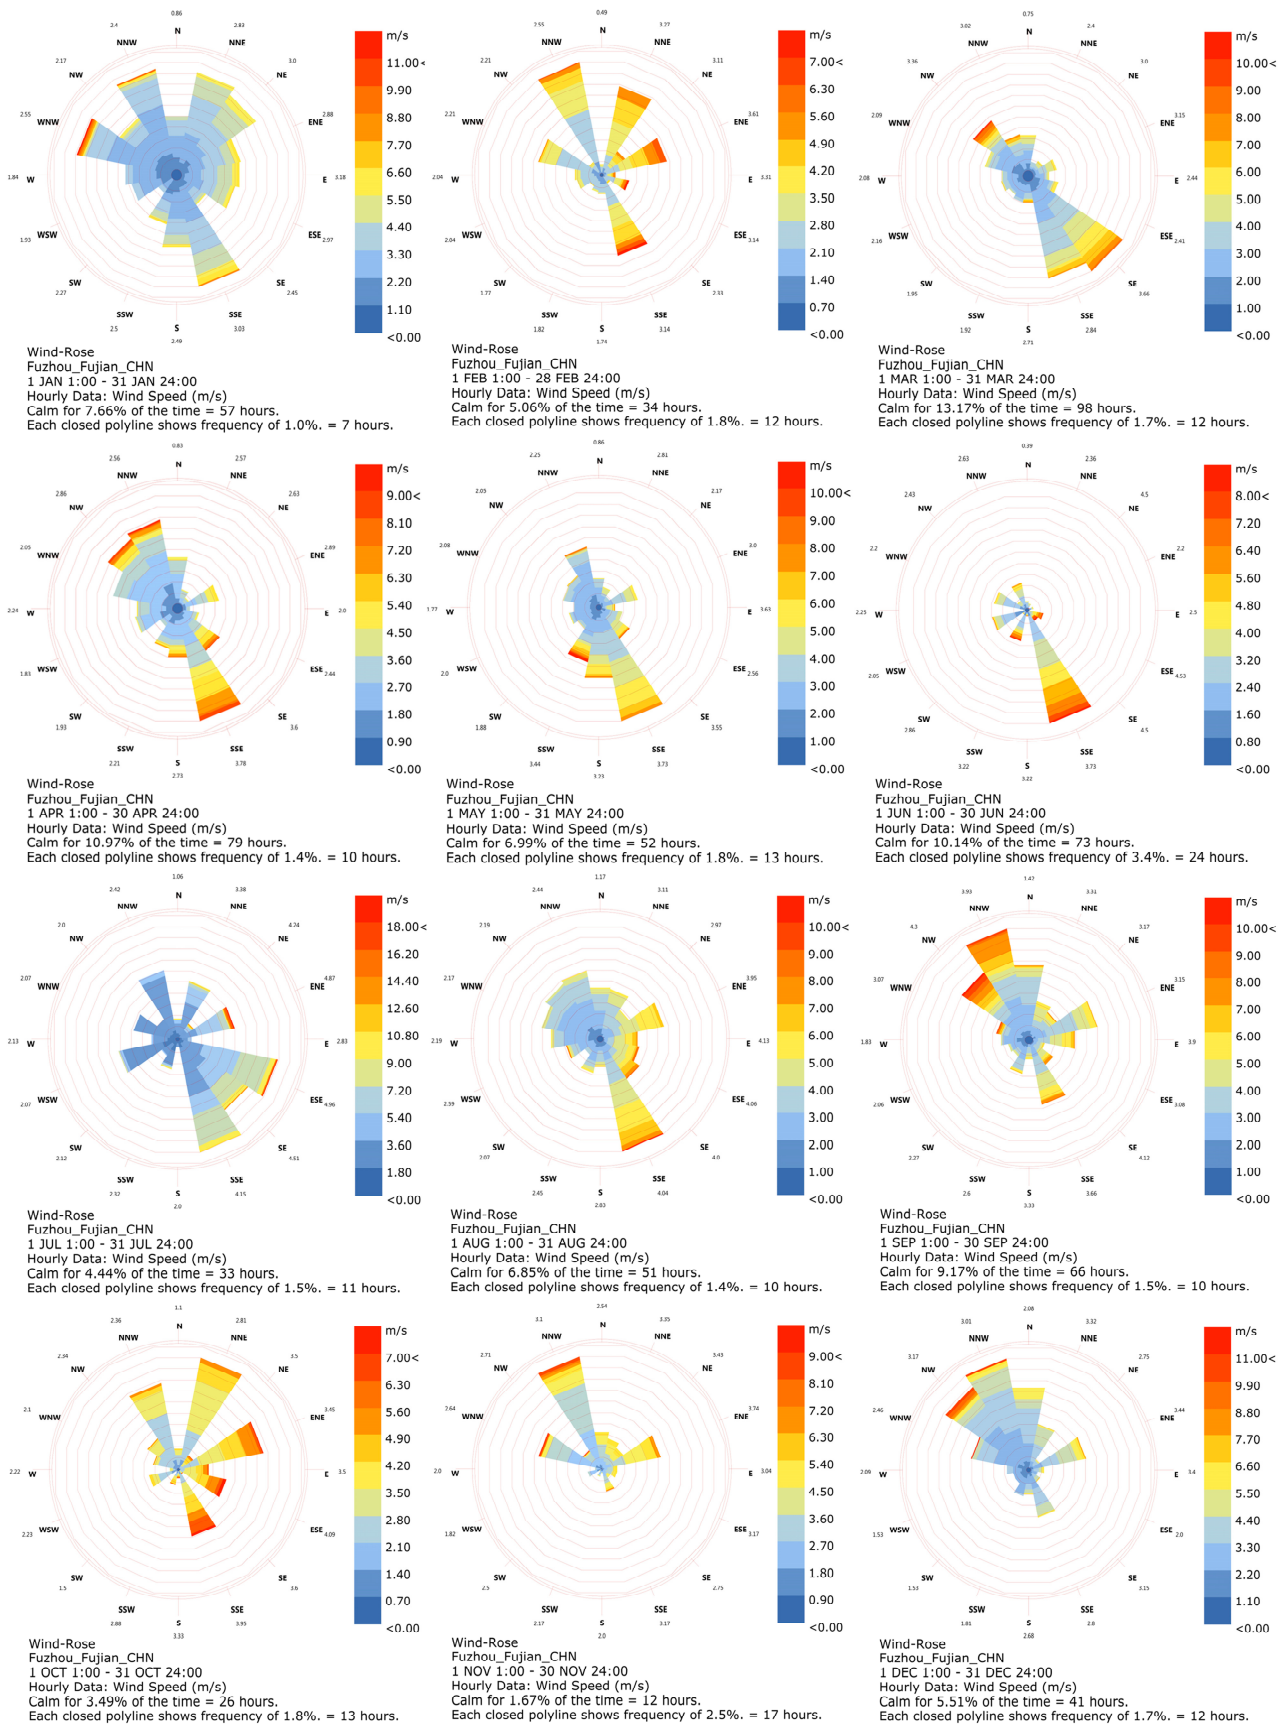
Figure 7. Analysis of the annual wind frequency rise in Fuzhou (image source: drawn by the author via Ladybug).

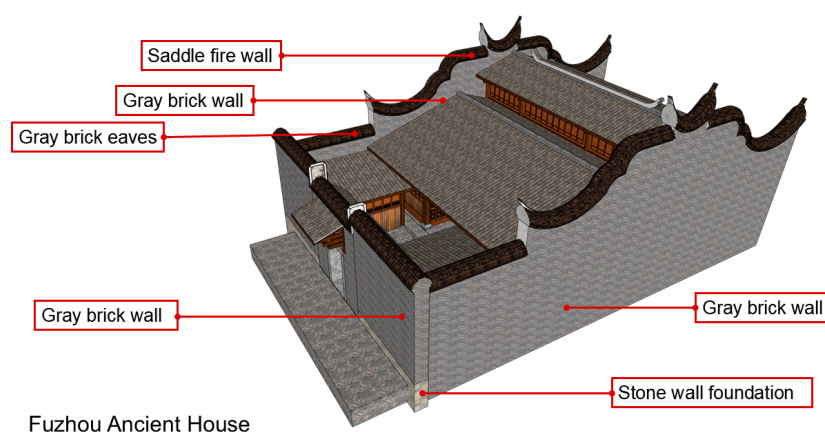
Figure 9. The location of gray brick in an ancient Fuzhou house (image source: drawn by the author).

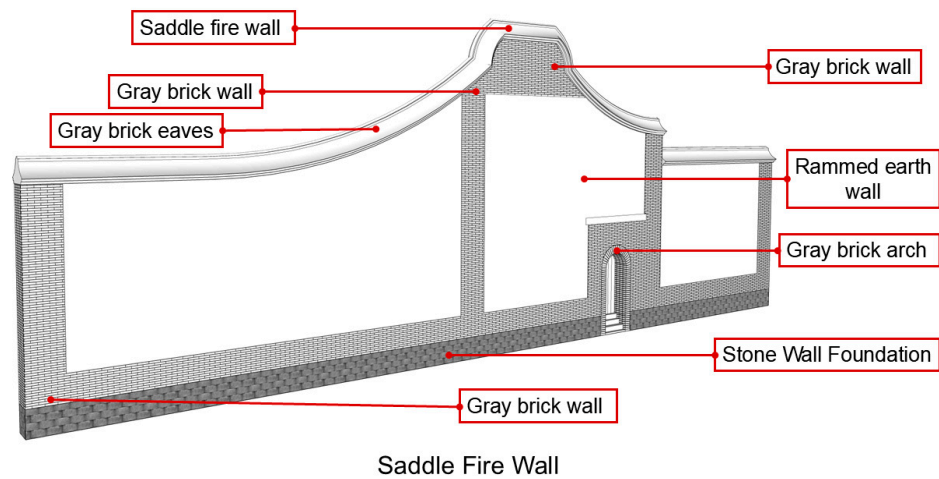
Figure 11. The location of gray bricks in the saddle fire wall (image source: drawn by the author).

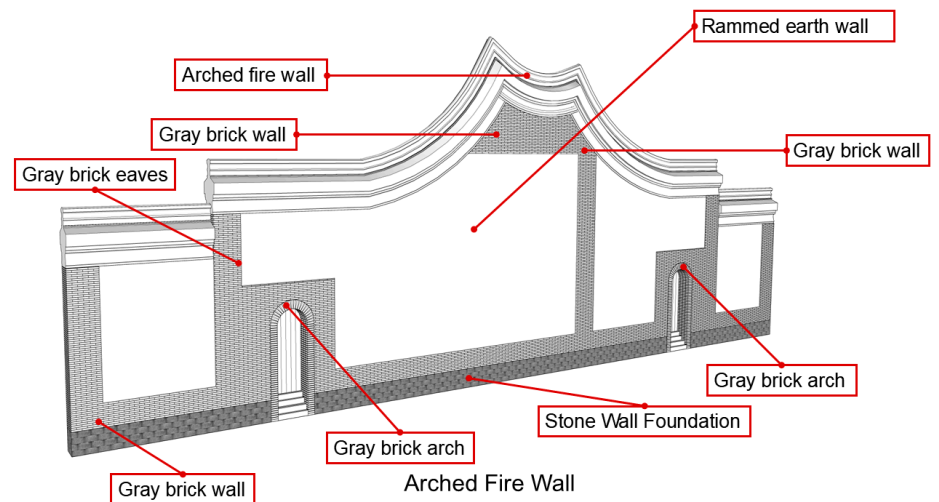
Figure 12. The location of gray bricks in the arched fire wall (image source: drawn by the author).

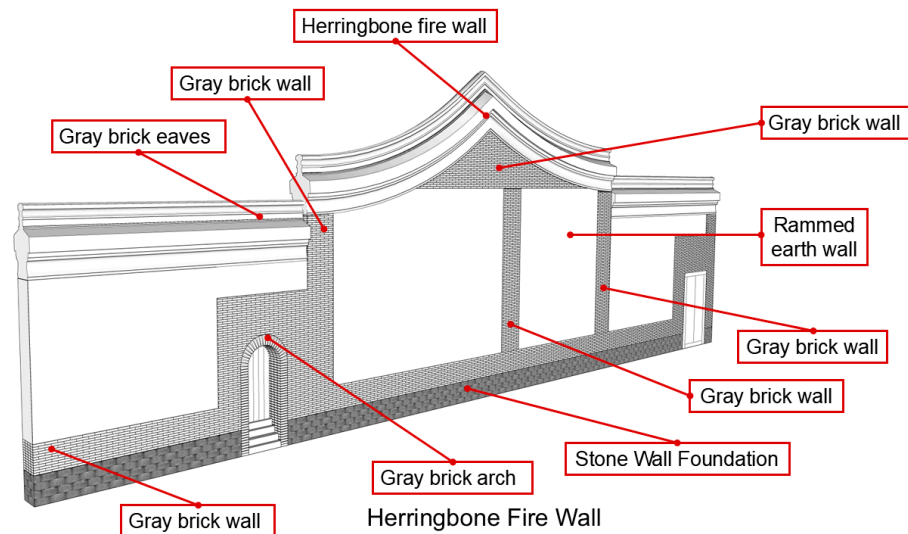
Figure 13. The location of gray bricks in the herringbone fire wall (image source: drawn by the author).

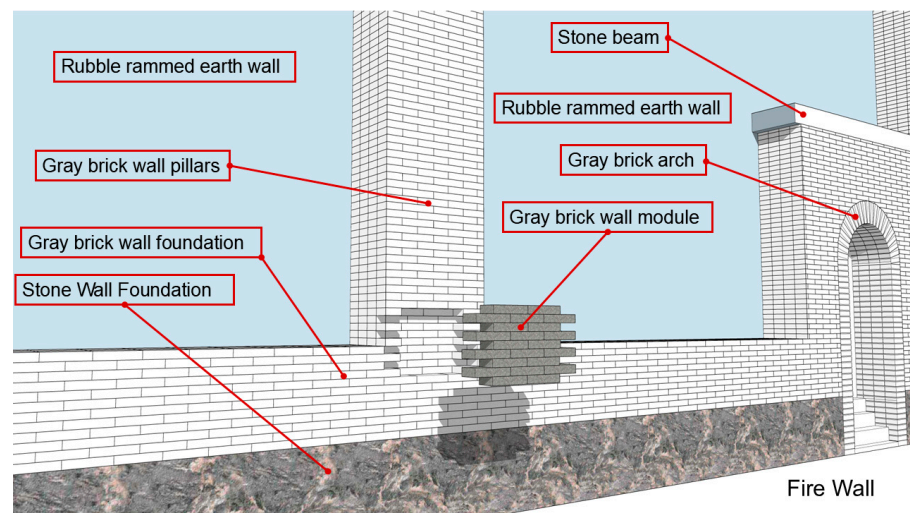
Figure 14. The distribution of gray bricks in the walls of Western-style buildings (image source: drawn by the author).

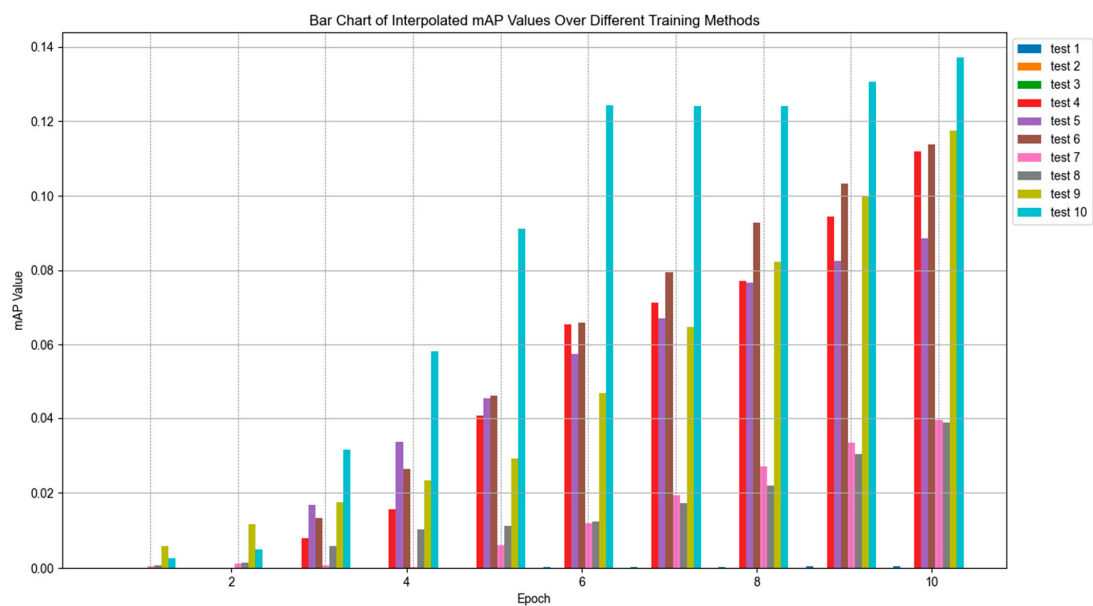
In order to improve the accuracy and recall rate of the model, we conducted 10 experiments in total. We continuously optimized and adjusted the hyperparameters to select the model configuration most suitable for gray brick wall damage detection in relation to Fuzhou’s ancient houses. Figure 16 displays the specific experimental results.

Figure 16. The mAP numerical statistics of the first ten epochs of ten model optimization experiments (image source: drawn by the author).

(3) In the third experiment, this study decreased the values of each data enhancement to minimize the impact of unnecessary image transformation on the model, resulting in an increase in the mean average precision (mAP) to 0.000045. This demonstrates that reducing the magnitude of the data enhancement can enhance the model's focus on the target features, particularly in the extraction of detailed features related to gray brick surface damage.

(5) In the fifth experiment, we turned off all the data enhancements, leading to a further increase in the mAP to 0.033756. This shows that when the sample size is limited, turning off the data enhancement can reduce unnecessary image change interference and allow the model to focus more on the damaged features of the gray brick surface, which is particularly effective for extracting stable visual features.

(9) In the ninth experiment, we used model-assisted annotation to enhance the quality of the samples' annotations. We reduced the training samples to 49 and significantly improved the mAP to 0.058166. This shows that high-quality annotation is more important than quantity. Model-assisted annotation can effectively reduce human errors, thereby enhancing the model's ability to identify the type of surface damage on gray bricks.

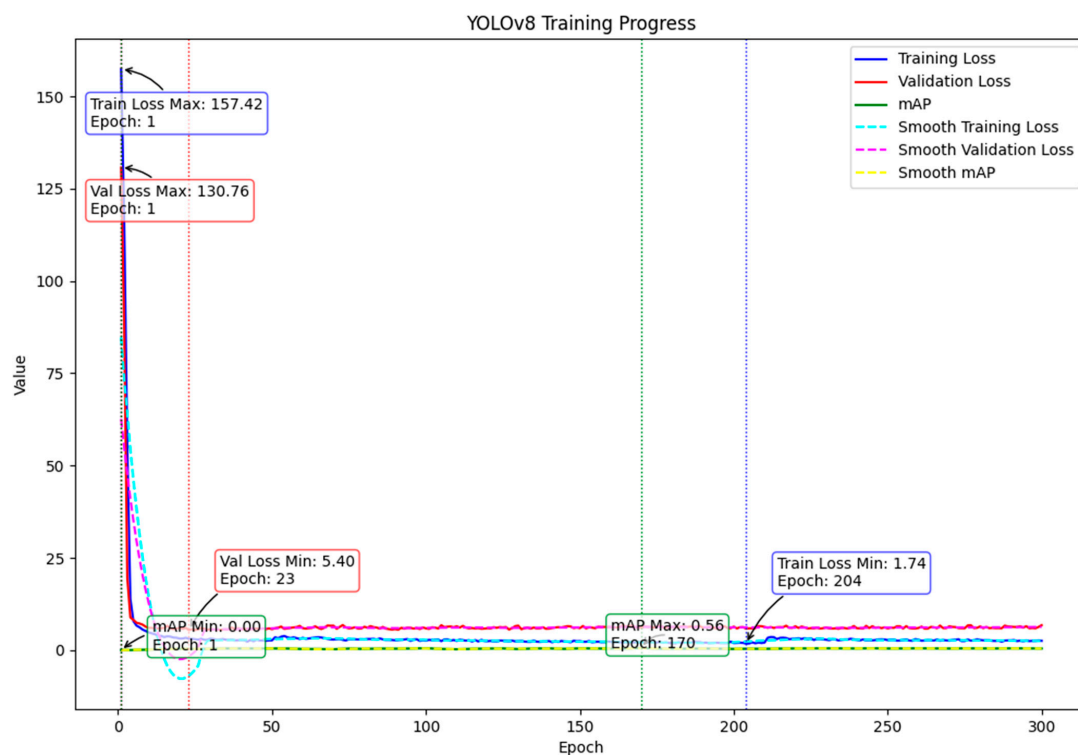
Figure 17 displays the changes in the training loss, validation loss, and mean average precision (mAP) during model training in this study. During the entire 300-epoch training process, it can be seen that the training loss and validation loss exhibit a clear downward trend in the first few epochs, which means that the model quickly learned the characteristics of the damaged gray bricks in the initial training stage. In the first epoch, the maximum value of the training loss is 157.42, and the maximum value of the validation loss is 130.76. As the training progresses, the training loss and validation loss gradually decrease. In the 23rd epoch, the validation loss reaches a minimum of 5.40, which shows that the model fits the validation set well at this time and overfitting has not yet occurred.

Figure 17. Loss value change trend during model training (image source: drawn by the author).

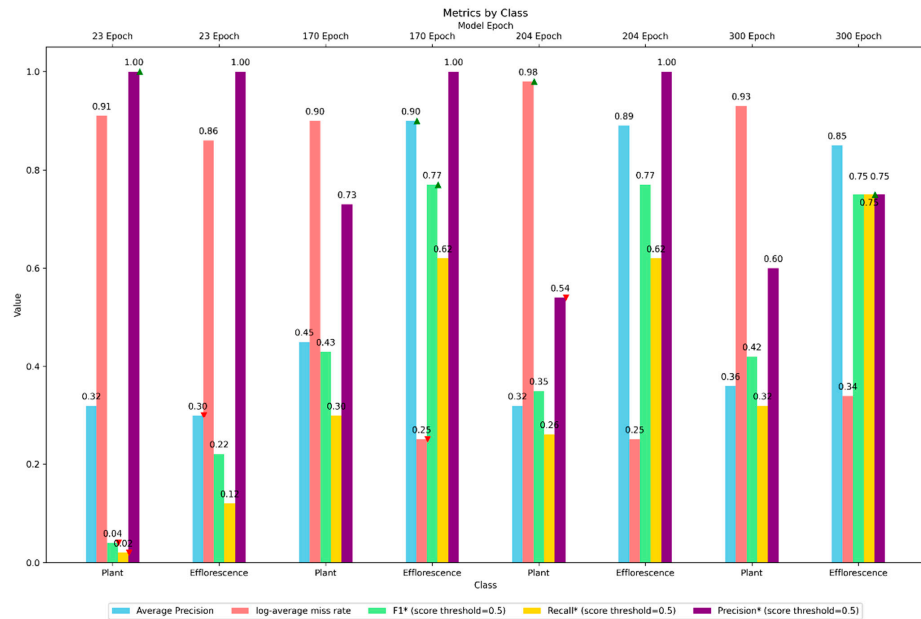
The 300th epoch model, as the final trained model, performed stably but failed to surpass the 170th epoch model. The average precision was relatively consistent, but it was still slightly inferior to the 170th epoch model in terms of the recall and F1 score. This shows that in the later training, the model has become saturated and failed to significantly improve its detection performance.

Figure 18. Performance statistics of the models at different epochs. (asterisk * in the figure indicates the median). In the figure, F1* indicates score threshold = 0.5; Recall* indicates score threshold = 0.5; Precision* indicates score threshold = 0.5. (image source: drawn by the author).

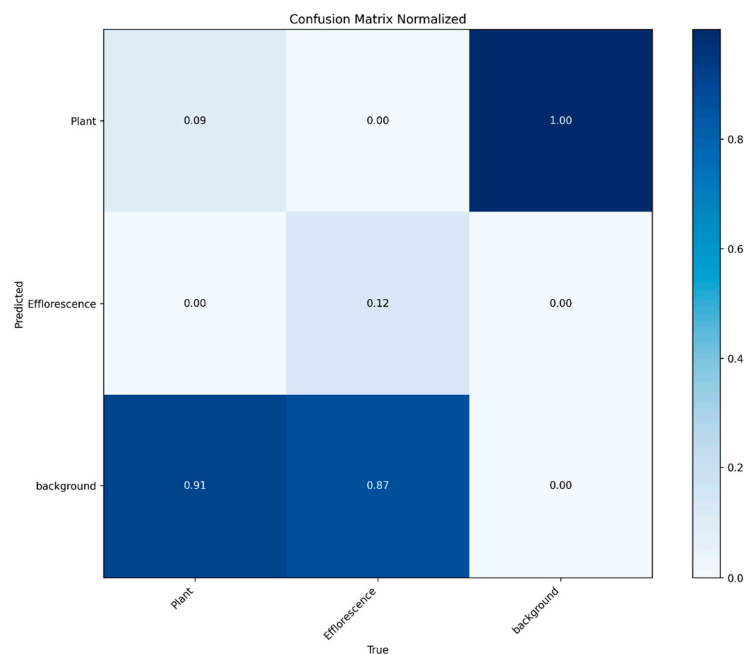
Figures 19–22 show the confusion matrix of the above four models for detailed analysis. The confusion matrix is used to intuitively display the prediction accuracy of the model for different categories, especially the classification effect and error type of the model in each category.

Figure 19. Confusion matrix of the 23rd epoch model (image source: drawn by the author).

Overall, the 23rd epoch model did not perform well in identifying the plant growth and gray brick efflorescence damage types, particularly due to the high false positive rate

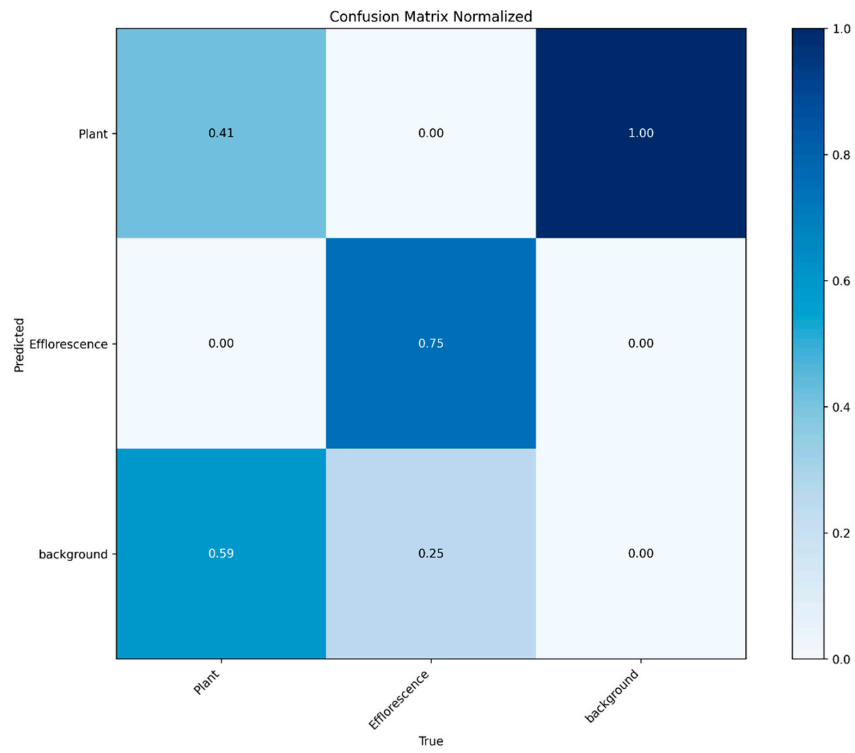
Figure 20. Confusion matrix of the 170th epoch model (image source: drawn by the author).

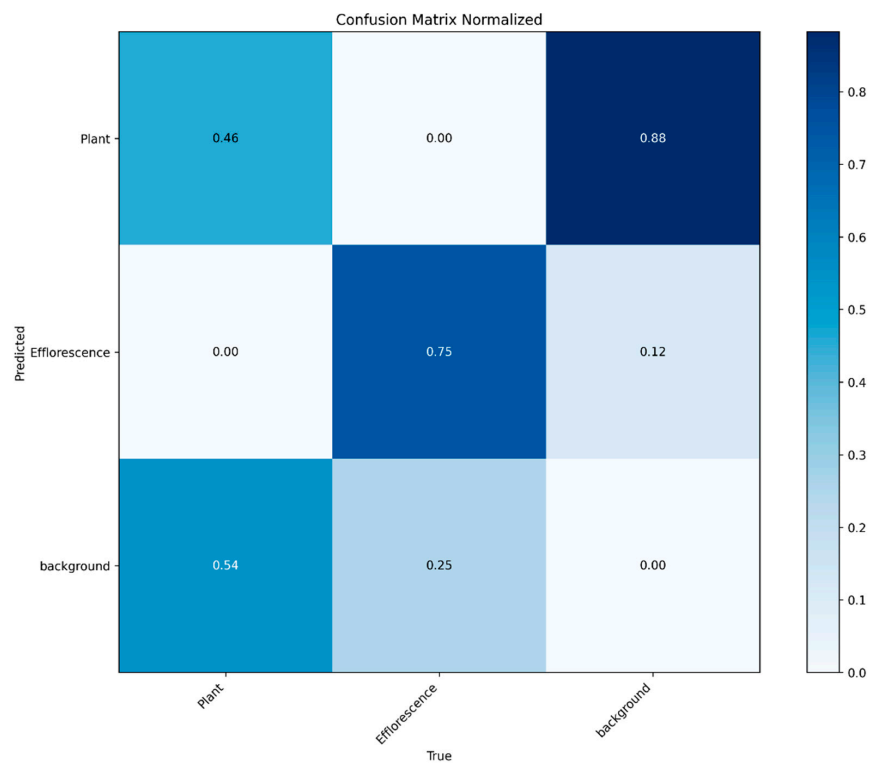
Figure 21. Confusion matrix of the 204th epoch model (image source: drawn by the author).

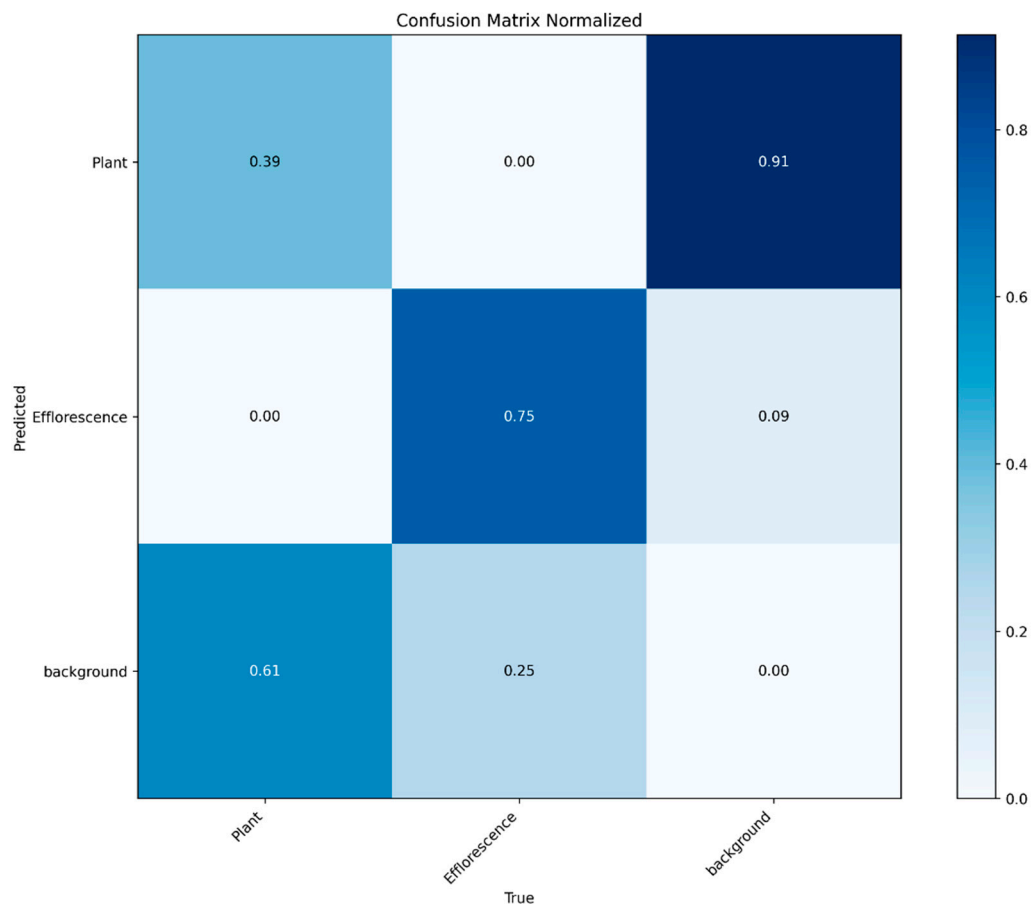
Figure 22. Confusion matrix of the 300th epoch model (image source: drawn by the author).

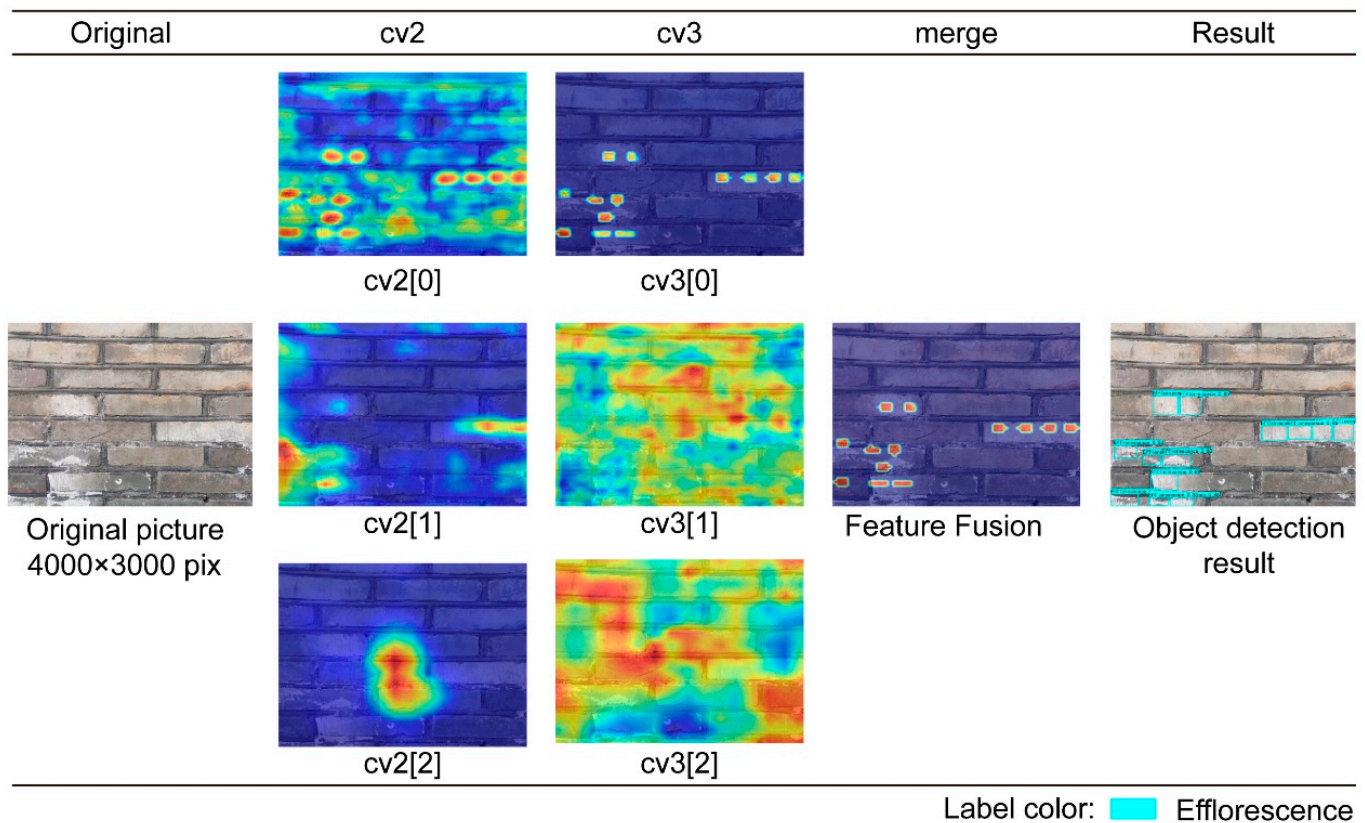
In the feature maps of the cv3 layer (cv3[0], cv3[1], cv3[2]), the model's extraction of high-level features focuses more on the overall distribution and morphology of the efflorescence region. In particular, in cv3[0], the model shows a strong response to multiple small areas of efflorescence and can better distinguish efflorescence from undamaged gray brick. In cv3[1], the model captures the brightness changes in the efflorescence region and shows a response to the internal structure of the efflorescence region. The model is better at separating different efflorescence features when the resolution is high compared to the last experiment. It is especially good at noticing small changes in the edge and center of the efflorescence.

Figure 26. Feature map of the model's original image detection process for gray brick efflorescence (image source: drawn by the author).

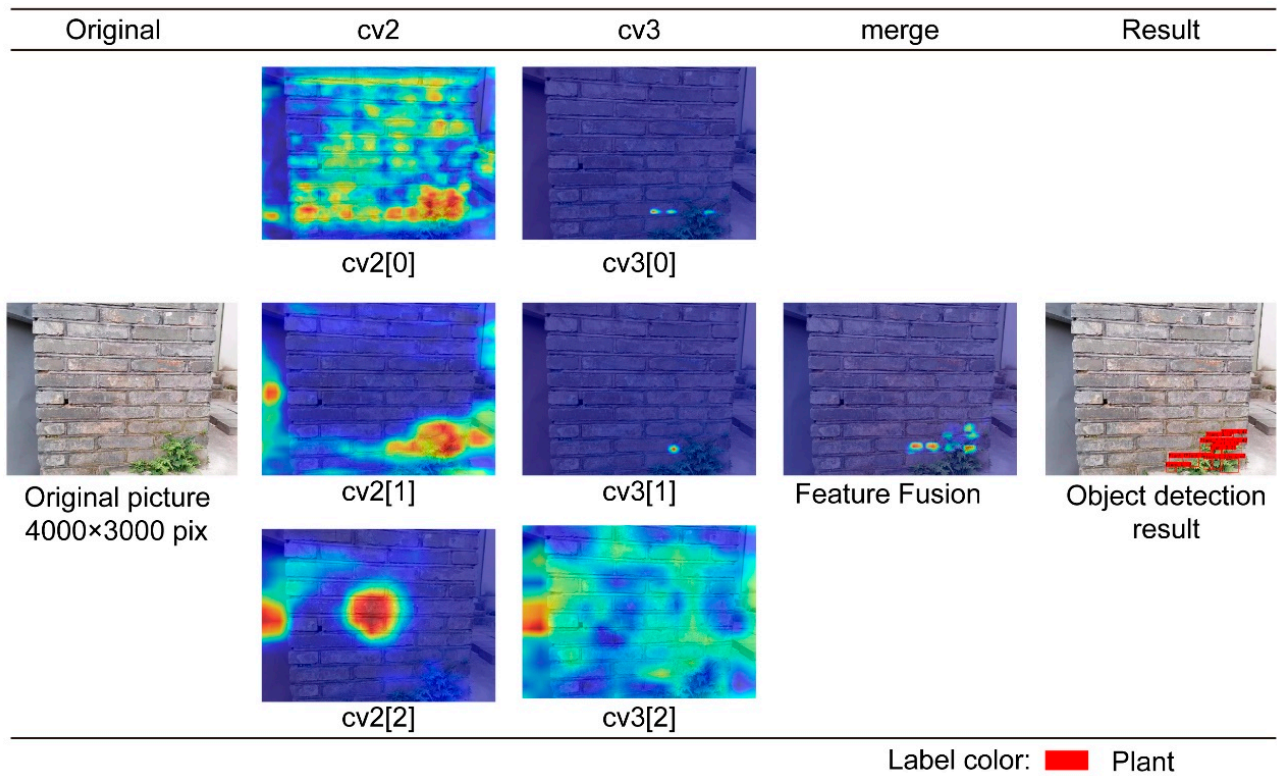
In terms of the detection of gray brick plant growth, it can be seen from the feature map in Figure 27 that the response of the cv2 layer to the plant growth area is mainly concentrated in the part below the image close to the ground. This is because the plant grows in a low position and has a significant texture difference with the background. In the high-resolution scene, the feature map of the cv2 layer (cv2[0], cv2[1], cv2[2]) displays more detailed edge and texture features, particularly for the plant's leaves and stems, where the model's response is more prominent. Because the high-resolution image contains more detailed information, the cv2 layer can capture the shape of the plant's leaves and the boundary between it and the gray brick background, thereby enhancing the recognition of the feature.

Figure 27. Feature map of the model’s original image detection process for gray brick plant growth (image source: drawn by the author).

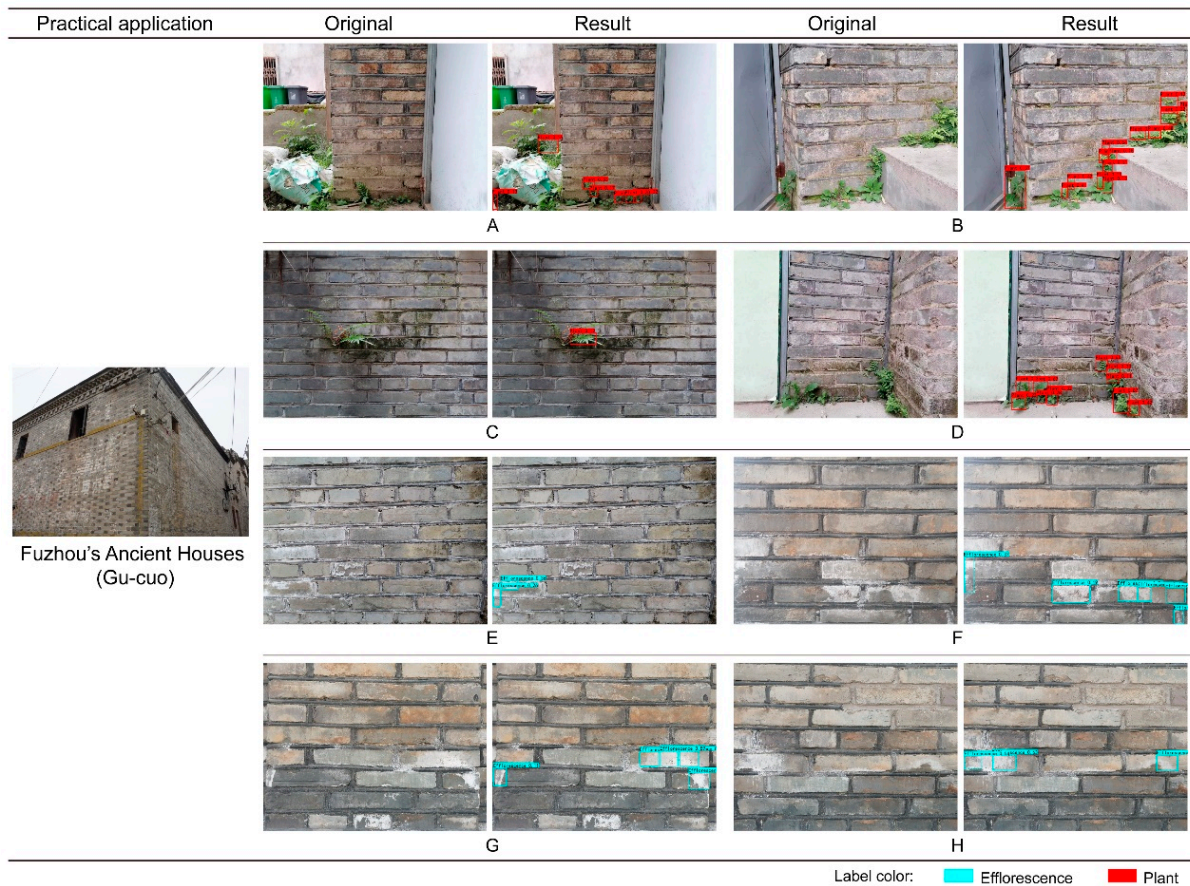
In the following experiments, we tested a large number of original gray brick images taken on site and used the YOLOv8 model to analyze the efflorescence and plant growth on the gray brick surface of the ancient houses in Fuzhou. Figure 28 shows the comparison between the original images and the test results in different scenes. Each group of photos indicates the model's detection of different types of damage. The following is a detailed description and analysis of each group of test results.

Figure 28. Testing of the model in field applications (image source: drawn by the author).
