Article

On Low-Velocity Impact Response and Compression after Impact of Hybrid Woven Composite Laminates

Yumin Li ^{1,*}, Yongxing Jin ¹, Xueting Chang ², Yan Shang ³ and Deng'an Cai ^{3,*}

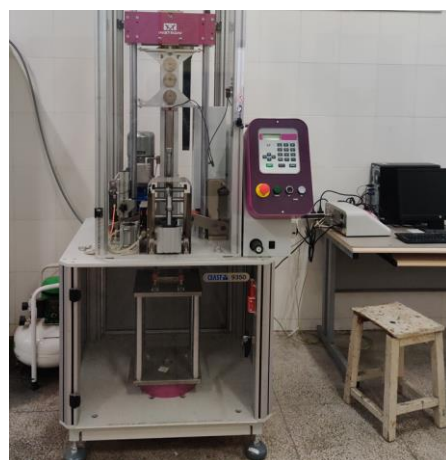
Figure 1. Instron CEAST 9350 and specimen for LVI test.

The LVI tests were performed on an Instron CEAST 9350 drop-weight impact machine according to the ASTM D7136 standard [21], as shown in Figure 1. The machine was outfitted with a 12.7 mm diameter hemispherical impactor. The impact energies were configured to 10 J, 20 J and 30 J, which reflect distinct energy levels that mimic plausible real-world impacts. Every specimen underwent three consecutive impacts at each energy level to evaluate its consistency and repeatability. A high-speed data-acquisition system was used to record data on contact force, absorbed energy and deflection.

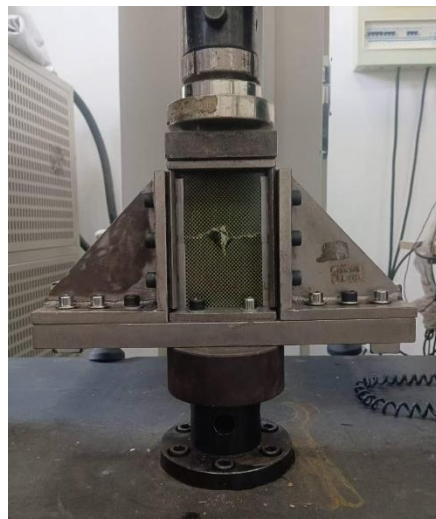
Figure 2. Test fixture and specimen of compression after impact.

According to the ASTM D7137 standard [22], the CAI tests were performed on impacted specimens to evaluate the residual compressive strength of composite laminates after impact, as shown in Figure 2. The CAI tests were conducted using an Instron 5982 universal testing machine. The specimens were positioned within a compression fixture to guarantee accurate alignment and reduce bending to a minimum. The experiment utilized a compressive force at a consistent rate of 1.25 mm/min until the point of failure. The residual compressive strength was determined, and the failure modes were recorded by conducting visual inspection and C-scanning analysis. This testing method is utilized to assess the compressive performance of composite laminate after impact and to provide post-impact information regarding their residual compressive strength.

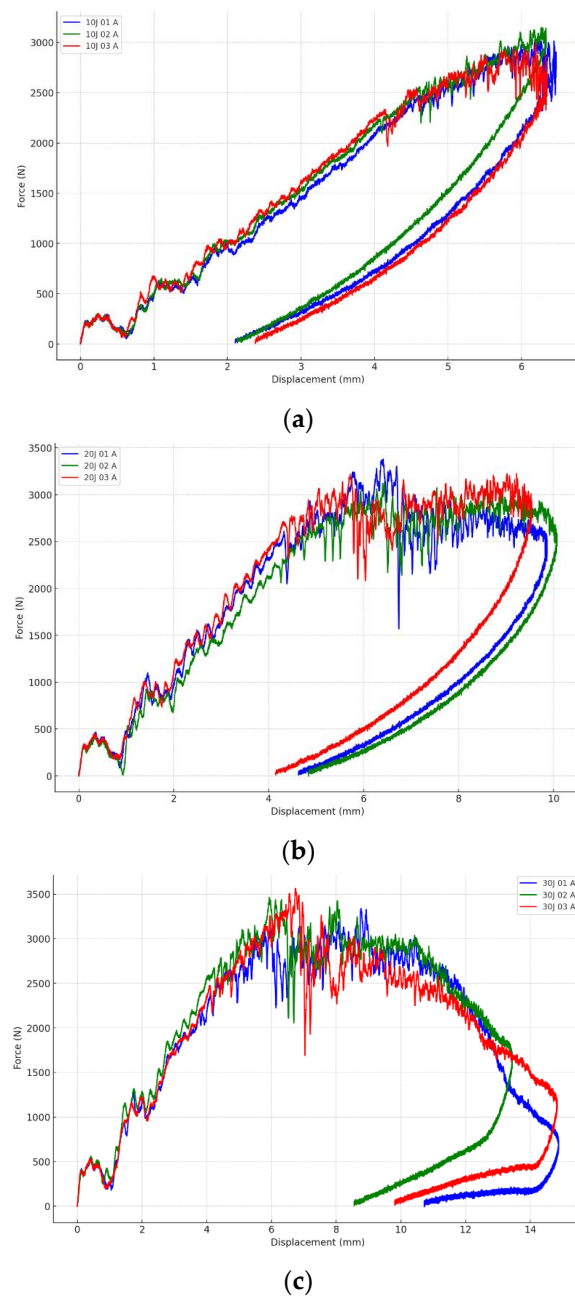
Figure 5. Impact force–displacement curves. (a) 10 J; (b) 20 J; (c) 30 J.

The force–displacement graphs for hybrid woven composite laminates affected at 10 J, 20 J and 30 J demonstrate how the material behaves as the impact energy increases, as shown in Figure 5. Each graph explains how various materials absorb and respond to shocks by changing mechanical qualities including stiffness, resilience and ultimate failure.

In Figure 5a, the material shows a constant initial increase in force with displacement, which remains linear until around 2 mm. The force peaks near 3000 N at approximately 6 mm of displacement, suggesting high material stiffness and strength at this level of impact energy. Beyond this peak, the force varies somewhat but remains high, indicating that the material does not undergo substantial structural collapse and can withstand small damage without losing integrity.

Figure 5b for the 20 J hit demonstrates a more rapid increase in force, reaching a similar peak force faster than the 10 J impact. However, the graph shows considerable variety across the samples after the peak, with some displaying sharp reductions in force. At this greater energy level, the material begins to lose structural integrity, resulting in increasing damage such as matrix cracking and delamination. The decrease in force at higher displacements, particularly in one sample, shows serious degradation or partial breakdown of the material under these conditions.

In Figure 5c, the material responds even more dramatically, with an initial abrupt increase in force followed by significant fluctuation. The peak force achieved is comparable to lower energy impacts, but it is followed by a sharp decrease in force across all samples, indicating major structural failures. The extreme drop-offs in force, particularly in two of the samples, indicate complete material failure or through-thickness penetrations, rendering the material incapable of resisting additional deformation effectively.

The force–displacement graphs show that with the increase in impact energy, the displacement of the impactor increases gradually. The hybrid laminates exhibit different load–displacement responses under different energy impacts.
