Advanced Analysis of Corroded Solar Reflectors

Abstract: The corrosion of the reflective layer is one of the main degradation mechanisms of solar reflectors. However, the appropriate assessment of the corroded reflector samples is not accomplished by the current analysis techniques. On the one hand, the reflectance measurement protocol of non-damaged solar reflectors for concentrating solar thermal technologies is widely addressed in the SolarPACES reflectance guideline. However, this methodology is not adequate for reflectors whose surface is partially corroded by many kind of corrosion agents. In this work, a new measurement technique to properly assess corroded samples was developed. To check the usefulness of the method, several damaged samples (subjected to two accelerated aging tests) were evaluated with the conventional technique and with the improved one. The results showed that a significant discrepancy is observed between the two methods for heavily corroded samples, with average reflectance differences of 0.053 ppt. The visualization of the reflector images illustrated that the improved method is more reliable. On the other hand, both the corrosion products formed and t

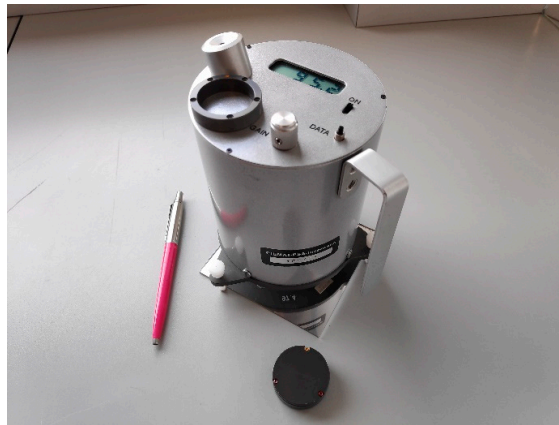
Figure 2. Portable specular reflectometer 15R-USB by Devices and Services (D&S).

The equipment selected to measure $\rho_{\lambda, \varphi}$, was the portable specular reflectometer 15R-USB by Devices and Services (D&S, Dallas, TX, USA) [35], which was specifically developed by the company in cooperation with Sandia National Laboratories to assess solar reflectors [36] (see Figure 2). It has a light-emitting diode (LED) source of $\lambda = [635, 685]\text{ nm}$, with a peak at $\lambda = 660\text{ nm}$. φ can be selected from $\varphi = \{3.5, 7.5, 12.5, 23.0\}\text{ mrad}$, and the $\theta_i = 15^{\circ}$. The instrument produces a collimated beam to a diameter of 10 mm (which corresponds to the measurement spot size) so that all of the reflected beam can be collected by the 22 mm diameter receiver lens. The beam deviation of the collimated incident beam is $\varphi_i = 5\text{ mrad}$ and therefore almost matching the sun disc on a clear-sky day. The instrument allows measuring curved mirrors and also first and second surface mirrors with different top-layer thickness.

All the measurements were taken at $\varphi = 12.5$ mrad. The instrument used (serial number 117) has a repeatability of ± 0.002 and a resolution of ± 0.001 . The calibrated reference standard, a 4-mm second-surface silvered-glass sample by OMT (serial number OMT-214044-02), has an uncertainty of 0.0015. Considering these values, the expanded type B uncertainty is 0.006. All measurements were taken in steady conditions (at constant temperature) by the same technician.

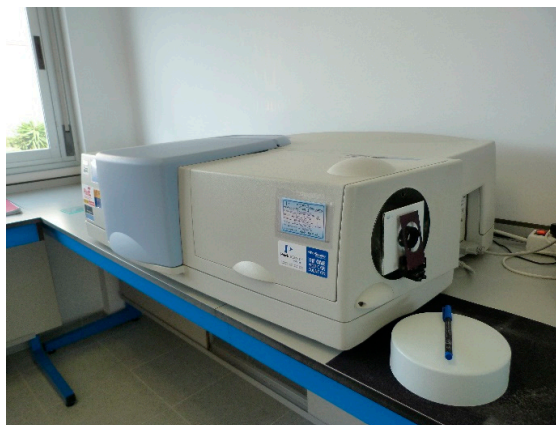
Figure 3. Spectrophotometer Lambda 1050 by Perkin Elmer (PE).

The scanning spectrophotometer (model Lambda 1050, Perkin Elmer (PE), Waltham, MA, USA) with a 150-mm diameter integrating-sphere accessory was employed to measure $\rho_{\lambda,h}$ (see Figure 3) [37]. It is a UV/Vis/NIR double beam and double monochromator instrument with two light sources, a deuterium lamp for the UV range, and a halogen lamp for the Vis/NIR range. The beam source has a spectral λ range from 175 to 3300 nm, $\theta_i = 8^\circ$ and is about 17 mm by 9 mm size. The detection system is composed of a photomultiplier for the UV/Vis range, and two detectors (a Peltier controlled PbS detector and a InGaAs detector) for the NIR range. The measurement spot in this case is 9 mm by 17 mm.

Measurements were taken in 5 nm steps in the range $\lambda = [320, 2500]$ nm. The maximum response time (0.04 s) was selected in the whole λ range, except in $\lambda = [600, 880]$ nm, where the minimum response time (1 s) was chosen. This combined response time was selected because it presents a proper compromise between accuracy and measuring time. The instrument used (serial number 1050N9061802) has an accuracy of ± 0.007 (at 635 nm). The calibrated reference standard, a 4-mm second-surface silvered-glass sample by OMT (serial number OMT-214044-02), has an uncertainty of

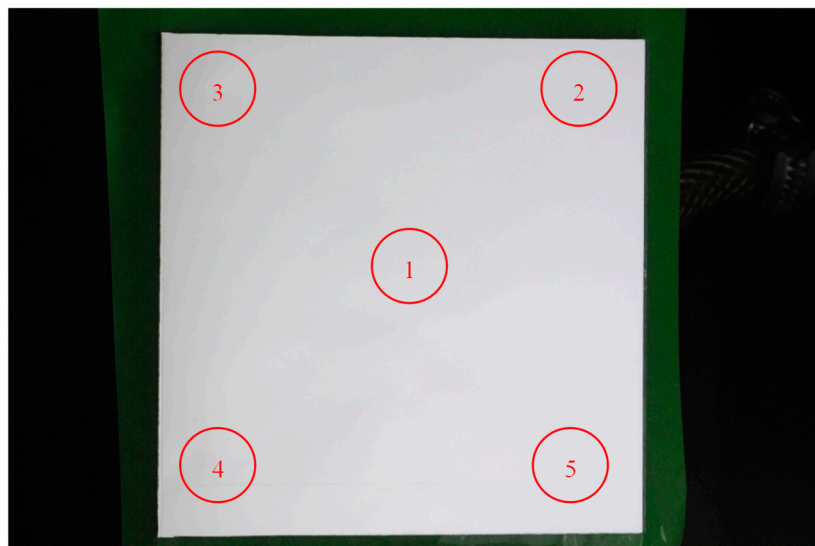
Figure 4. Five spots measured on each reflector sample with the reflectometer, according to the conventional measurement technique.

As it is recommended in this guideline, $\rho_{\lambda,\varphi}$ was measured in five points of each reflector sample, taken in the center of the sample and close to the four corners of the sample (see Figure 4), and the average value as well as the standard deviation was reported. The measurements were always taken at a distance to the sample edge higher than 10 mm. The equipment used for the measurements was the portable specular reflectometer 15R-USB by D&S, described in Section 2.4.1. A mask was always used to characterize each reflector sample in order to always measure the same spots and so properly assess the evolution of the possible corrosion partners.

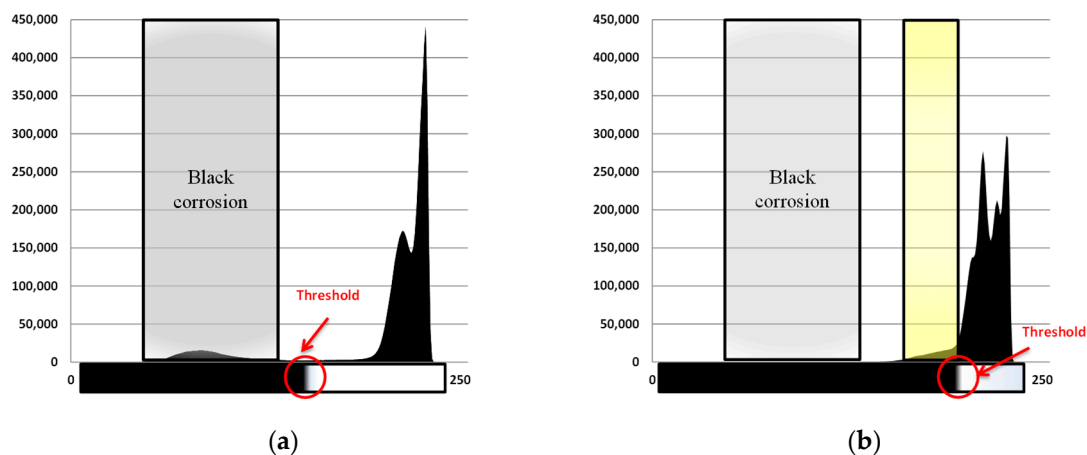
Figure 6. Histogram image of a corroded sample with black corrosion (a) and yellow corrosion (b).

In Figure 6, it is depicted the histogram with the different tonalities of black and white that could exist in the pixels (from zero to 255). Depending on the threshold chosen, the detection of black and white can vary. If the threshold selected is zero, all the pixels colors will be detected as white, while if it is 255, the opposite case would occur, and all the pixels will be detected as black. The Figure 6a shows the histogram of a sample with black corrosion. In this case, the white tonalities started in the range of 188 to 232 and the black from 58 to 125. The threshold selected was 148, distinguishing perfectly between corroded (from zero to 148) and non-corroded area (from 148 to 255). However, for samples where the corrosion appears with a color different to black, the threshold should be modified in order to detect this corrosion (see Figure 6b). In this case, the corrosion tonalities are yellow and the threshold selected to recognize this color as corrosion was 194. As a consequence, the corroded area was counted from zero to 194.

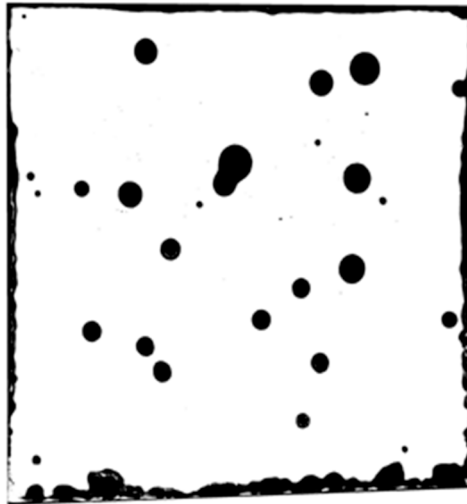
Figure 7. Binary image of Figure 8 to calculate the total corroded area.

The pictures were taken with a homogenous illumination of 1000 mA in the whole sample to avoid shadow areas and with an exposure time of 1/15 s. As it was previously explained, for typical corrosion whose corrosion color is black, the threshold employed was 148. Nevertheless, for corrosion whose color is not black, for instance yellow, the threshold should be changed to higher values in order to detect the degradation. Additionally, a distinction between the corroded area starting in the cut edges and originated by corrosion spots can be implemented. With an image treatment software (Matlab or ImageJ), it is possible to perform the transformation of the real image to a binary image, where the corroded surface is in black and the useful area is in white, permitting to estimate the non-corroded surface percentage (see Figure 7). After several tests, it was determined that the minimum quality recommended to take the image should be 254.6 pixels/mm, which corresponds to a vertical and horizontal resolution of 300 ppi. The accuracy of the software is good enough because the operator of the software can avoid manually the side effects that could be interpreted as corrosion but they are not. Examples of this kind of side effects are shading when the photo was taken, and soiling deposited on the reflector surface. Consequently, the accuracy in detecting the real corrosion is very high. To have a quantitative value of this accuracy, one corroded reflector sample was analyzed by taken five pictures and calculating the corroded area with the software, keeping all the parameters constant. The repeatability obtained was $\pm 0.07\%$.
