Article

Innovative Flexural Repair Technique of Pre-Damaged T-Beams Using Eco-Friendly Steel-Fibre-Reinforced Geopolymer Concrete

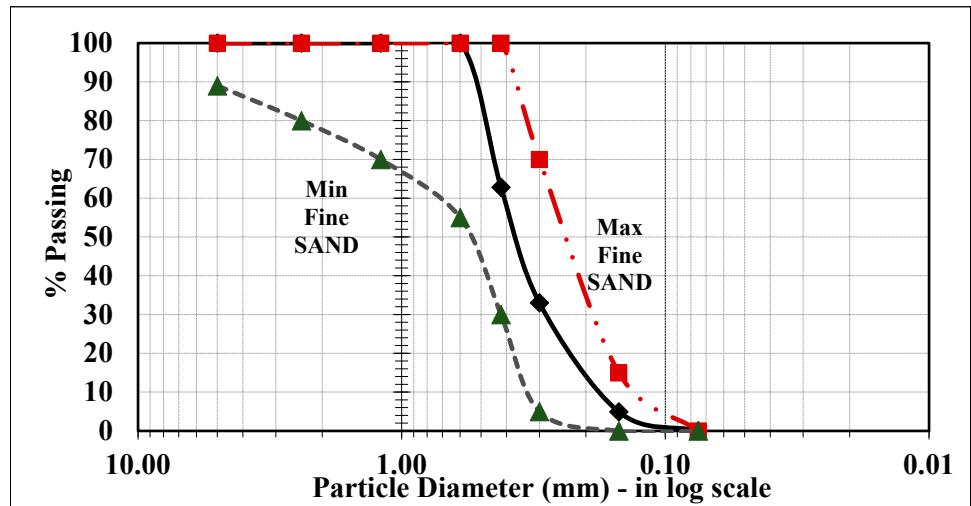
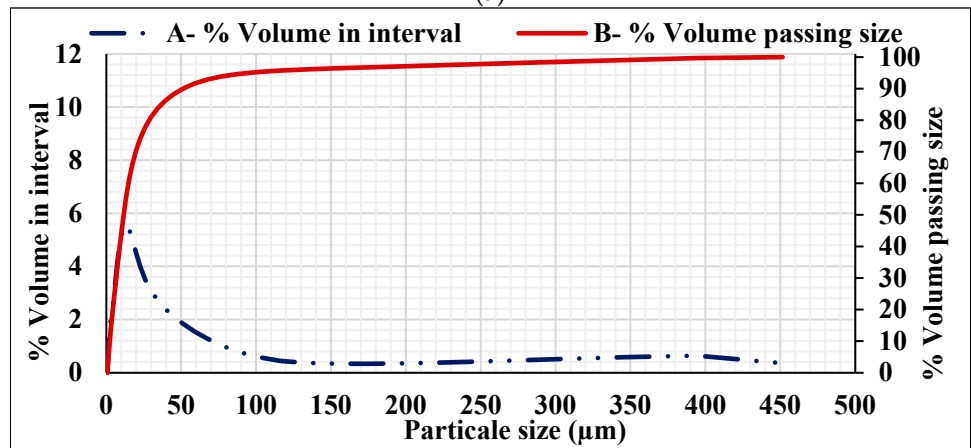
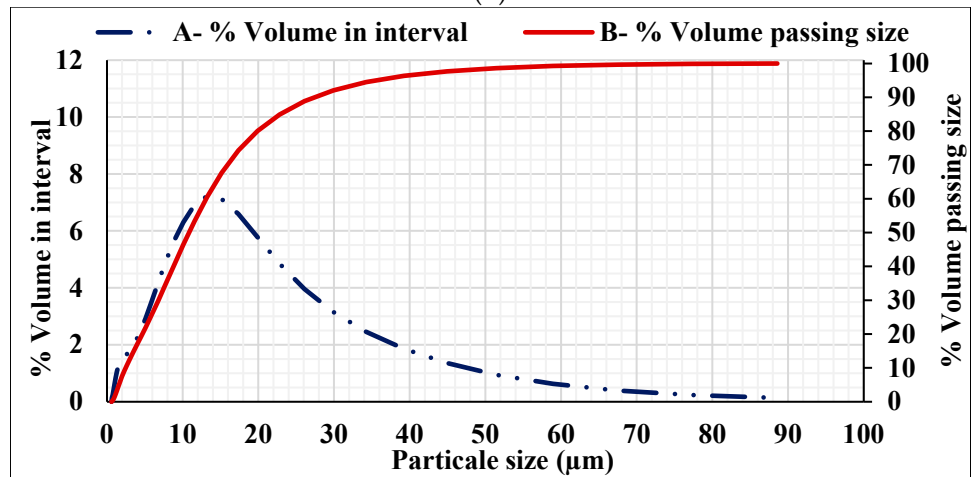
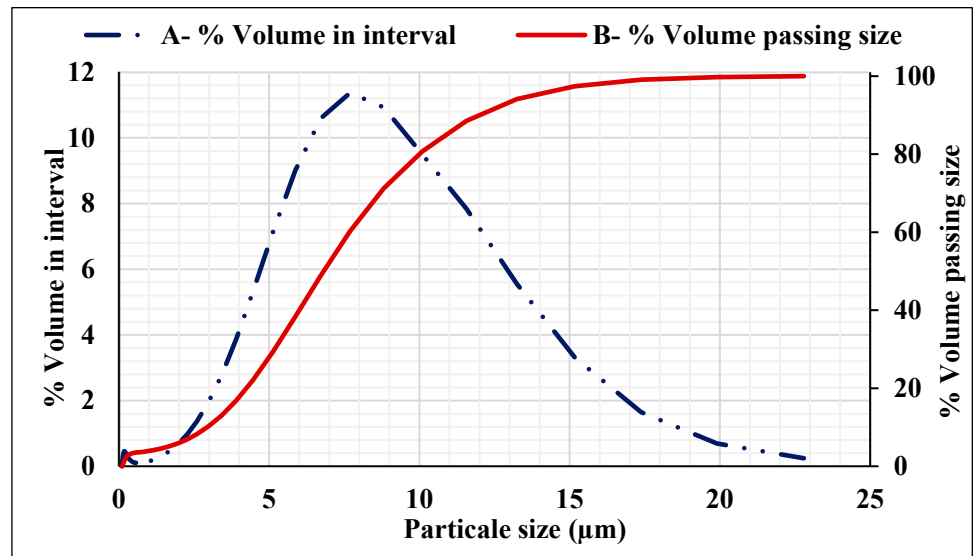
Figure 1. Particle size distribution: (a) silica sand; (b) fly ash; (c) GGBS; and (d) USF.

As an aggregate, silica sand with a maximum particle size of 600 µm was used, according to the BS882 standard [48]. The grain size distribution of raw materials is shown in Figure 1. The average particle size of FA, GGBS, and USF was 27 µm, 13.5 µm, and 7 µm, respectively. In this research, hook-ended steel fibres were employed as fibre reinforcement at a volume percentage of 2% in order to create a sustainable repair material for concrete constructions. The fibres have a length of 33 mm, a diameter of 0.75 mm, and an aspect ratio of 44, with mechanical properties of 1100 MPa tensile strength and 200 GPa Young's modulus. The alkaline activator solution was a mixture of potassium silicate (K₂SiO₃) and potassium hydroxide (KOH) [49]. For preparing 1 litre of KOH solution with 16 M, an approximate ratio of 1 KOH: 1 H₂O by mass was prepared, while the mass ratios of K₂SiO₃/KOH were maintained at 2.50. Figure 2 shows the photos of binder, KOH flakes, and steel fibres that were incorporated in synthesising the GPC.

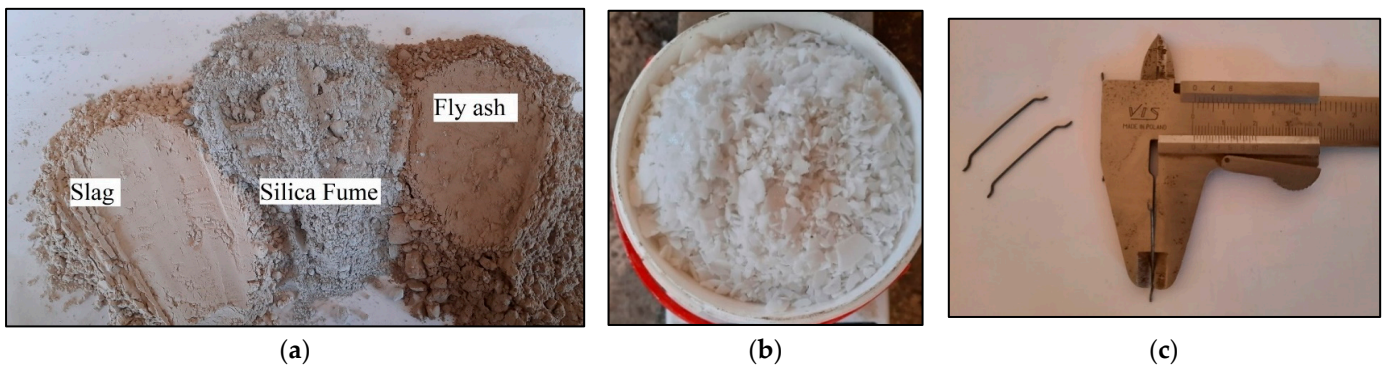
Figure 2. GPC ingredients: (a) binder materials; (b) KOH flakes; (c) steel fibres.

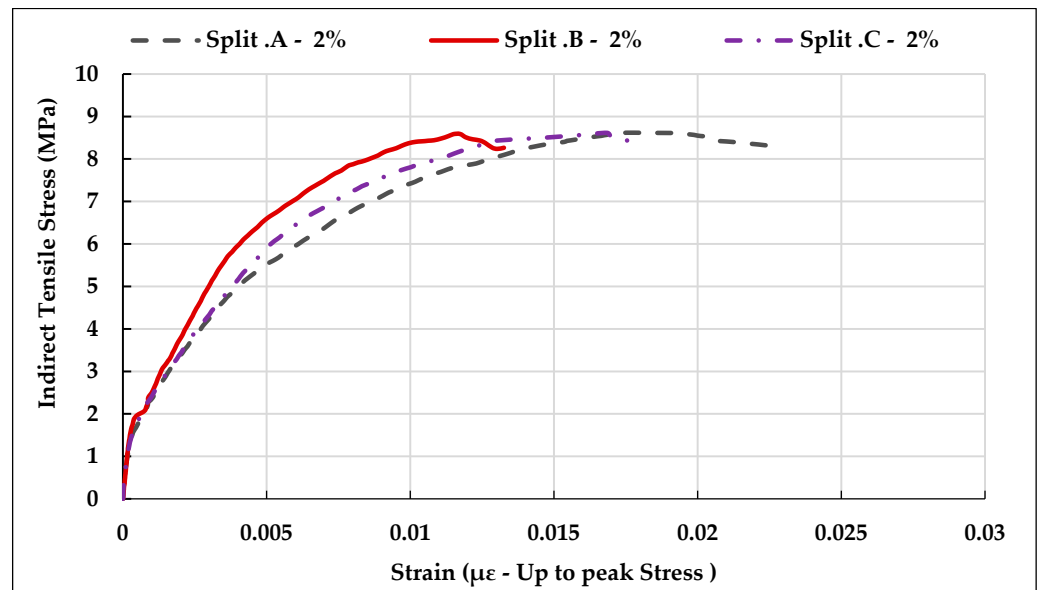
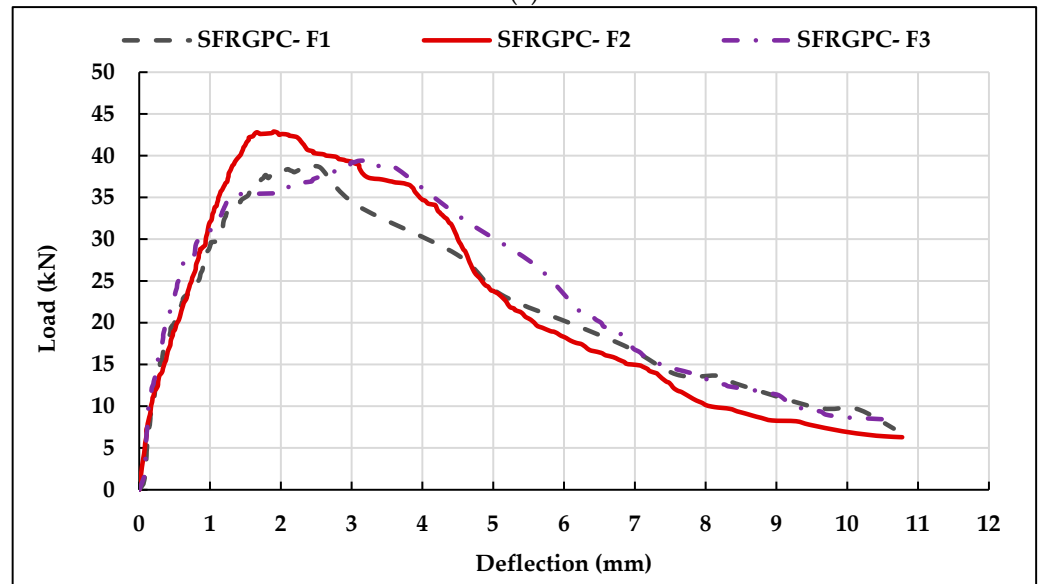
Figure 4. (a) Stress–strain curve for specimens with a 2% steel fibre. (b) Load versus mid-span deflection curve for SFRGPC prism beams.

The mean compressive strength at 28 days after casting was equal to 86.5 MPa. The average stress for splitting indirect tension was 8.60 MPa, as shown in Figure 4a. The experimental results in Figure 4b indicate strain-softening behaviour after the peak load. The load–deflection curve also demonstrated that when cracking began, the load reduced gradually as a result of fibre bridging until slippage occurred throughout the fibres and the geopolymer matrix. Moreover, the failure pattern for splitting tensile samples and flexural prisms is shown in Figure 5.

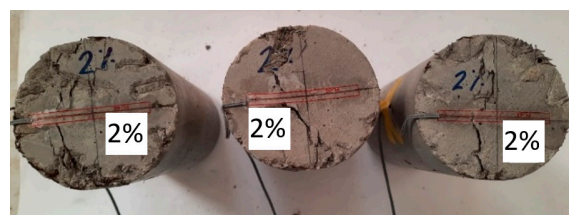
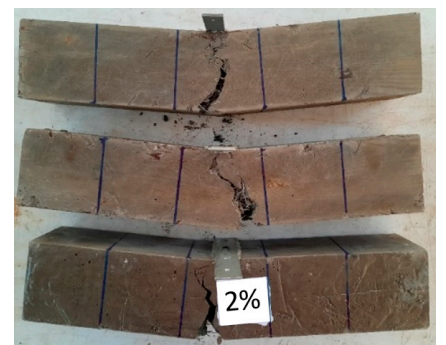
Figure 5. Failure pattern: (a) split test; (b) flexural test.

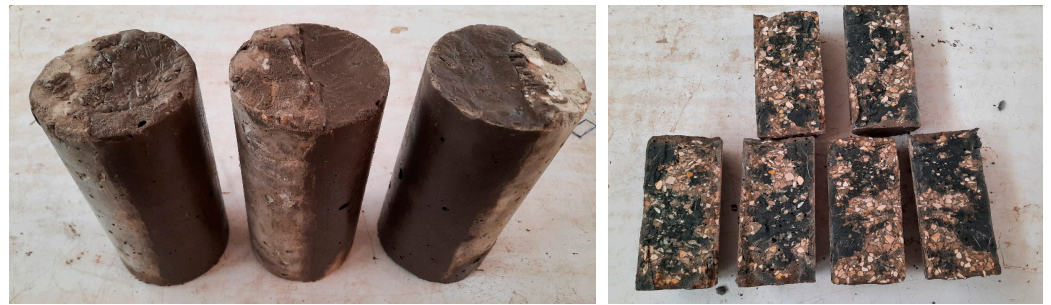
Figure 6. Samples configuration and failure patterns of composite normal strength concrete substrate and SFRGPC repair material.

To evaluate the bonding behaviour between the normal-strength concrete substrate (with a 28-day cube compressive strength of 34.4 MPa) as an existing concrete and SFRGPC as a repair composite material, three normal-strength concrete cylindrical samples were prepared and tested in indirect tension. Afterward, only one-half of each sample was returned to the mould, and the SFRGPC fresh mix was poured. Figure 6 shows the composite samples for testing the cohesion between the repair material and the substrate concrete. These 3 samples were tested in indirect tension at the age of 28 days for repair material. The average tensile strength was about 2.3 MPa, which represents excellent bond strength, as depicted by Sprinkel and Ozyildirim [42].

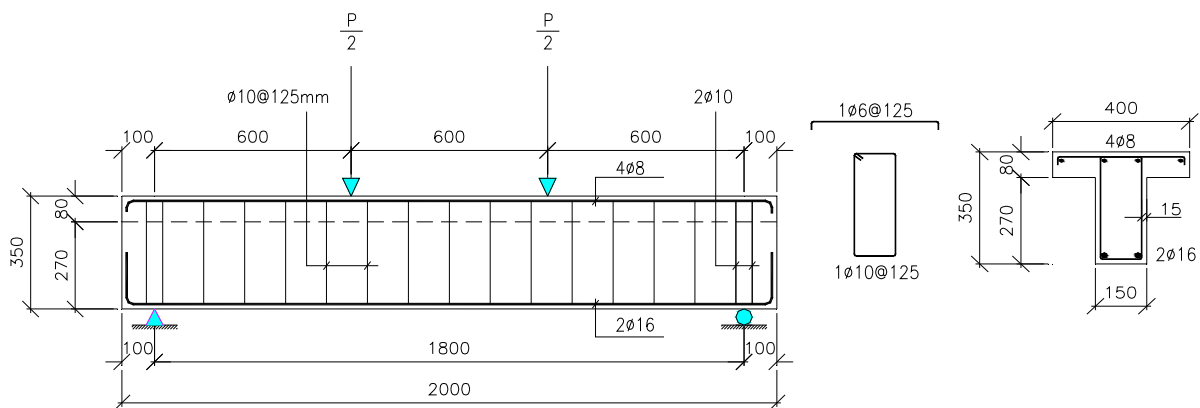
Figure 7. Typical details and geometry of flexural T-beams.

The study involved the construction of seven identical reinforced concrete T-beams, which were used to assess the effectiveness of SFRGPC as a novel repair material. The T-beams built for the study were cast from ordinary Portland reinforced concrete with a cube strength of 34.4 MPa. Figure 7 depicts the sizes of the beams, which have a total height of 350 mm and a width of 150 mm, as well as an 80 mm thick slab flange and a width of 400 mm. They were 2000 mm in total length, with a clear span length of 1800 mm.

The study focused on repairing T-beams using flexural approaches, with all beams designed to fail in flexural mode. Each beam had two deform bars, sized 16 mm in diameter and 2200 mm in length, installed on the tensile side with a characteristic yielding stress value of 600 MPa on the tensile side. The slab was also reinforced with an upper reinforcement of 4Ø8. To prevent shear failure, the shear span (600 mm)-to-depth ratio was selected to be 1.8, which falls between 1.5 and 2.5 to guarantee the close results between the experimental and the calculated flexural capacity of the beam under loading [52]. Also, Ø10 stirrups (590 MPa yield strength value) were arranged in the web at 125 mm intervals. The narrow distribution of stirrups proved to be more effective in enhancing the shear capacity of beams with a small shear span-to-depth ratio (i.e., 2.5) [52]. The ultimate strengths for the Ø16 and Ø10 bars were 800 MPa and 665 MPa, respectively. Finally, plastic spacers were used to ensure that the actual measured reinforcement cover after installation in the shutter met the required concrete reinforcement cover of 15 mm.

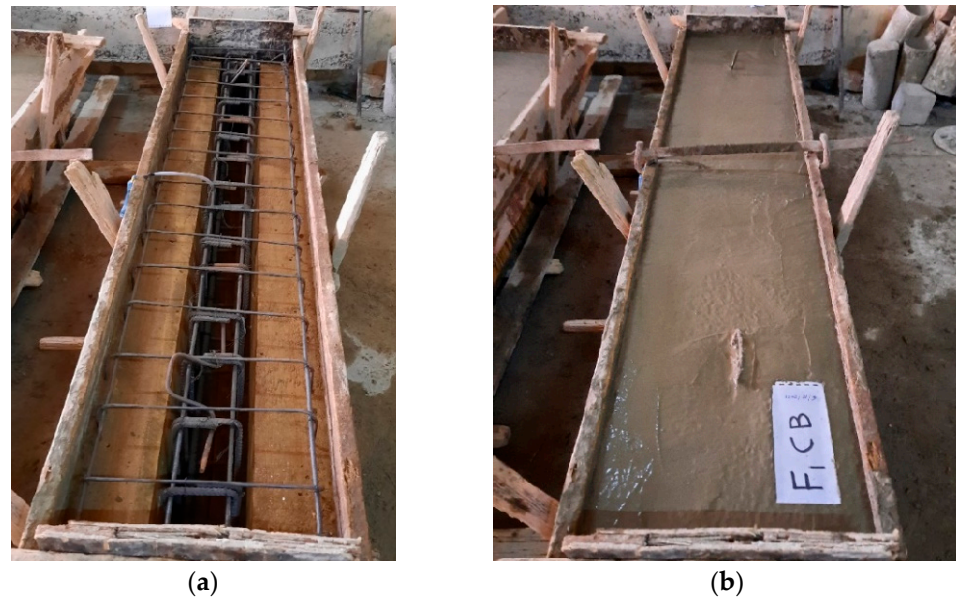
Figure 8. Fabrication of T-beams: (a) installation of a steel cage inside a wooden mould; (b) concrete pouring.

Figure 8 illustrates the wooden mould used for the T-beam specimens and the assembly of the steel reinforcement cage. The concrete components were mixed using a 210-L shear mixer (plastering/tilling mixer). The dry components were mixed for 2 min before the

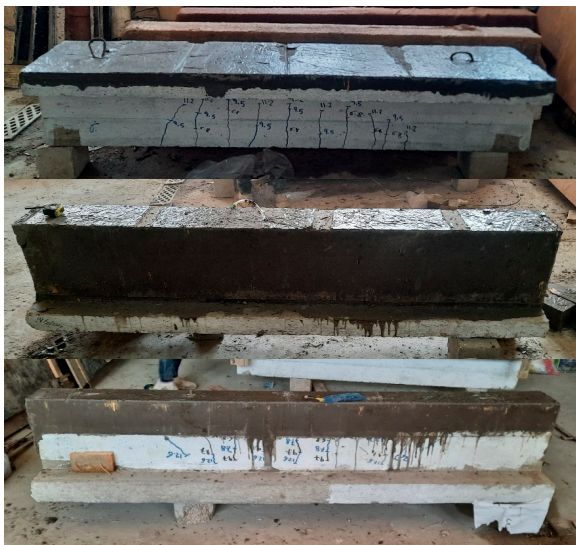
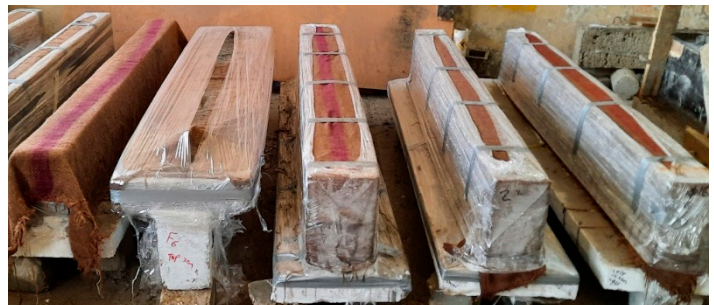
Figure 9. Sample of casting repair materials and water spray curing.

The concrete was removed by using a chipping hammer. Once the desired depth was achieved, water was used to clean the interface before applying the repair material. For beam F7, roughening of the surface by scabbling techniques for a depth of 2–2.5 mm. The formwork was kept in place for 24 h after casting. After demoulding and overcoming the concerns of debonding, three techniques were adopted to avoid cracking resulting from differential shrinkage. First, the existing concrete at the interface was wetted prior to casting the SFRGPC. Second, a plastic film was placed over the geopolymer surface after casting to limit water evaporation. Third, the repaired material was kept moist for 28 days after de-moulding using burlap and plastic sheets, as shown in Figure 9 [53,54].

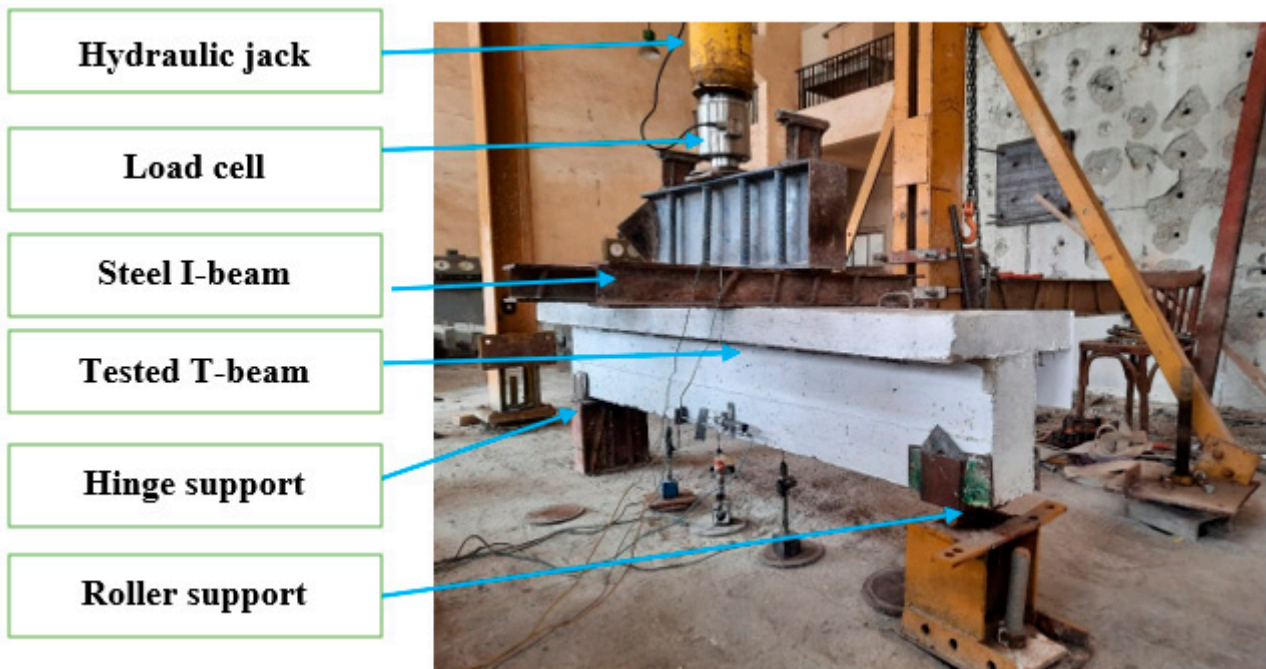
Figure 10. Test setup for the control beams (flexural failure).

The experimental testing of the repaired T-beams was carried out under a four-point loading arrangement, with one end allowed to have hinge support while the other end had roller support, as shown in Figure 10. The loading was applied using a heavy steel beam (I-shape) on the top of the slab. A hydraulic jack, capable of carrying up to 500 kN, was used to incrementally increase the loading by 10 kN during the test procedure. LVDTs were utilised to measure deflection at the beam's midspan during flexural testing, and their accuracy was 0.001 mm. Furthermore, crack width was also measured at the bottom chord of the beams. As can be seen, the LVDTs were fixed to the beams using metallic angles, which were glued onto the surface of concrete beams. Any rotation of the LVDTs during testing was considered negligible.

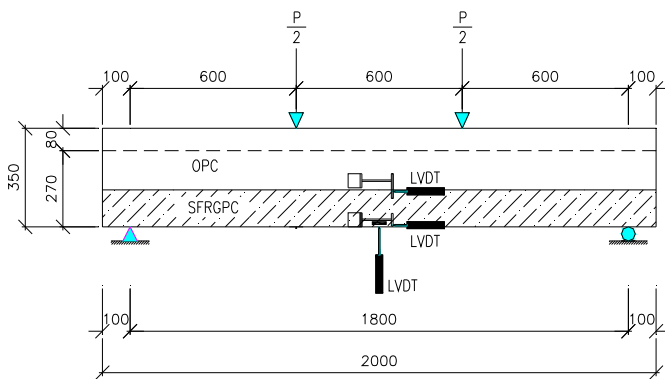
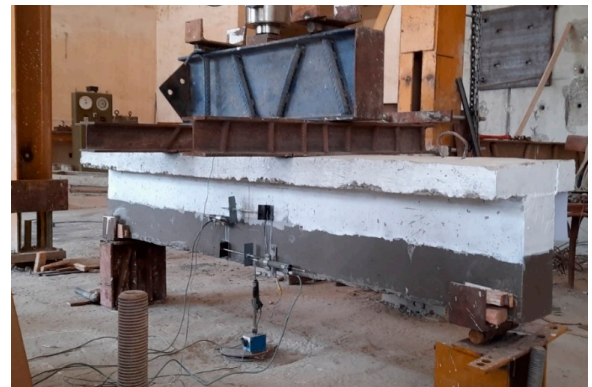
Figure 11. Test setup for repaired T-beams.

To evaluate the performance of beams repaired with SFRGPC layers, in addition to measuring the load and deflection at the half span length, measurements were also taken for the slip or differential movement at the interface, as shown in Figure 11. Furthermore, crack width propagation was also measured at the bottom chord of the beam for all cases and compared to control beams.

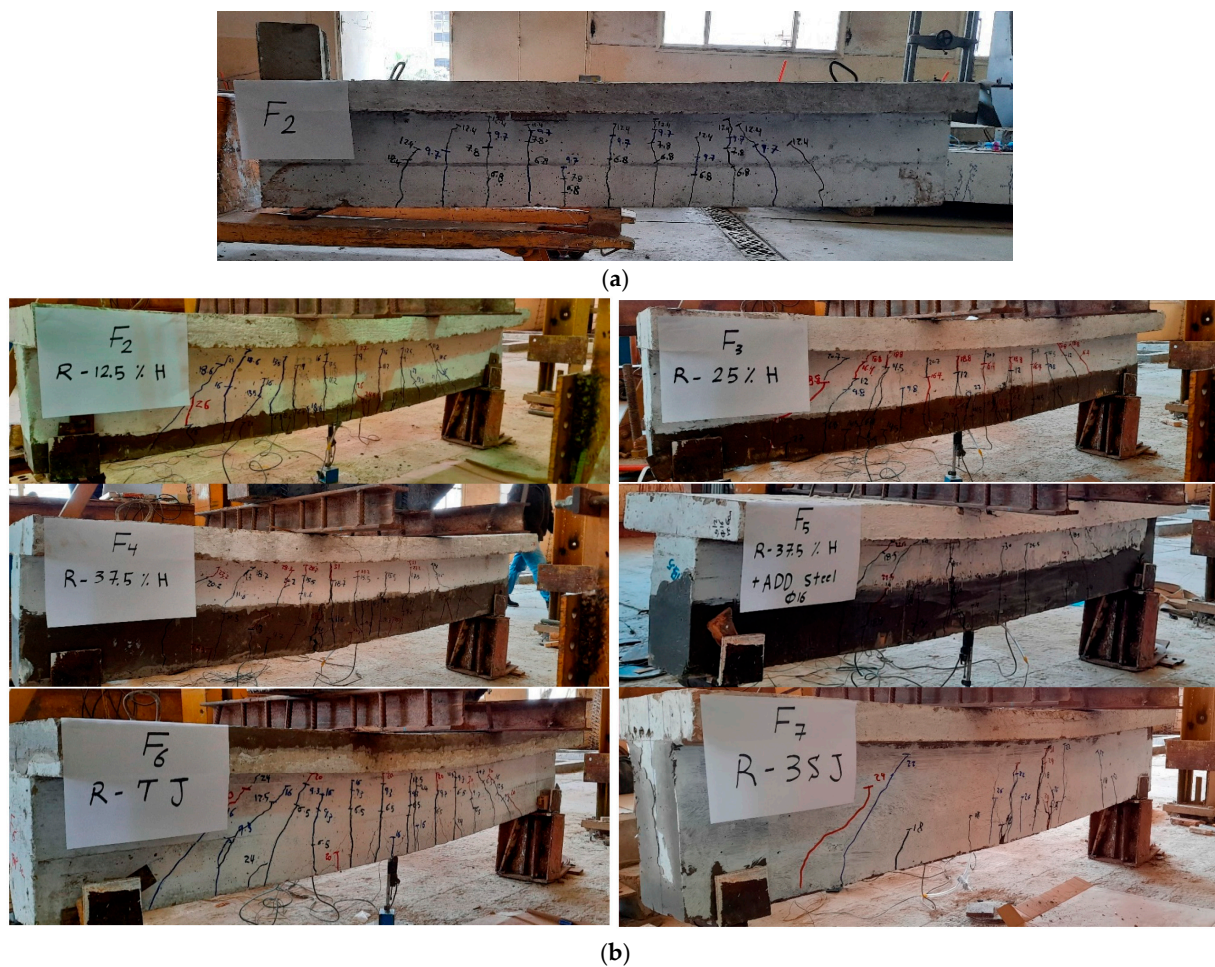
Figure 12. (a) Crack pattern of an identical beam at 50% loading level; (b) crack pattern for repaired T-beams F2–F7.

In this section, experimental test results from beams repaired by SFRGPC are presented and discussed. The method used to identify the failure mode of each test beam involved analysing the pattern of crack initiation and propagation, measuring the width of the cracks, determining the initial stiffness (P/Δ), observing load deflection, identifying peak loads, and measuring ductility (deflection values at ultimate load). These findings were then used to study the performance of preloaded beams that were repaired with SFRGPC, which was the focus of the experimental program. Figure 12a shows the crack pattern of beam F2 at the 50% loading stage and before the repair procedure. It was noted that the crack pattern for all beams at this level was nearly similar, and the visual inspection showed about 11 cracks that start from the bottom face of the beam and extend vertically near the

lower face of the slab. Briefly, the failure pattern mode for all repaired T-beams is shown in Figure 12b.

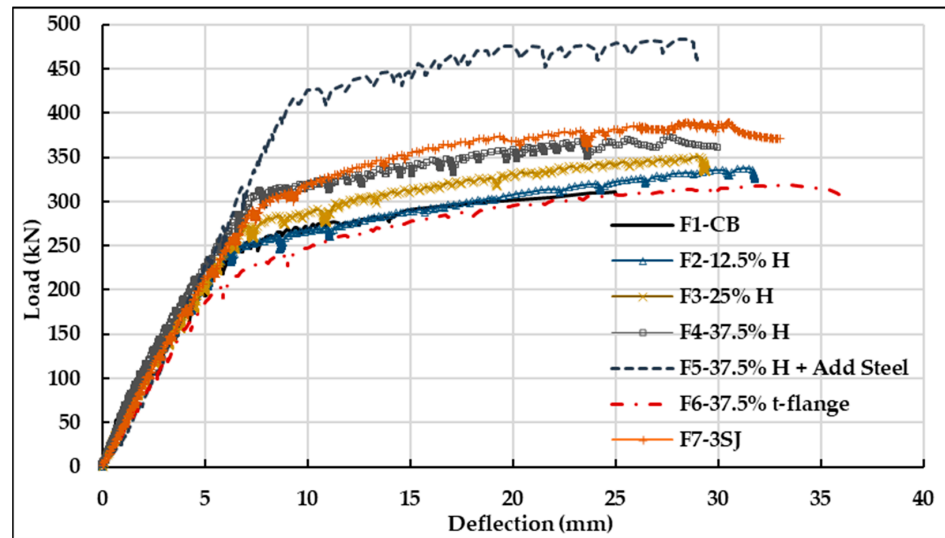
Figure 13. Load–deflection for all flexural repair techniques.

By inspecting Figure 13, it appears that the control beam (F1-CB) capacity was 310 kN, with a peak deflection of 25 mm. However, the peak load of F2, F3, and F4 was 337 kN, 350 kN, and 372.3 kN with an increase in load capacity of repaired beams compared to F1-CB by 8.7%, 12.9% and 20.1%, respectively, and higher ultimate deflection values of 31.23 mm, 29.08 mm, and 27.7 mm, respectively, indicating that the repaired beams were more ductile than F1-CB.

In beam F5, which is similar to F4 but with additional reinforcement on the tension side, the improvement in ultimate load reached about 56% and 30% in comparison to F1-CB and F4, respectively. It is obvious that embedding steel into repair material represents a very successful way of repairing concrete beams. However, it is important to note that the peak deflection was 28.5 mm, which depicts more ductile behaviour than F1-CB and F4. Furthermore, the repaired beam at the compression side (F6) has a peak load of 318.4 kN, which is relatively close to F1-CB and a higher deflection of approximately 33.1 mm than F1-CB. This higher deflection can be attributed to the degraded stiffness of the preloaded beam, which was not treated during the repair process, as the repair was on the compression side only.

The T-beam repaired with three-sided jackets (F7) had the highest capacity with fibres only, sustaining a maximum load of 390 kN; this represents a capacity increase of 25.8% in comparison to the control beam. Furthermore, its deflection was observed to be 30.5 mm. This value indicates the ductility of the beam, which refers to its ability to undergo significant deformation before failing. A high deflection value can be a desirable property in some situations, as it can help dissipate energy and prevent sudden and catastrophic failure.

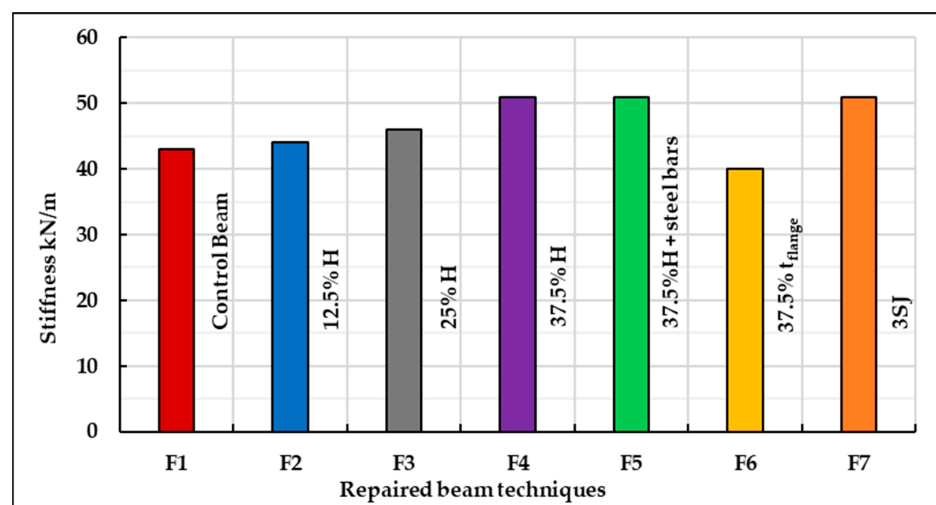
Figure 14. Comparison of stiffness for all repair techniques.

The initial stiffness (P/Δ) of the repaired pre-damaged T-beams was significantly increased by the addition of layers of SFRGPC, as shown in Figure 14. The maximum initial stiffness was achieved by beams F4, F5, and F7, which had an initial stiffness of 51 kN/mm, representing an 18.6% increase compared to the initial stiffness of F1-CB. On the other hand, the repaired beams F2 and F3 achieved a slight increase in initial stiffness of about 2% and 7%, respectively, compared to the control beam F1-CB. It is worth noting that the repaired beam F6 on the compression side had lower stiffness due to the previous crack pattern at the preliminary stage of pre-damaged. Overall, the results indicate that the repaired beams with SFRGPC can effectively improve the initial stiffness and performance corresponding to peak loads.

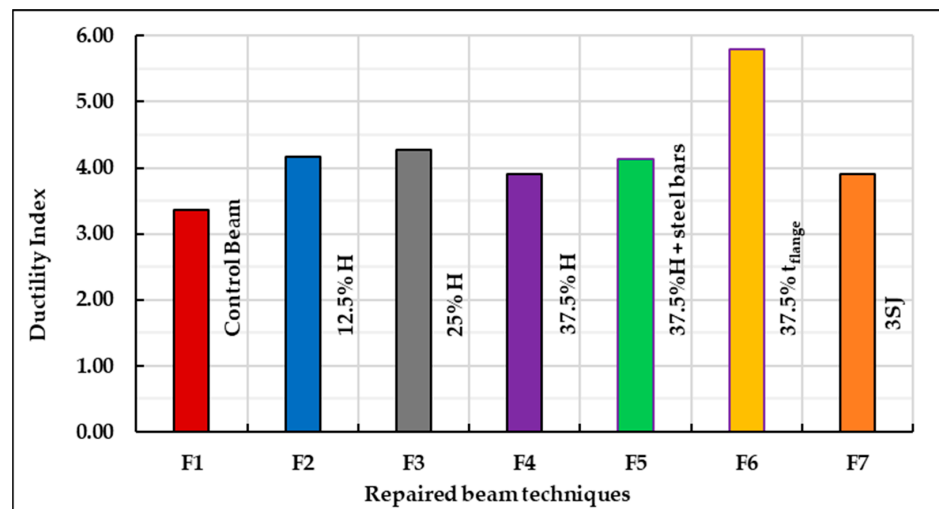
Figure 15. Ductility index for all repair techniques.

The ductility index is calculated as the ratio of the deflection under peak load (Δ_p) to the deflection under yield load (Δ_y). It measures a beam’s ability to sustain inelastic deformation without significantly reducing its load-carrying capacity [55]. From Figure 15, it can be observed that the control beam F1-CB experienced a ductility index of 3.36. All repaired beams at the tensile side experienced a ductility index of 3.9 to 4.28, which is more than F1-CB by 16–27%. The repaired beam at the compression side F6 experienced a ductility index of 5.8, which is more than the control beam by 70%; this is attributed to the reduced value of beam deflection at the yield load in combination with the enhanced peak deflection due to the contribution of the fibrous repair material at compression side at the ultimate stage as it possesses higher compressive strength than OPC material.

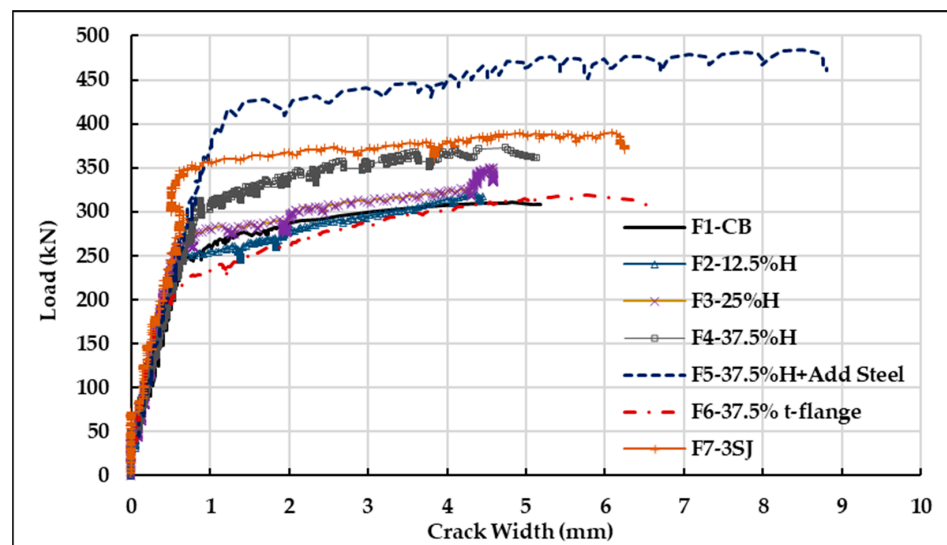
Figure 16. Crack width for all repair techniques at yield and peak.

Figure 16 shows that the crack width at yield load for F1-CB was about 0.7 mm, while for all repaired beams, it was between 0.43 and 1.2 mm. The crack width at peak load for F1-CB was 5.1 mm, while for F2, F3, and F4 was 5.68, 4.6, and 4.75 mm, respectively. However, it increased by 66% for F5 and 20% for F7 due to their high carrying capacity. In the case of the F6, the crack width increased by 11% due to the preloading stage.

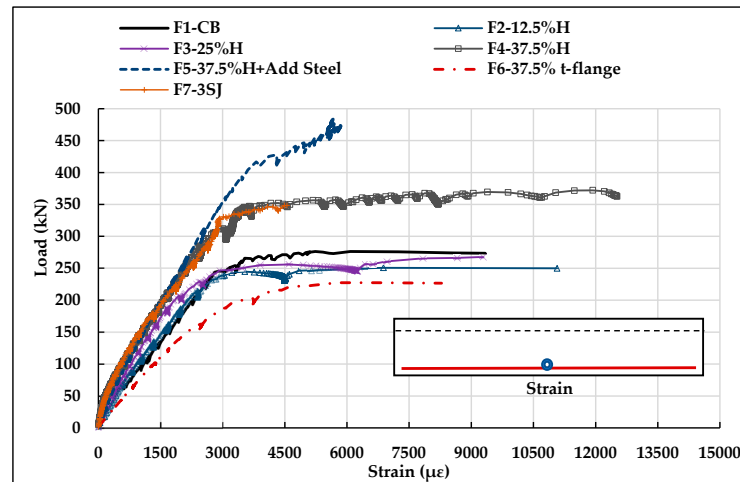
Figure 17. Strains measured in longitudinal reinforcement for all repair techniques.

Strain gauges were installed on the longitudinal reinforcement to show where the failure of the beam develops, as shown in Figure 17. The steel-yielding plateau is obvious for all beams except for F5. It may be comprehended that this additional bar, in conjunction with fibrous repair material, started to change the failure pattern of the beam from tension to compression failure.

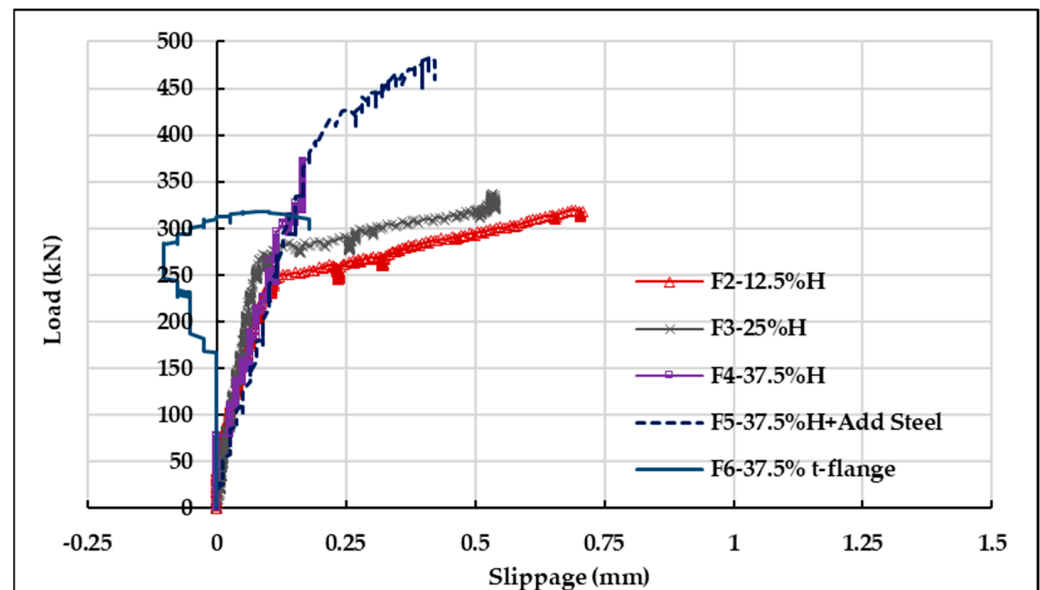
Figure 18. Load-slippage values for the repaired T-beams.

Figure 18 shows the slippage at the interface for different repair techniques; the maximum slippage was observed for F2, and the minimum slippage was observed for F6.

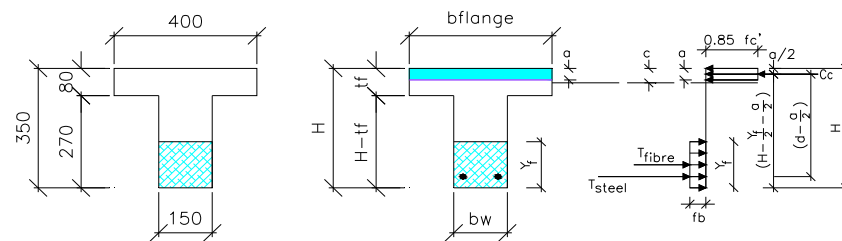
Figure 19. Section dimension and stress diagram for beams F2, F3, F4, and F5.

To determine the beam strength, it is necessary to achieve equilibrium between the internal forces and stress resultants for repair beams F2, F3, F4, and F5, as illustrated in Figure 19. According to the equivalent stress diagram, the compression stress in the compression zone is $0.85 f_c'$. The resultant force of the bottom steel bars (T_{steel}) acts at the centre of the steel bars. Moreover, the contribution of the tensile stress in the SFRGPC ($T_{i,fibre}$) adds to this couple.

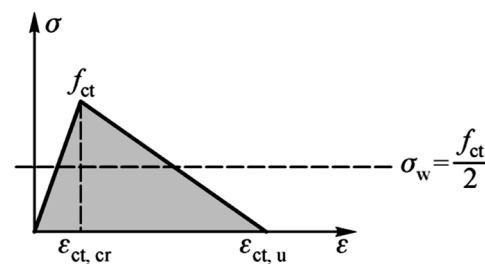
Figure 20. Idealised tensile stress contribution.

For simplicity, a uniform tensile stress might be considered [58,59], as shown in Figure 20.

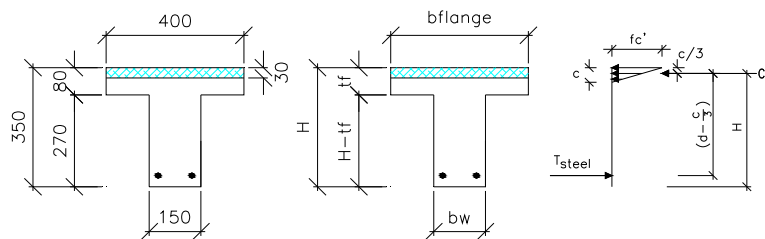
Figure 21. Section dimension and idealised stress diagram for beam F6.

Figure 21 shows the section dimensions and equivalent stress distribution for repair beam F6-37.5% ts-flange at the compression.

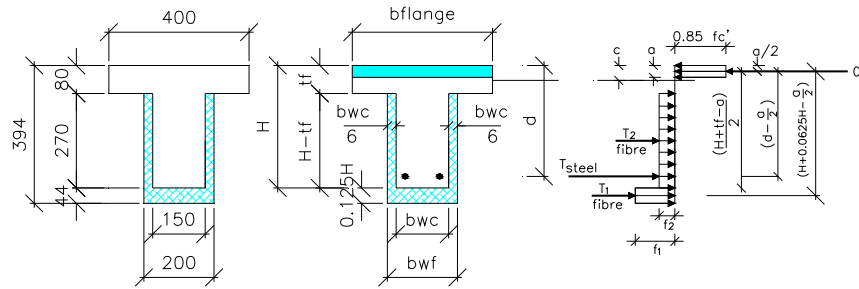
Figure 22. Section dimension and idealised stress diagram for beam F7.

Figure 22 shows the section dimensions and equivalent stress distribution for repair beam F7-3SJ.
