Article

Environmental Transformation and the Current State of Hydrogeological Condition in the Wojkowice Area—Southern Poland

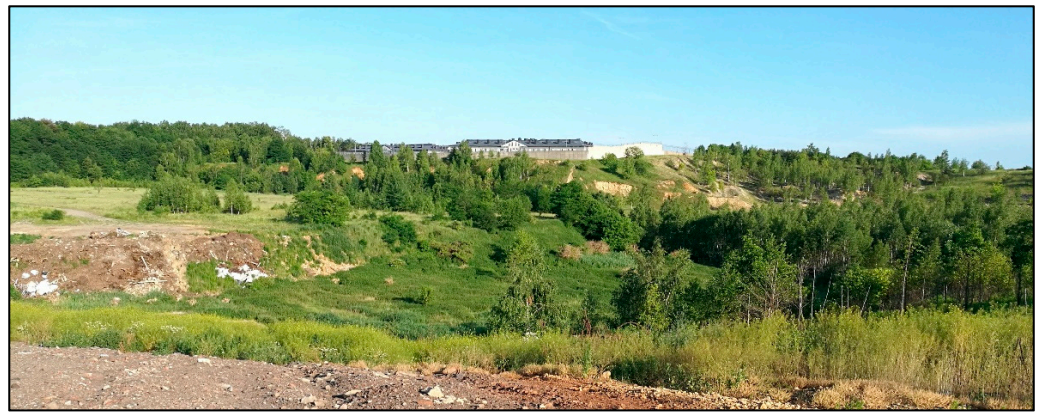
Figure 3. View towards the south-east showing part of the “Saturn” Cement Plant (in the background is the penitentiary in Wojkowice). Photo by A. Zarychta.

In order to better display the largest transformations of the landscape in Wojkowice, a 14,000 m long line of topographic profile A–I (Figure 2a,b,g) was marked across these objects (Figure 2g). In profile A–B, at a distance of 1900 to 2600 m, there is a depression which originated due to extraction activity of the “Saturn” Cement Plant. As a result of mining, this area has dropped by almost 36 m (from 315 to 279 m a.s.l.) (Figure 3).

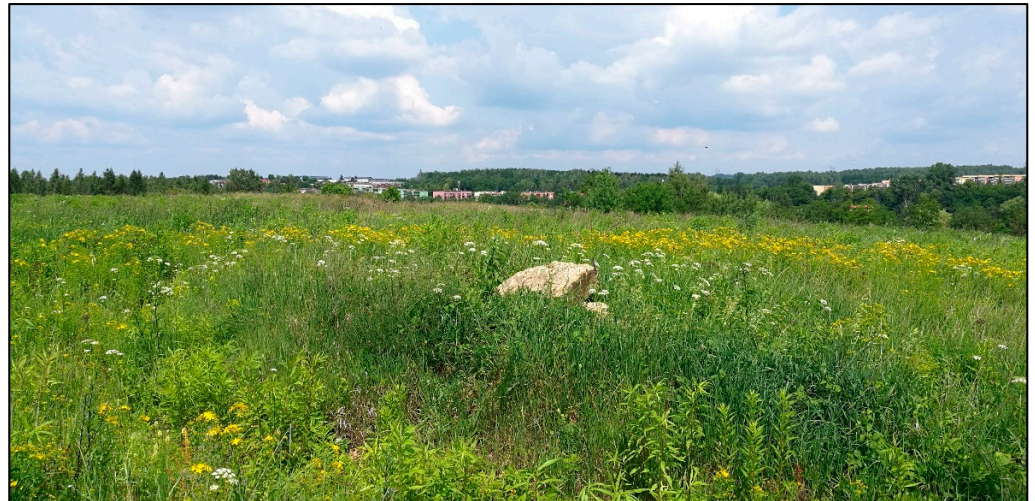
Figure 5. The patches of *Solidago canadensis* in agriculture wasteland. Photo by R. Zarychta.

The non-forest (herbaceous) communities in the town's ecosystem mainly consist of arable fields and wastelands at various stages of succession (Figure 5). Small areas are represented by xerothermic grasslands occurring in new ecological niches and the largest complexes of these grasslands develop within the inactive post-limestone workings of the "Saturn" Cement Plant (Figure 1).

Unused farmland is subject to spontaneous succession often initiated by *Solidago canadensis* (Figure 5). This is an invasive species which is native to North America and characteristic of the *Rudbeckio-Solidaginetium* association. *Calamagrostietum epigeji* communities naturally colonize agricultural wastelands and reclaimed areas associated with municipal waste (Żychcice–Saturn and post-limestone quarry–Figure 1) in the form of large patches. It creates single species aggregations and makes it difficult for other species to encroach.
